# Contaminated Land Phase One Desk Study for Proposed redevelopment of the existing residential property into a new residential dwelling at Little Nook Farm, Heywood Old Road, Manchester, M24 4GS.

Prepared for:

SM Properties,  
Little Nook Farm,  
Heywood Old Road,  
Manchester,  
M24 4GS.

September 2025

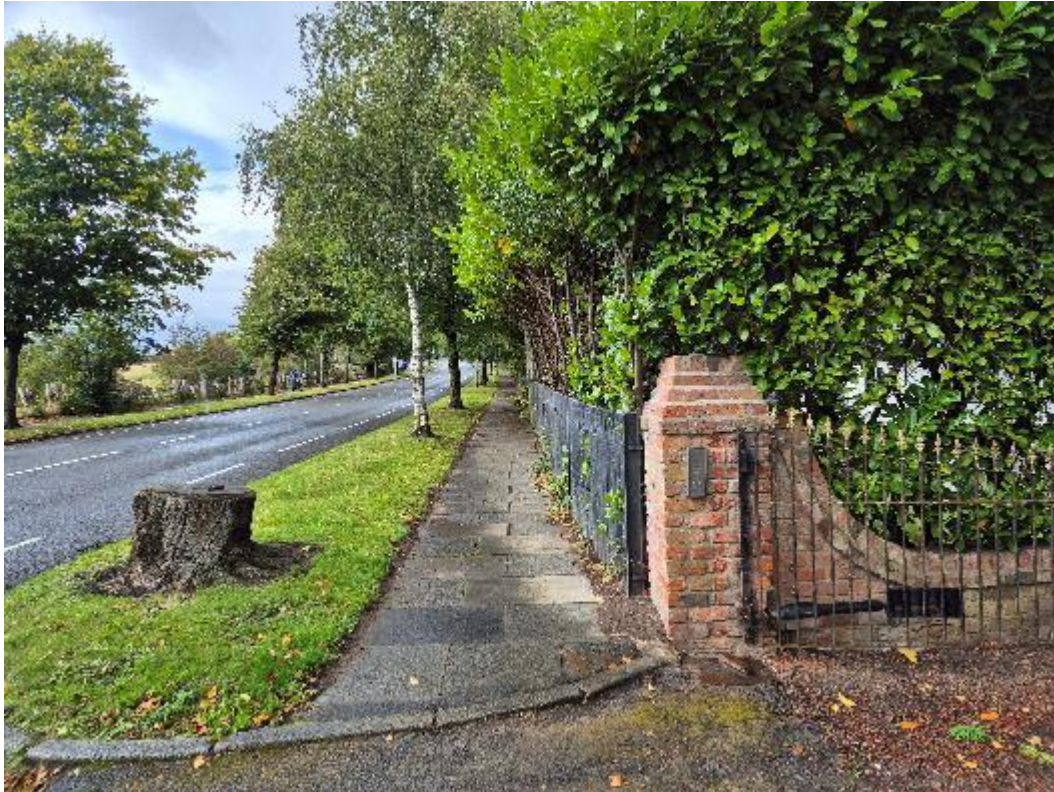
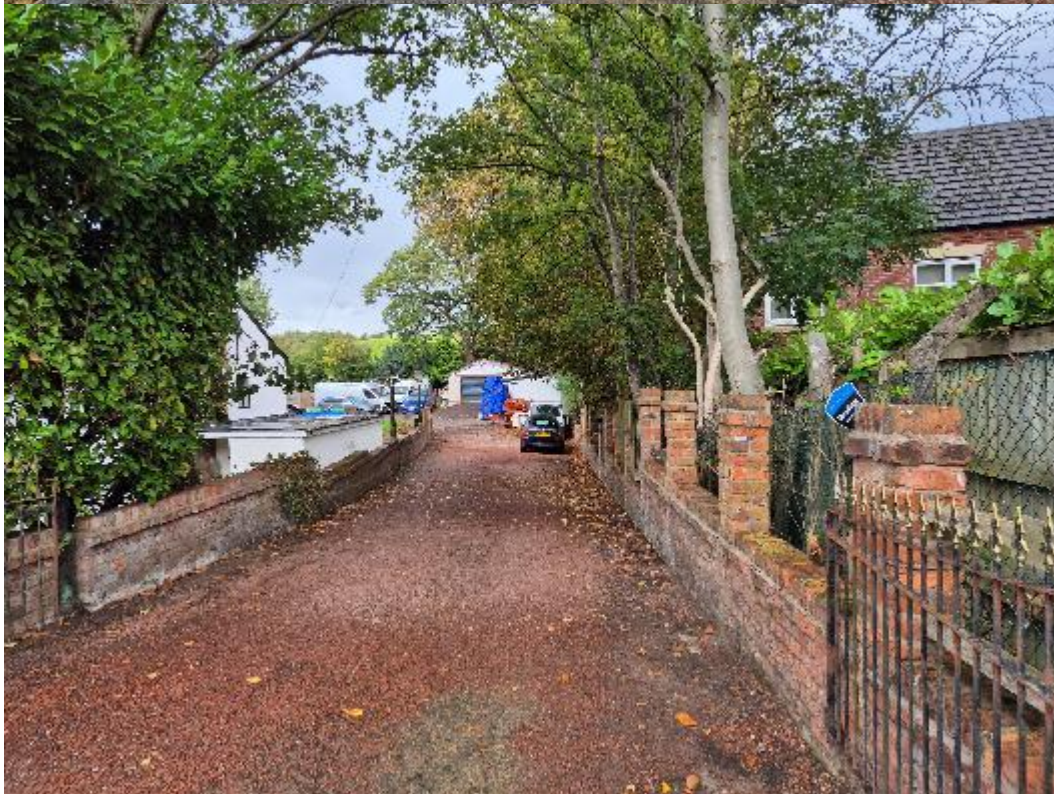
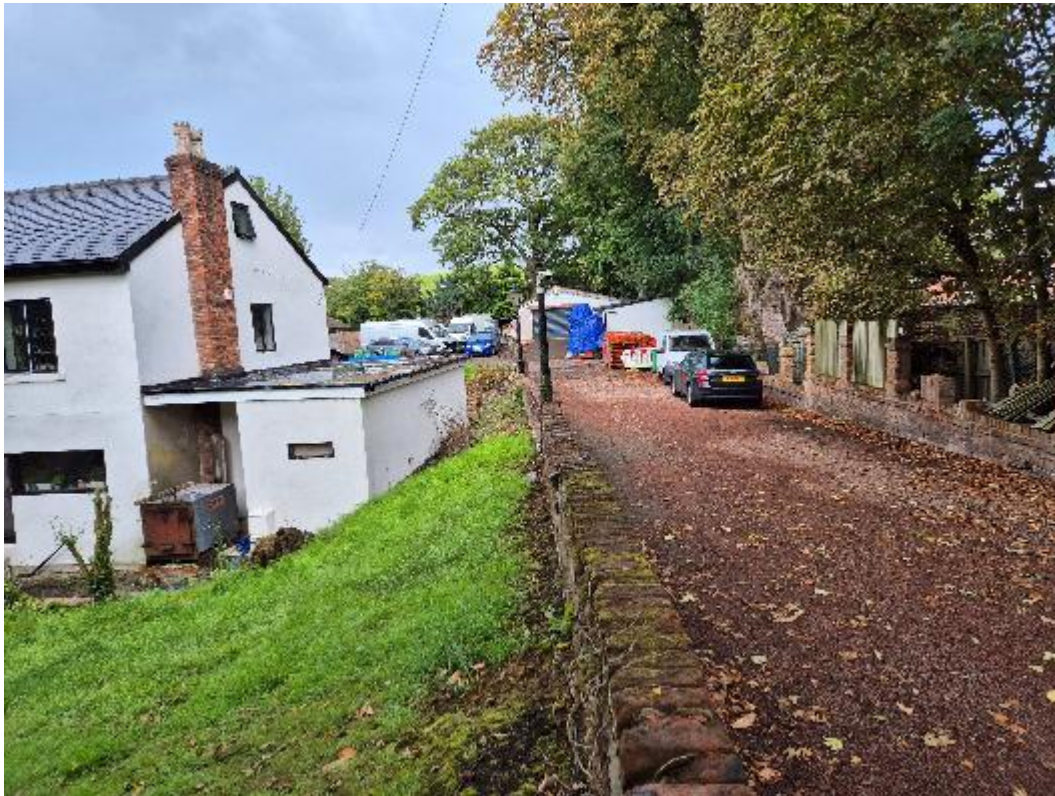
Access into the site and the western boundary

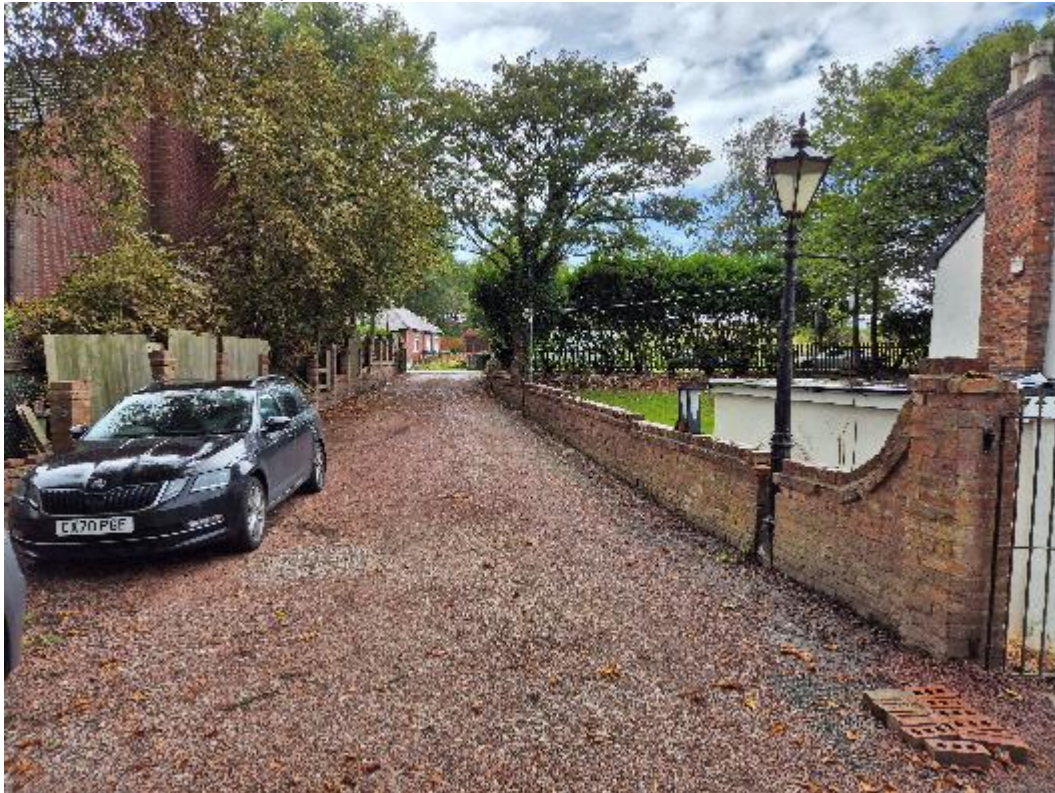
The back to the access point

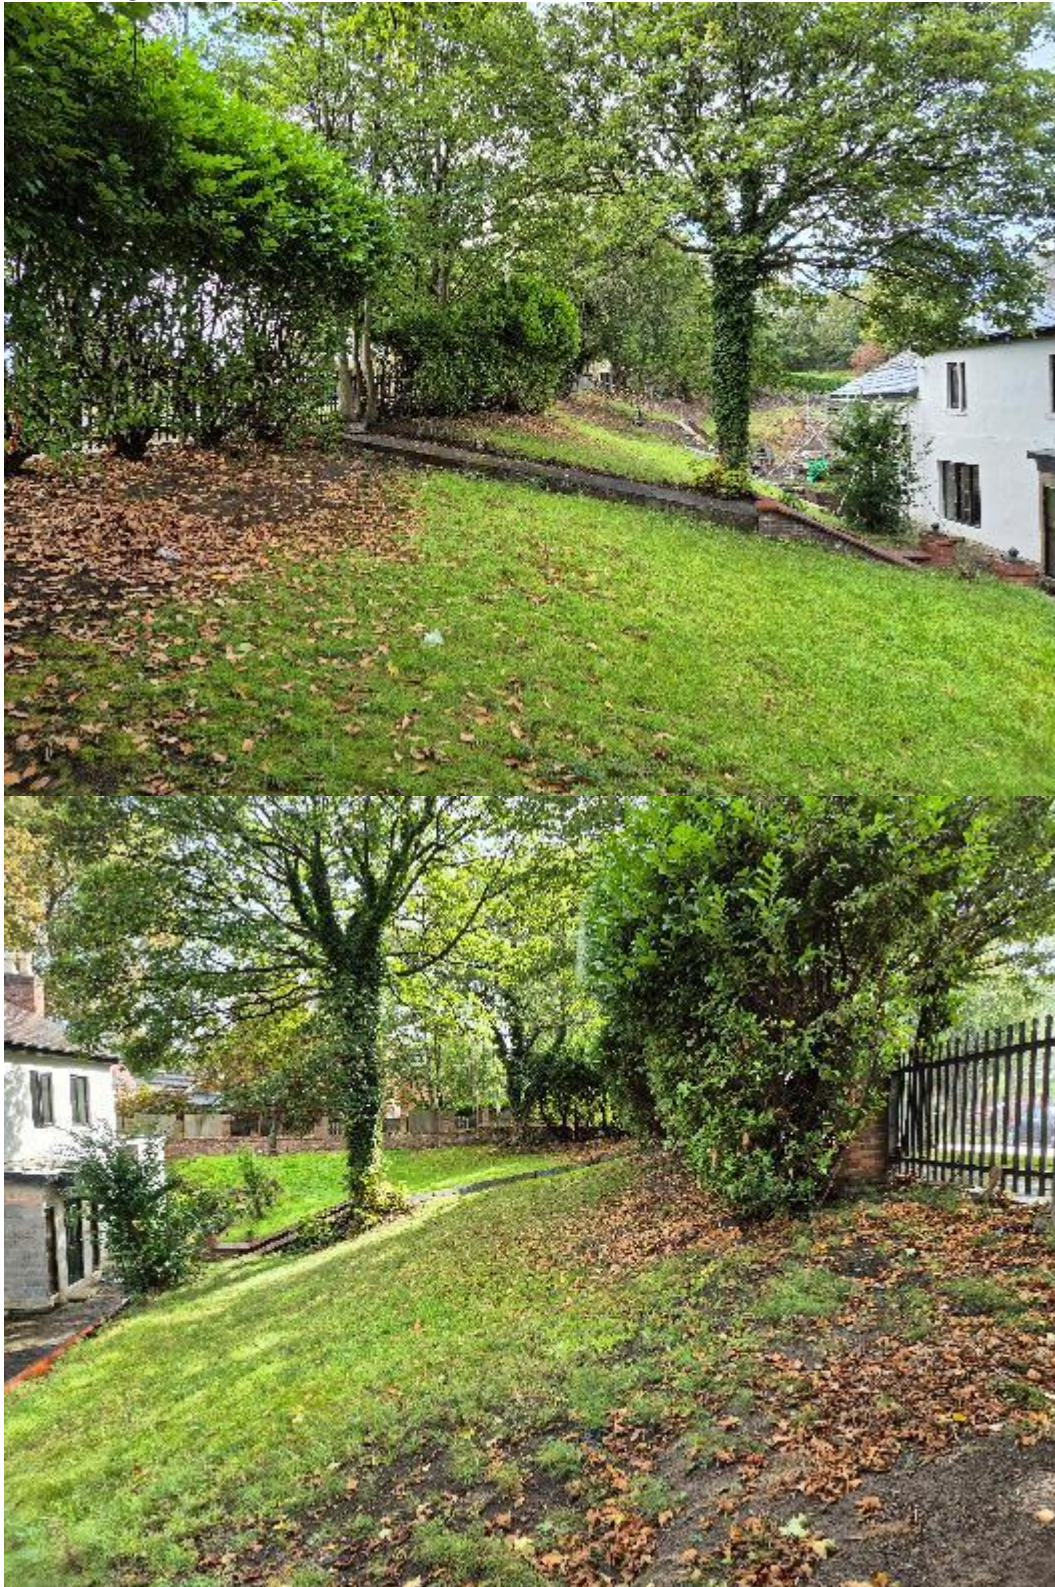
The Front garden along the roadside

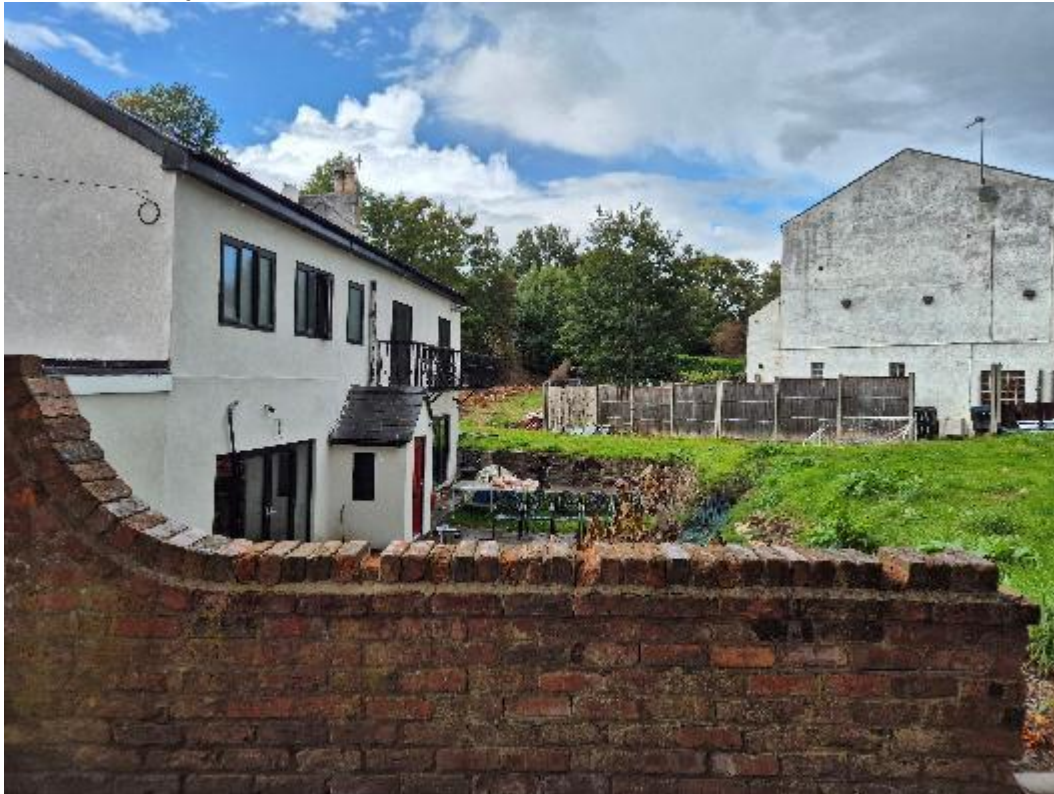
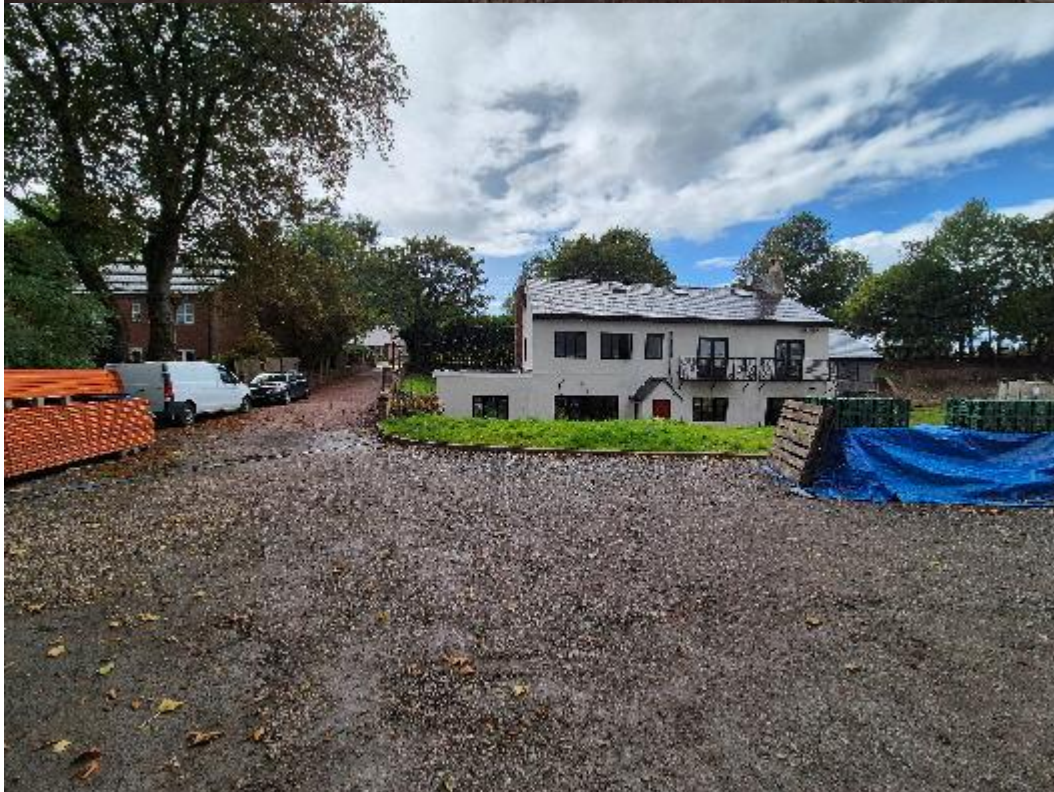
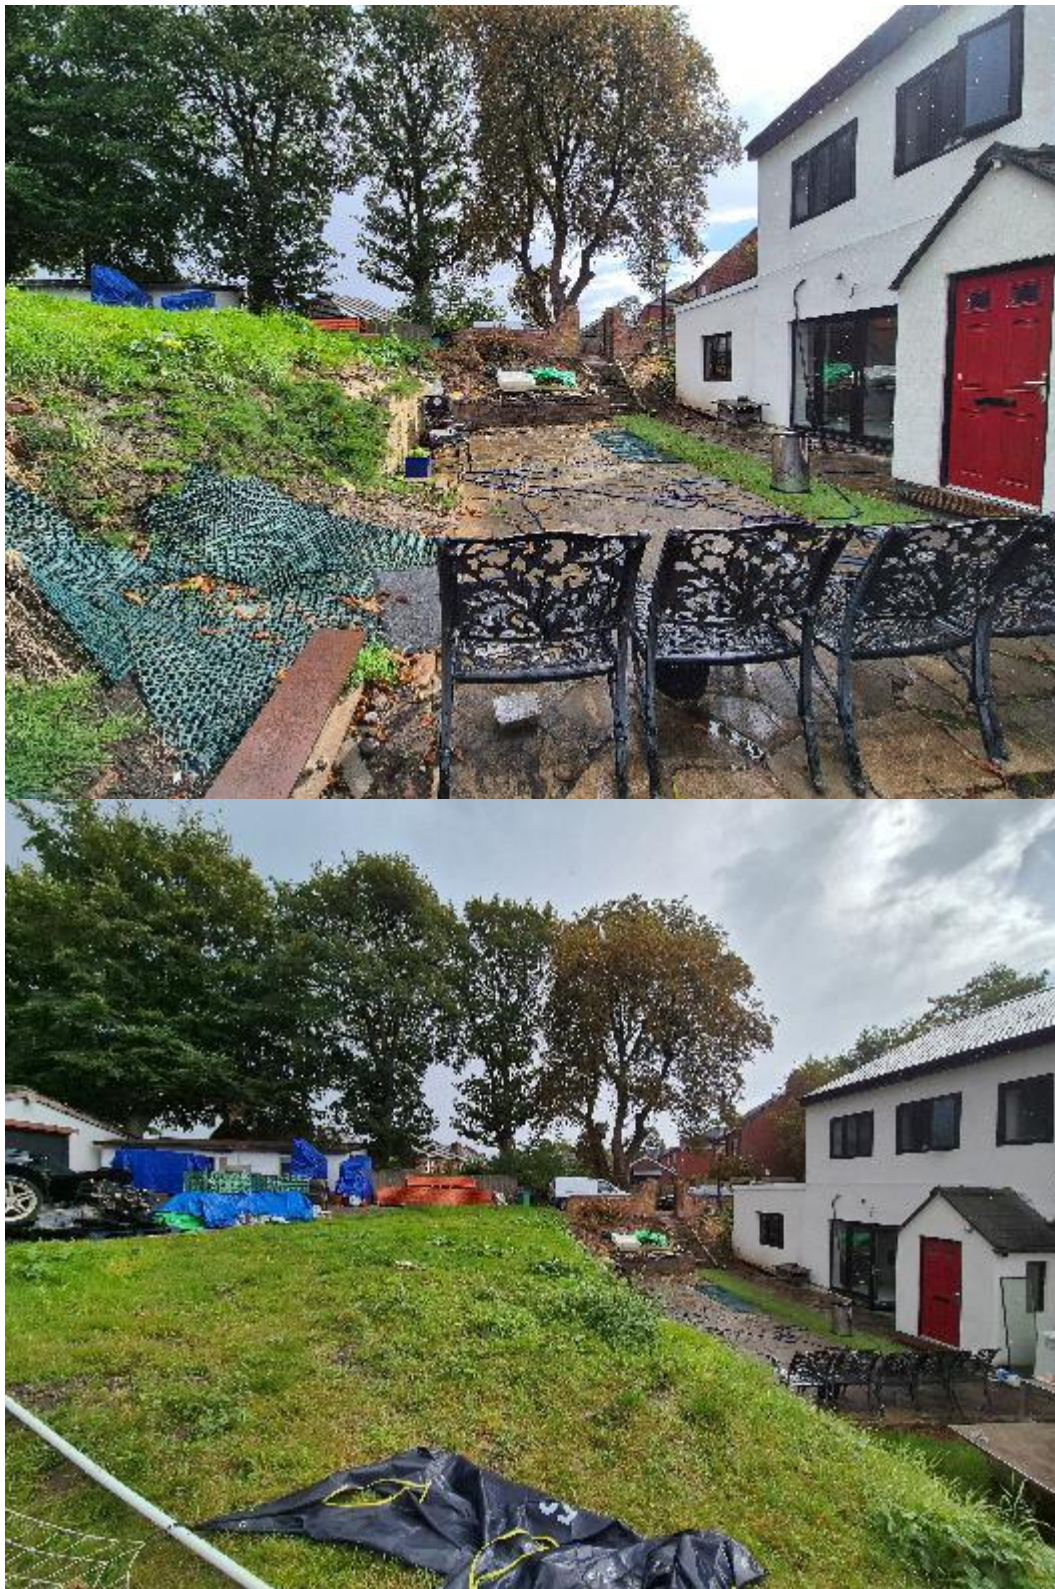
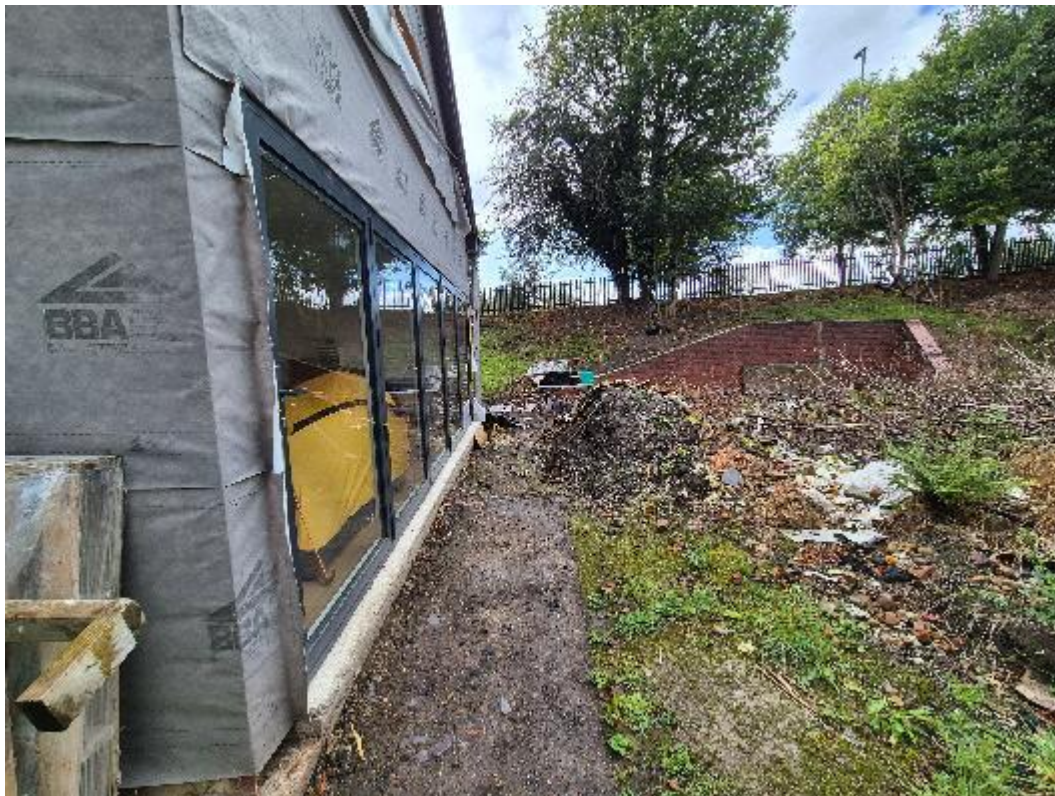
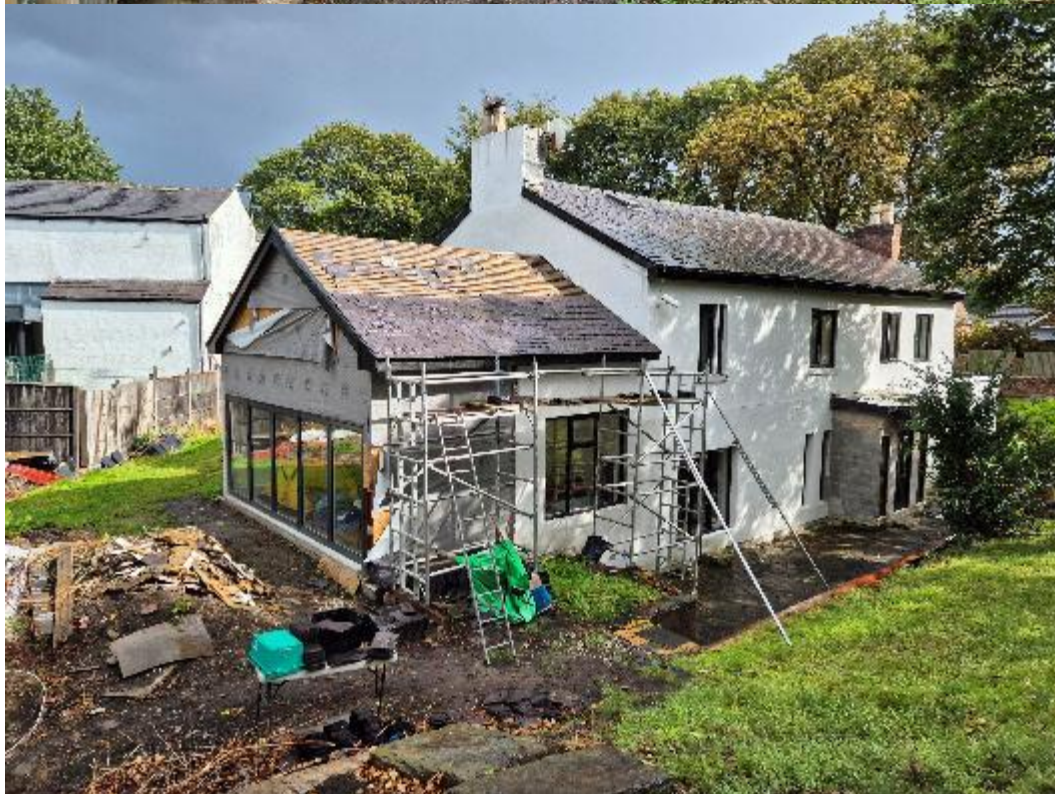
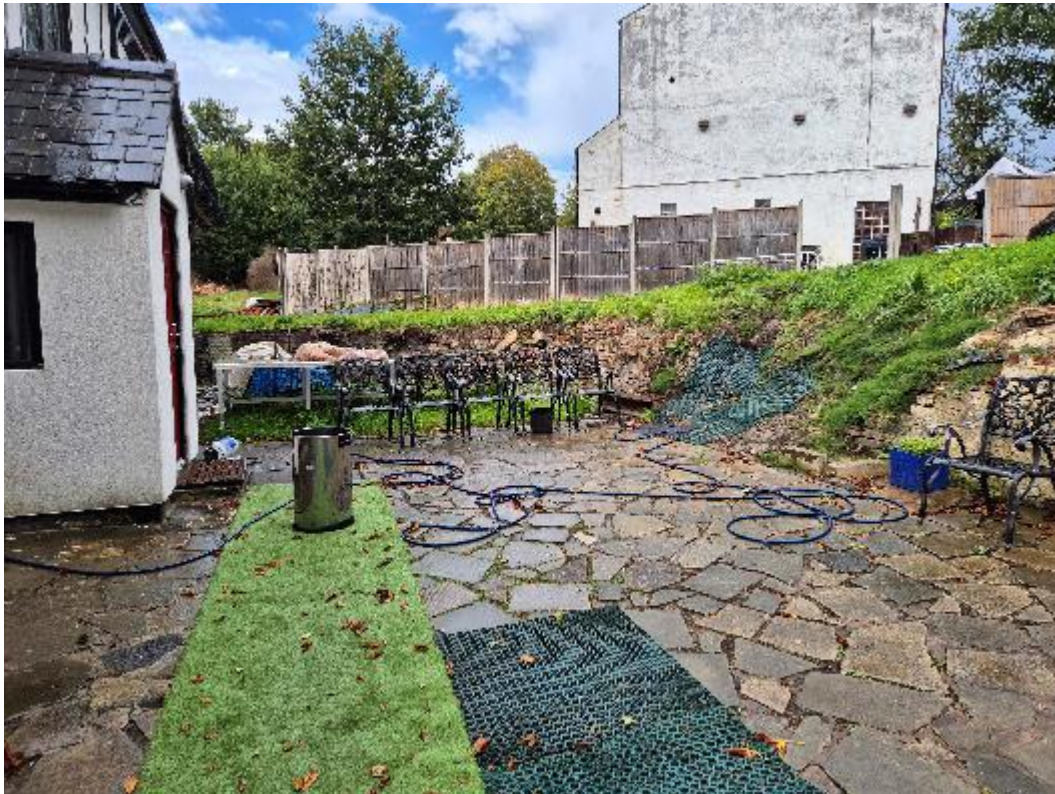
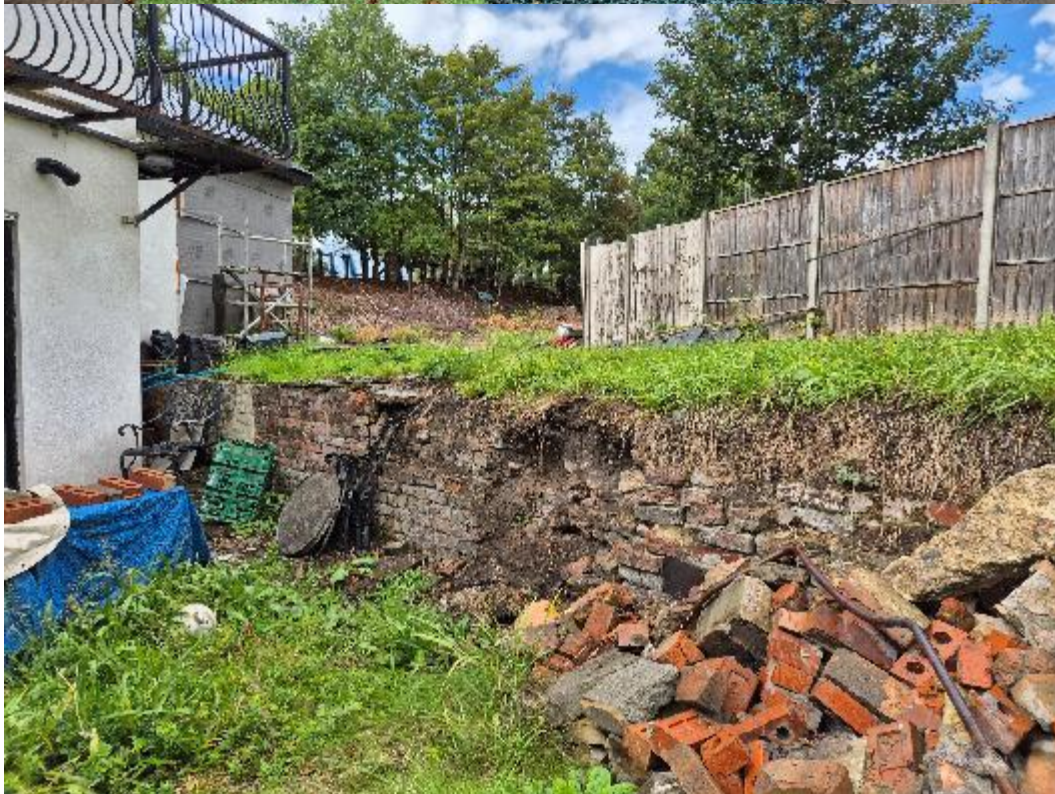
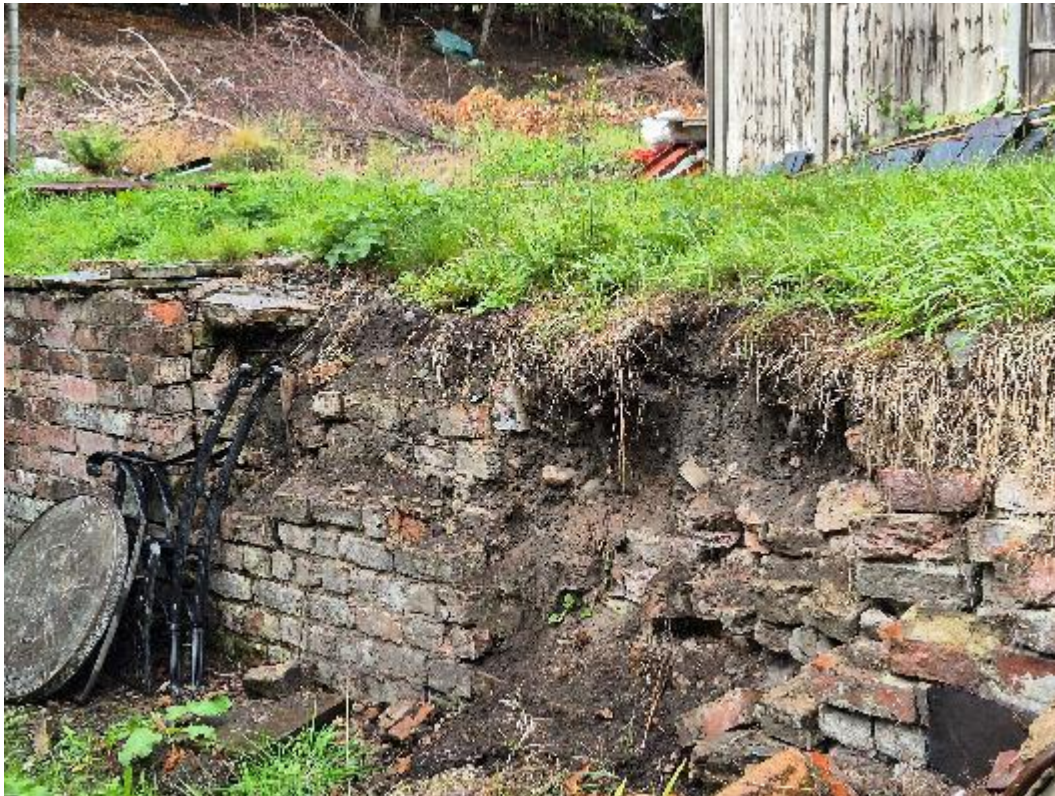
The existing house and rear patio area, looking at the southern façade, rear façade, northern façade and western façade.

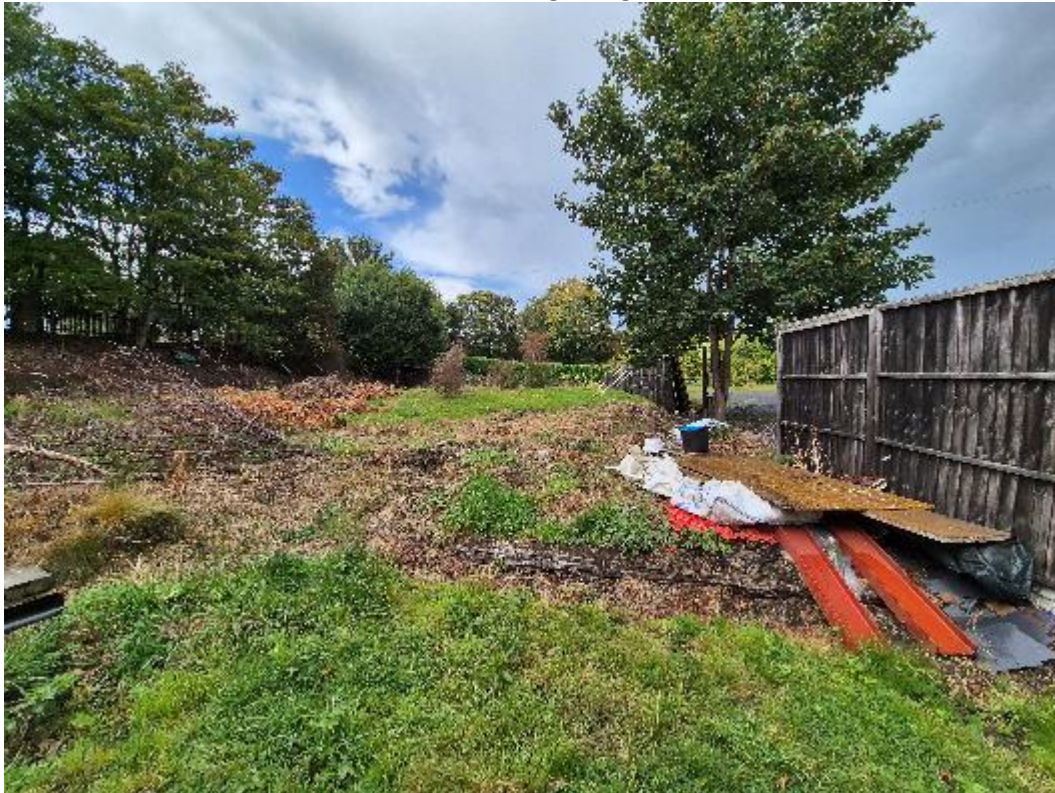
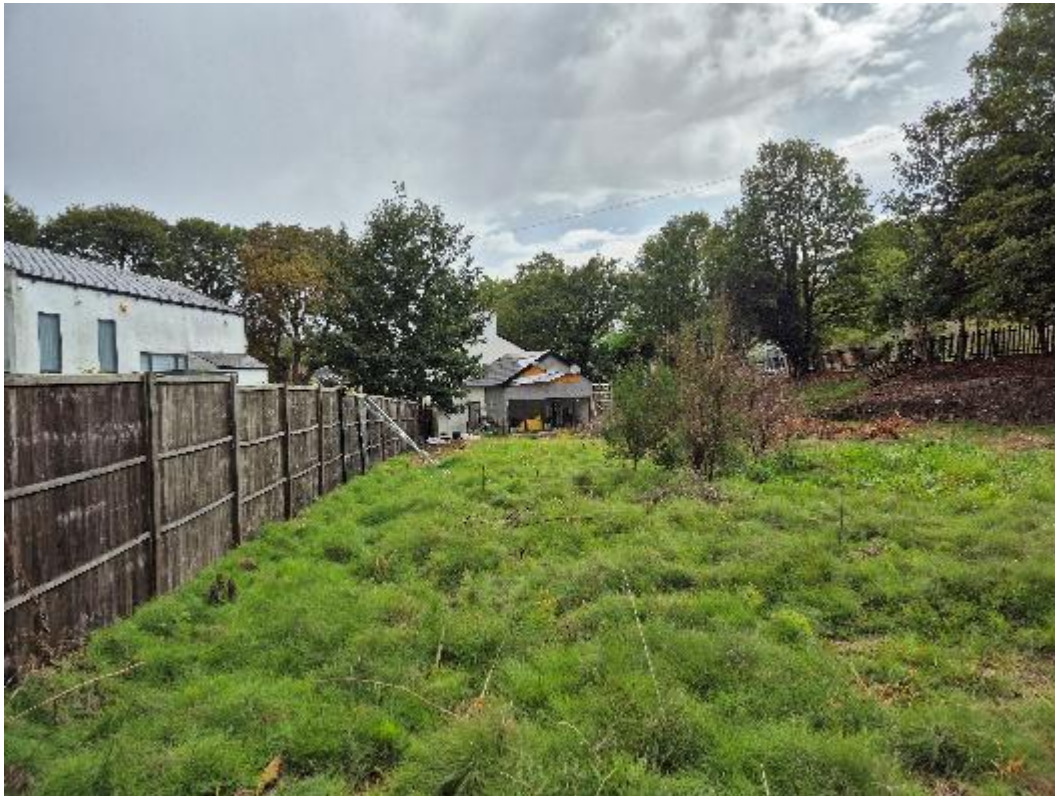
Garden area to the north of the house, looking along the eastern boundary north and south

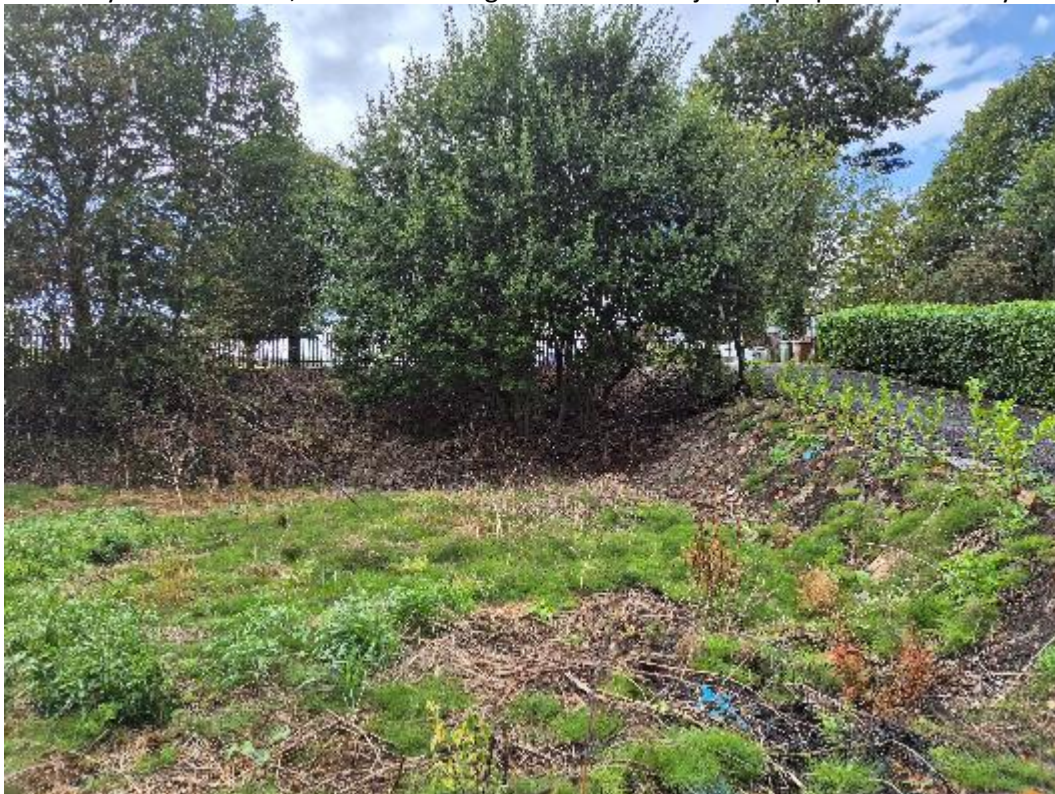
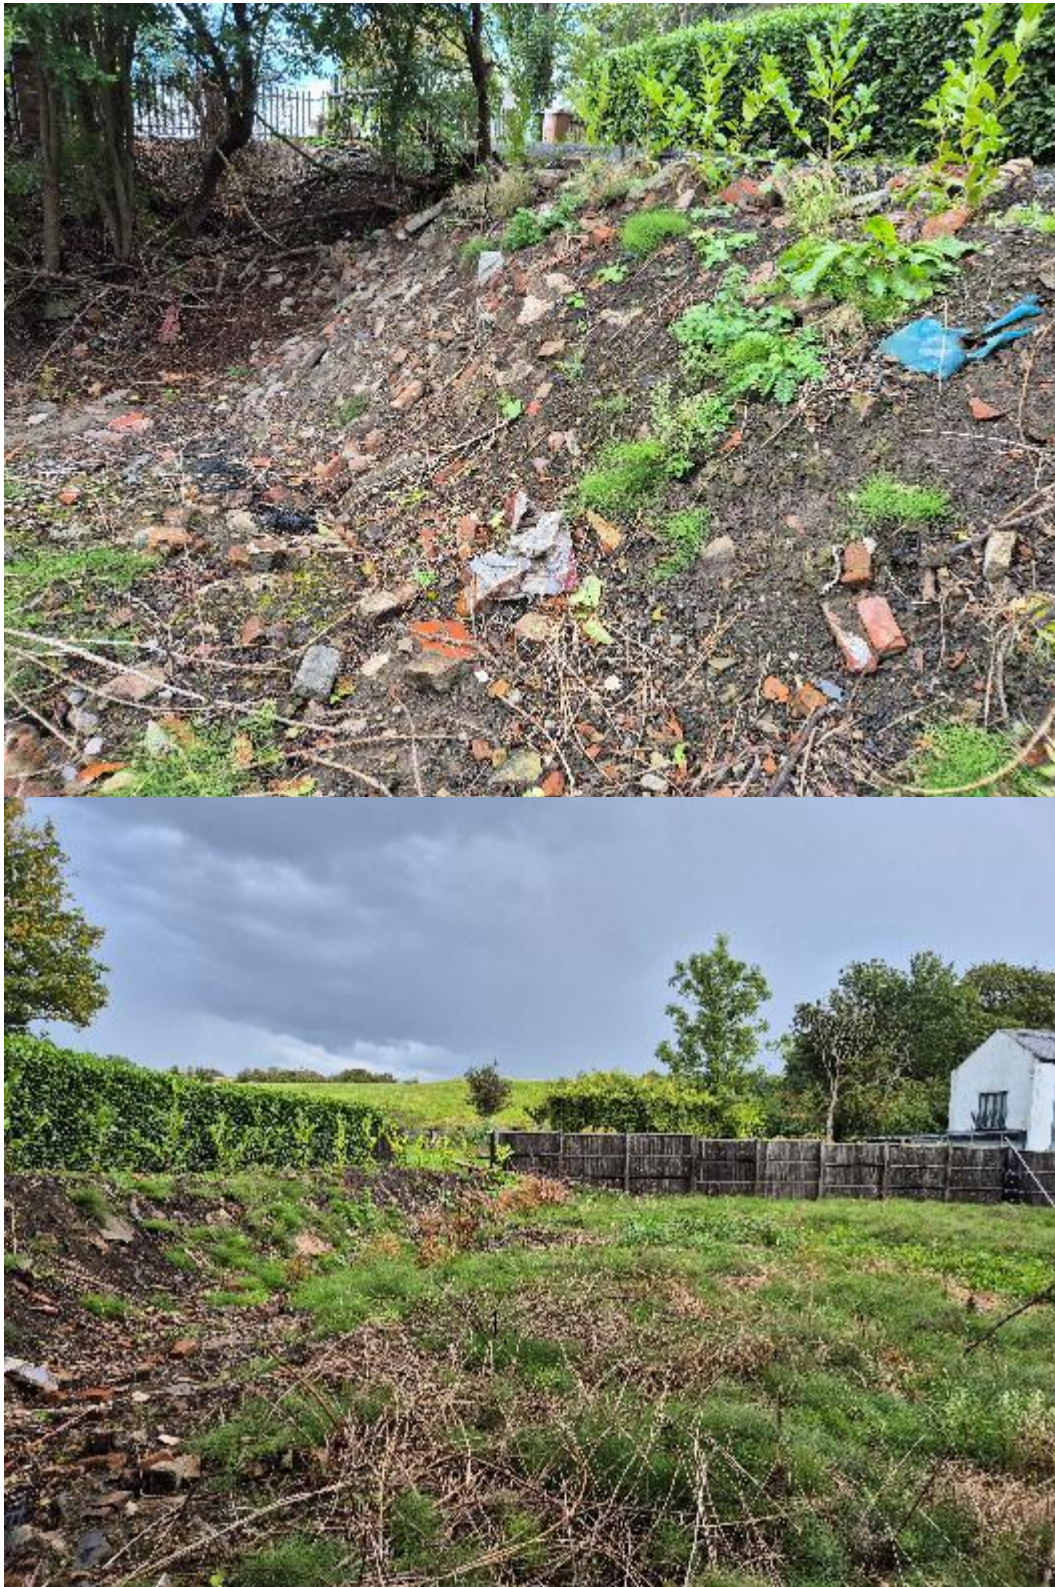
Northern

boundary west and east, with the made ground for the adjacent properties driveway.

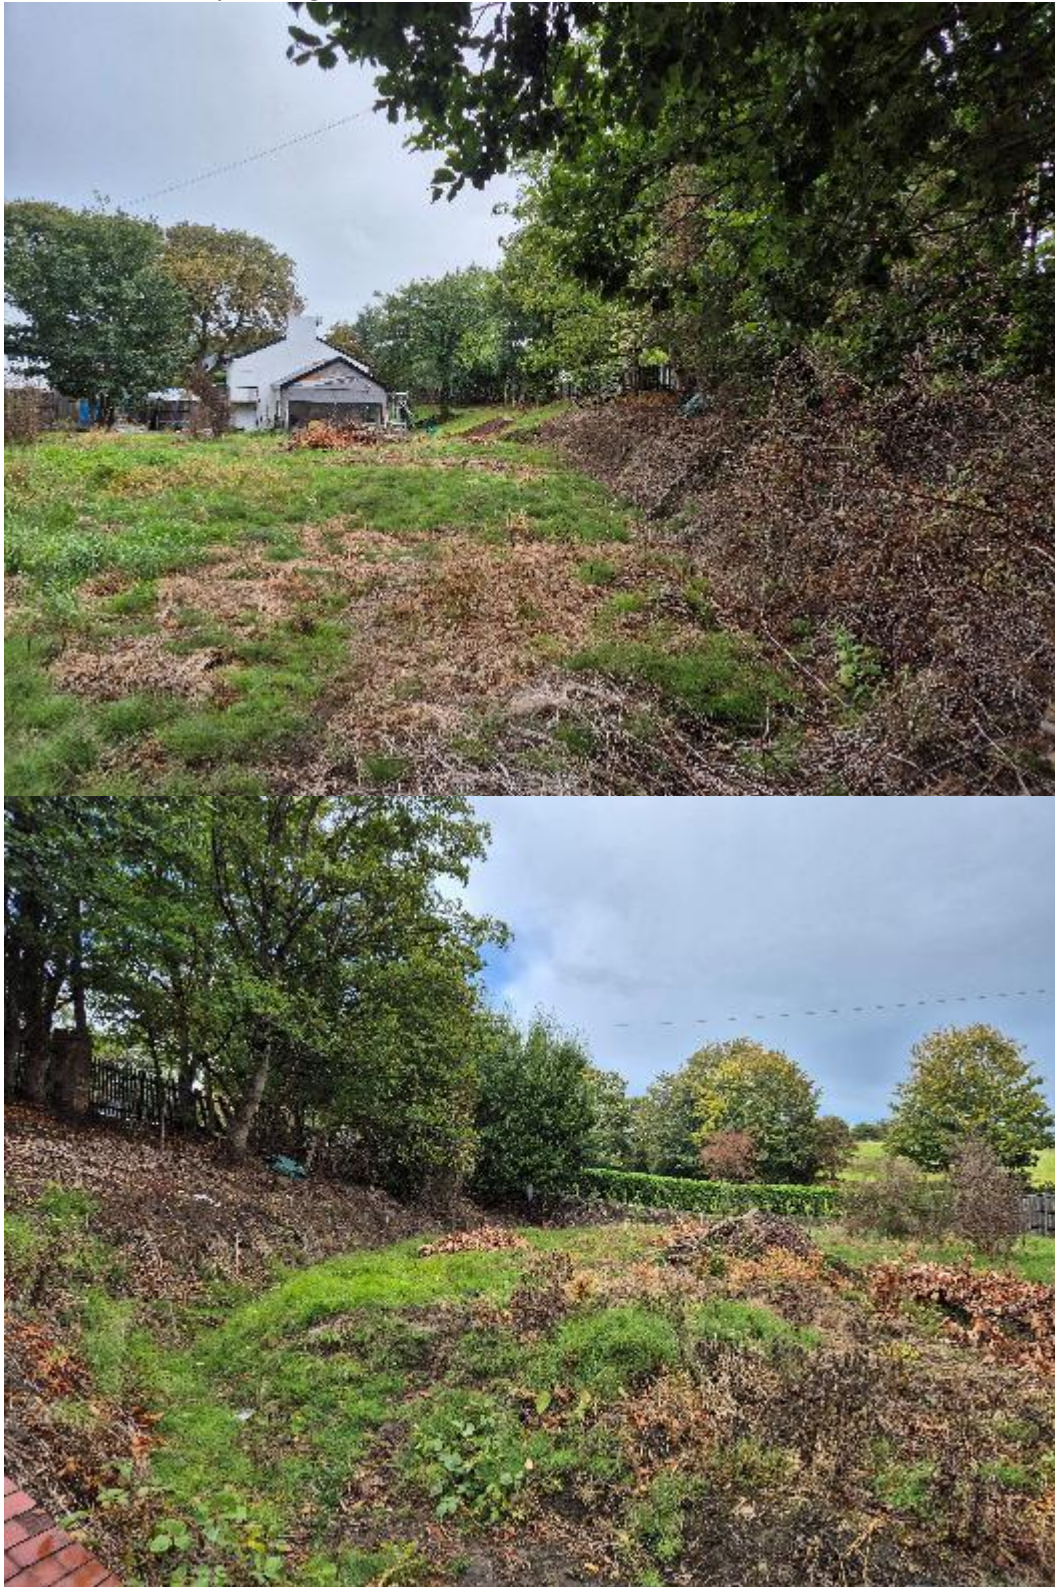
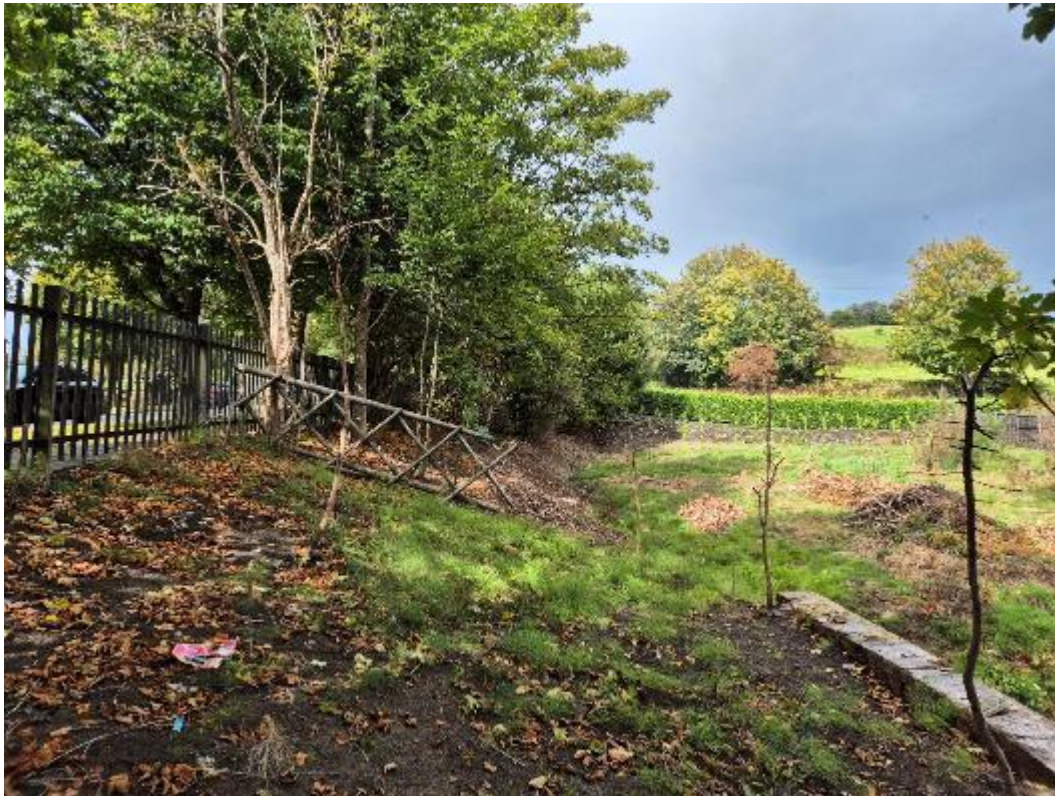
Western boundary looking south then north

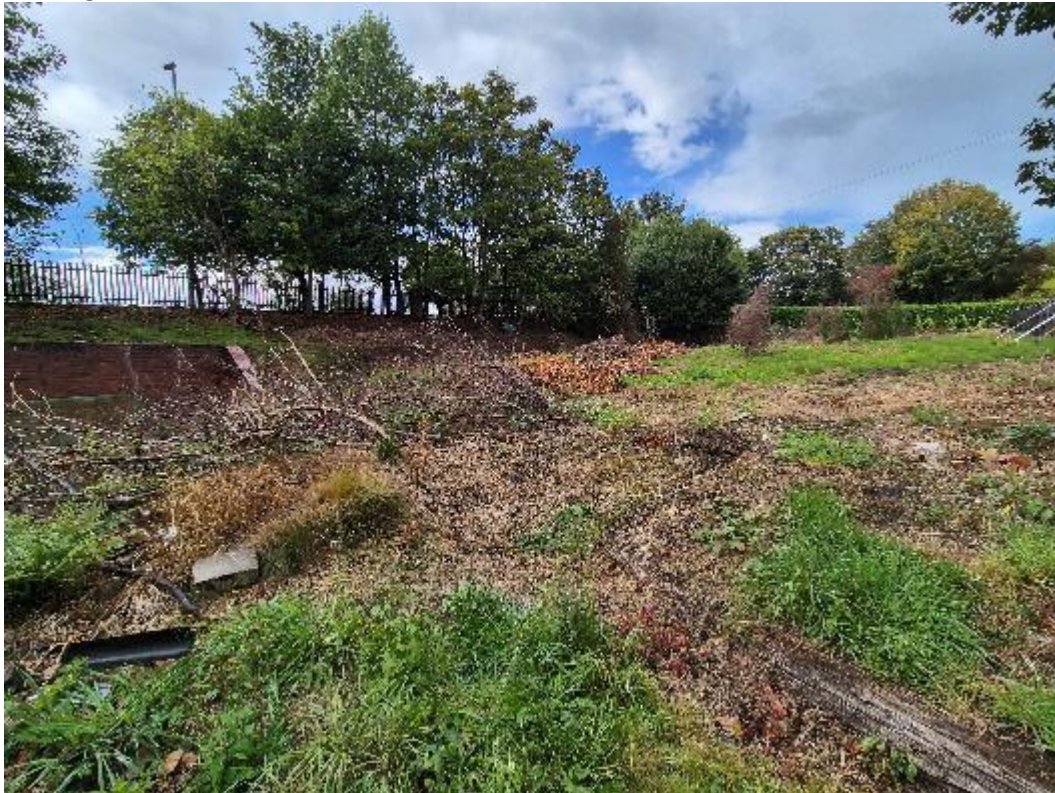
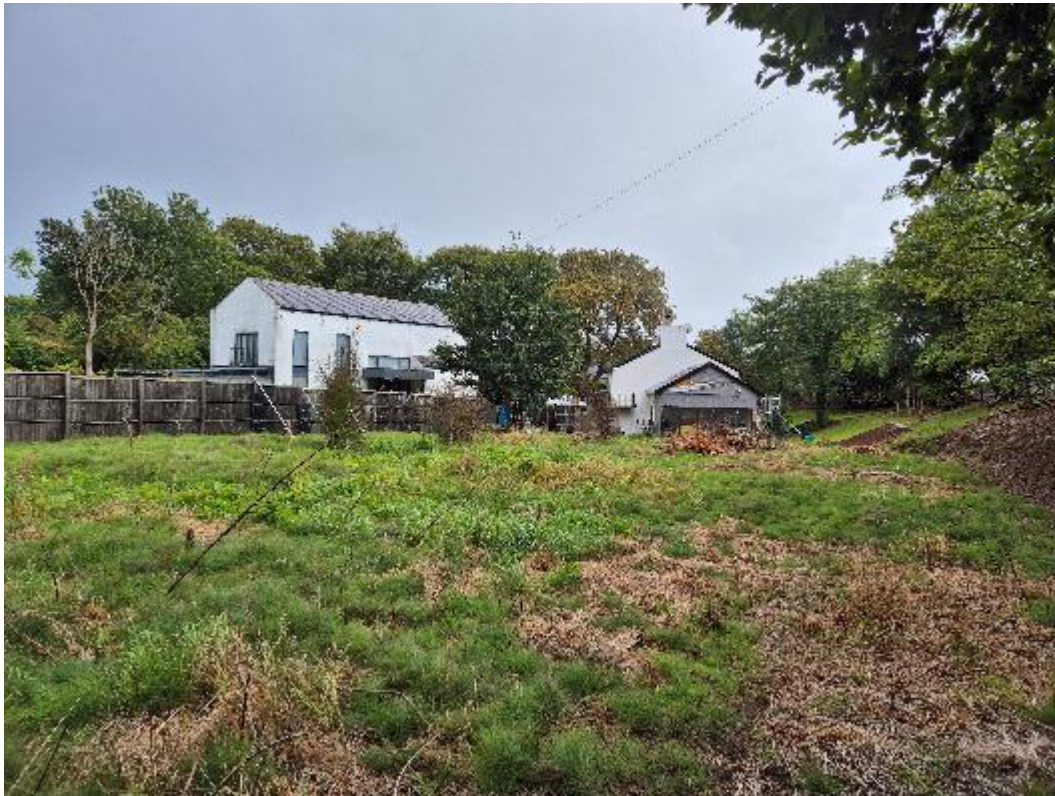
Looking across the area from the northwest corner to southeast and southeast corner to northwest
