# Contaminated Land Phase One Desk Study for Proposed redevelopment of the existing residential property into a new residential dwelling at Little Nook Farm, Heywood Old Road, Manchester, M24 4GS.

Prepared for:

SM Properties,  
Little Nook Farm,  
Heywood Old Road,  
Manchester,  
M24 4GS.

September 2025

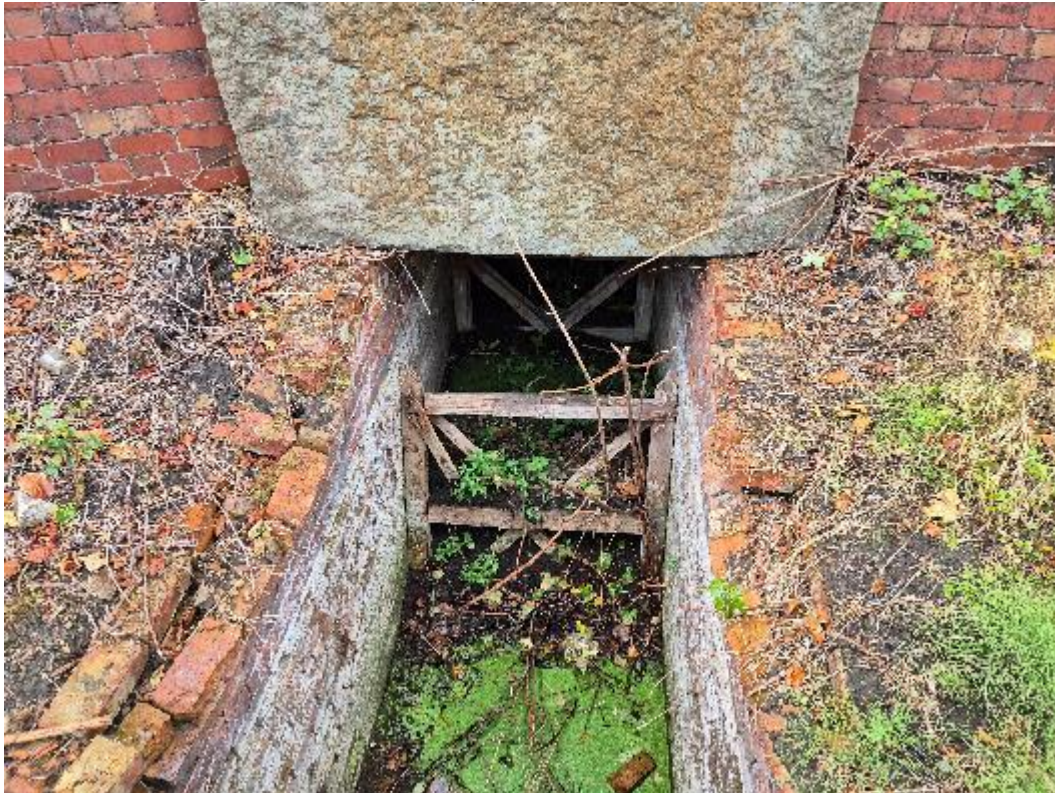
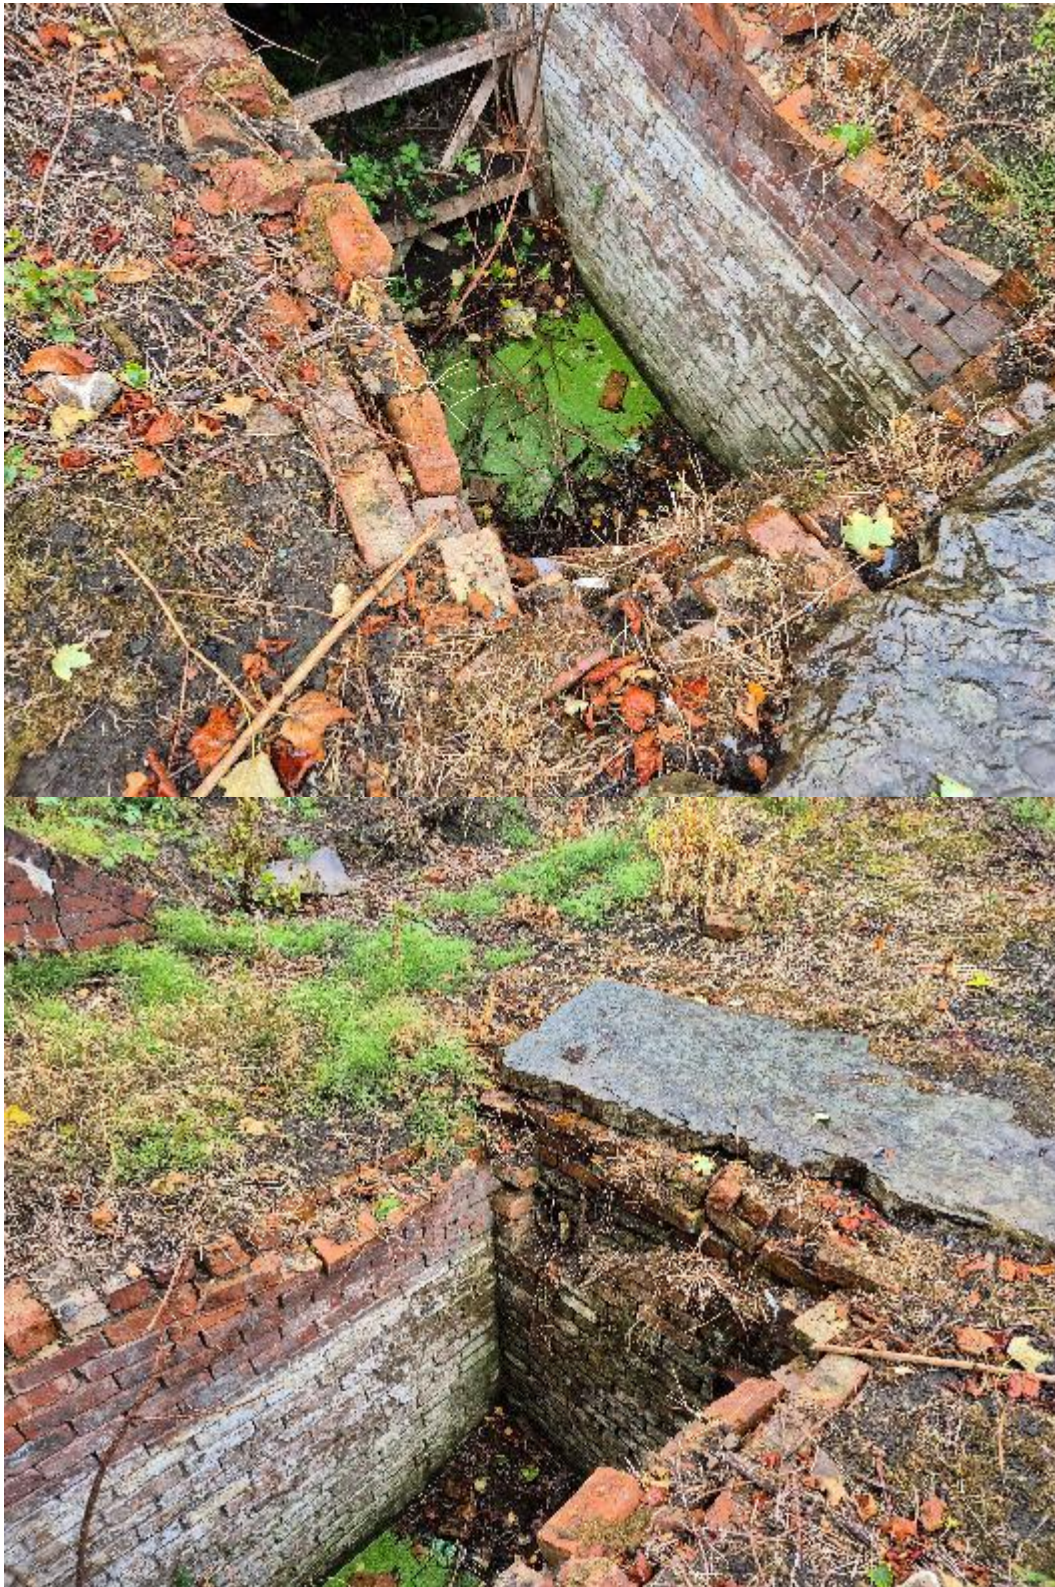
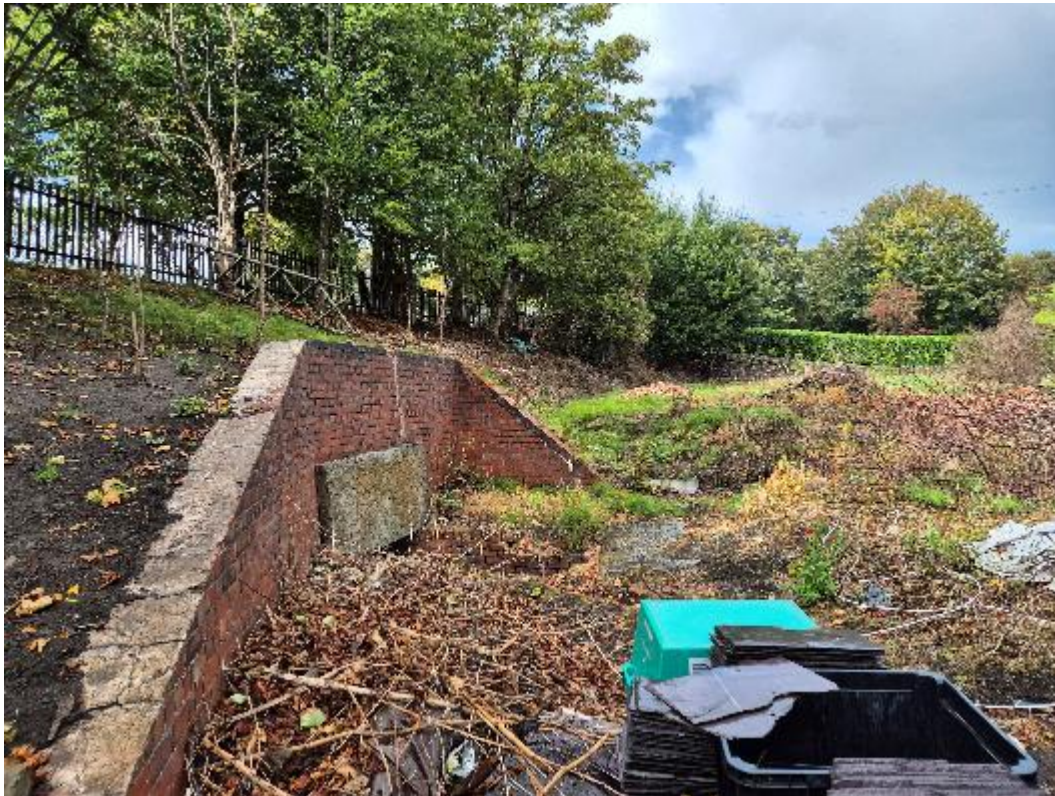
The culvert along the western boundary

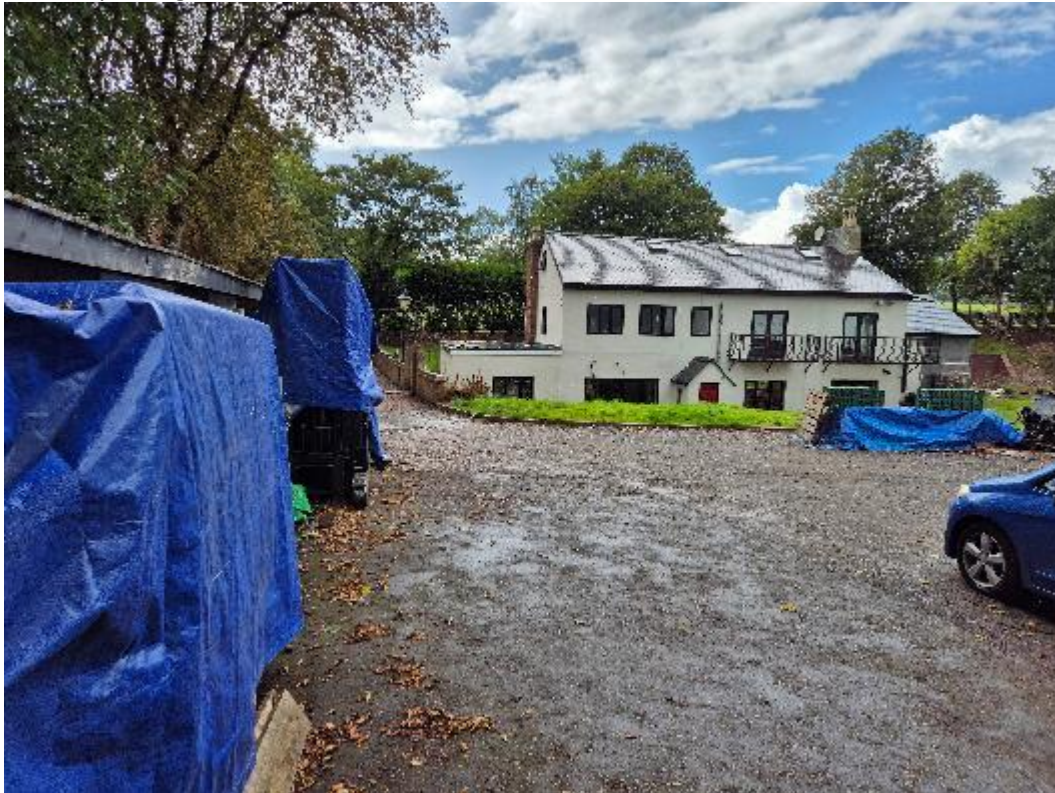
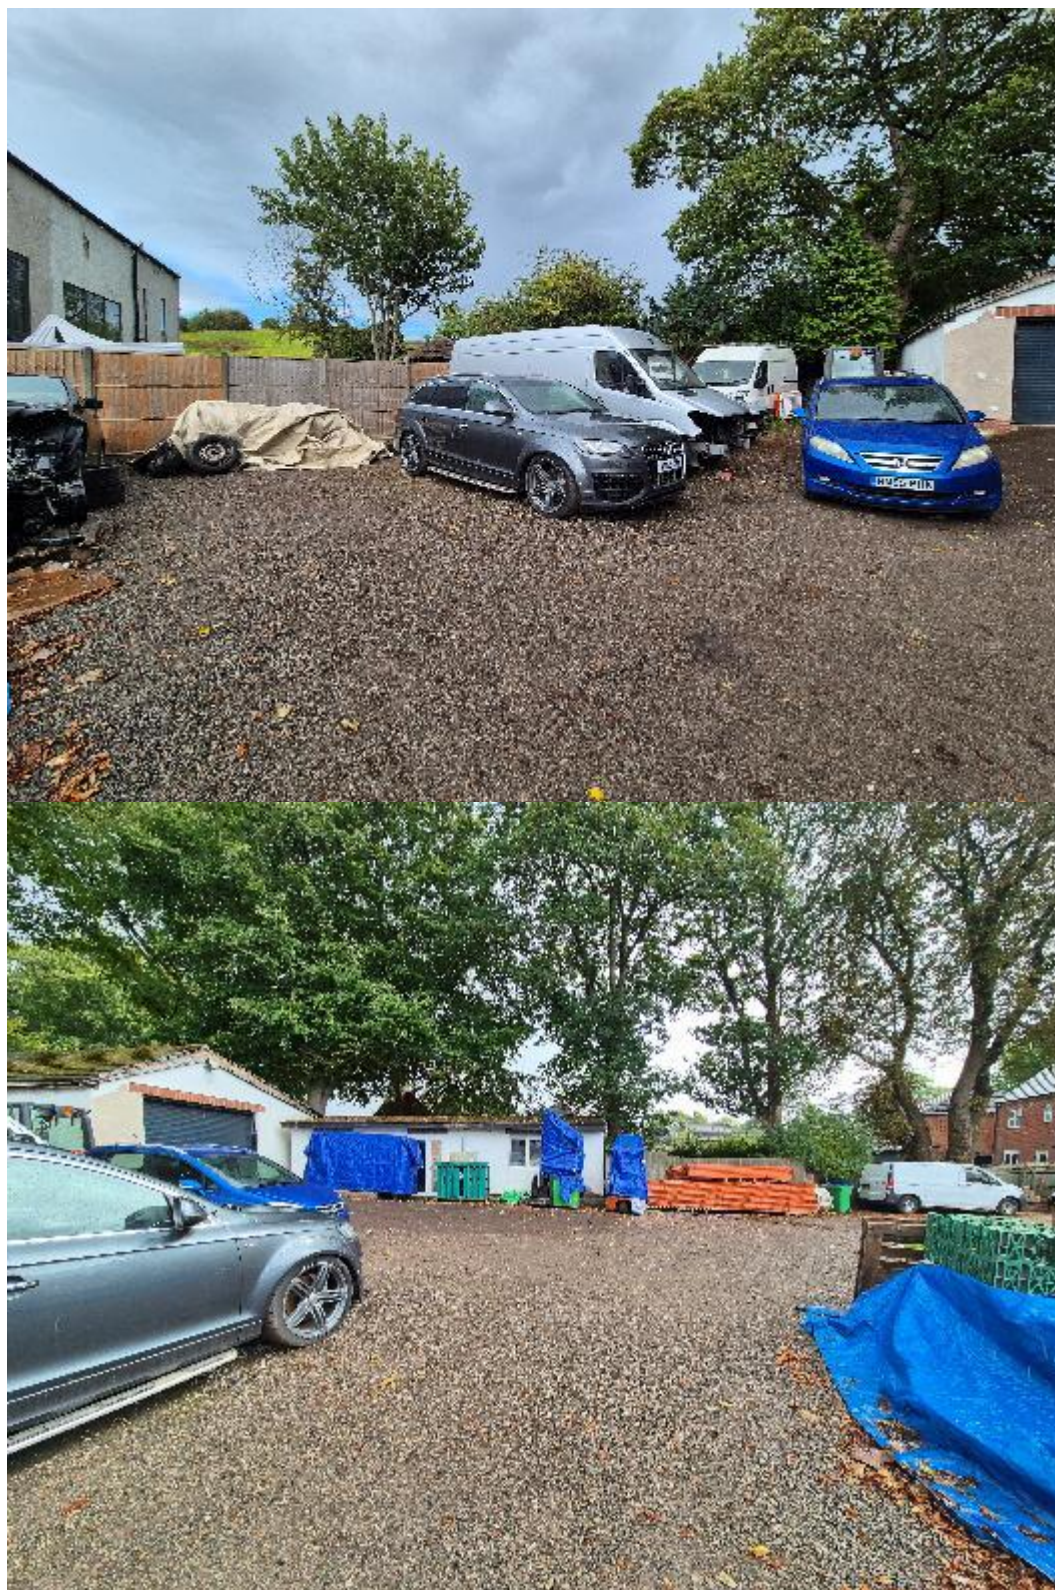
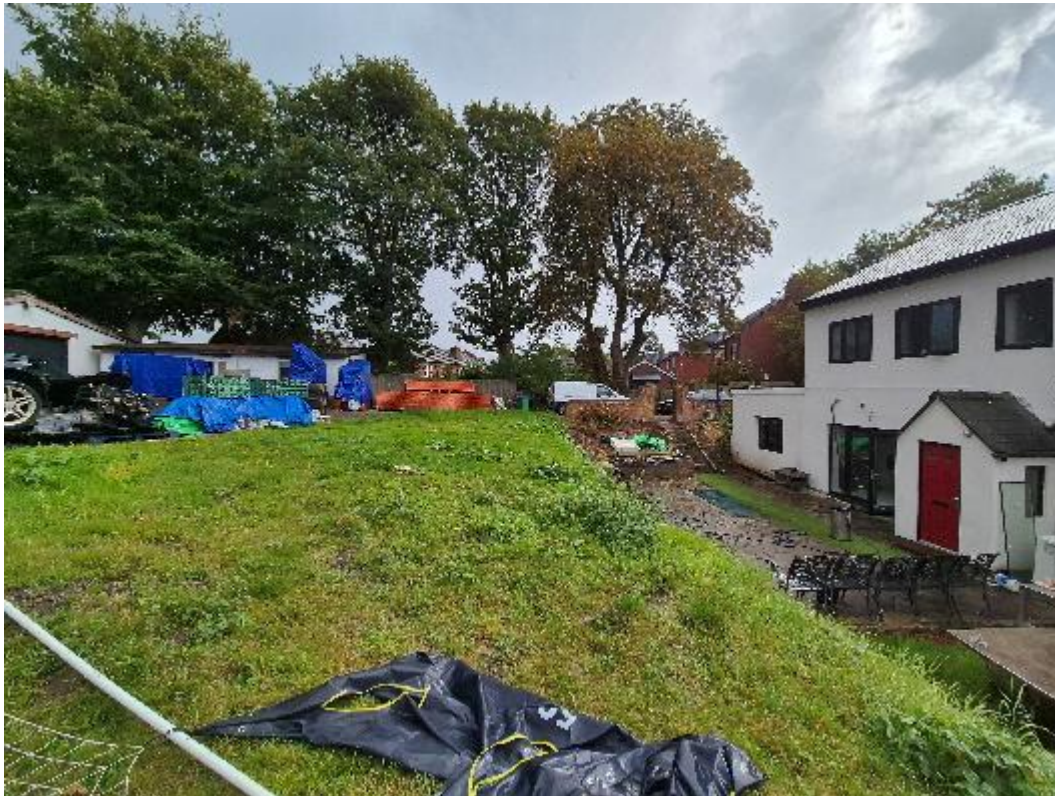
The car parking area to the east

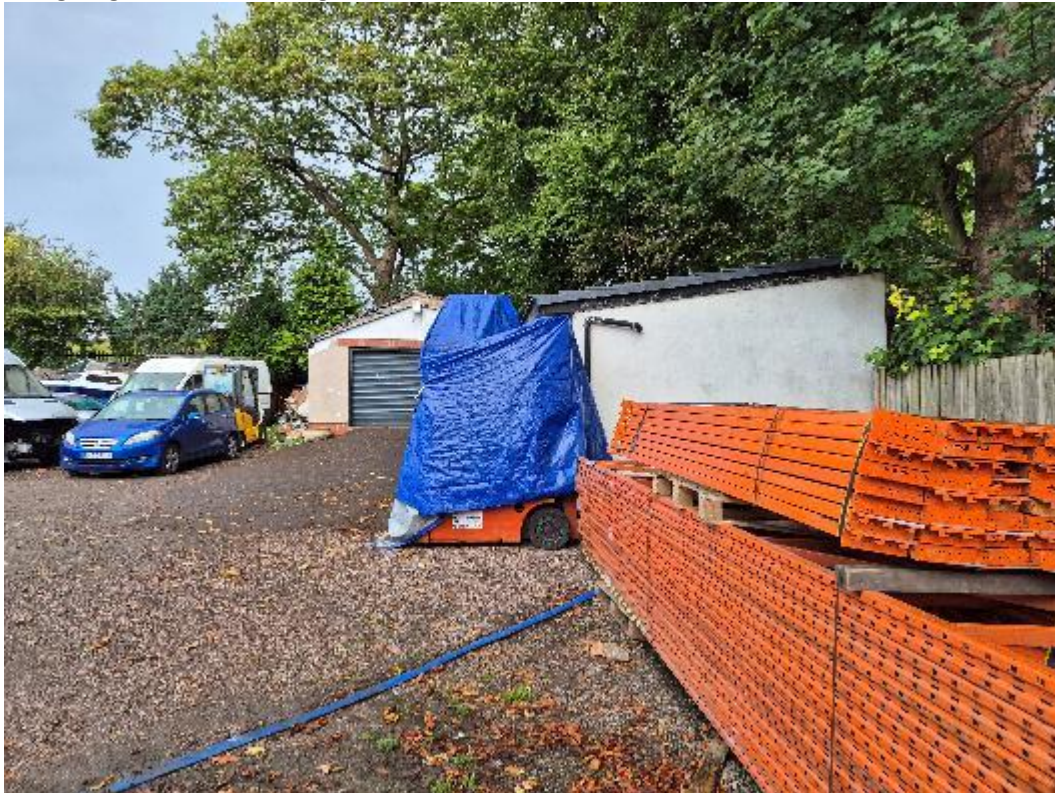
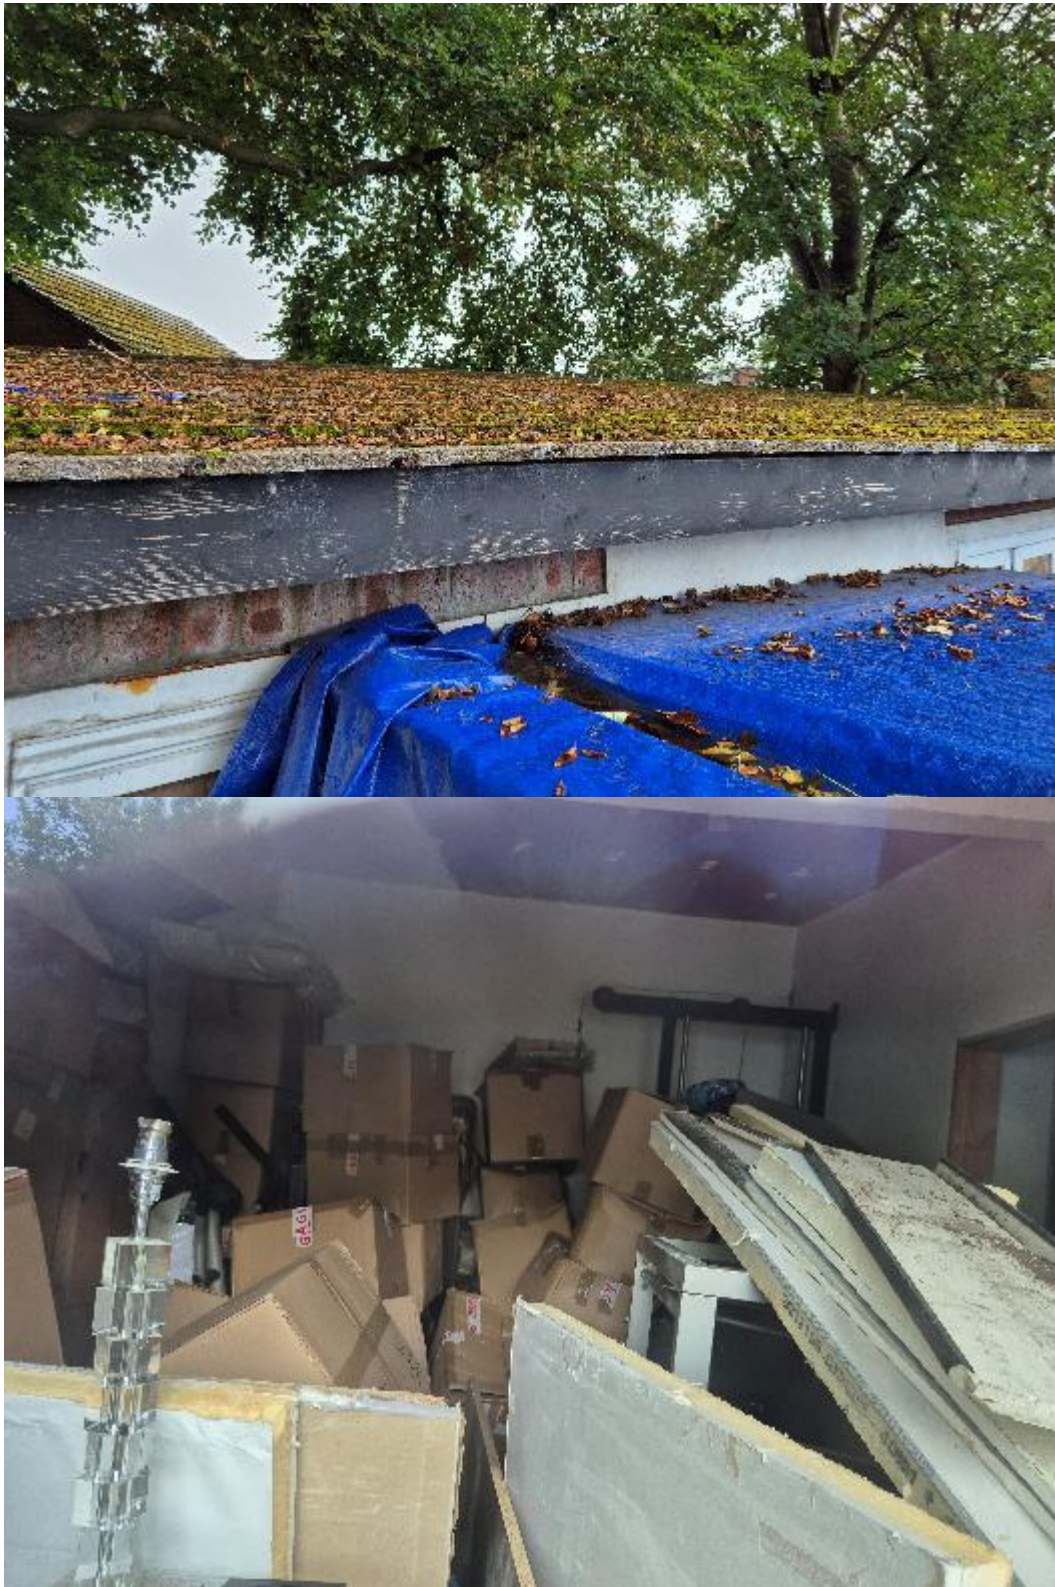
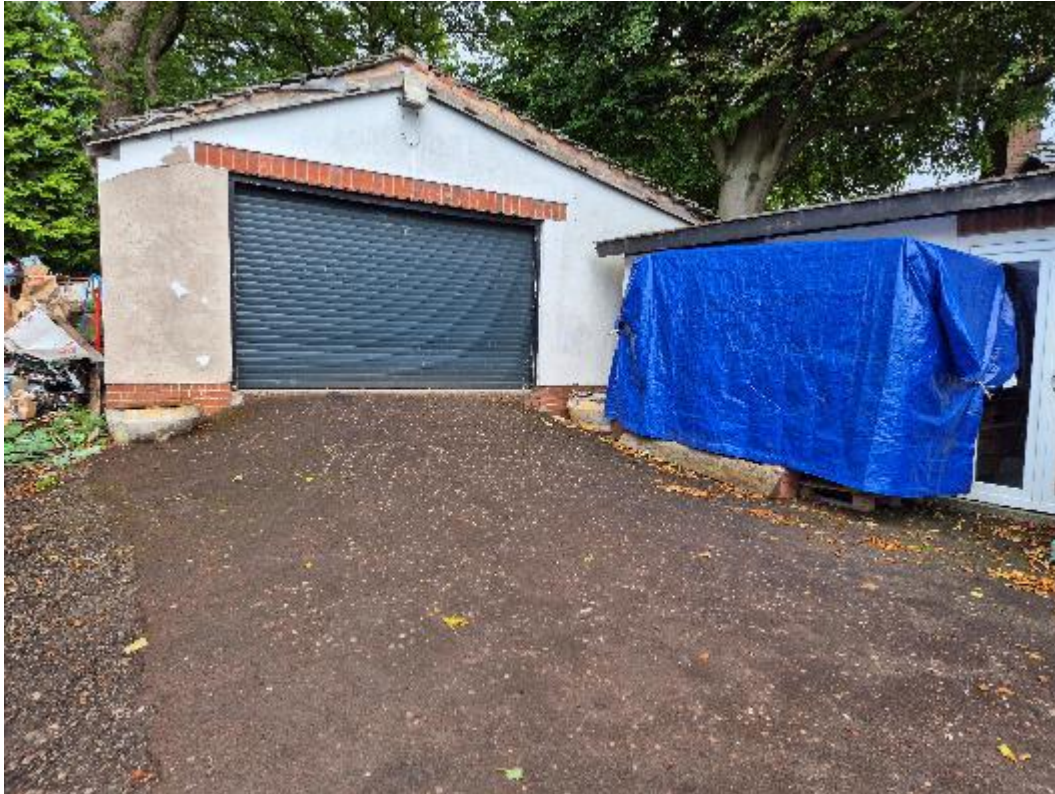
The garage and outbuilding
