## **SCHEDULE OF CONDITION FOR:**

**Drake Street  
Rochdale  
OL16 1PJ**

**Survey Date: 17<sup>th</sup> March 2026**

**For: Great Places Housing Group**

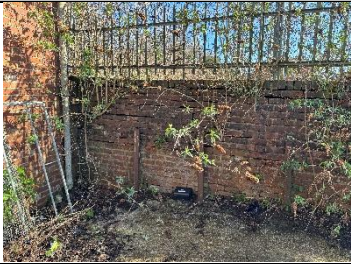
| ITEM | LOCATION | ELEMENT | PHOTOGRAPHIC RECORD | CONDITION/ NOTES |
|---|---|---|---|---|
| 1 | Speedwell Garage Ltd, 210-216 Drake Street, Rochdale, OL16 1UP | Boundary wall positioned to the West of the site, facing from the external site perimeter | | Solid masonry wall observed (16 brick courses high). Buddleia growth/ displacement of brick courses, cracked/ spalled bricks, missing/ defective pointing, finished with brick on edge course, steel palisade railings affixed to wall. |

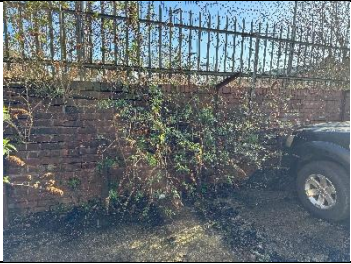
| ITEM | LOCATION | ELEMENT | PHOTOGRAPHIC RECORD | CONDITION/ NOTES |
|---|---|---|---|---|
| 2 | Speedwell Garage Ltd, 210-216 Drake Street, Rochdale, OL16 1UP | Boundary wall positioned to the West of the site, facing from the external site perimeter | | Solid masonry wall observed (16 brick courses high). Buddleia growth/ displacement of brick courses, cracked/ spalled bricks, missing/ defective pointing, finished with brick on edge course, steel palisade railings affixed to wall. |

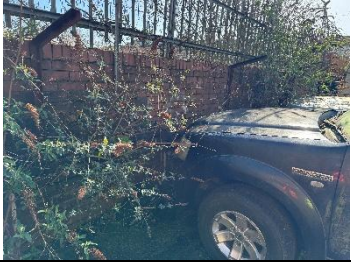
| ITEM | LOCATION | ELEMENT | PHOTOGRAPHIC RECORD | CONDITION/ NOTES |
|---|---|---|---|---|
| 3 | Speedwell Garage Ltd, 210-216 Drake Street, Rochdale, OL16 1UP | Boundary wall positioned to the West of the site, facing from the external site perimeter | | Solid masonry wall observed (16 brick courses high). Buddleia growth/ displacement of brick courses, cracked/ spalled bricks, missing/ defective pointing, finished with brick on edge course, steel palisade railings affixed to wall. |

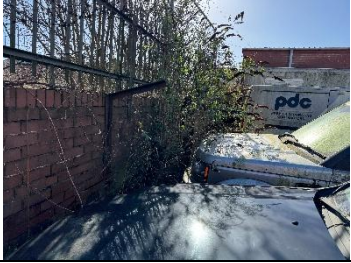
| ITEM | LOCATION | ELEMENT | PHOTOGRAPHIC RECORD | CONDITION/ NOTES |
|---|---|---|---|---|
| 4 | Speedwell Garage Ltd, 210-216 Drake Street, Rochdale, OL16 1UP | Boundary wall positioned to the West of the site, facing from the external site perimeter | | Solid masonry wall observed (16 brick courses high). Buddleia growth/ displacement of brick courses, cracked/ spalled bricks, missing/ defective pointing, finished with brick on edge course, steel palisade railings affixed to wall. |

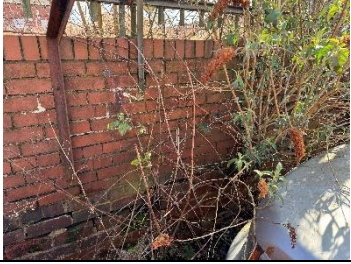
| ITEM | LOCATION | ELEMENT | PHOTOGRAPHIC RECORD | CONDITION/ NOTES |
|---|---|---|---|---|
| 5 | Speedwell Garage Ltd, 210-216 Drake Street, Rochdale, OL16 1UP | Boundary wall positioned to the West of the site, facing from the external site perimeter | | Solid masonry wall observed (16 brick courses high). Buddleia growth/ displacement of brick courses, cracked/ spalled bricks, missing/ defective pointing, finished with brick on edge course, steel palisade railings affixed to wall. |

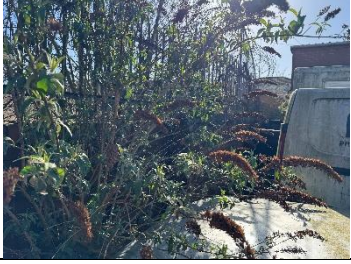
| ITEM | LOCATION | ELEMENT | PHOTOGRAPHIC RECORD | CONDITION/ NOTES |
|---|---|---|---|---|
| 6 | Speedwell Garage Ltd, 210-216 Drake Street, Rochdale, OL16 1UP | Boundary wall positioned to the West of the site, facing from the external site perimeter | | Solid masonry wall observed (16 brick courses high). Buddleia growth/ displacement of brick courses, cracked/ spalled bricks, missing/ defective pointing, finished brick on edge course, steel palisade railings affixed to wall. |

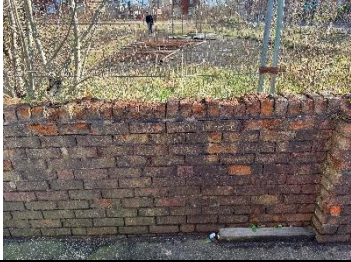
| 13 | Speedwell Garage Ltd, 210-216 Drake Street, Rochdale, OL16 1UP | Boundary wall positioned to the West of the site, facing from the external site perimeter | | Solid masonry wall (12 brick courses high). Appears to have suffered sustained impact damage overtime. Finished with brick on edge course, cracked/spalled bricks, missing pointing, brick on edge variously spalled. Vegetation to several areas. |

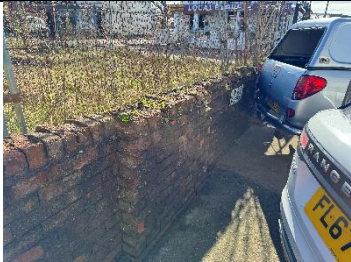
| 14 | Speedwell Garage Ltd, 210-216 Drake Street, Rochdale, OL16 1UP | Boundary wall positioned to the West of the site, facing from the external site perimeter | | Solid masonry wall (12 brick courses high). Appears to have suffered sustained impact damage overtime. Finished with brick on edge course, cracked/spalled bricks, missing pointing, brick on edge variously spalled. Vegetation to several areas. |

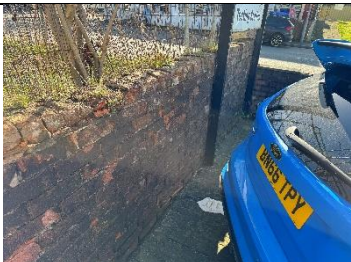
| 16 | Speedwell Garage Ltd, 210-216 Drake Street, Rochdale, OL16 1UP | Boundary wall positioned to the West of the site, facing from the external site perimeter | | Solid masonry wall (12 brick courses high). Appears to have suffered sustained impact damage overtime. Finished with brick on edge course, cracked/spalled bricks, missing pointing, brick on edge variously spalled. Vegetation to several areas. |

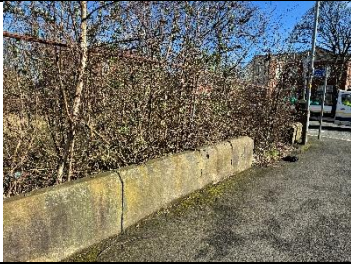
| 37 | Drake Street,<br>Rochdale, OL16 1PJ | Boundary wall<br>positioned to the<br>South of the site,<br>facing from the<br>external site perimeter | | Heras fencing along boundary<br>of site. Overgrown vegetation<br>along perimeter. Slight staining<br>and surface deposits/ patina to<br>stone walling. |

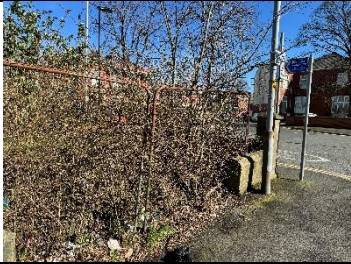
| 38 | Drake Street,<br>Rochdale, OL16 1PJ | Boundary wall<br>positioned to the<br>South of the site,<br>facing from the<br>external site perimeter | | Heras fencing along boundary<br>of site. Overgrown vegetation<br>along perimeter. Slight staining<br>and surface deposits/ patina to<br>stone walling. |

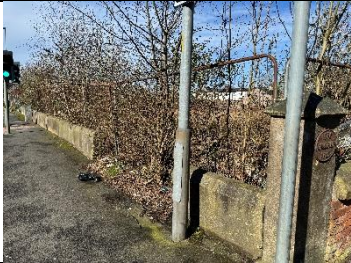
| 39 | Drake Street,<br>Rochdale, OL16 1PJ | Boundary wall<br>positioned to the<br>South of the site,<br>facing from the<br>external site perimeter | | Heras fencing along boundary<br>of site. Site entrance blocked<br>with spoil heap and vegetation.<br>Sign pole not maintained and<br>weathered stone pier. Slight<br>staining and surface deposits/<br>patina to stone walling. |

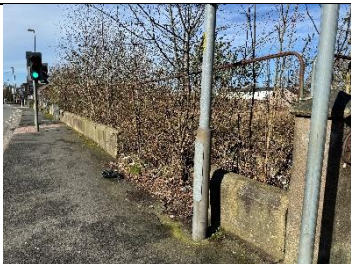
| 40 | Drake Street,<br>Rochdale, OL16 1PJ | Boundary wall<br>positioned to the<br>South of the site,<br>facing from the<br>external site perimeter | | Heras fencing along boundary<br>of site. Site entrance blocked<br>with spoil heap and vegetation.<br>Sign pole not maintained and<br>weathered stone pier with 4-<br>way cap; some impact damage<br>to capping. |

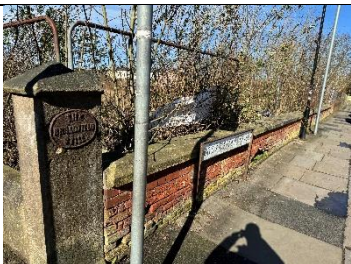
| 41 | Broadfield Stile,<br>Rochdale, OL16 1PJ | Boundary wall<br>positioned to the East<br>of the site, facing from<br>the external site<br>perimeter | | Solid masonry wall. Cracked<br>bricks, spalling, missing pointing<br>and damaged in various areas<br>throughout length of the wall.<br>Stone copings installed appear<br>generally intact. Missing brick<br>work at base of wall. Road name<br>signage corroded. |

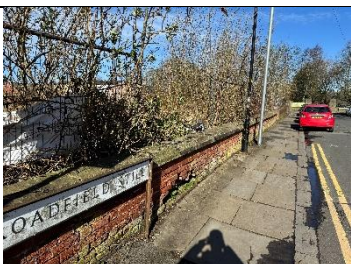
| 42 | Broadfield Stile,<br>Rochdale, OL16 1PJ | Boundary wall<br>positioned to the East<br>of the site, facing from<br>the external site<br>perimeter | | Solid masonry wall. Cracked<br>bricks, spalling, missing pointing<br>and damaged in various areas<br>throughout length of the wall.<br>Stone copings installed appear<br>generally intact. Missing brick<br>work at base of wall. Road name<br>signage corroded. |

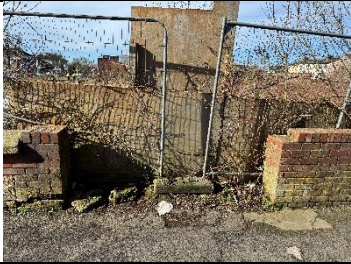
| 49 | Broadfield Stile, Rochdale, OL16 1PJ | Boundary wall positioned to the East of the site, facing from the external site perimeter | | Heras fencing along boundary of site. Suspected former pedestrian access to site as no wall in this location. |

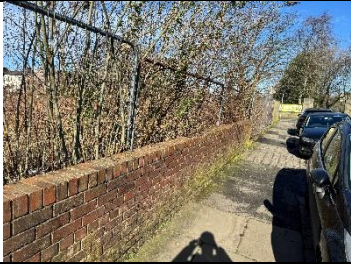
| 50 | Broadfield Stile, Rochdale, OL16 1PJ | Boundary wall positioned to the East of the site, facing from the external site perimeter | | Heras fencing along boundary of site. Solid masonry wall with brick on edge finish. General water staining and minor vegetation at low level. |

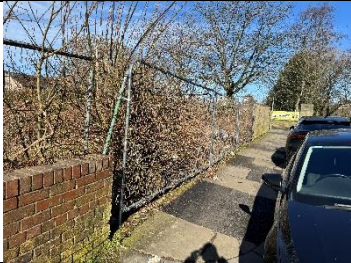
| 51 | Broadfield Stile, Rochdale, OL16 1PJ | Boundary wall positioned to the East of the site, facing from the external site perimeter | | Heras fencing, vegetation and debris along boundary of site. |

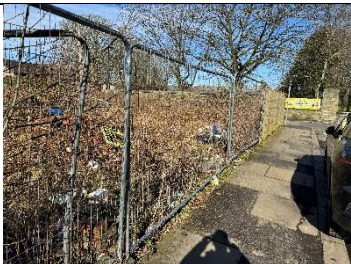
| 52 | Broadfield Stile, Rochdale, OL16 1PJ | Boundary wall positioned to the East of the site, facing from the external site perimeter | | Heras fencing, vegetation and debris along boundary of site. |

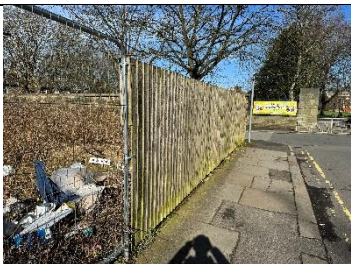
| 53 | Broadfield Stile, Rochdale, OL16 1PJ | Boundary wall positioned to the East of the site, facing from the external site perimeter | | Timber featheredge fence to boundary. Vegetation behind fence. General weathering and discoloration to boards. Fence line leaning out of plumb. Cracked and uneven slabs to pavement. |

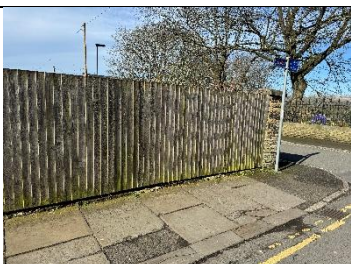
| 54 | Broadfield Stile, Rochdale, OL16 1PJ | Boundary wall positioned to the East of the site, facing from the external site perimeter | | Timber featheredge fence to boundary. Vegetation behind fence. General weathering and discoloration to boards. Fence line slightly out of plumb. Cracked and uneven slabs to pavement. |

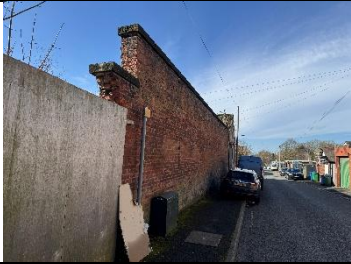
| 67 | St Alban's Street,<br>Rochdale, OL16 1UU | Boundary wall<br>positioned to the<br>North of the site,<br>facing from the<br>external site perimeter | | Solid masonry wall. Localised cracked/ missing pointing, spalled bricks in various areas throughout length of the wall. Coping stones generally weathered. Wall poorly terminated within several cracked, spalling/ missing bricks |

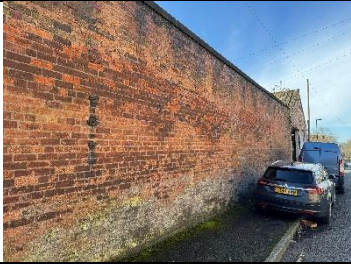
| 68 | St Alban's Street,<br>Rochdale, OL16 1UU | Boundary wall<br>positioned to the<br>North of the site,<br>facing from the<br>external site perimeter | | Solid masonry wall. Localised cracked/ missing pointing, spalled bricks in various areas throughout length of the wall. Coping stones generally weathered. Wall visually observed to be out of plumb to upper extremities. |

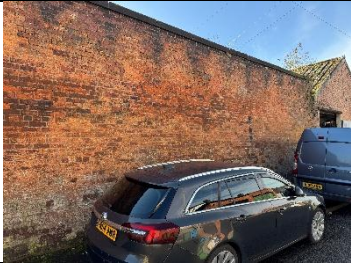
| 69 | St Alban's Street,<br>Rochdale, OL16 1UU | Boundary wall<br>positioned to the<br>North of the site,<br>facing from the<br>external site perimeter | | Solid masonry wall. Localised cracked/ missing pointing, spalled bricks in various areas throughout length of the wall. Coping stones generally weathered. Wall visually observed to be out of plumb to upper extremities. |

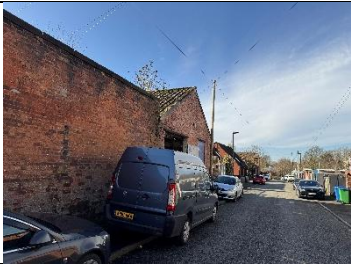
| 70 | St Alban's Street,<br>Rochdale, OL16 1UU | Boundary wall<br>positioned to the<br>North of the site,<br>facing from the<br>external site perimeter | | Solid masonry wall. Various spalling to brickwork, missing pointing and damaged in various areas throughout length of the wall. Coping stones weathered and uneven. Top off wall out of plumb. |

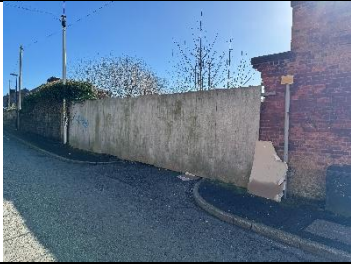
| 71 | St Alban's Street,<br>Rochdale, OL16 1UU | Boundary wall<br>positioned to the<br>North of the site,<br>facing from the<br>external site perimeter | | Plywood panels blocking entrance to the site. Vegetation behind plywood panels and ivy located at the top of the panels. Delamination noted to some localised areas indicating hoarding is approaching the end of its useful life. |

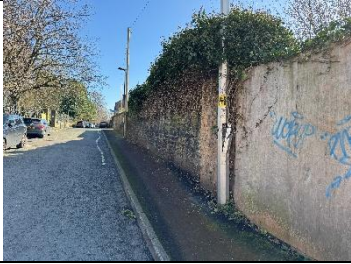
| 72 | St Alban's Street,<br>Rochdale, OL16 1UU | Boundary wall<br>positioned to the<br>North of the site,<br>facing from the<br>external site perimeter | | Metal telephone pole damaged and positioned adjacent to the site. |

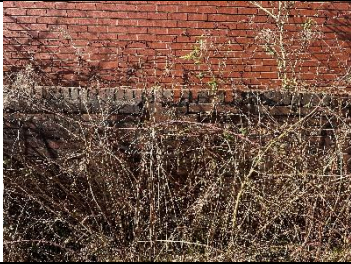
| 85 | Speedwell Garage Ltd, 210-216 Drake Street, Rochdale, OL16 1UP | Boundary wall positioned to the West of the site, facing from within the site curtilage | | Solid masonry wall. Minor vegetative growth to the length of the wall. Brick on edge finish. Missing/ loose pointing. Some localised spalling/ brick decay. Limited observations due to vegetative growth within the site. |

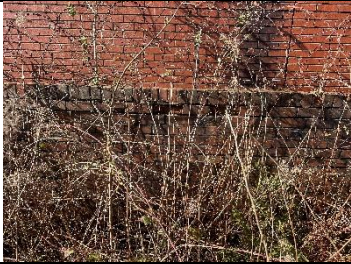
| 86 | Speedwell Garage Ltd, 210-216 Drake Street, Rochdale, OL16 1UP | Boundary wall positioned to the West of the site, facing from within the site curtilage | | Solid masonry wall. Minor vegetative growth to the length of the wall. Brick on edge finish. Missing/ loose pointing. Some localised spalling/ brick decay. Limited observations due to vegetative growth within the site. |

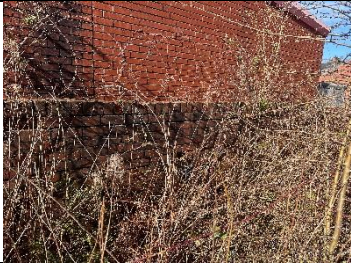
| 87 | Speedwell Garage Ltd, 210-216 Drake Street, Rochdale, OL16 1UP | Boundary wall positioned to the West of the site, facing from within the site curtilage | | Solid masonry wall. Minor vegetative growth to the length of the wall. Brick on edge finish. Missing/ loose pointing. Some localised spalling/ brick decay. Limited observations due to vegetative growth within the site. |

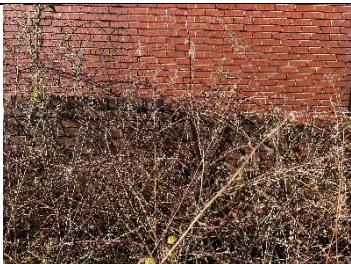
| 88 | Speedwell Garage Ltd, 210-216 Drake Street, Rochdale, OL16 1UP | Boundary wall positioned to the West of the site, facing from within the site curtilage | | Solid masonry wall. Minor vegetative growth to the length of the wall. Unfinished stretcher bond. Poorly pointed, missing/ loose pointing. Buddleia growth to some localised areas. Limited observations due to vegetative growth within the site. |

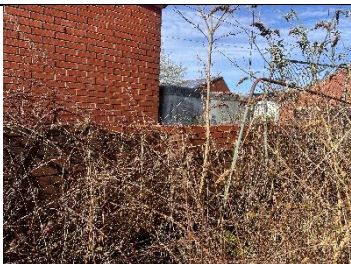
| 89 | Speedwell Garage Ltd, 210-216 Drake Street, Rochdale, OL16 1UP | Boundary wall positioned to the West of the site, facing from within the site curtilage | | Solid masonry wall. Minor vegetative growth to the length of the wall. unfinished stretcher bond. Poorly pointed, missing/ loose pointing. Buddleia growth to some localised areas. Limited observations due to vegetative growth within the site. |

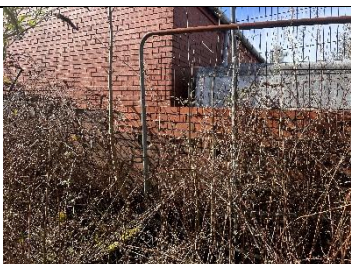
| 90 | Speedwell Garage Ltd, 210-216 Drake Street, Rochdale, OL16 1UP | Boundary wall positioned to the West of the site, facing from within the site curtilage | | Solid masonry wall. Minor vegetative growth to the length of the wall. unfinished stretcher bond. Poorly pointed, missing/ loose pointing. Buddleia growth to some localised areas. Limited observations due to vegetative growth within the site. |

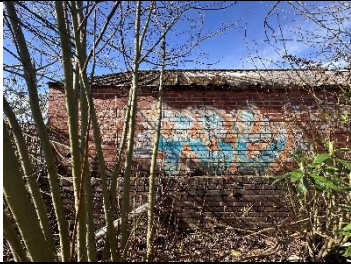
| 103 | Speedwell Garage Ltd, 210-216 Drake Street, Rochdale, OL16 1UP | Boundary structure positioned to the West of the site, facing from within the site curtilage | | Corrugated concrete roof sheets installed to adjacent structure; suspected asbestos. Rainwater goods appear to comprise concrete half round gutters which are damaged/spalled; suspected asbestos. Debris may be present on site. |

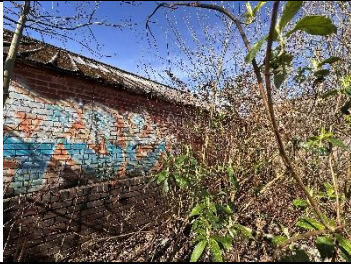
| 104 | Speedwell Garage Ltd, 210-216 Drake Street, Rochdale, OL16 1UP | Boundary structure positioned to the West of the site, facing from within the site curtilage | | Corrugated concrete roof sheets installed to adjacent structure; suspected asbestos. Rainwater goods appear to comprise concrete half round gutters which are damaged/spalled; suspected asbestos. Debris may be present on site. |

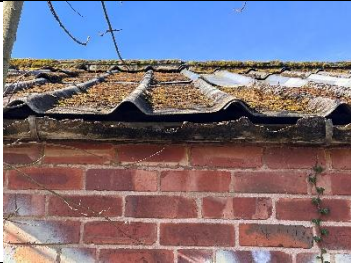
| 105 | Speedwell Garage Ltd, 210-216 Drake Street, Rochdale, OL16 1UP | Boundary structure positioned to the West of the site, facing from within the site curtilage | | Corrugated concrete roof sheets installed to adjacent structure; suspected asbestos. Rainwater goods appear to comprise concrete half round gutters which are damaged/spalled; suspected asbestos. Debris may be present on site. |

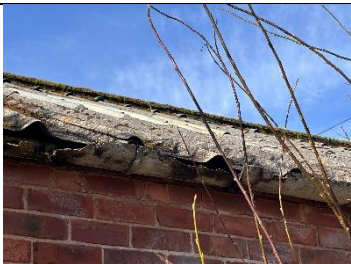
| 106 | Speedwell Garage Ltd, 210-216 Drake Street, Rochdale, OL16 1UP | Boundary structure positioned to the West of the site, facing from within the site curtilage | | Corrugated concrete roof sheets installed to adjacent structure; suspected asbestos. Rainwater goods appear to comprise concrete half round gutters which are damaged/spalled; suspected asbestos. Debris may be present on site. |

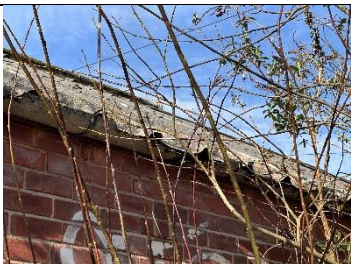
| 107 | Speedwell Garage Ltd, 210-216 Drake Street, Rochdale, OL16 1UP | Boundary structure positioned to the West of the site, facing from within the site curtilage | | Corrugated concrete roof sheets installed to adjacent structure; suspected asbestos. Rainwater goods appear to comprise concrete half round gutters which are damaged/spalled; suspected asbestos. Debris may be present on site. |

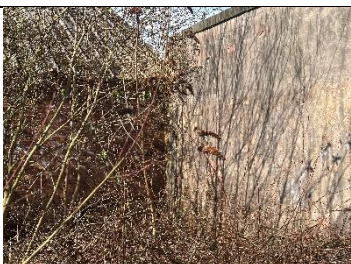
| 108 | Speedwell Garage Ltd, 210-216 Drake Street, Rochdale, OL16 1UP | Boundary structure positioned to the West of the site, facing from within the site curtilage | | Solid masonry wall. Sand/cement render installed; variously weathered cracked and missing. Coping stones weathered/ generally appear intact/ seated atop the wall. Missing pointing/ spalling of brickwork. Graffiti present. |

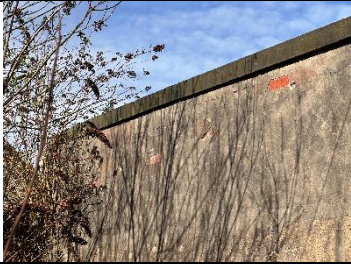
| 115 | St Alban's Street,<br>Rochdale, OL16 1UU | Boundary wall<br>positioned to the<br>North of the site,<br>facing from within the<br>site curtilage | | Solid masonry wall. Sand/<br>cement render installed;<br>variously weathered cracked<br>and missing. Coping stones<br>weathered/ generally appear<br>intact/ seated atop the wall.<br>Missing/ loose pointing to some<br>areas. Horizontal cracking. |

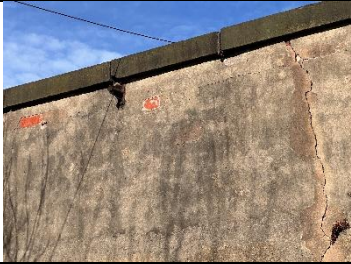
| 116 | St Alban's Street,<br>Rochdale, OL16 1UU | Boundary wall<br>positioned to the<br>North of the site,<br>facing from within the<br>site curtilage | | Solid masonry wall. Sand/<br>cement render installed;<br>variously weathered cracked<br>and missing. Coping stones<br>weathered/ generally appear<br>intact/ seated atop the wall.<br>Missing/ loose pointing to some<br>areas. Large vertical crack. |

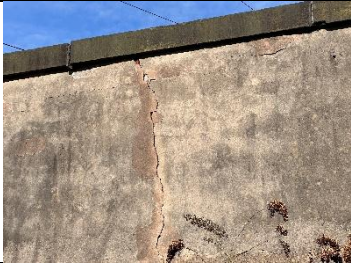
| 117 | St Alban's Street,<br>Rochdale, OL16 1UU | Boundary wall<br>positioned to the<br>North of the site,<br>facing from within the<br>site curtilage | | Solid masonry wall. Sand/<br>cement render installed;<br>variously weathered cracked<br>and missing. Coping stones<br>weathered/ generally appear<br>intact/ seated atop the wall.<br>Missing/ loose pointing to some<br>areas. Large vertical crack. |

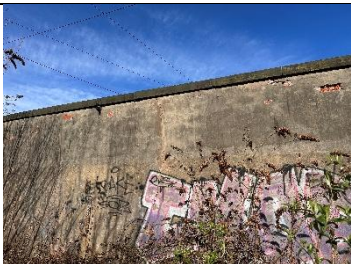
| 118 | St Alban's Street,<br>Rochdale, OL16 1UU | Boundary wall<br>positioned to the<br>North of the site,<br>facing from within the<br>site curtilage | | Solid masonry wall. Sand/<br>cement render installed;<br>variously weathered cracked<br>and missing. Coping stones<br>weathered/ generally appear<br>intact/ seated atop the wall.<br>Missing pointing/ spalling of<br>brickwork. Graffiti present. |

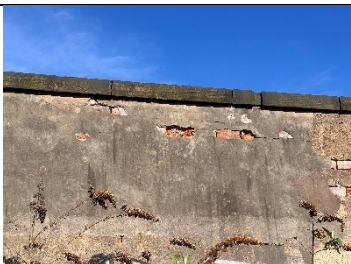
| 119 | St Alban's Street,<br>Rochdale, OL16 1UU | Boundary wall<br>positioned to the<br>North of the site,<br>facing from within the<br>site curtilage | | Solid masonry wall. Sand/<br>cement render installed;<br>variously weathered cracked<br>and missing. Coping stones<br>weathered/ generally appear<br>intact/ seated atop the wall.<br>Missing pointing/ spalling of<br>brickwork. |

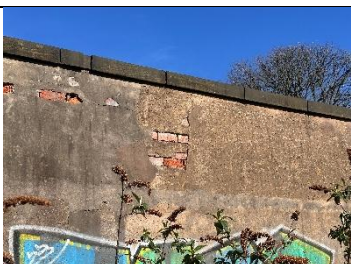
| 120 | St Alban's Street,<br>Rochdale, OL16 1UU | Boundary wall<br>positioned to the<br>North of the site,<br>facing from within the<br>site curtilage | | Solid masonry wall. Sand/<br>cement render installed;<br>variously weathered cracked<br>and missing. Coping stones<br>weathered/ generally appear<br>intact/ seated atop the wall.<br>Missing pointing/ spalling of<br>brickwork. |

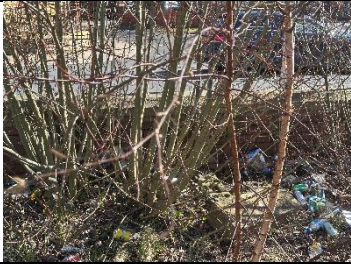
| 139 | Broadfield Stile,<br>Rochdale, OL16 1PJ | Boundary wall<br>positioned to the East<br>of the site, facing from<br>within the site<br>curtilage | | Heras fencing installed behind<br>masonry wall within the site.<br>Self-seeded and vegetative<br>growth intertwined within<br>Heras. Debris along site<br>boundary. Minor defects to<br>brickwork/ stone copings<br>installed and generally intact. |

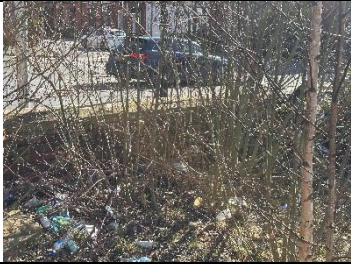
| 140 | Broadfield Stile,<br>Rochdale, OL16 1PJ | Boundary wall<br>positioned to the East<br>of the site, facing from<br>within the site<br>curtilage | | Heras fencing installed behind<br>masonry wall within the site.<br>Self-seeded and vegetative<br>growth intertwined within<br>Heras. Debris along site<br>boundary. Minor defects to<br>brickwork/ stone copings<br>installed and generally intact. |

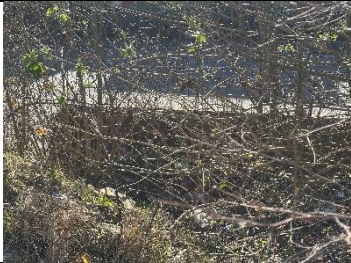
| 141 | Drake Street,<br>Rochdale, OL16 1PJ | Boundary wall<br>positioned to the<br>South of the site,<br>facing from within the<br>site curtilage | | Heras fencing installed behind<br>stone boundary within the site.<br>Self-seeded and vegetative<br>growth intertwined within<br>Heras. Debris along site<br>boundary. Limited observations<br>of wall. Surface patina/ limited<br>defects observed. |

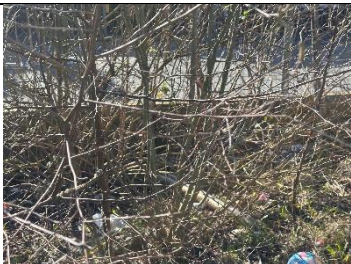
| 142 | Drake Street,<br>Rochdale, OL16 1PJ | Boundary wall<br>positioned to the<br>South of the site,<br>facing from within the<br>site curtilage | | Heras fencing installed behind<br>stone boundary within the site.<br>Self-seeded and vegetative<br>growth intertwined within<br>Heras. Debris along site<br>boundary. Limited observations<br>of wall. Surface patina/ limited<br>defects observed. |

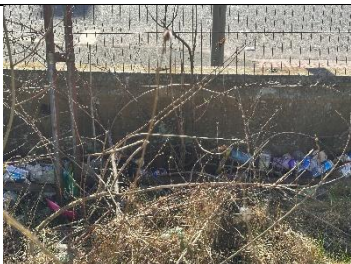
| 143 | Drake Street,<br>Rochdale, OL16 1PJ | Boundary wall<br>positioned to the<br>South of the site,<br>facing from within the<br>site curtilage | | Heras fencing installed behind<br>stone boundary within the site.<br>Self-seeded and vegetative<br>growth intertwined within<br>Heras. Debris along site<br>boundary. Limited observations<br>of wall. Surface patina/ minor<br>hole observed. |

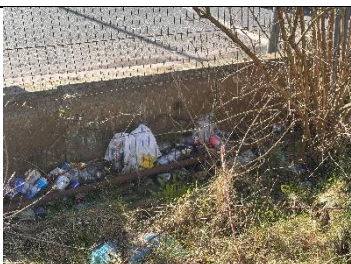
| 144 | Drake Street,<br>Rochdale, OL16 1PJ | Boundary wall<br>positioned to the<br>South of the site,<br>facing from within the<br>site curtilage | | Heras fencing installed behind<br>stone boundary within the site.<br>Self-seeded and vegetative<br>growth intertwined within<br>Heras. Debris along site<br>boundary. Limited observations<br>of wall. Surface patina/ minor<br>hole observed. |

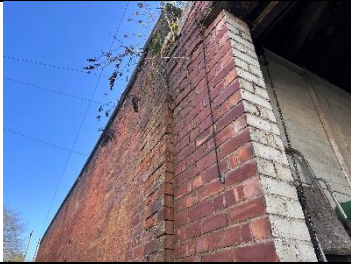
| 169 | St Alban's Street,<br>Rochdale, OL16 1UU | Boundary wall<br>positioned to the<br>North of the site,<br>facing from the<br>external site perimeter | | Solid masonry wall. Buddleia growth and displacement of brick courses at the vertical junction and top of wall abutment. Spalling and missing pointing to upper area. Stone copings displaced, wall out of plumb/ not tied into adjacent. |

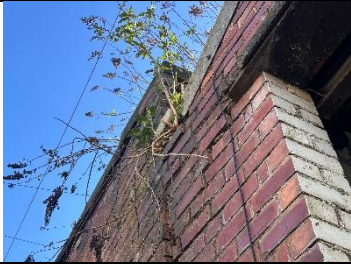
| 170 | St Alban's Street,<br>Rochdale, OL16 1UU | Boundary wall<br>positioned to the<br>North of the site,<br>facing from the<br>external site perimeter | | Solid masonry wall. Buddleia growth and displacement of brick courses at the vertical junction and top of wall abutment. Spalling and missing pointing to upper area. Stone copings displaced, wall out of plumb/ not tied into adjacent. |

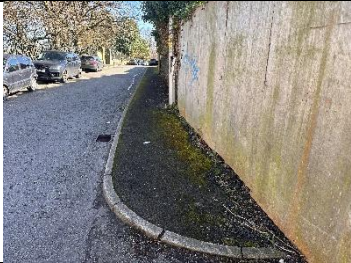
| 171 | St Alban's Street,<br>Rochdale, OL16 1UU | Boundary wall<br>positioned to the<br>North of the site,<br>facing from the<br>external site perimeter | | Site access from St Albans Street; Tarmac pedestrian pavement, general condition is sound; no potholing or otherwise observed. Vegetative build up along hoarded section of boundary. Kerb edging intact. No line markings observed. |

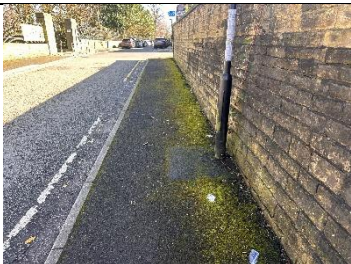
| 172 | St Alban's Street,<br>Rochdale, OL16 1UU | Boundary wall<br>positioned to the<br>North of the site,<br>facing from the<br>external site perimeter | | Tarmac pedestrian pavement, general condition is sound; no potholing or otherwise observed. Vegetative build up adjacent to stone walling. Kerb edging intact. Line markings faded. Street lighting installed to this location. |

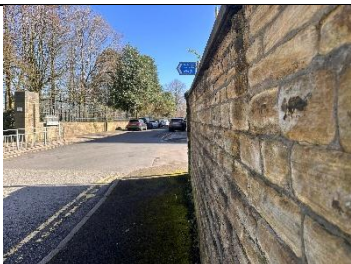
| 173 | St Alban's Street,<br>Rochdale, OL16 1UU | Boundary wall<br>positioned to the<br>North of the site,<br>facing from the<br>external site perimeter | | Tarmac pedestrian pavement, general condition is sound; no potholing or otherwise observed. Vegetative build up adjacent to stone walling. Kerb edging intact. Line markings faded. |

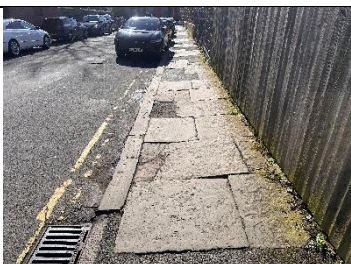
| 174 | St Alban's Street,<br>Rochdale, OL16 1UU | Boundary wall<br>positioned to the<br>North of the site,<br>facing from the<br>external site perimeter | | Large format stone pavements variously cracked and minorly displaced; trip hazards to some areas. Stone kerb edging generally intact. Mains surface water drainage grid to Northeast corner. Line marking to adjacent road faded. |

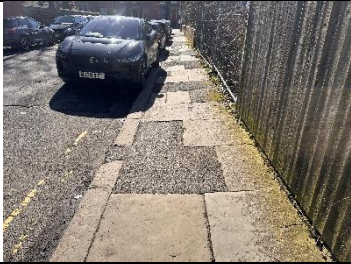
| 175 | Broadfield Stile, Rochdale, OL16 1PJ | Boundary wall positioned to the East of the site, facing from the external site perimeter | | Large format stone paviours variously cracked and minorly displaced. Stone kerb edging generally intact. Mains surface water drainage grid to Northeast corner. Line marking to adjacent road faded. Missing paviours infilled with tarmac. |

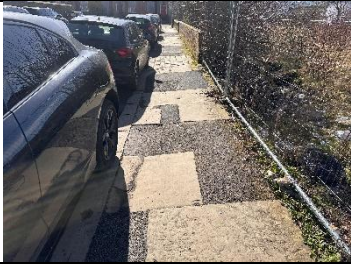
| 176 | Broadfield Stile, Rochdale, OL16 1PJ | Boundary wall positioned to the East of the site, facing from the external site perimeter | | Large format stone paviours variously cracked and minorly displaced. Stone kerb edging generally intact. Mains surface water drainage grid to Northeast corner. Line marking to adjacent road faded. Missing paviours infilled with tarmac. |

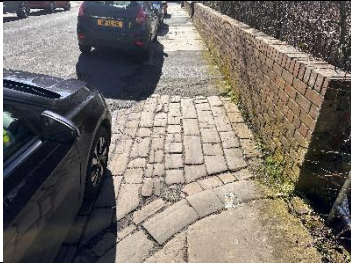
| 177 | Broadfield Stile, Rochdale, OL16 1PJ | Boundary wall positioned to the East of the site, facing from the external site perimeter | | Cobbled section to what appears to be a historic access point to the site; now blocked off. Generally, condition of cobbles is sound; however, covered over with tarmac to left side. Some vegetative build up along wall edge. |

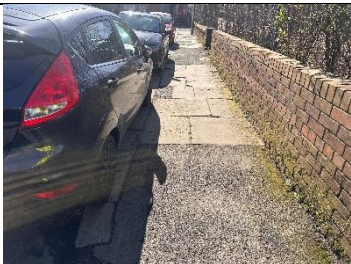
| 178 | Broadfield Stile, Rochdale, OL16 1PJ | Boundary wall positioned to the East of the site, facing from the external site perimeter | | Large format stone paviours variously cracked and minorly displaced. Stone kerb edging generally intact. Mains surface water drainage grid to Northeast corner. Line marking to adjacent road faded. Missing paviours infilled with tarmac. |

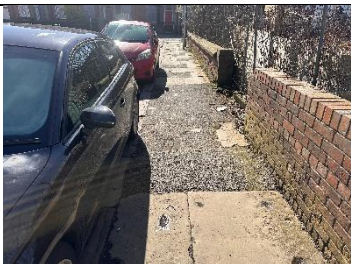
| 179 | Broadfield Stile, Rochdale, OL16 1PJ | Boundary wall positioned to the East of the site, facing from the external site perimeter | | Large format stone paviours variously cracked and minorly displaced. Stone kerb edging generally intact. Mains surface water drainage grid to Northeast corner. Line marking to adjacent road faded. Missing paviours infilled with tarmac. |

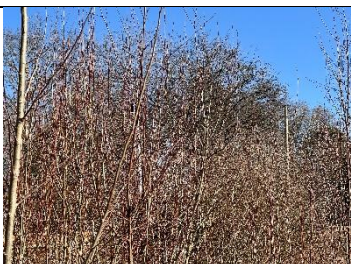
| 180 | Developable land at Drake Street, Rochdale, OL16 1PJ | Within the site curtilage toward the Northwest corner of the site | | Telephone lines are noted overhead and cut through the developable site area. Telephone lines appear intertwined with trees and vegetation situated in the site. Care should be taken during any site clearance. |

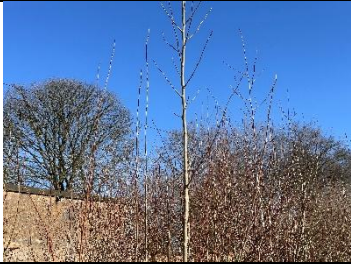
| 181 | Developable land at Drake Street, Rochdale, OL16 1PJ | Within the site curtilage toward the Northwest corner of the site | | Telephone lines are noted overhead and cut through the developable site area. Telephone lines appear intertwined with trees and vegetation situated in the site. Care should be taken during any site clearance. |

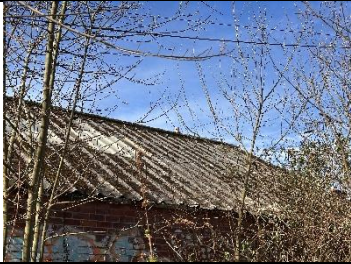
| 182 | Developable land at Drake Street, Rochdale, OL16 1PJ | Within the site curtilage toward the Northwest corner of the site | | Telephone lines are noted overhead and cut through the developable site area. Telephone lines appear intertwined with trees and vegetation situated in the site. Care should be taken during any site clearance. |

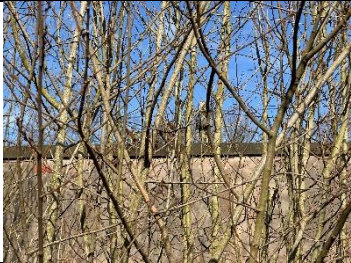
| 183 | Developable land at Drake Street, Rochdale, OL16 1PJ | Within the site curtilage toward the Northwest corner of the site | | Telephone lines are noted overhead and cut through the developable site area. Telephone lines appear intertwined with trees and vegetation situated in the site. Care should be taken during any site clearance. |

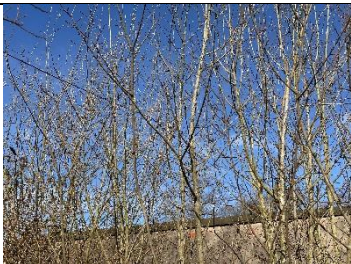
| 184 | Developable land at Drake Street, Rochdale, OL16 1PJ | Within the site curtilage toward the Northwest corner of the site | | Telephone lines are noted overhead and cut through the developable site area. Telephone lines appear intertwined with trees and vegetation situated in the site. Care should be taken during any site clearance. |

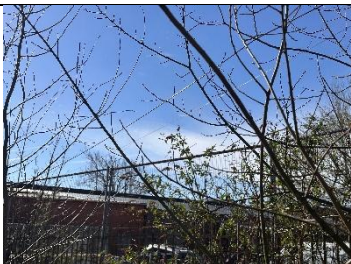
| 185 | Developable land at Drake Street, Rochdale, OL16 1PJ | Within the site curtilage toward the Northwest corner of the site | | Telephone lines are noted overhead and cut through the developable site area. Telephone lines appear intertwined with trees and vegetation situated in the site. Care should be taken during any site clearance. |

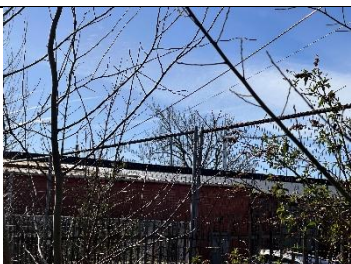
| 186 | Developable land at Drake Street, Rochdale, OL16 1PJ | Within the site curtilage toward the Northwest corner of the site | | Telephone lines are noted overhead and cut through the developable site area. Telephone lines appear intertwined with trees and vegetation situated in the site. Care should be taken during any site clearance. |
