R4372

SHEEP BANK FARM, WHITTAKER, LITTLEBOROUGH,  
ROCHDALE, MANCHESTER, OL15 0LH

JUNE 2026

# REPORT ON STRUCTURE

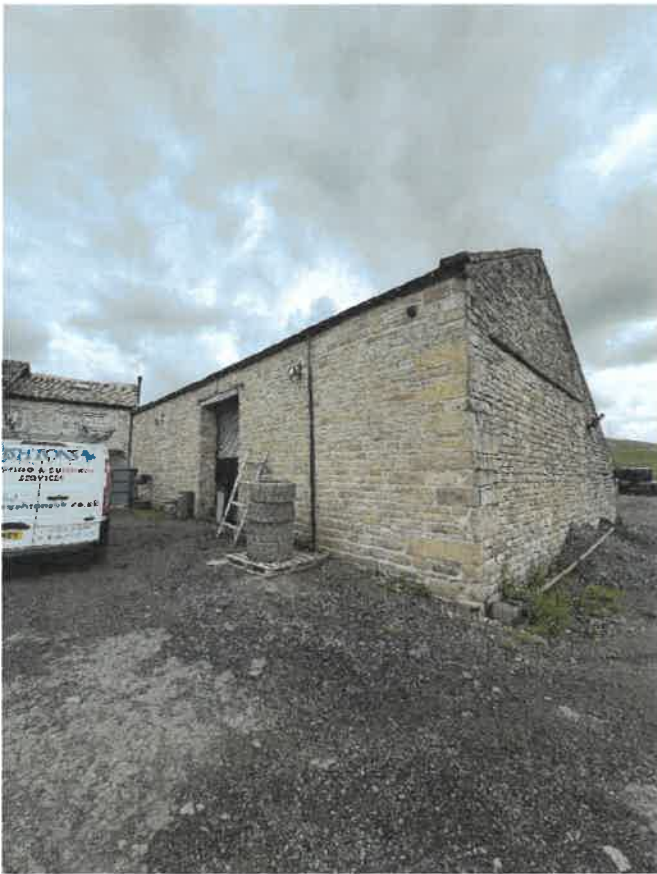
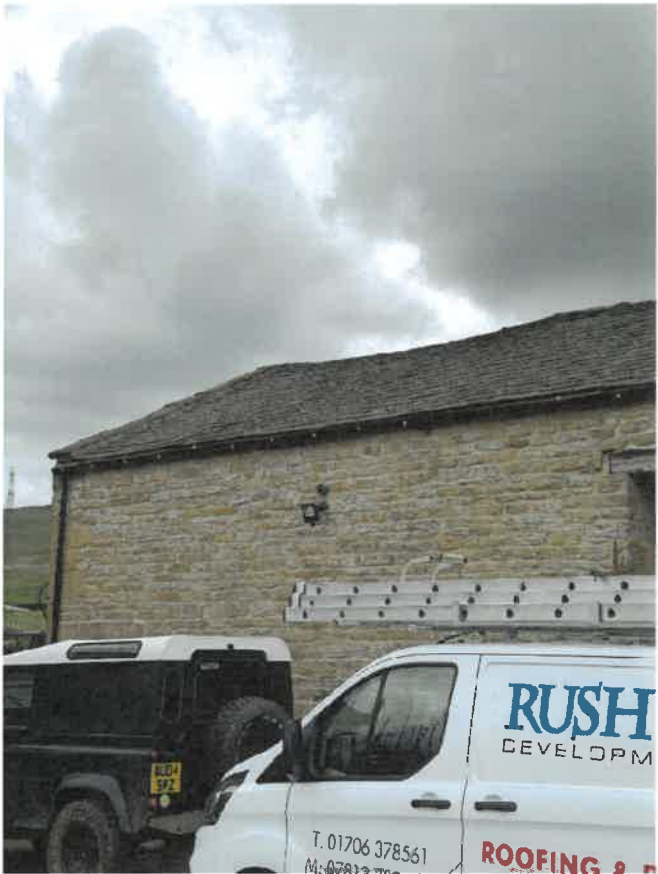
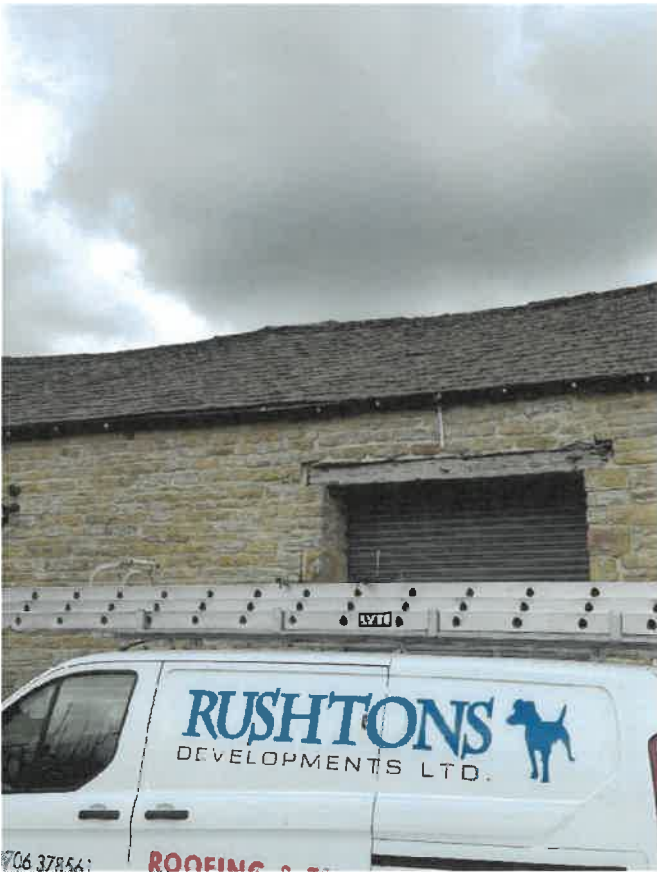
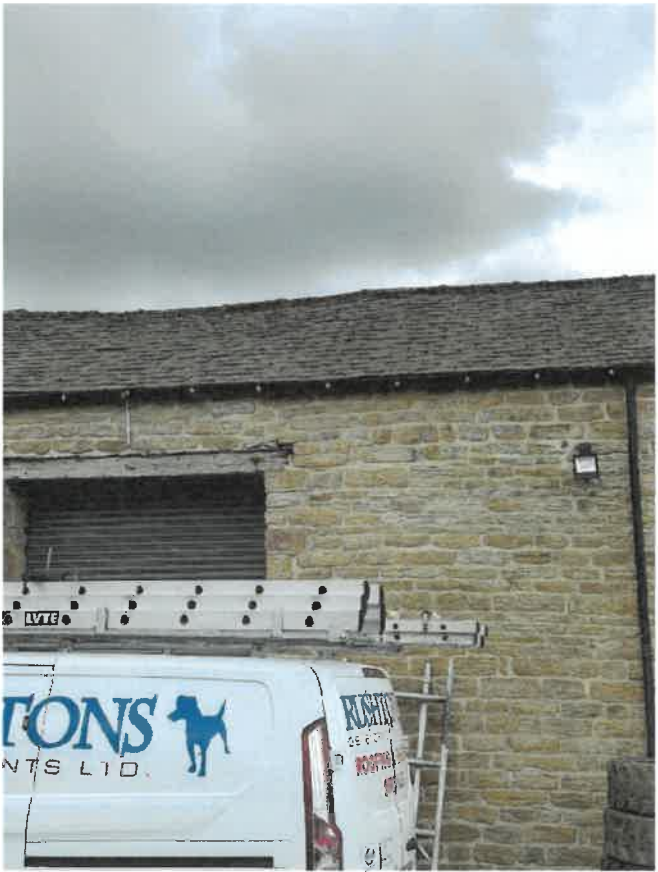
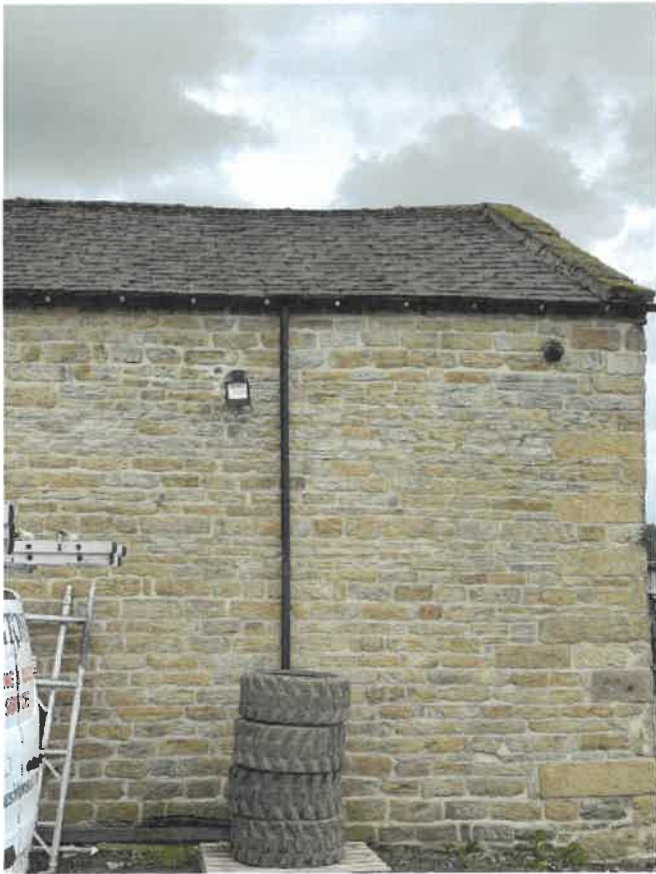
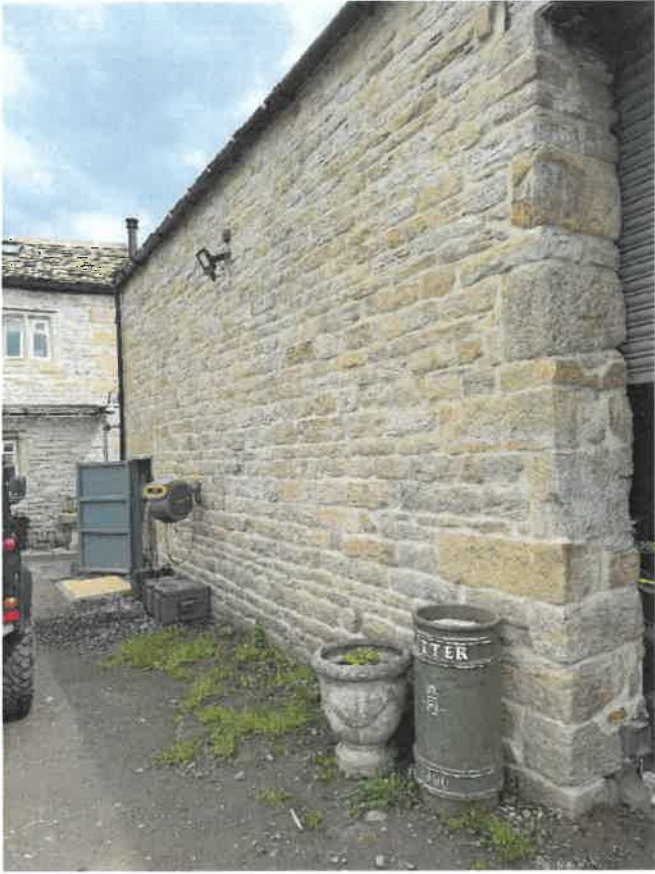
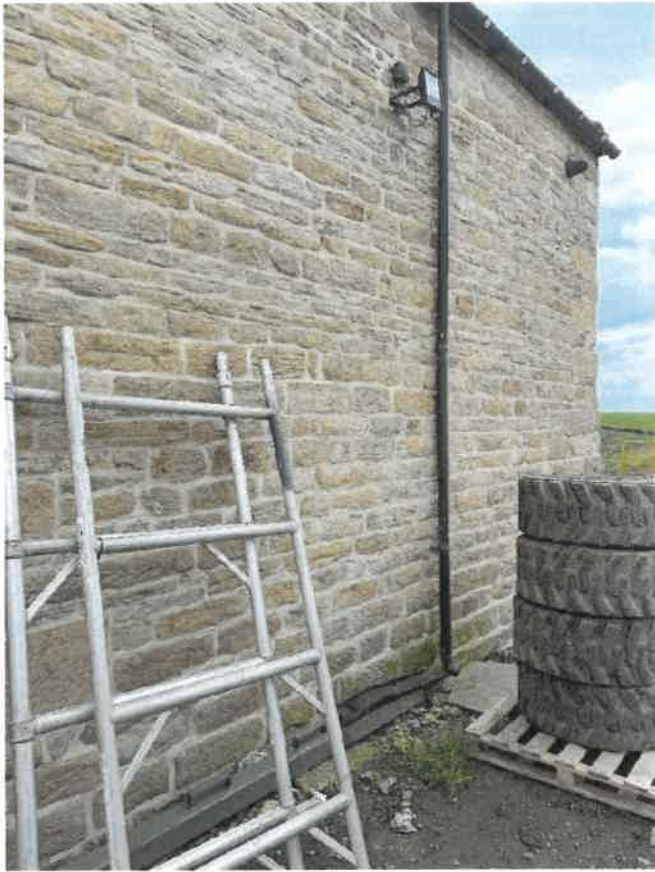
The front elevation comprises traditional stone masonry construction pointed using a mortar sympathetic in colour to the buff-coloured stonework.

Towards the left-hand side is a small entrance doorway incorporating a substantial stone lintel. Centrally positioned within the elevation is a large agricultural opening fitted with a roller shutter door. Timber lintels are present at high level above this opening supporting the masonry above.

The front elevation is generally considered to be structurally satisfactory.

Minor undulations and localised distortions are present along the length of the elevation. However, these are typical of a traditional stone agricultural structure of this age and do not indicate structural instability.

No significant cracking, stepped fractures or defects associated with foundation movement were observed.

Approximately three metres to the right of the principal opening, adjacent to the rainwater downpipe, a localised outward bulge is present. Whilst noticeable, the distortion is not considered excessive and no associated cracking was observed. Accordingly, this distortion is considered historic and non-progressive in nature.

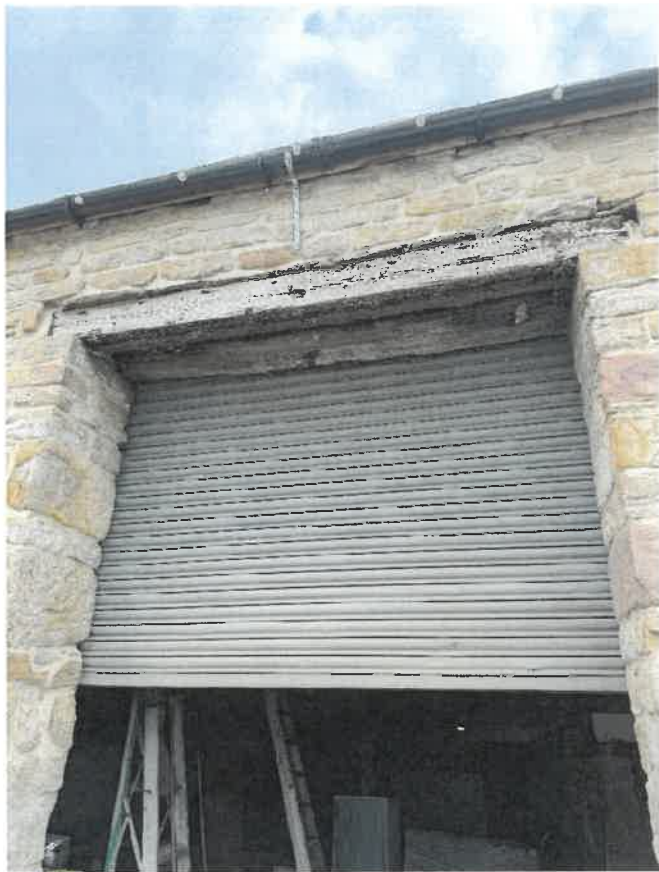
Photograph 7

The timber lintels above the roller shutter opening exhibit weathering and deterioration. (Photograph 7). Whilst not presenting an immediate structural

concern, these lintels would benefit from replacement as part of the proposed conversion works.

1. Replace deteriorated timber lintels above the front roller shutter opening as part of the conversion works.
2. Undertake localised repointing works using a mortar sympathetic to the existing stonework where required.

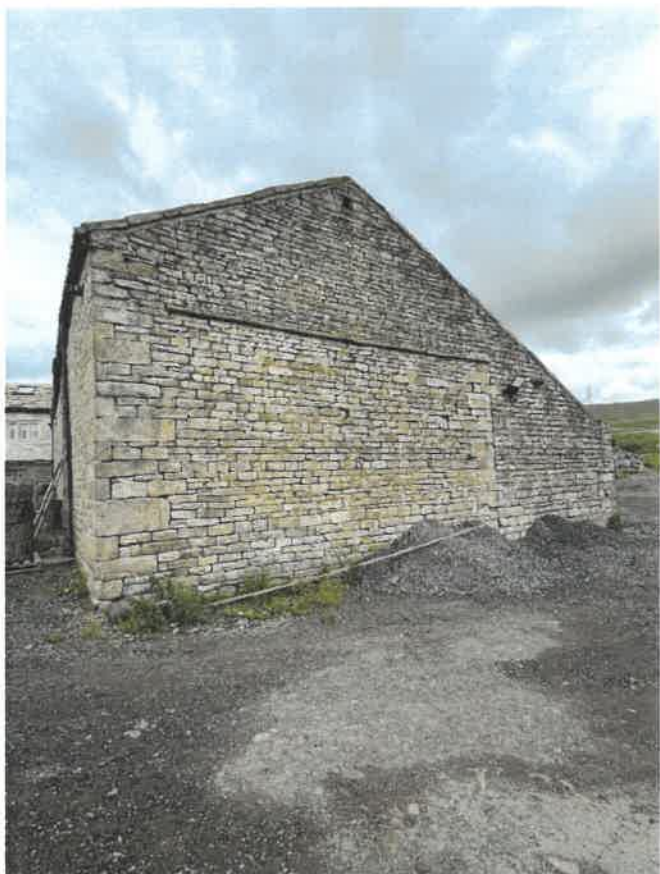
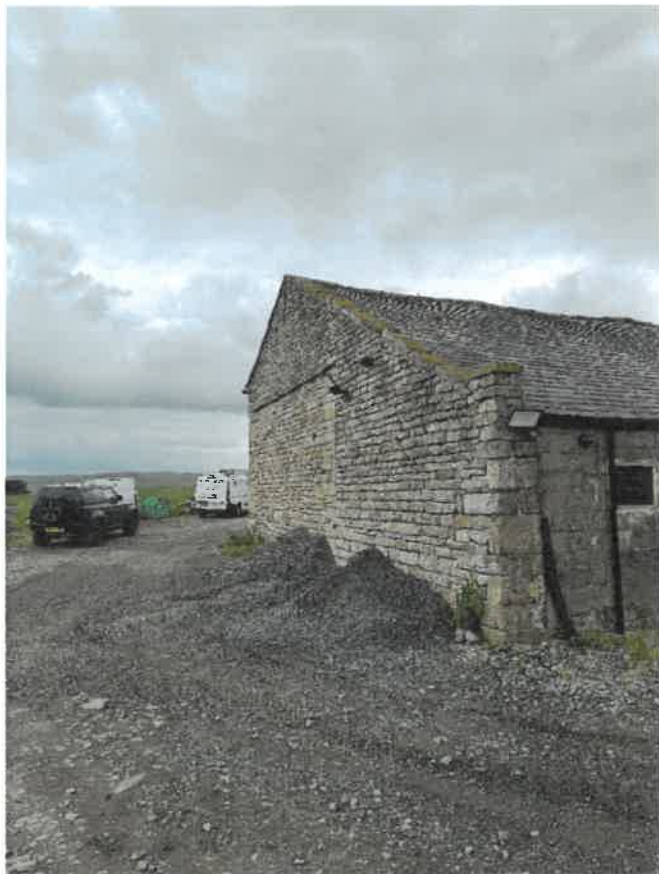
The right-hand elevation forms an asymmetric gable end reflecting the differing proportions of the front and rear roof slopes.

The elevation comprises stone masonry construction believed to incorporate a rubble-filled core. Large stone quoins are present at the front right-hand corner of the building.

Located slightly rearward of the centreline of the elevation is a vertical masonry butt joint which may indicate the former presence of an adjoining structure. Supporting this interpretation are sloping coping stones visible at high level suggestive of a former roof abutment.

The right-hand elevation is considered to be structurally satisfactory.

The elevation exhibits a slight concave distortion when viewed along its length. However, the distortion is modest and falls within the range commonly encountered in traditional stone agricultural buildings.

The elevation exhibits excellent vertical alignment with no significant lean or deviation from plumb.

No significant cracking, separation, bulging, open joints or evidence of foundation movement was observed.

As part of the proposed conversion works, consideration should be given to repointing the elevation using a mortar sympathetic to the existing stonework in order to improve weather resistance and minimise rainwater penetration into the masonry fabric.

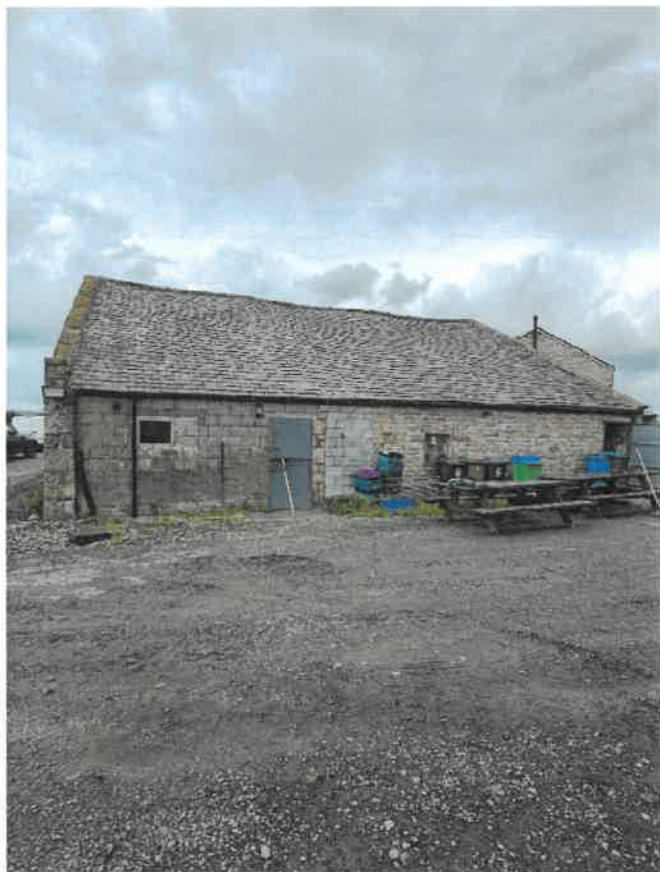
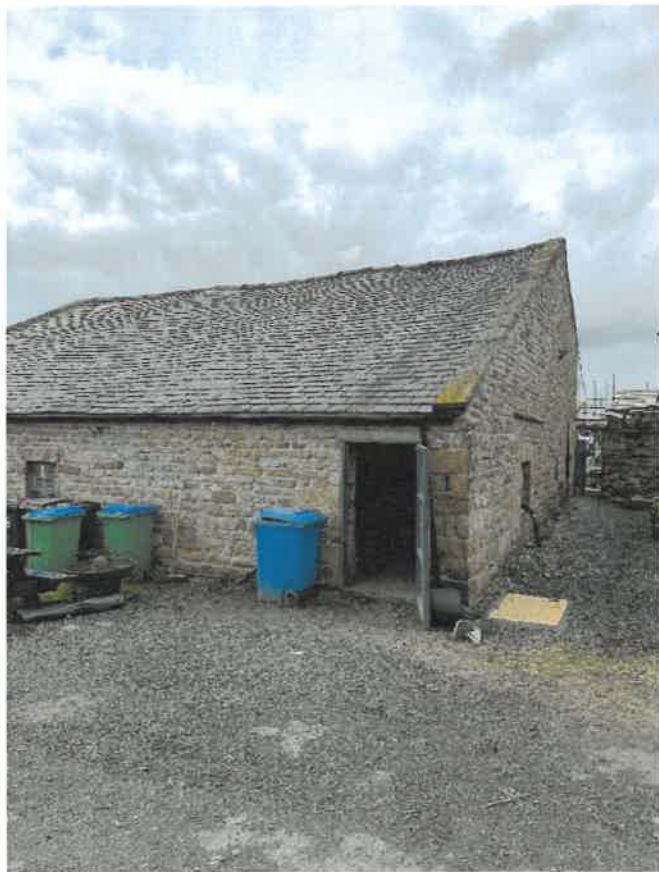
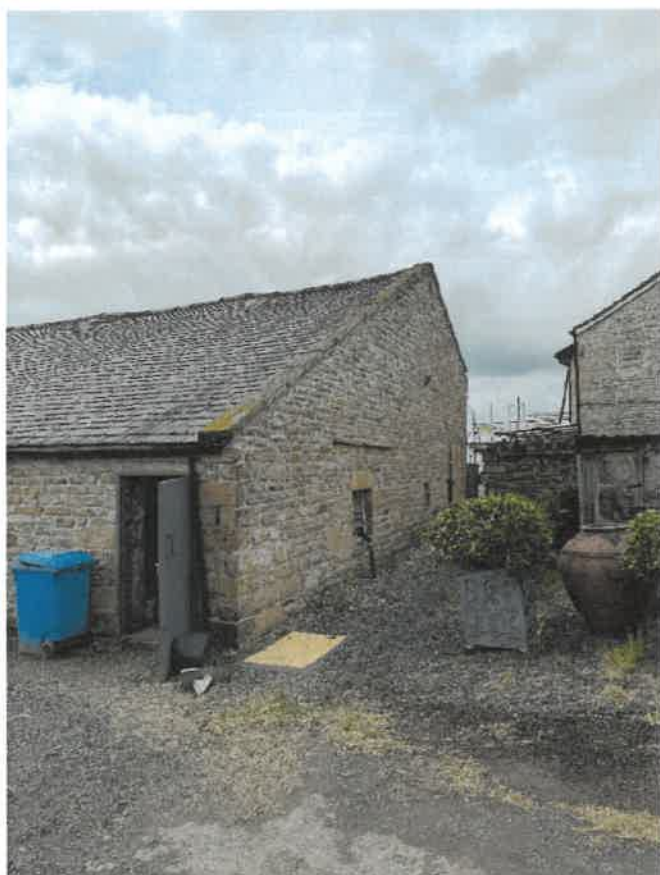
The majority of the elevation comprises traditional stone masonry construction extending from the left-hand side to a position slightly right of centre. The stonework has been pointed using a cementitious mortar sympathetic to the appearance of the existing masonry.

To the right of the window is a former doorway which has been infilled using aerated concrete blockwork. Further right is a steel personnel door and a small window opening contained within an area of dense concrete blockwork construction which appears to represent a later alteration to the building.

The original stone-built section of the rear elevation is considered to be in excellent structural condition.

The masonry exhibits good alignment and verticality and is free from signs of excessive foundation settlement, structural instability or ongoing movement.

No significant stress fractures, stepped cracking or separation were observed.

The dense concrete blockwork and aerated blockwork infill sections located towards the right-hand side of the elevation appear to represent later alterations. It is anticipated that these elements will be removed and replaced with stone masonry as part of the proposed conversion works. Subject to appropriate detailing, such works are considered entirely acceptable.

3. Remove existing non-original blockwork infill panels and reconstruct these areas using stone masonry to match the existing building.
4. Replace the existing roof coverings and secondary roof timbers as required to facilitate modern insulation, ventilation and weatherproofing requirements whilst retaining the principal timber trusses. The creation of the inset first floor balconies to the rear roof slope should be readily achieved with good structural design.

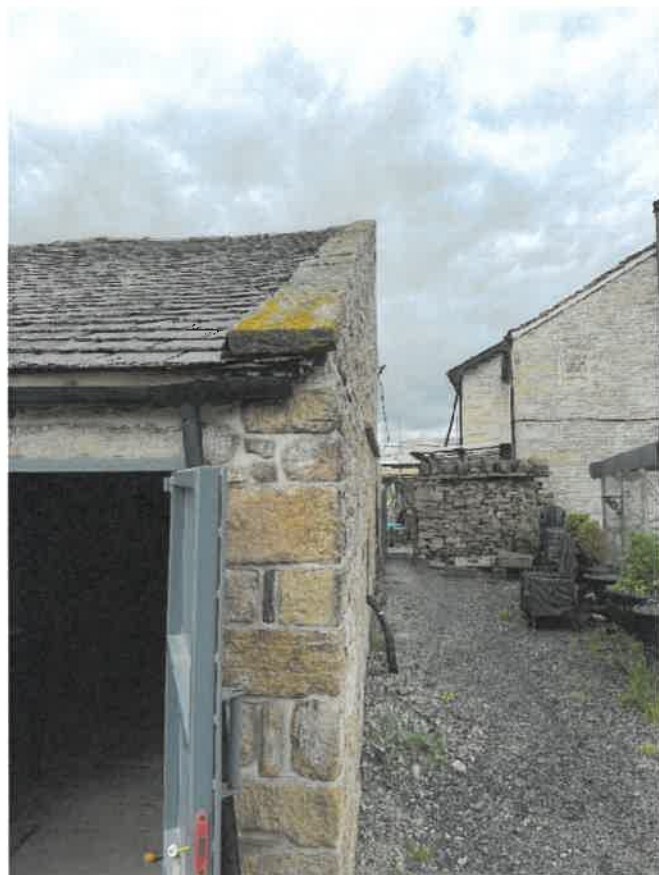
*Photograph 14*

The gable is capped with substantial stone coping units bedded on mortar. (Photograph 14). Towards the forward section are two small window openings incorporating stone surrounds. Slightly further to the rear is a larger window opening incorporating stone surrounds and a substantial stone lintel. A small ventilation or roosting opening is present immediately below the apex of the gable.

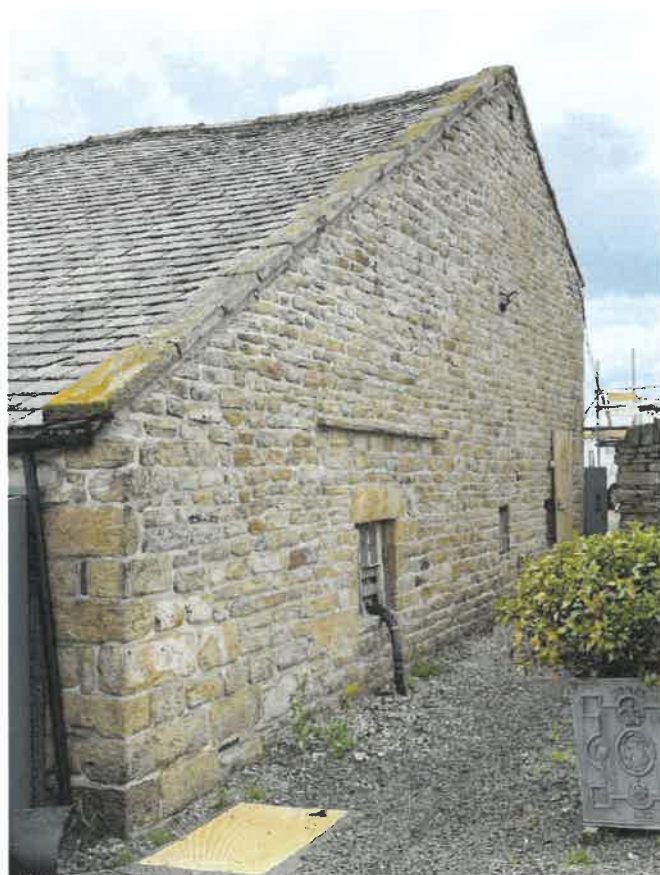
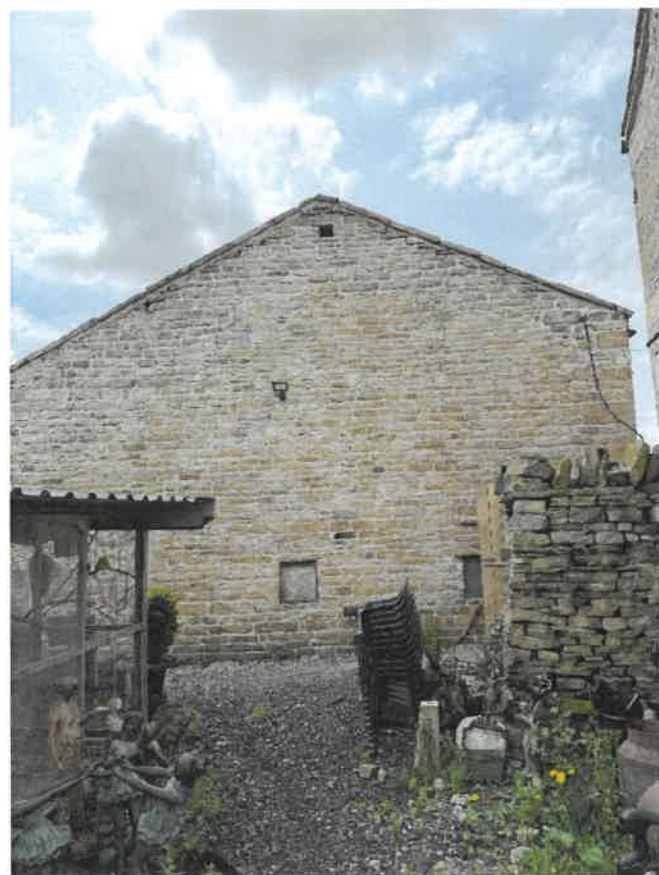
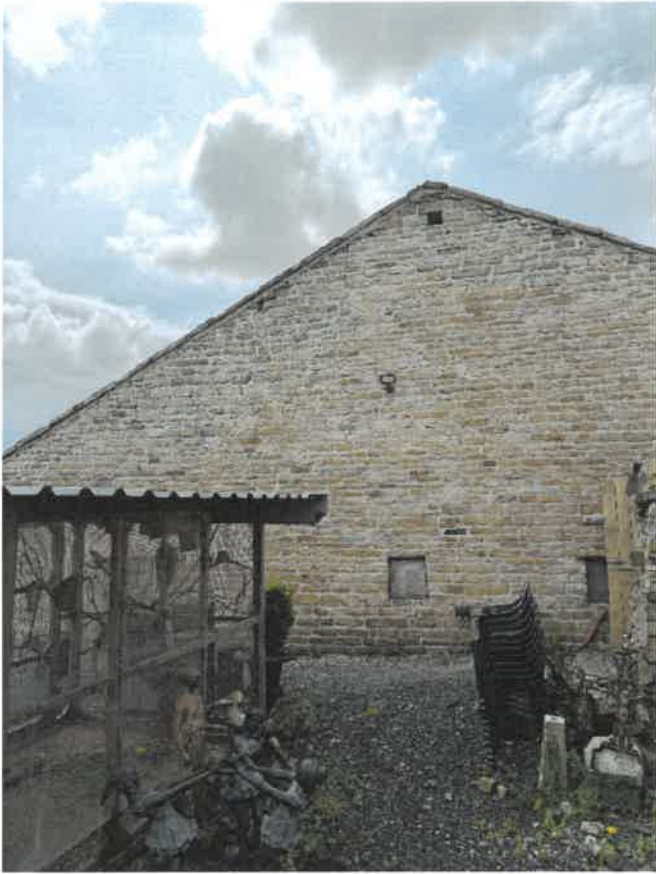
The wall construction comprises traditional stone masonry believed to incorporate a rubble-filled core. The masonry has been pointed using cementitious mortar sympathetic in appearance to the existing stonework.

The left-hand elevation is considered to be structurally satisfactory.

A discernible outward bulge is present slightly rearward of the centre of the elevation. Whilst visible, the distortion is not considered excessive and there is no evidence to suggest ongoing movement.

No significant cracking, stepped fracturing, separation or defects associated with foundation movement were observed.

The overall alignment and verticality of the elevation remain satisfactory, and the wall continues to perform its structural function adequately.

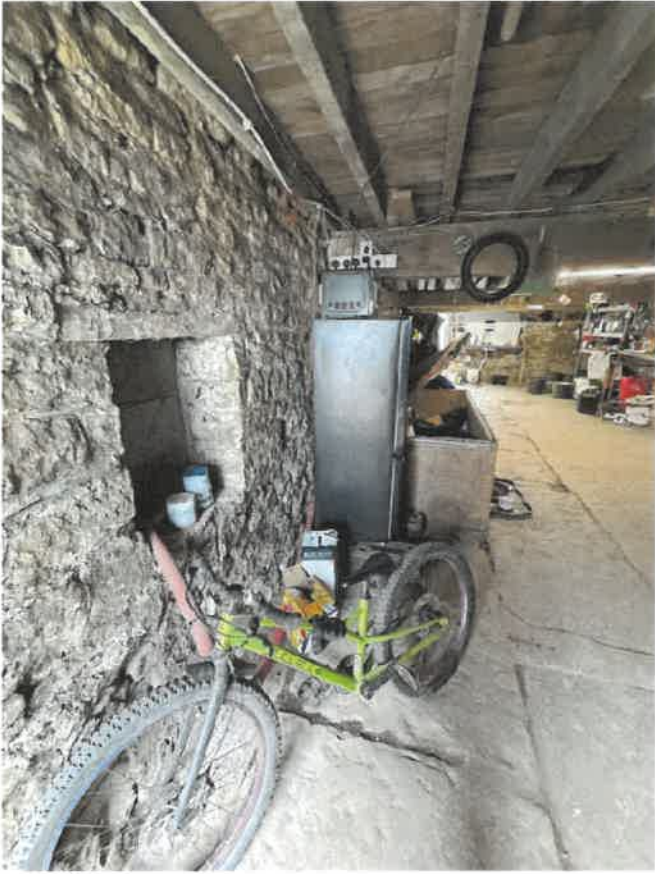
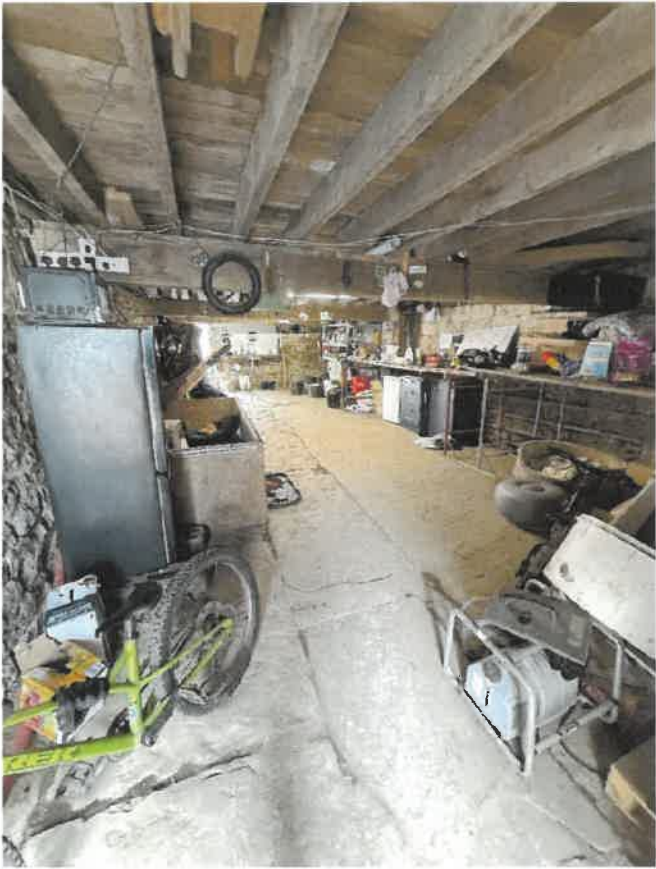
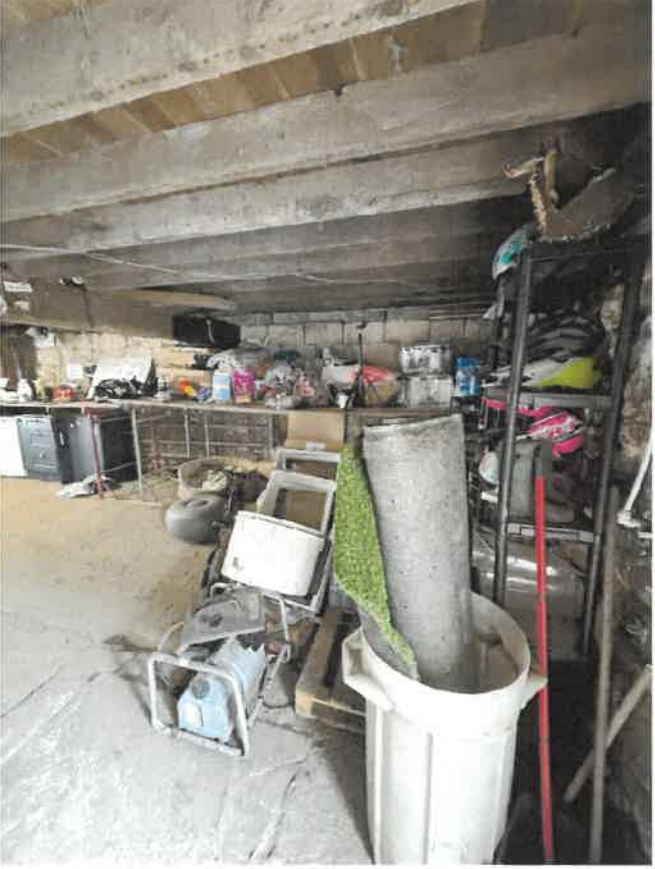
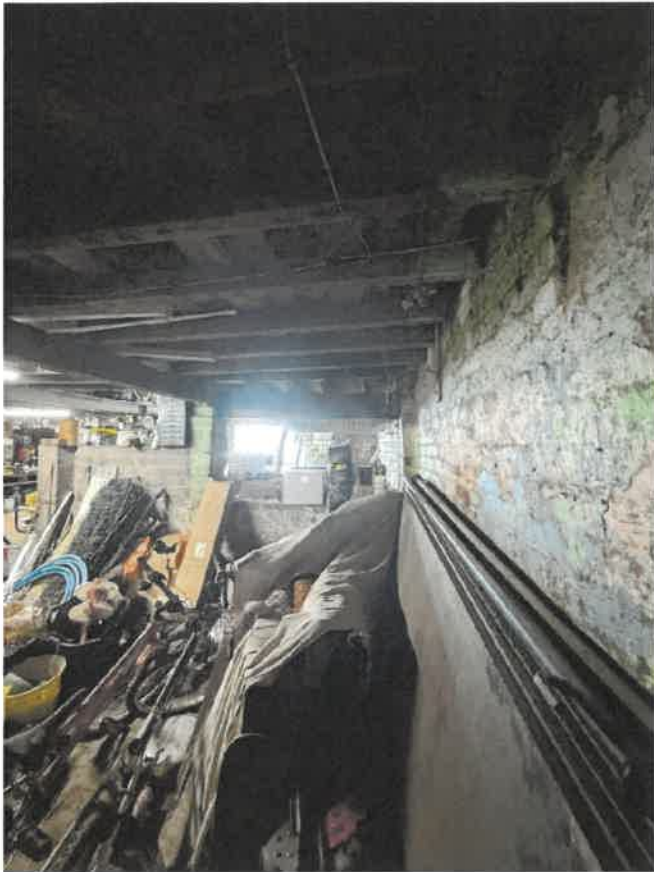
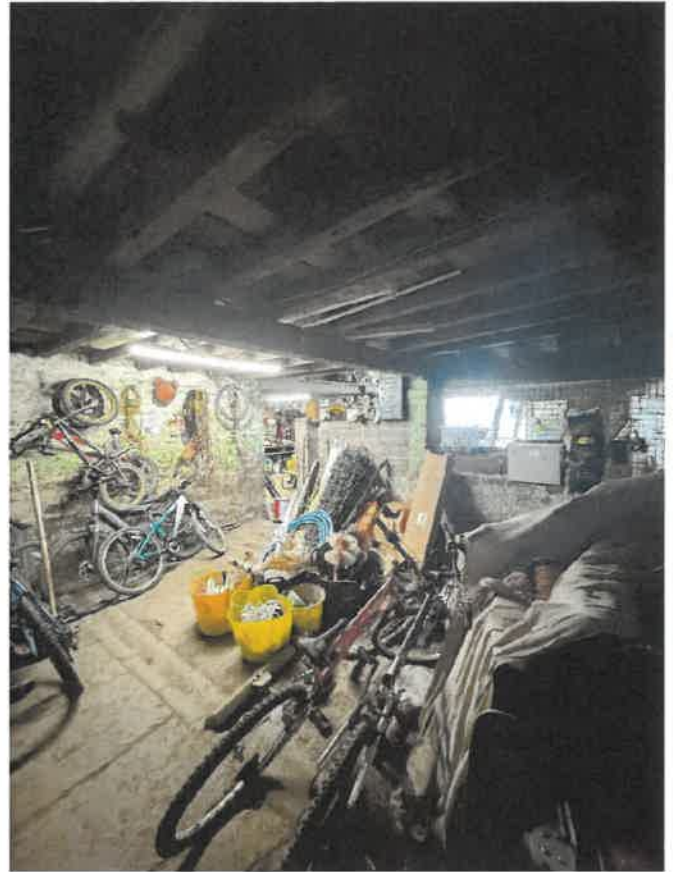
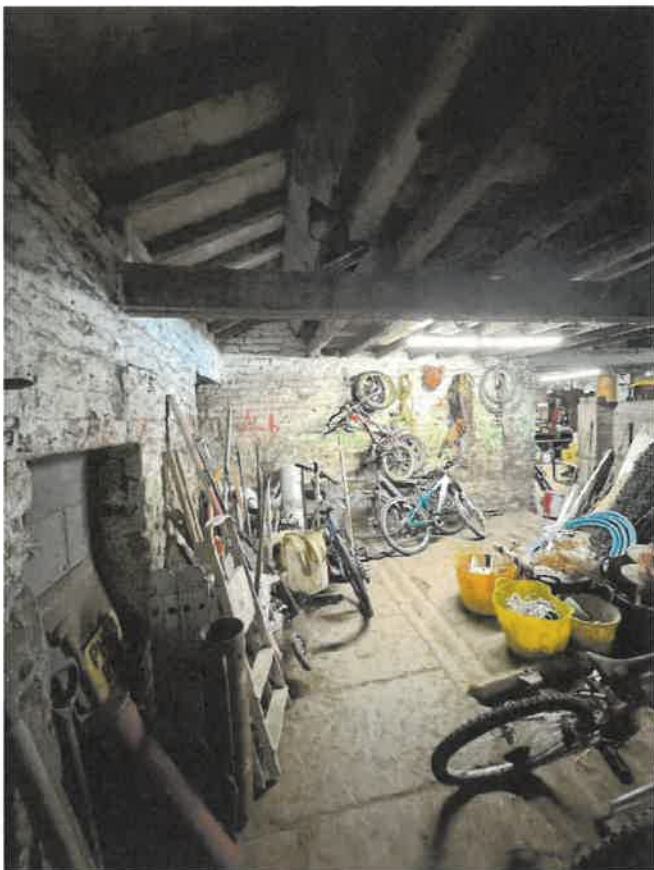
Internally, the left-hand section of the building comprises a room approximately 4.6 metres wide. The left-hand wall comprises exposed stone masonry whilst a concrete blockwork wall forms the right-hand side. Overhead is a mezzanine floor formed using timber joists spanning in a front-to-back direction supported by substantial timber beams spanning left to right.

The floor construction comprises a combination of large York stone flags together with areas of concrete slab construction.

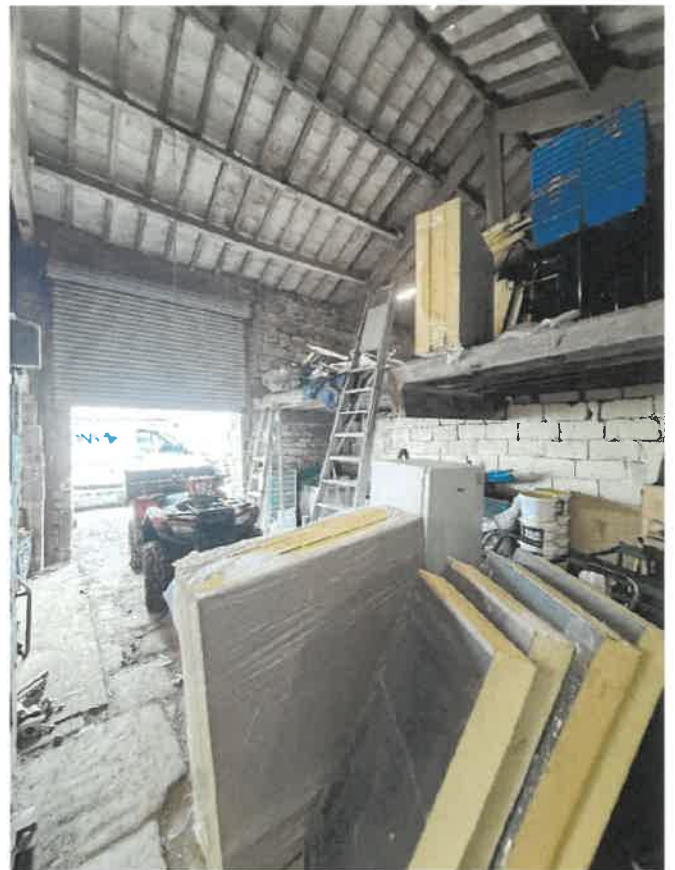
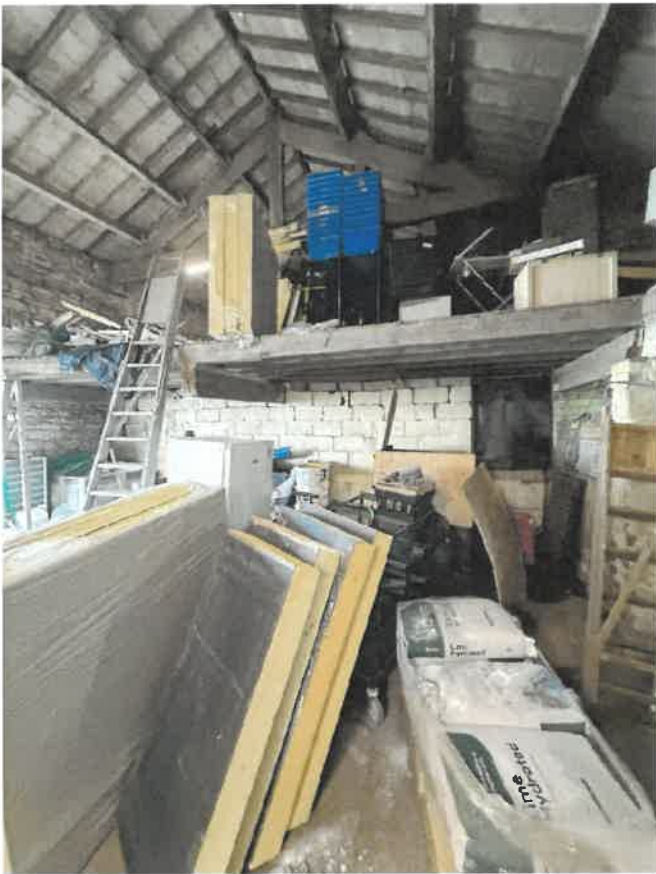
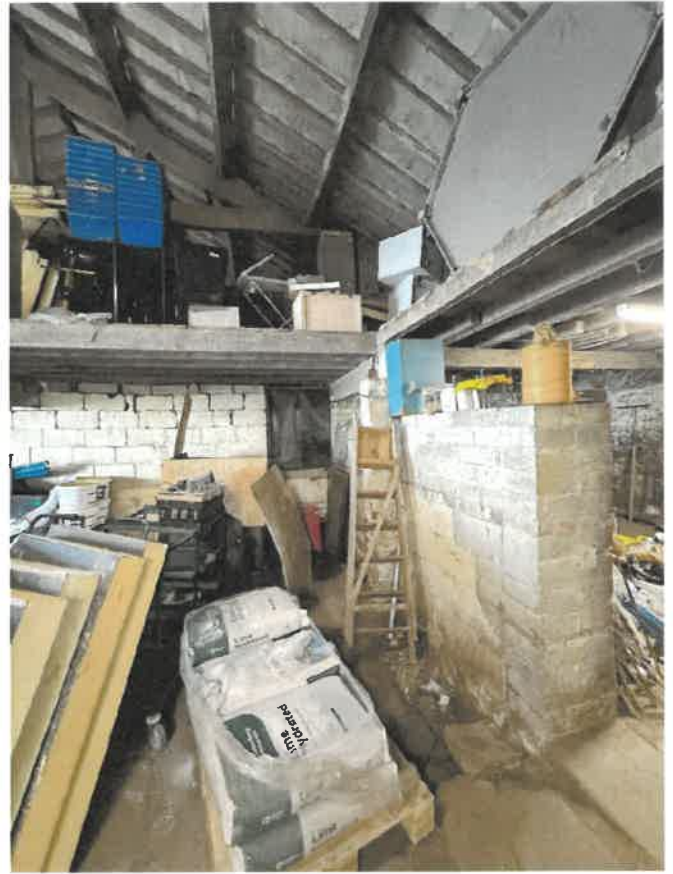
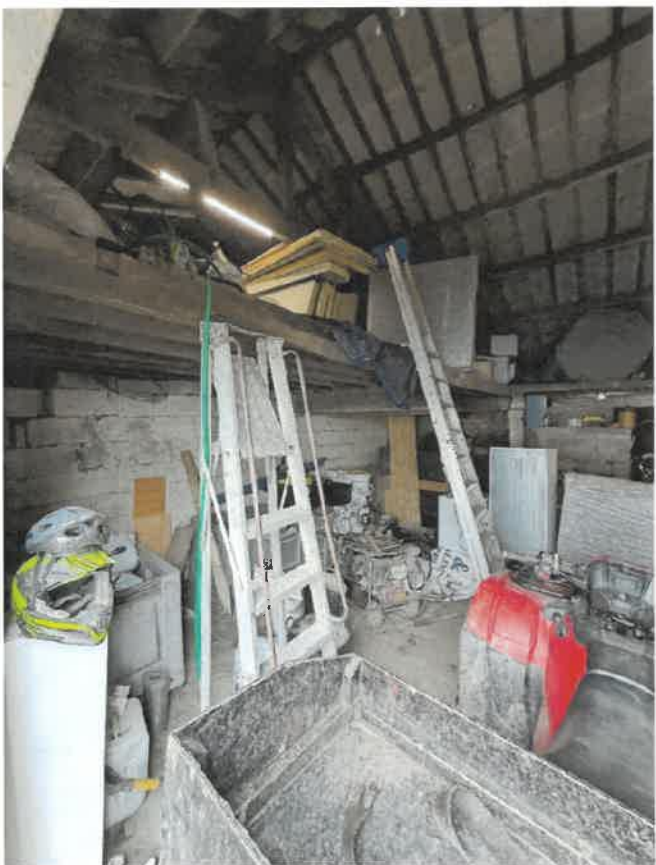
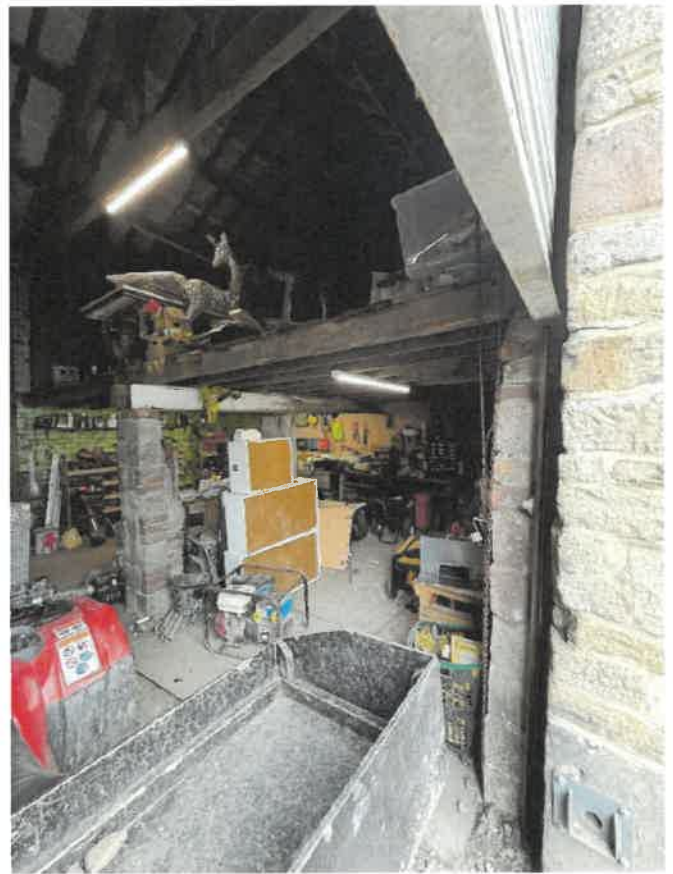
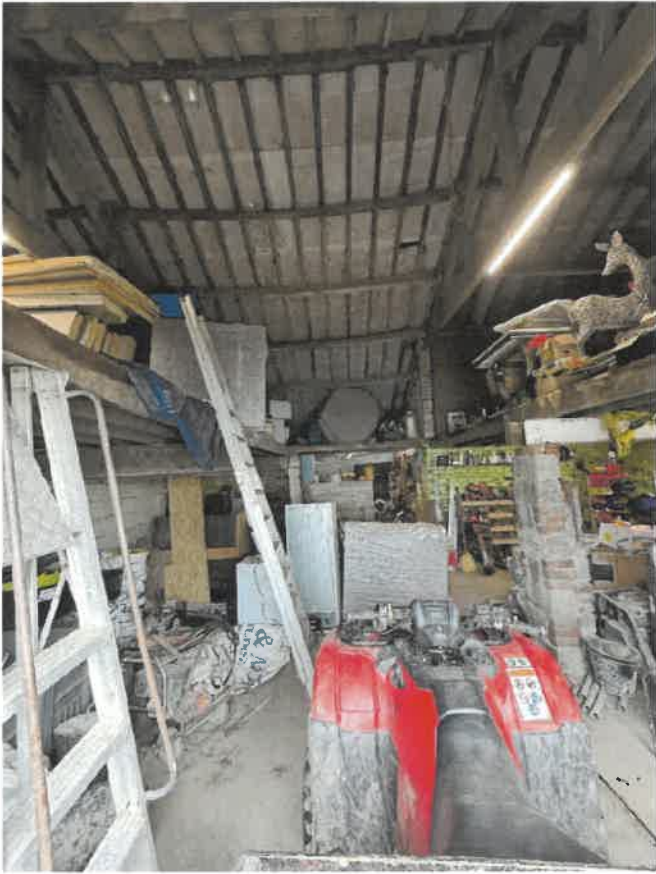
Mezzanine floor structures are present on both sides of the central opening. To the right-hand side, timber floor joists span in a front-to-back direction and are supported by steel beams spanning left to right. These steel beams are

supported upon masonry piers formed from brickwork and concrete blockwork.

The ground floor construction within this area principally comprises large York stone flags exhibiting localised historic settlement and undulation.

The internal masonry walls, mezzanine structures and supporting steelwork were generally found to be performing satisfactorily at the time of the inspection.

The York stone floor surfaces exhibit localised undulations and historic differential settlement. However, these movements are considered long-standing and are not indicative of ongoing structural instability.

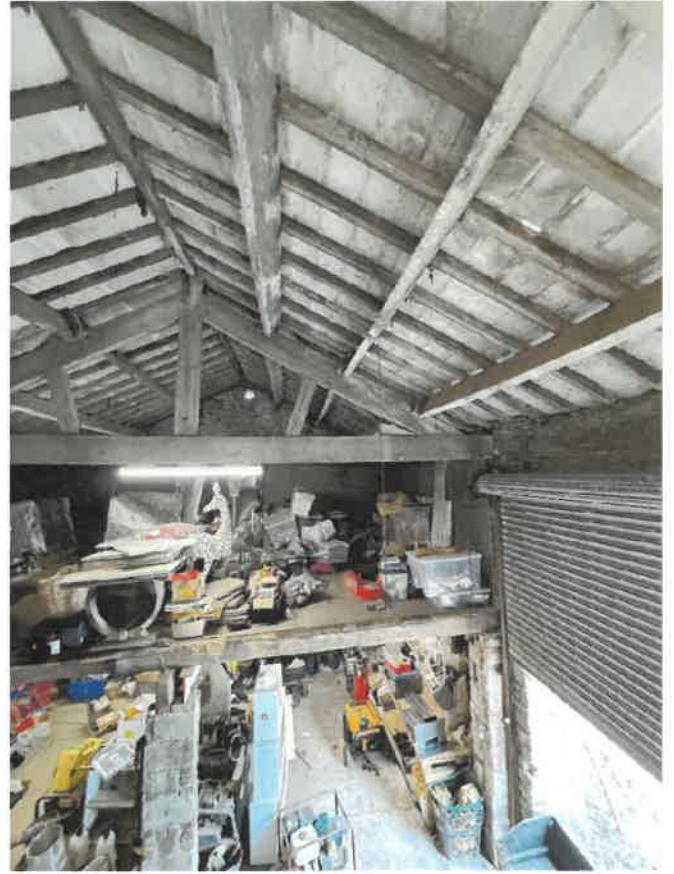
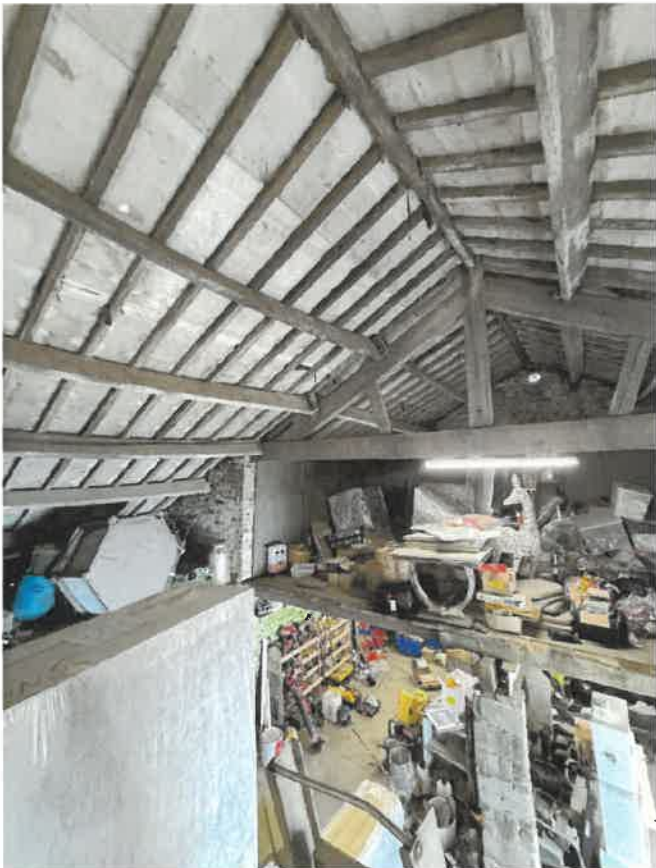
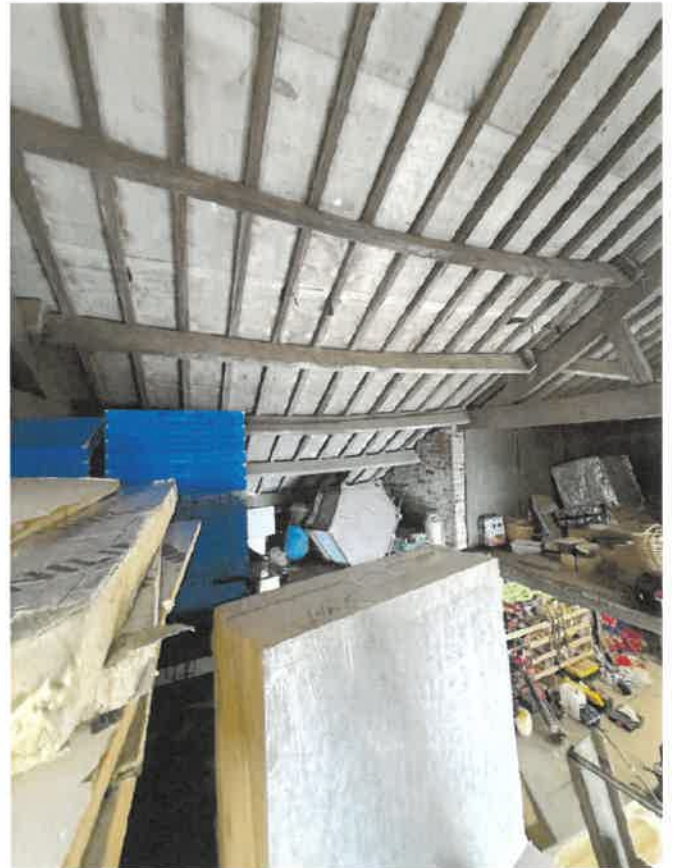
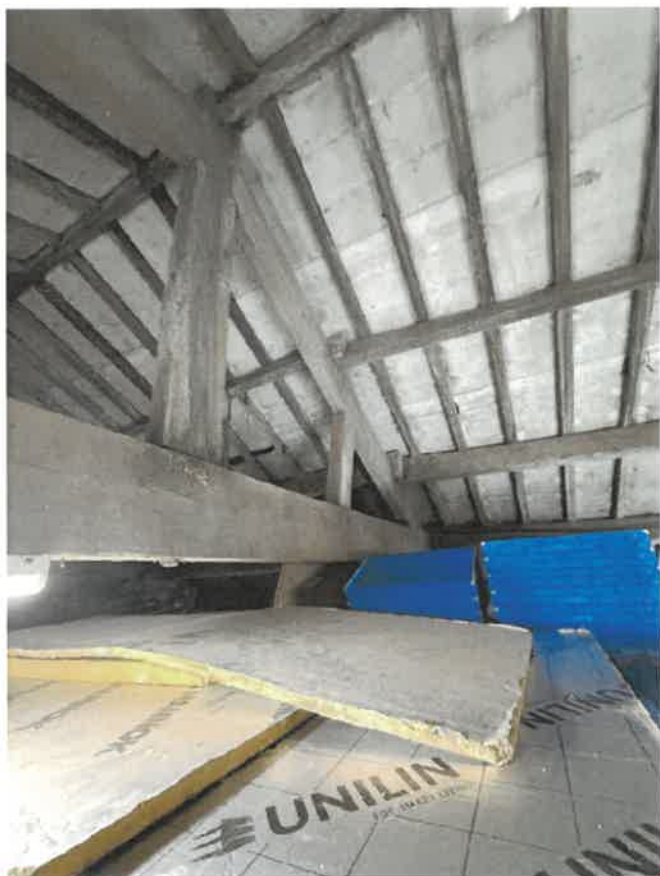
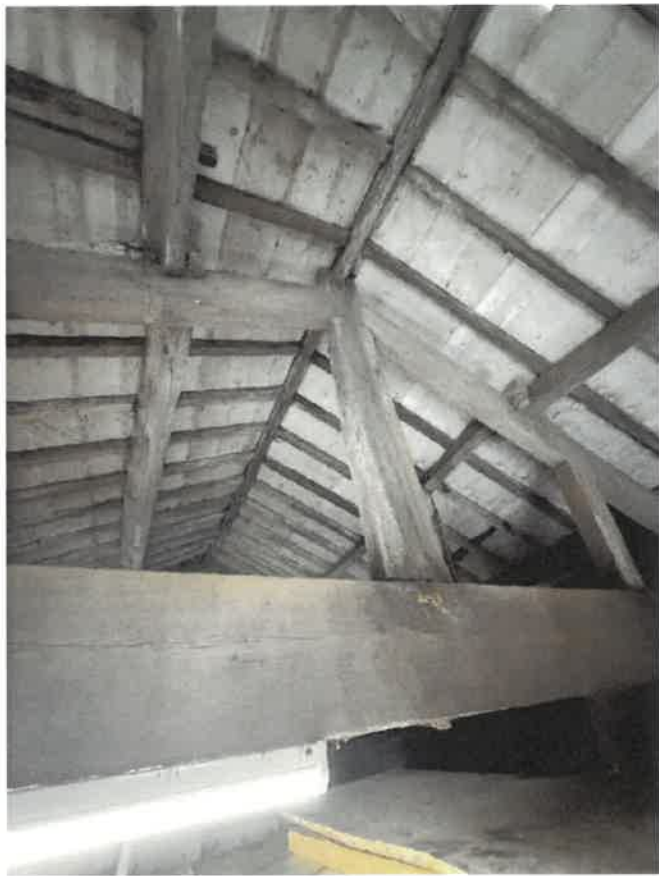
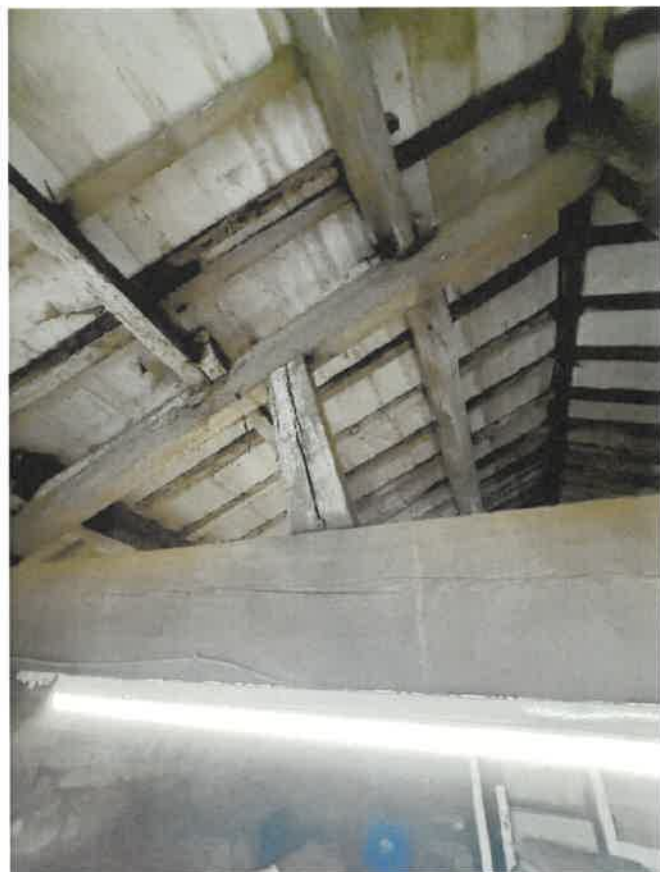
The roof structure comprises traditional timber construction formed using rafters at relatively close centres supporting both the front and rear roof slopes.

The shorter front roof slope is supported by three lines of timber purlins spanning between principal trusses. The longer rear roof slope incorporates approximately five to six lines of purlins due to the increased roof span.

At approximately third points along the length of the building are substantial timber trusses spanning in a front-to-back direction. These trusses broadly resemble king-post trusses incorporating substantial principal timbers together with large timber diagonal braces.

The principal timber roof trusses appear to be structurally satisfactory and continue to perform their intended loadbearing function.

The purlins serving both roof slopes exhibit varying degrees of sagging consistent with their age, span and orientation. This is particularly evident owing to the weak-axis orientation of the purlins. Whilst noticeable, this does not presently indicate structural failure of the roof structure.
