# Tree Condition Survey Report (VTA)

**Site:** The Highfield Hospital, Manchester Rd, Rochdale OL11 4LZ

**Client:** Circle Health

| <i>GC Document Reference</i> | J251099 | | | |

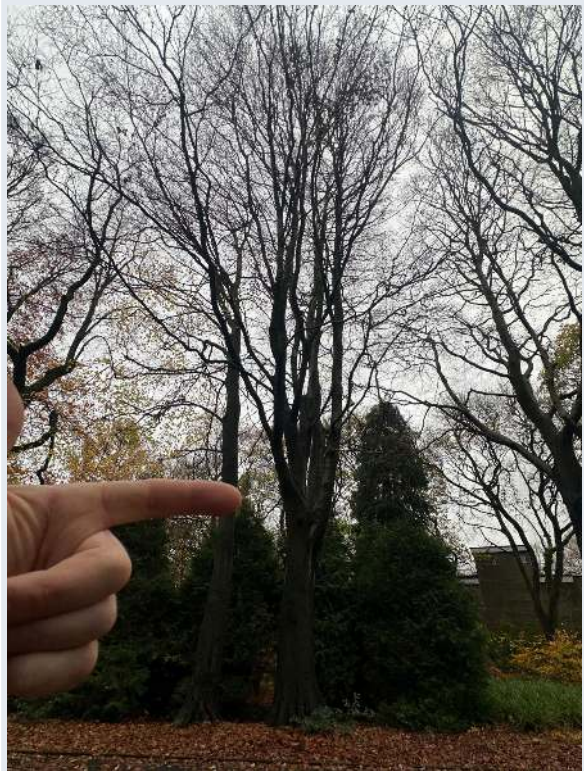
| Common beech Tree ID #10 | |

| Tree Survey Schedule | | | | | | | | | | | | | | | | | |
|---|---|---|---|---|---|---|---|---|---|---|---|---|---|---|---|---|---|
| 10 | 6775 | Common beech | Fagus sylvatica | 20+m | 600 | Mature | Good | Good | Actively rubbing branch | No Visible Issues or Defects | Acoustically tested with rubber mallet - no significant decay noted | Crossing/Rubbing Branches, Minor Dead Wood Under 50mm Diameter | None Observed | Accessible Woodland , Footpath, Road, Street light/furniture | High | | Client |

| Tree / Group ID | Common Name | Work Task | Work Priority | Description | Tag No |
|---|---|---|---|---|---|
| 10 | Common beech | Remove Specific Branch/Limb | Within 6 - 12 Months | Remove actively rubbing branch located at 5metres causing damage to eastern stem | 6775 |

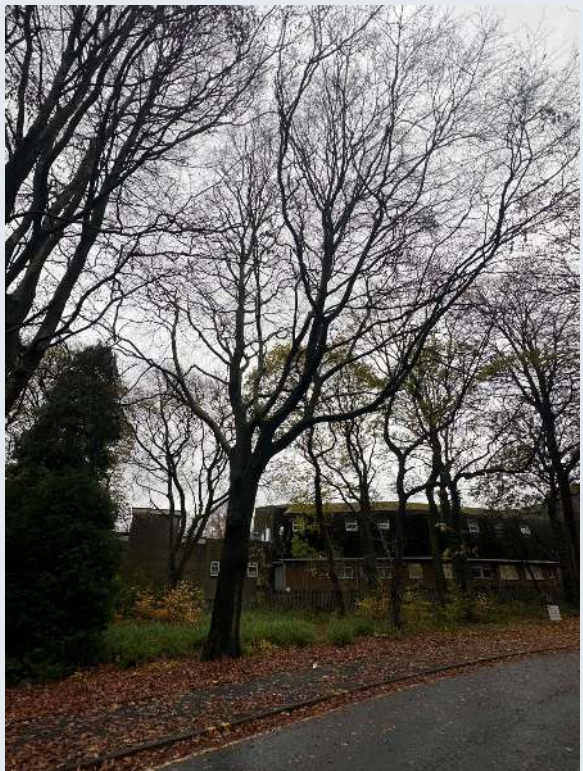
Common beech Tree ID #11

| Tree Survey Schedule | | | | | | | | | | | | | | | | | |
|---|---|---|---|---|---|---|---|---|---|---|---|---|---|---|---|---|---|
| 11 | 6788 | Common beech | Fagus sylvatica | 16-20m | 500 | Mature | Good | Good | | No Visible Issues or Defects | Acoustically tested with rubber mallet - no significant decay noted | Major Dead Wood Over 50mm Diameter, Minor Dead Wood Under 50mm Diameter | None Observed | Accessible Woodland , Footpath, Road, Street light/furniture | High | Good | Client |

| Tree / Group ID | Common Name | Work Task | Work Priority | Description | Tag No |
|---|---|---|---|---|---|
| 11 | Common beech | Remove Dead Wood | Within 6 - 12 Months | Remove deadwood over footpath and road | 6788 |
