# Asbestos Management Survey

Unit 1, West Croft Industrial Estate, Manchester Old Rd, Greater, Middleton, Manchester M24 4GJ

1 Nov 2023

IC23396

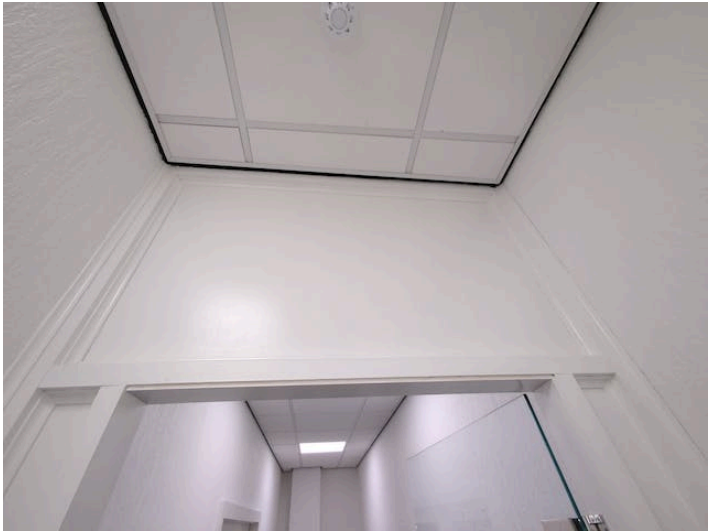
| Location | 001 - Circulation | Item | Door header |
| Material | Timber | Extent | |

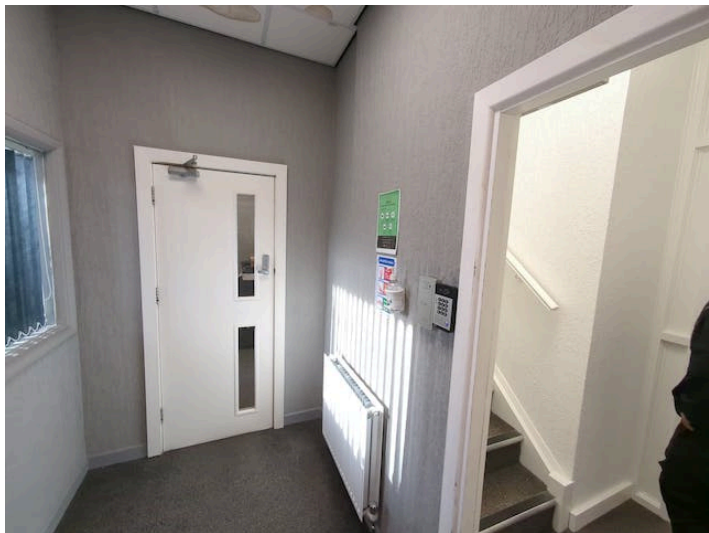
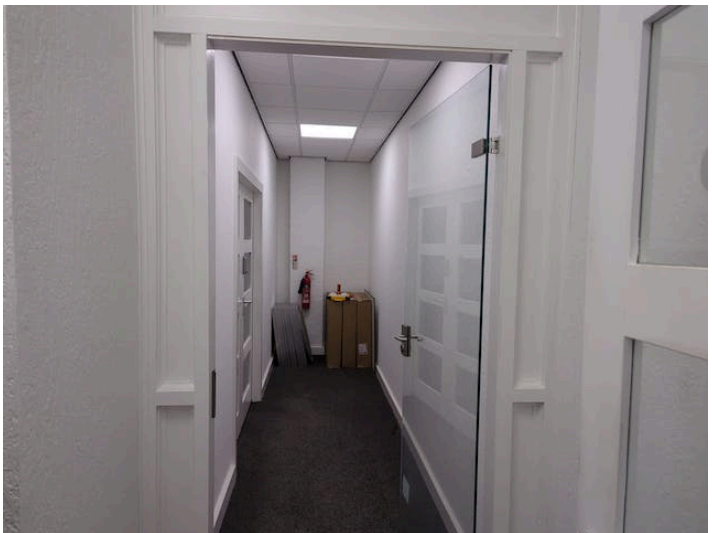
## Main &gt; 0 &gt; 001 - Circulation &gt; Location Notes

| Location Notes | Plasterboard walls, timber doors, uovc windows, MMMF ceiling tiles | | |

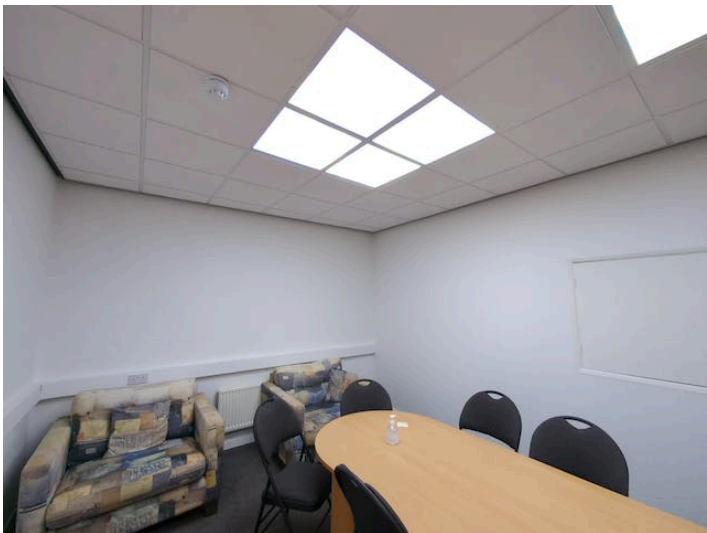
## Main &gt; 0 &gt; 002 - Office &gt; Location Notes

| Location Notes | Concrete floor Plasterboard walls, MMMF ceiling tiles | | |

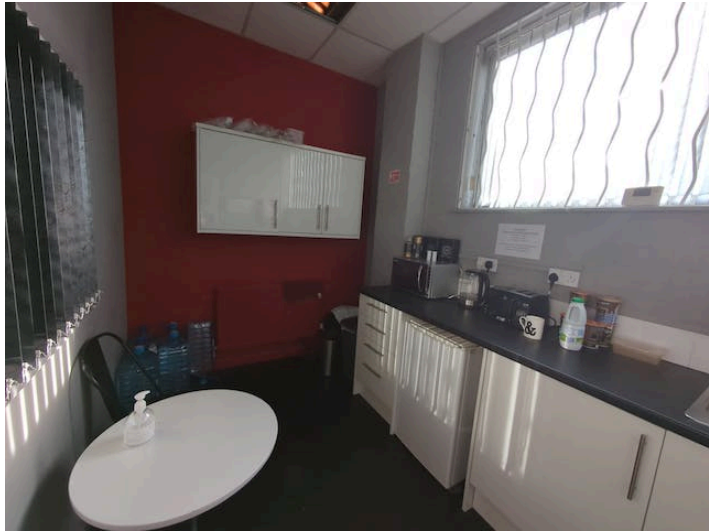
## Main &gt; 0 &gt; 003 - Kitchen &gt; Location Notes

| Location Notes | Concrete floor Plasterboard walls, MMMF ceiling tile, uPVC windows | | |

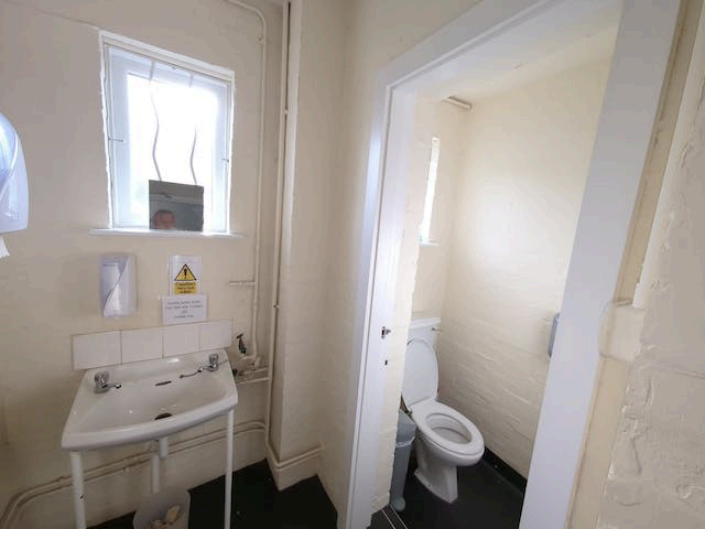
## Main &gt; 0 &gt; 004 - WC &gt; Location Notes

| Location Notes | Concrete floor, plasterboard and MMMF ceiling, brick walls, uPVC windows | | |

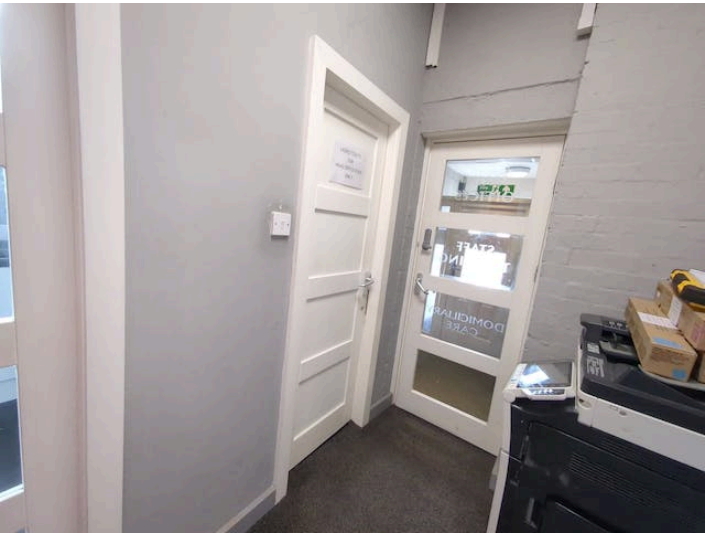
## Main &gt; 0 &gt; 005 - circulation &gt; Location Notes

| Location Notes | Concrete floor Plasterboard walls, MMMF ceiling tiles, timber doors | | |

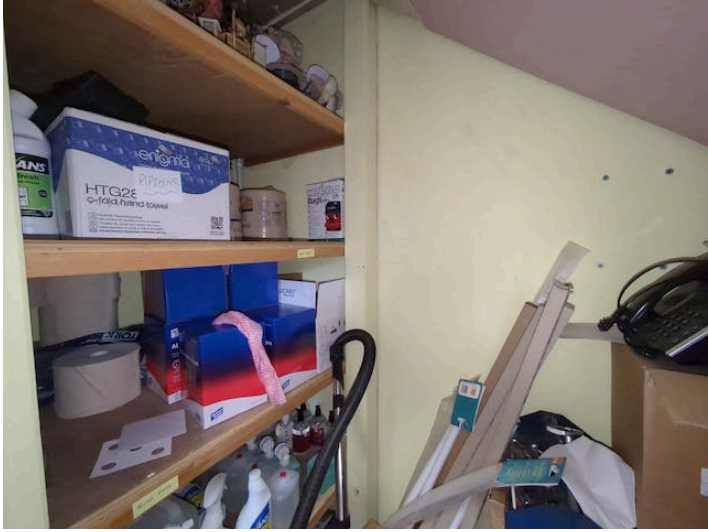
## Main &gt; 0 &gt; 006 - under stairs cupboard &gt; Location Notes

| Location Notes | Concrete floor, plasterboard ceiling and walls | | |

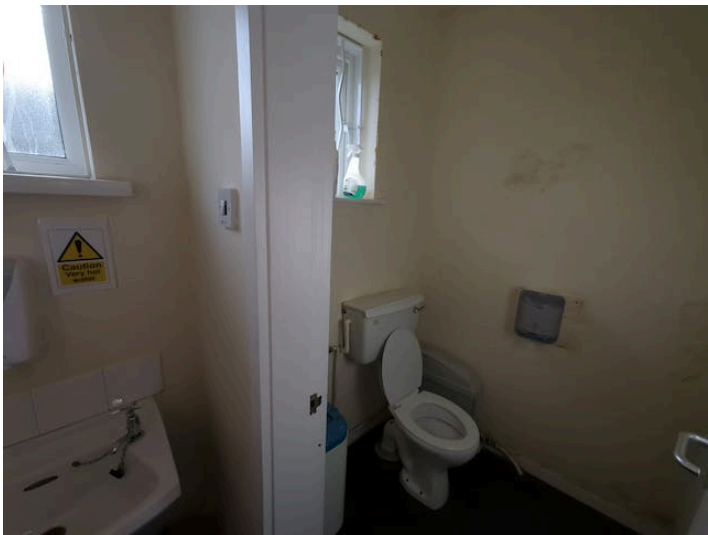
## Main &gt; 0 &gt; 007 - WC &gt; Location Notes

| Location Notes | Concrete floor, plasterboard ceiling, brick walls, uPVC windows | | |

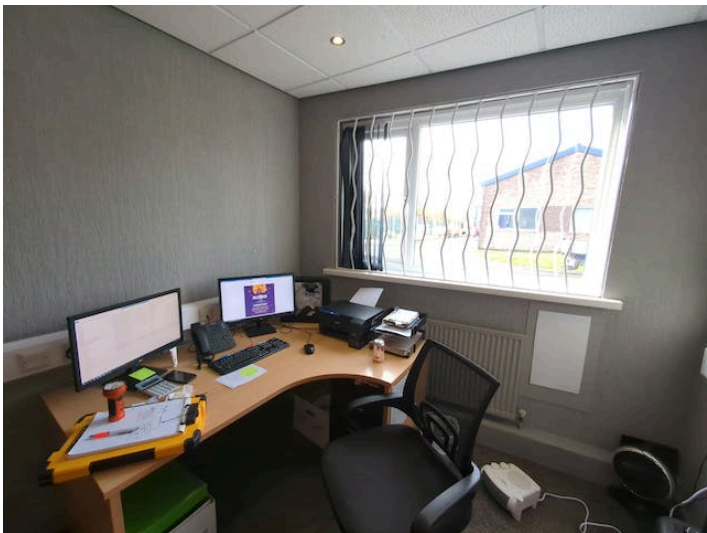
## Main &gt; 0 &gt; 008 - Office &gt; Location Notes

| Location Notes | Concrete floor, plasterboard ceiling, brick walls, uPVC windows | | |

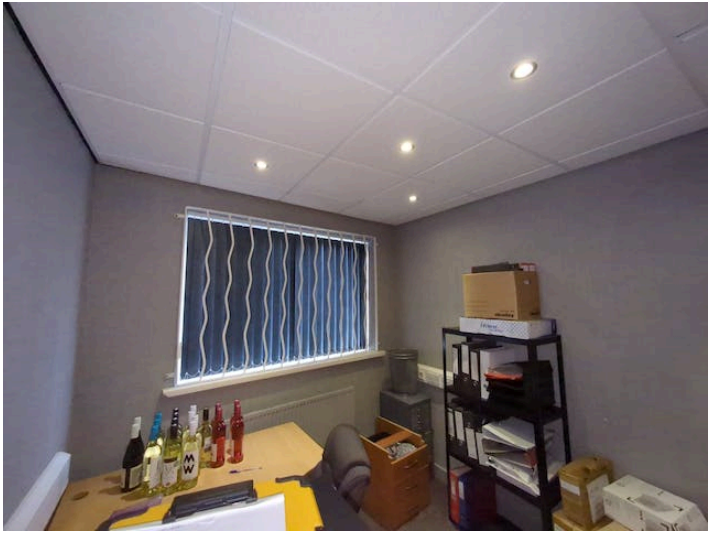
## Main &gt; 0 &gt; 009 - Office &gt; Location Notes

| Location Notes | Concrete floor, brick walls, MMMF ceiling tiles | | |

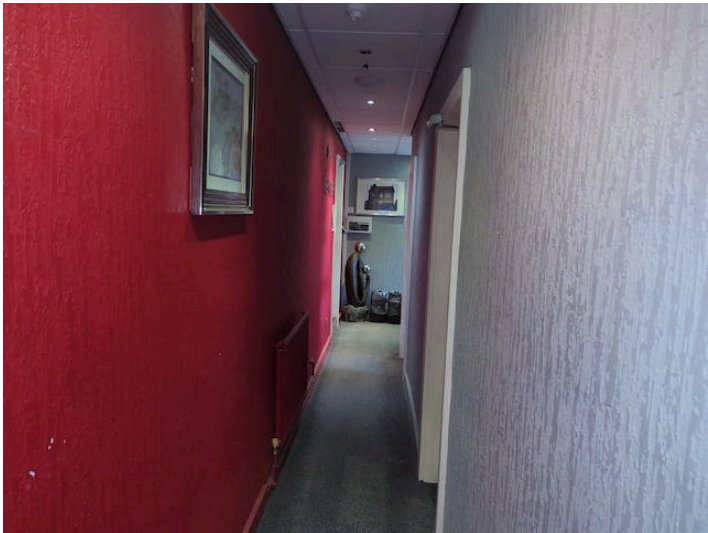
## Main &gt; 0 &gt; 010 - circulation &gt; Location Notes

| Location Notes | Concrete floor, brick walls, MMMF ceiling tiles | | |

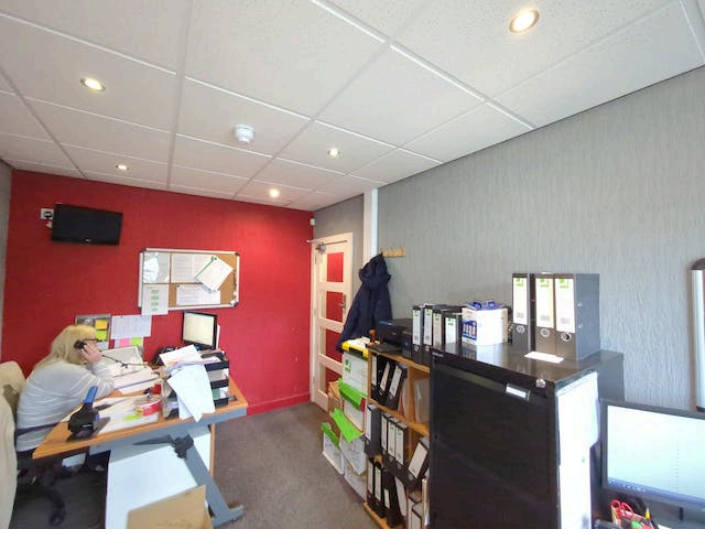
## Main &gt; 0 &gt; 011 - Office &gt; Location Notes

| Location Notes | Concrete floor, plasterboard and MMMF ceiling, brick walls, uPVC windows | | |

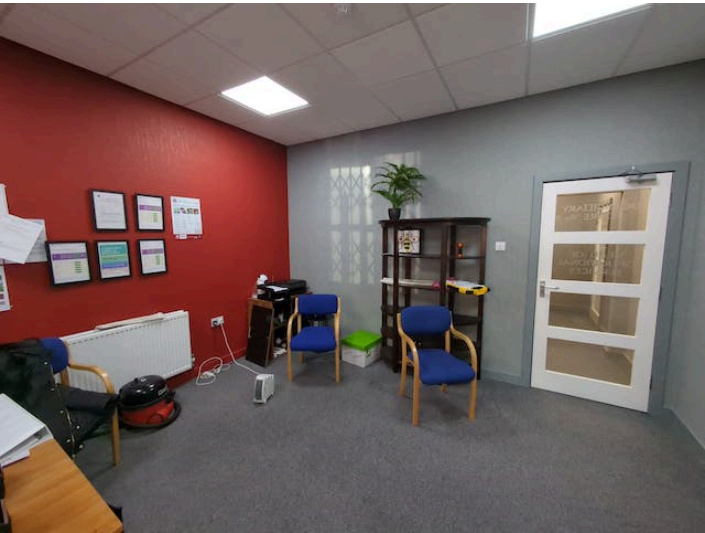
## Main &gt; 0 &gt; 012 - Office &gt; Location Notes

| Location Notes | Concrete floor Plasterboard and brick walls, MMMF ceiling tiles, timber doors | | |

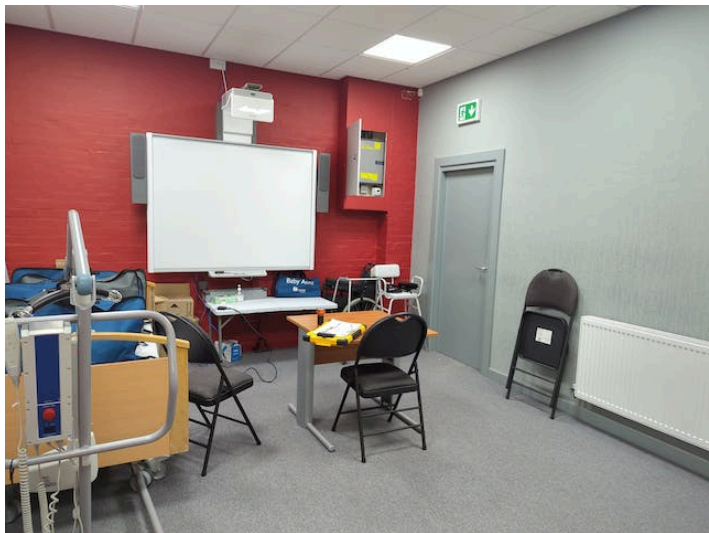
## Main > 0 > 013 - Office > Location Notes

| Location Notes | Concrete floor Plasterboard and brick walls, MMMF ceiling tiles, timber doors | | |

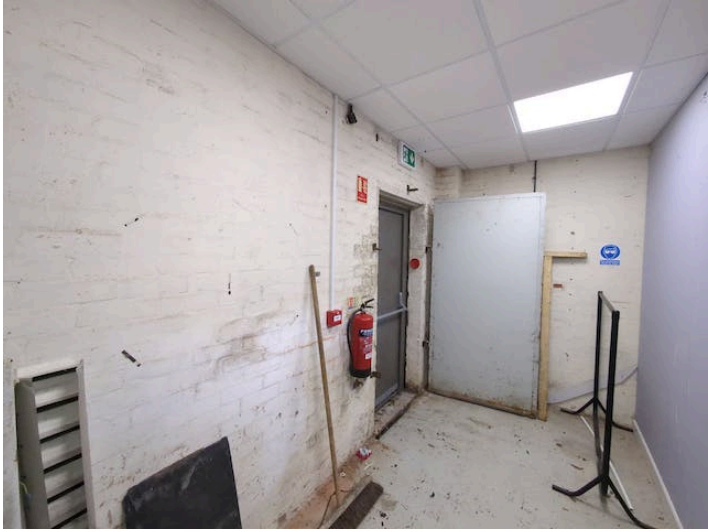
## Main &gt; 0 &gt; 014 - Rear Fire Exit &gt; Location Notes

| Location Notes | Concrete floor Plasterboard and brick walls, MMMF ceiling tiles, steel and timb door | | |

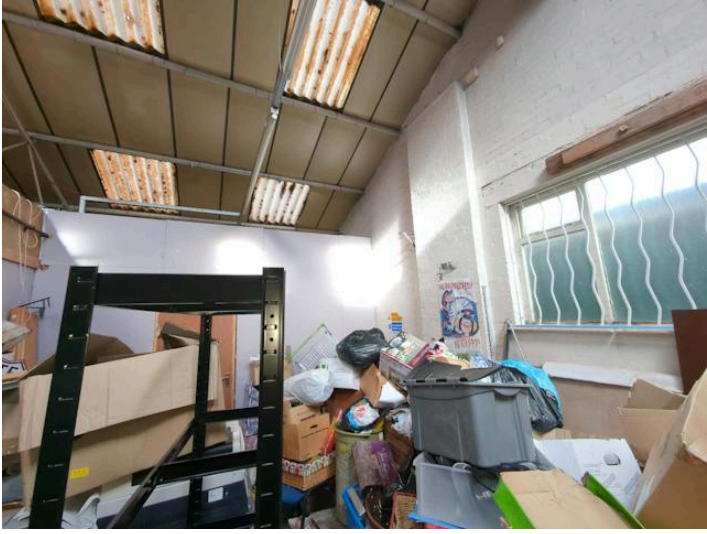
## Main &gt; 0 &gt; 015 - Store &gt; Location Notes

| Location Notes | Concrete floor, brick walls, Timber window, plasterboard partitions | | |

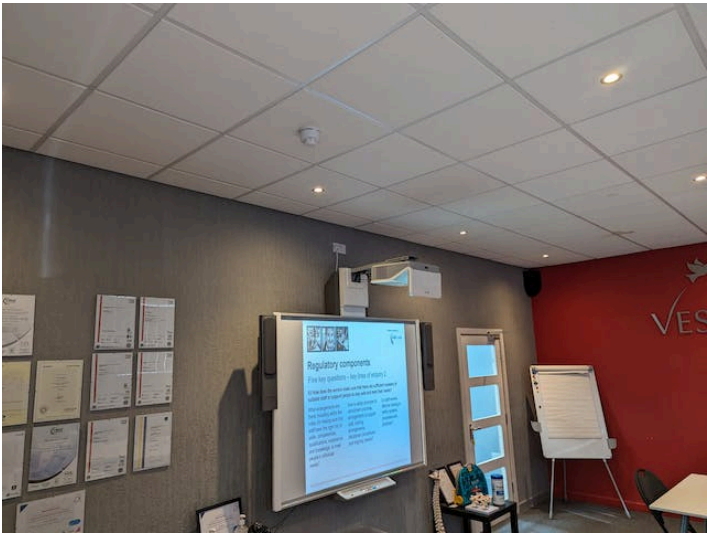
## Main &gt; 0 &gt; 016 - Training Room &gt; Location Notes

| Location Notes | Concrete floor Plasterboard and brick walls, MMMF ceiling tiles, timber doors | | |

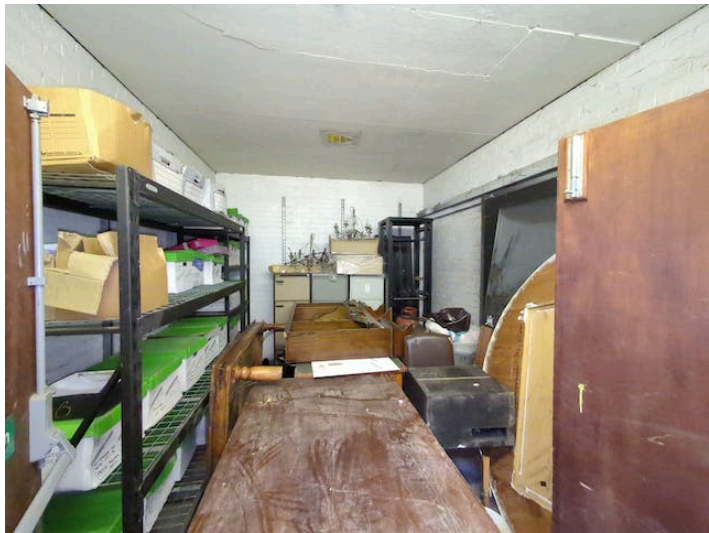
Main > 0 > 017 - Store > Location Notes

| Location Notes | Concrete floor, brick walls, board ceiling | | |

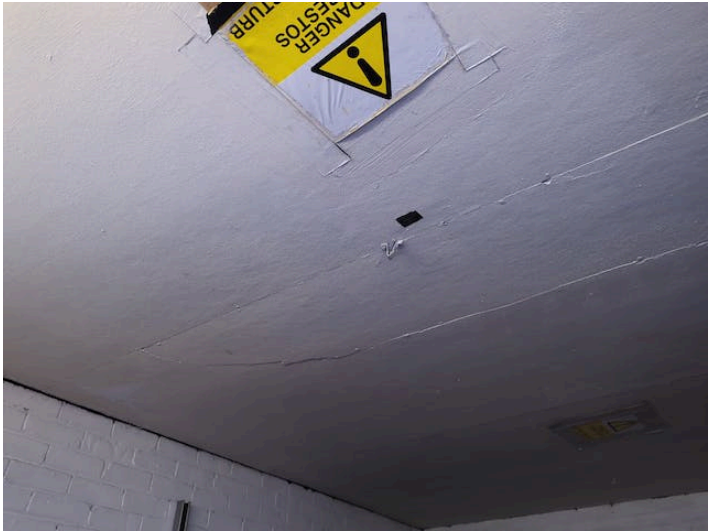
## Main &gt; 0 &gt; 017 - Store &gt; Boarding to ceiling

| Location | 017 - Store | Item | Boarding to ceiling |
| Material | Insulation Board | Extent | 40 sq m |
| Strategy / Sample Id | Sample / VCM/SA1/011123 | Fibre Type | Amosite and Chrysotile |

| Product Type (or Debris from Product) | 2 | Extent of Damage / Deterioration | 1 |

| Recommendation | Manage and annually re-inspect | | |

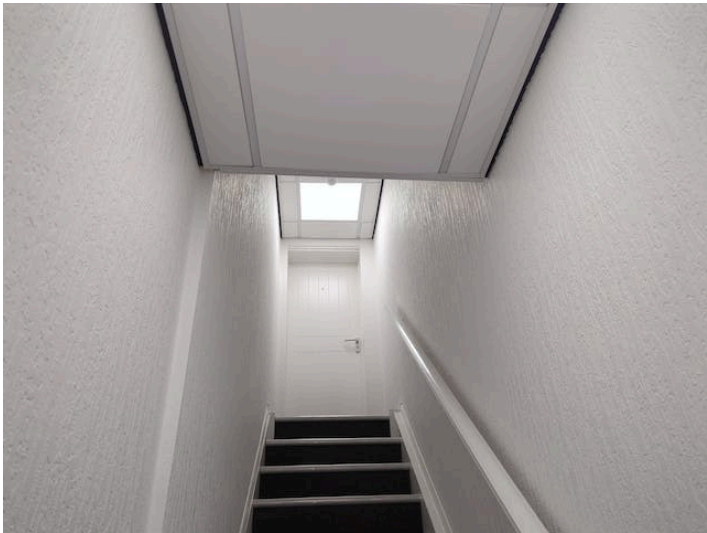
## Main > 0 > Stairs to 1st > Location Notes

| Location Notes | Plasterboard walls, timber stairs, MMMF ceiling tiles | | |

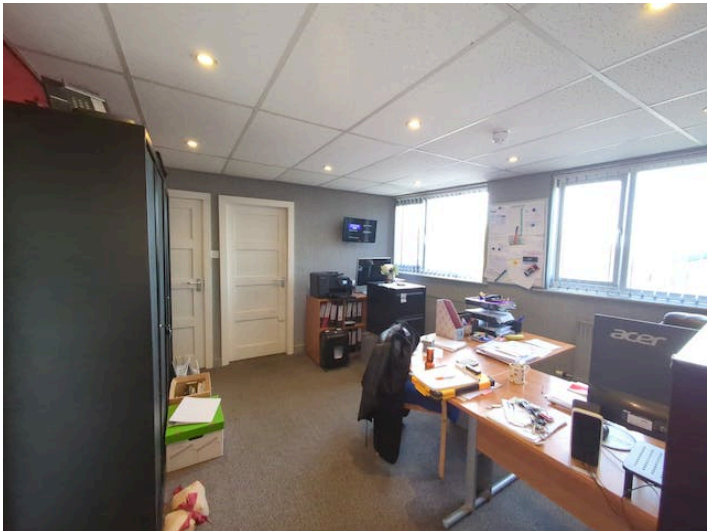
## Main > 1 > 001 - Office > Location Notes

| Location Notes | Timber floor, uPVC windows, MMMF ceiling tiles with plasterboard ceiling above,vplasterboard and brick walls | | |

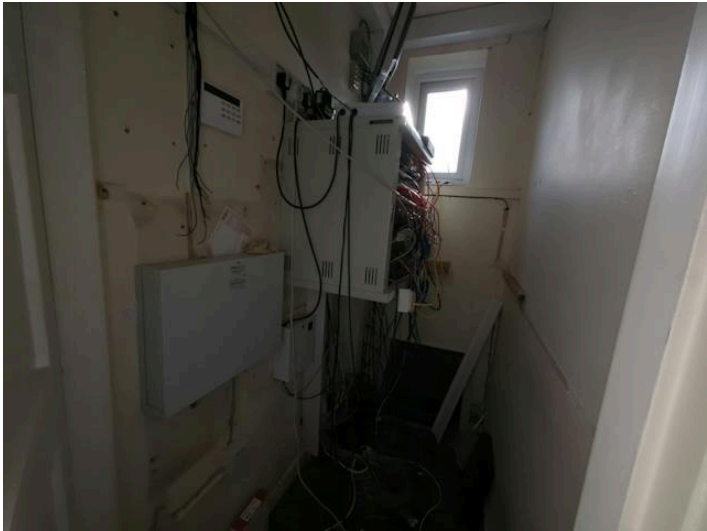
## Main > 1 > 002 - Server Room > Location Notes

| Location Notes | Timber floor, plasterboard walls and ceiling, uPVC window | | |

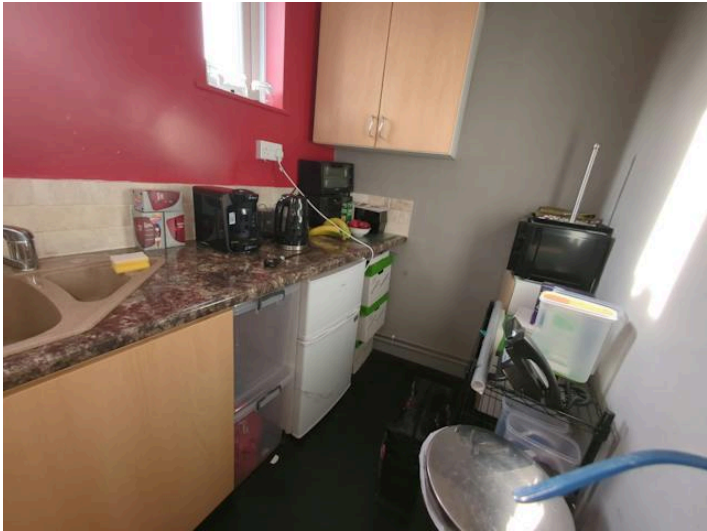
## Main &gt; 1 &gt; 003 - kitchen &gt; Location Notes

| Location Notes | Timber floor, plasterboard walls and ceiling, uPVC windows | | |

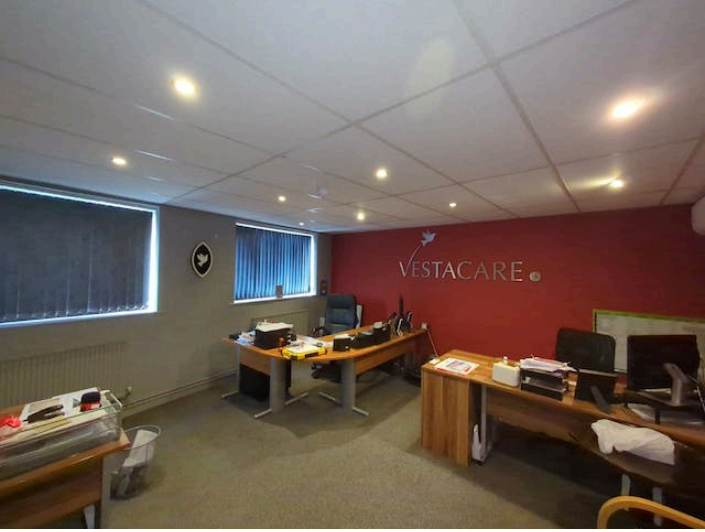
## Main &gt; 1 &gt; 004 - Office &gt; Location Notes

| Location Notes | Timber floor, uPVC windows, MMMF ceiling tiles with plasterboard ceiling above, plasterboard and brick walls | | |

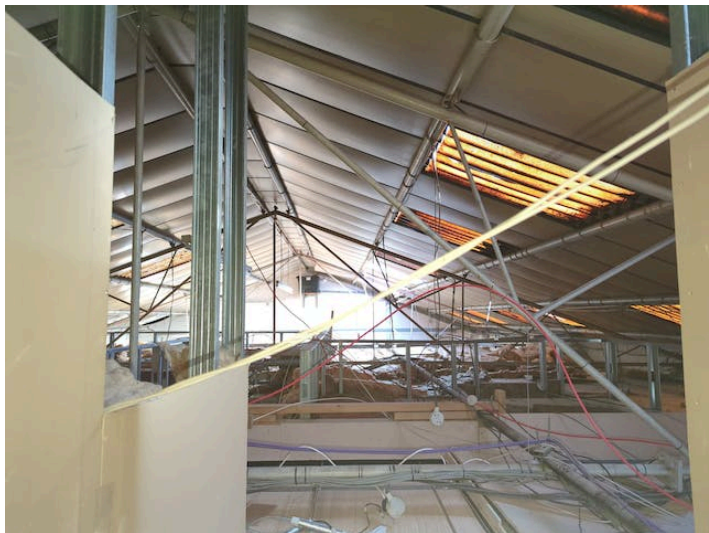
## Main > 1 > 005 - Roof Void > Location Notes

| Location Notes | Plasterboard inner roof sheets, metal frame, plasterboard stud partitions | | |

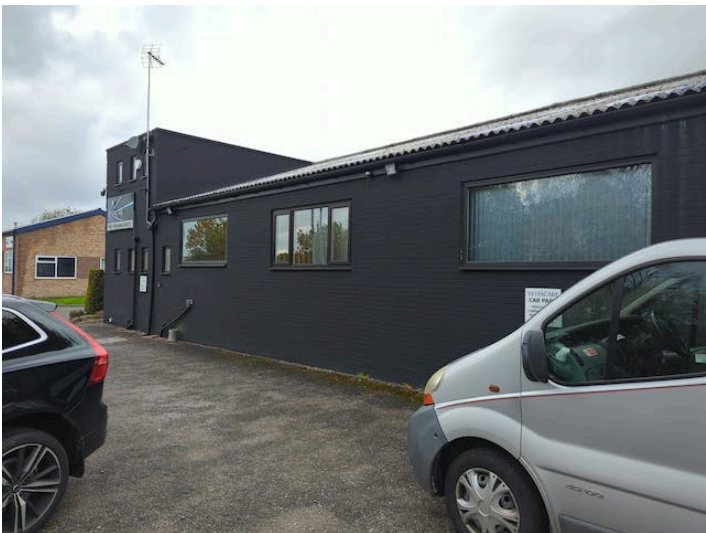
## Main &gt; Exterior &gt; External &gt; Location Notes

| Location Notes | Brick walls, part flat roof, part cement sheet roof, upvs windows | | |

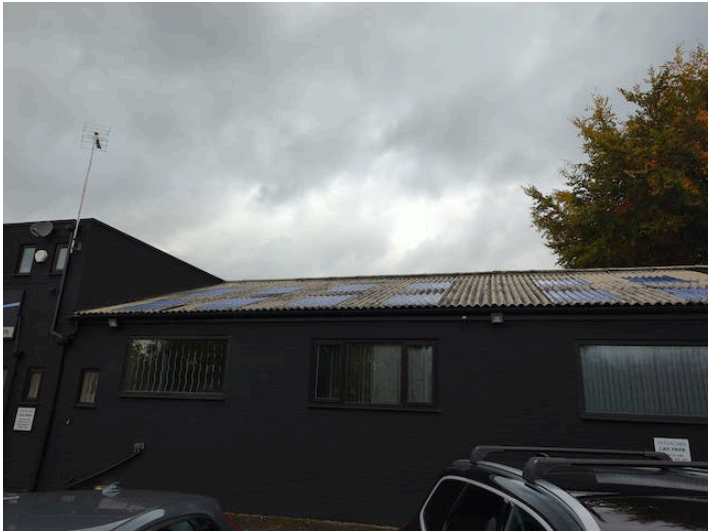
## Main &gt; Exterior &gt; Roof &gt; Exterior Sheets

| Location | Roof | Item | Exterior Sheets |
| Material | Cement | Extent | 120 sq m |
| Strategy / Sample Id | Sample / VCM/SA2/011123 | Fibre Type | Chrysotile |

| Product Type (or Debris from Product) | 1 | Extent of Damage / Deterioration | 1 |

| Recommendation | Manage and annually re-inspect | | |
