## Survey Report

Stid Fold Barn  
Barnfield Lane  
Wardle  
OL12 9PN

Survey date: 28<sup>th</sup> May 2026

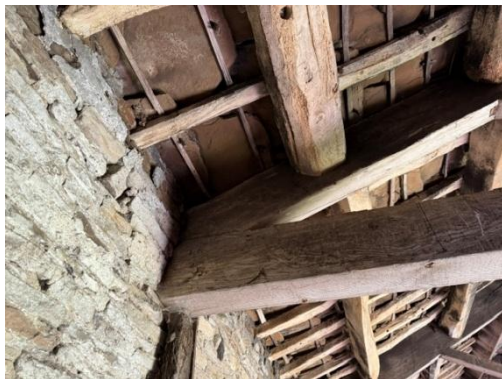
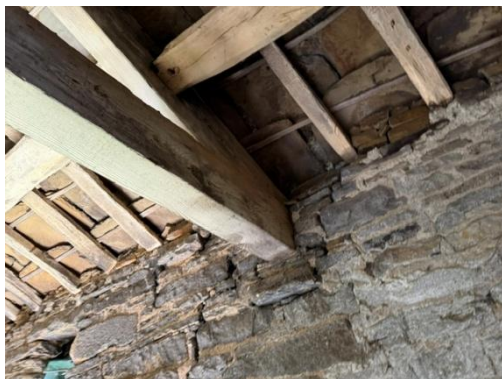
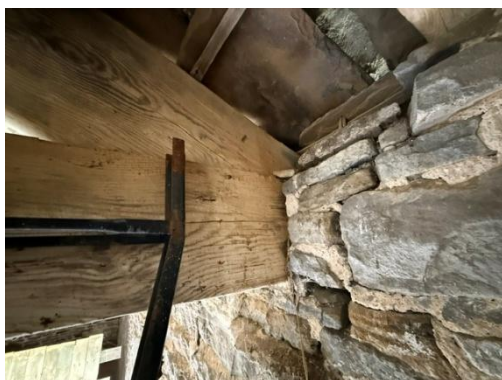
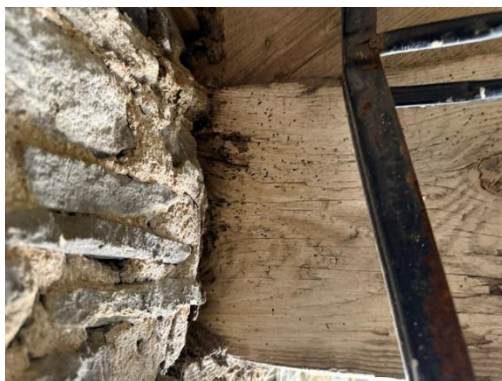
The roof structure comprises two substantial timber trusses, believed to be constructed from oak (images below), which provide support to the roof structure. The trusses are built into and bear upon the external stone masonry walls (image 1 to 4).

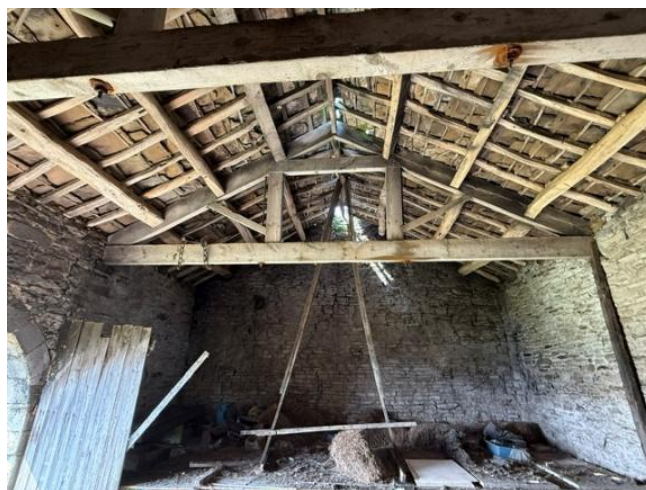
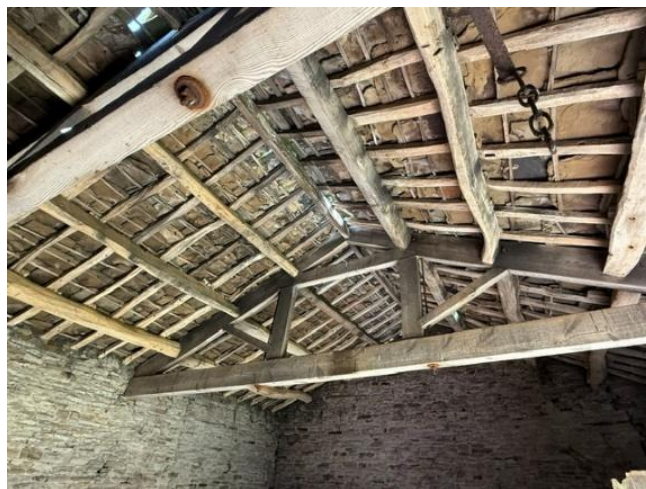
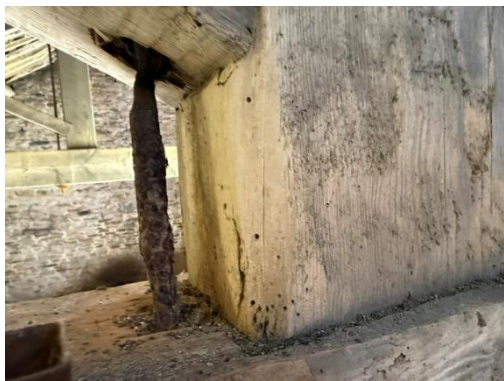
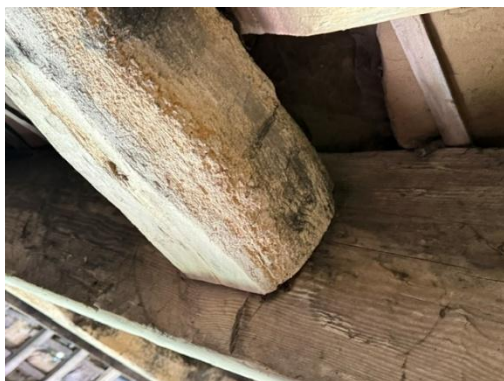
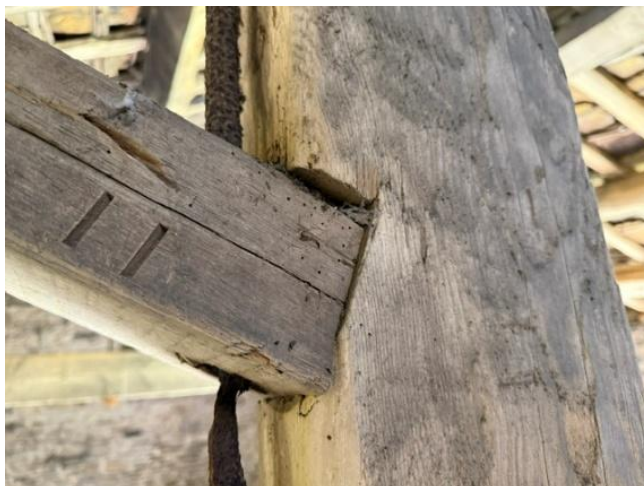
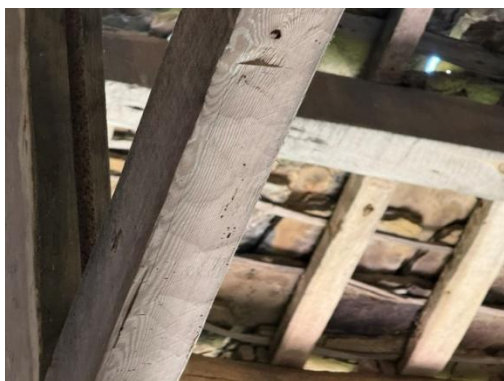
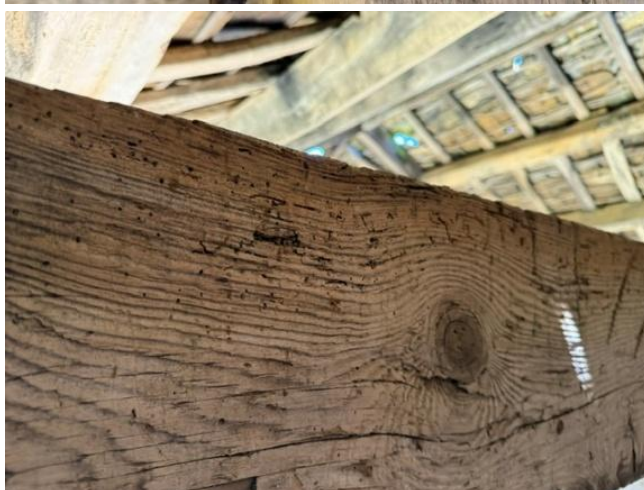
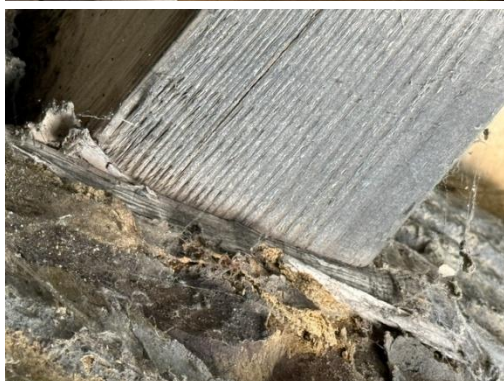
Exit holes associated with wood boring beetle activity (*Anobium punctatum*) are visible to both rafters (images 5 to 8, and below). The appearance of the exit holes, particularly to the rear slope, indicates the activity is on going.

Activity was particularly evident to areas of timber which have been exposed to elevated moisture levels over a prolonged period.

**1.** Apply insecticide gel to all the exposed and accessible areas of the two oak principle trusses towards the centre of the barn. Drill and inject timber preservative into embedded truss ends to reduce the risk of decay where timber is in direct contact with masonry.

2. We strongly recommend that treatment for wood boring beetle activity is extended to include any timber from the building which are to be repurposed within the building.

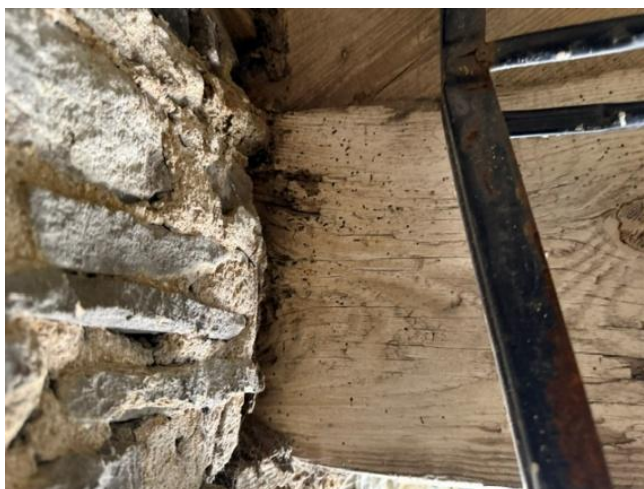
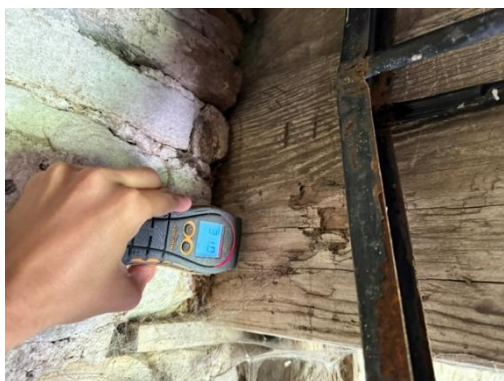
Moisture meter tests to the trusses where they are embedded within the stone walls returned elevated readings (images 9 to 12). The increased moisture content is considered likely to result from water penetration through defects to the roof covering and associated masonry.

Once repairs have been undertaken to the roof covering and external structure, moisture levels within the timbers would be expected to reduce over time. However, as the bearing ends are built into solid stone walls, some degree of natural moisture migration from the surrounding masonry should be anticipated and continued monitoring of the concealed bearing points may be appropriate during the conversion process.

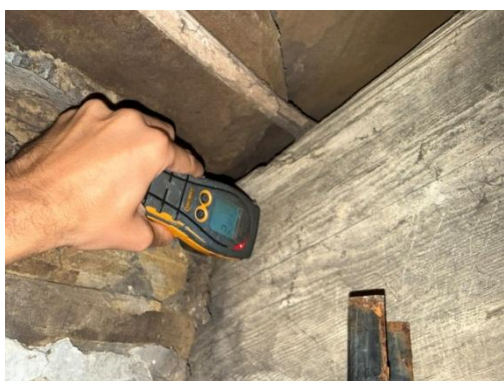
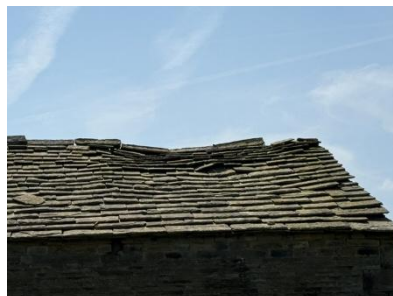
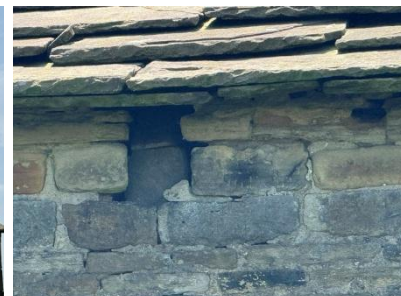
The building is currently not weather-tight and evidence of water penetration was noted throughout the roof structure (images below). Such conditions are conducive to timber decay and wood boring beetle infestation.
