# CULVERT PROTECTION CALCULATION REPORT AT HOLLINGWORTH ROAD, LITTLEBOROUGH.

Project ref: YZ074  
Issue: 05  
Date: 10/02/2026  
Prepared by: Henry Byfield  
Engineer  
BEng | AaPS

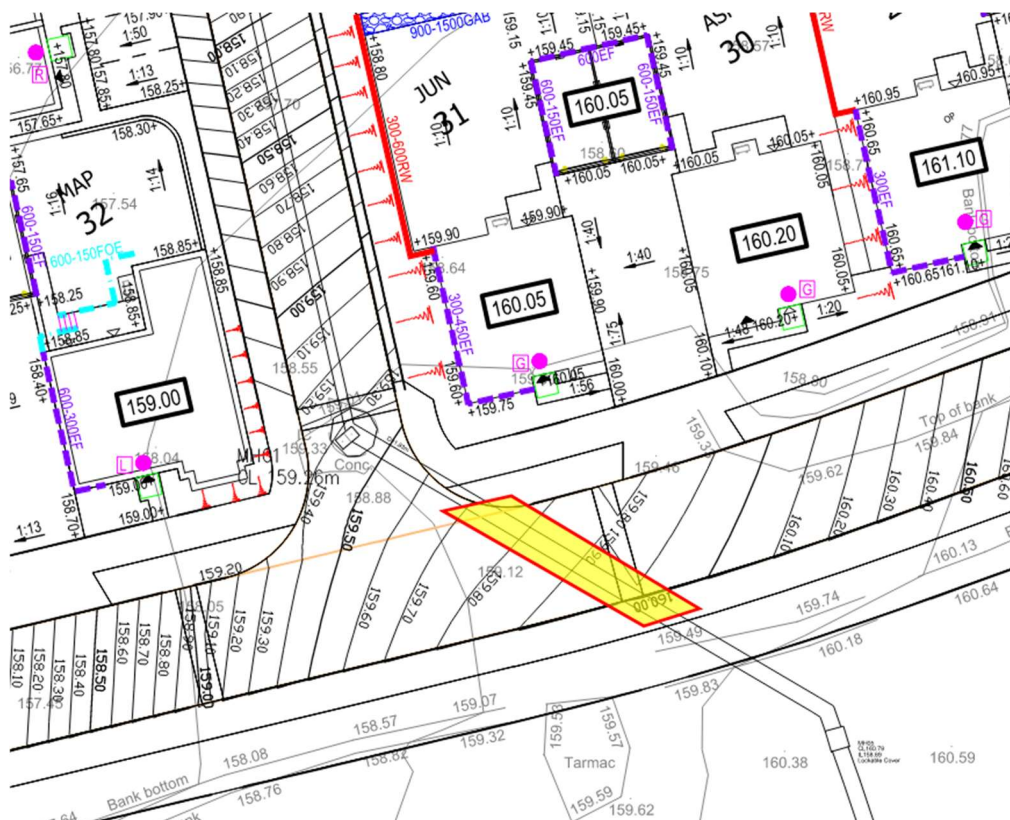
Most onerous cover to culvert is located in yellow above.

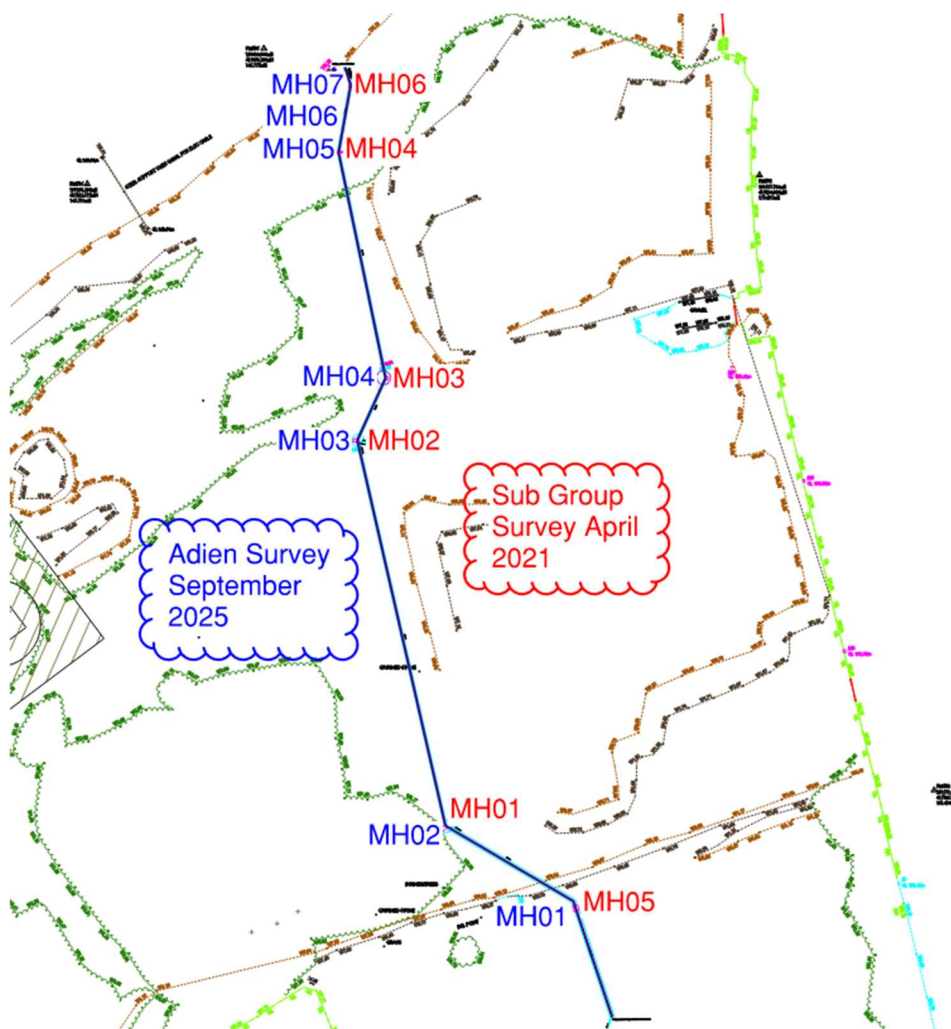
The maximum cover is at MH05 (Adien) / MH04 (Sub Group).

Cover to the crown of pipe = 4.85m

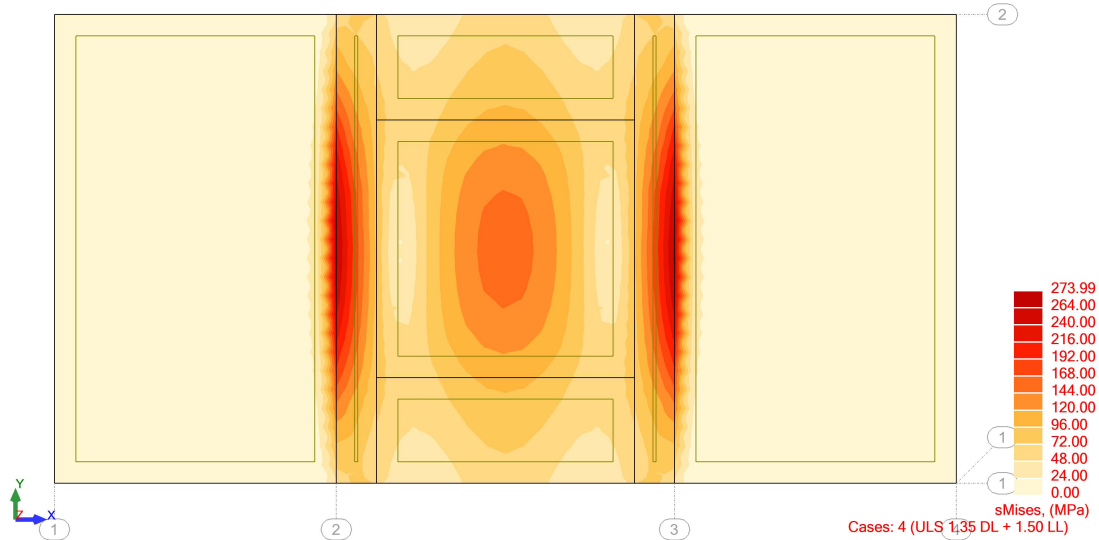
$273.99 \text{ N/mm}^2 < 275 \text{ N/mm}^2$ , Therefore PASS  
Stresses are within allowable limits.

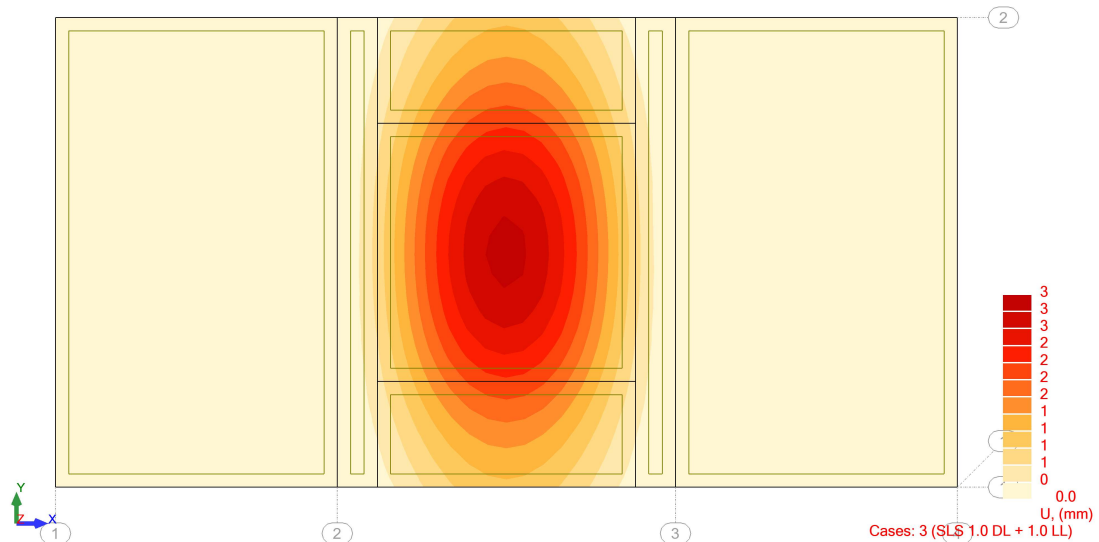
Consider an allowable deflection = span / 200 for a short spanning structural element with no brittle finishes =  $900 / 200 = 4.5 \text{ mm}$

$3 \text{ mm} < 4.5 \text{ mm}$ , Therefore PASS  
Deflections are within allowable limits.

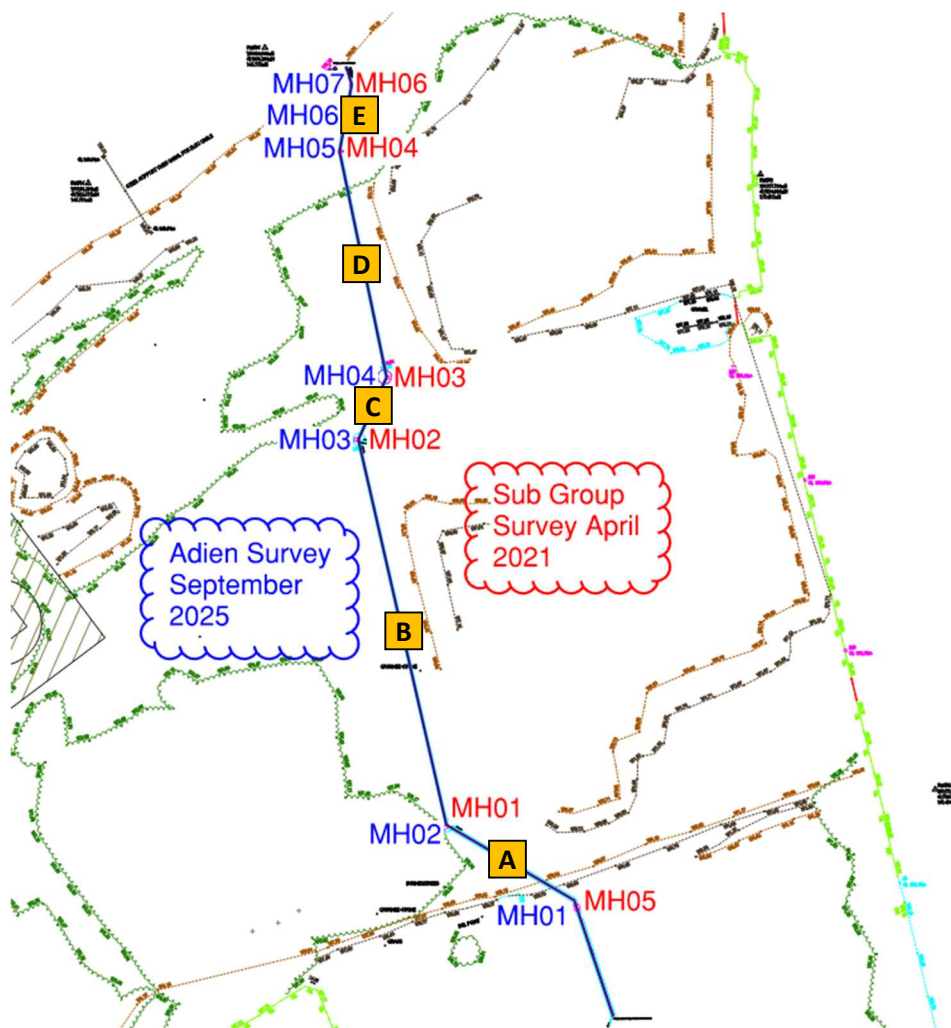
The report findings show that the condition of the culvert within the extents shown below have not worsened. No issues were flagged during Adien's recent survey.

The below markup shows the survey extents of the culvert. The node references differ between reports so have been labelled as sections A through E for ease of comparison within this report, and tabulated on the following pages side by side.

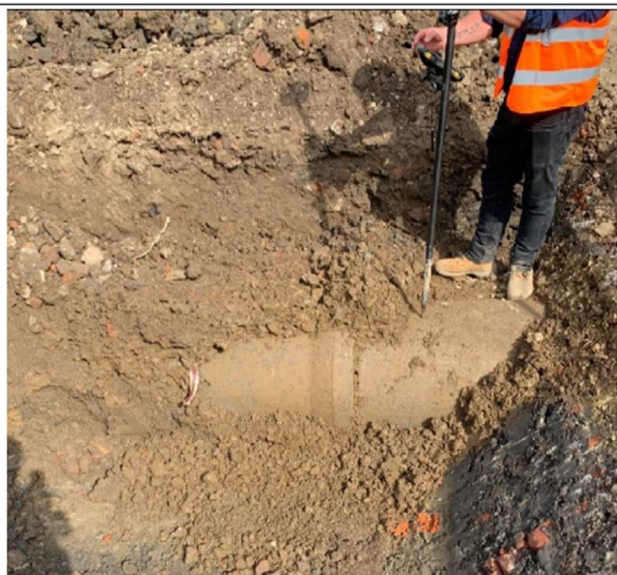
Photo of "raw water main" culvert pipe. This confirms that the material is concrete and it has gravel bedding.
