## ADDENDUM STRUCTURAL ENGINEER'S REPORT

37 Rochdale Road  
Middleton  
M24 2PT

Contract No: 12489  
Dated: August 2026

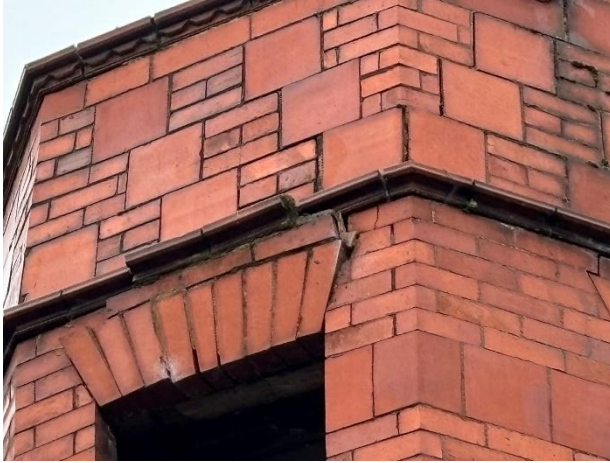
- 3.1.1 The front elevation appeared to be in a very similar condition to that noted in 2024 with the exception of the brick arch over the second floor window in the chamfered wall. In 2024 this was noted to have rotated forwards but during our recent visit it was noted to be missing.

Rotated brick arch noted in 2024

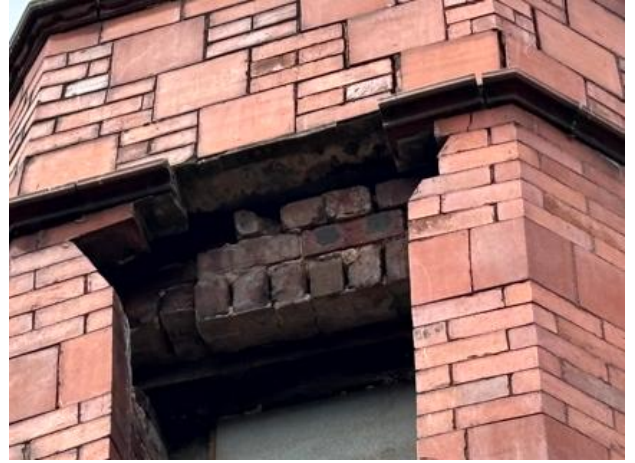
Brick arch missing in 2026

- 4.1 The general condition of the property has not deteriorated significantly over the period of time elapsed since our 2024 inspection.
- 4.2 Notwithstanding the general condition, there is a significant loss that has occurred to the front elevation where the brick arch in the chamfered wall has either been removed or has fallen. No clear evidence of collateral damage was noted in relation to this. The remaining brickwork above the window opening will now be vulnerable to collapse and should be provided with some temporary propping.

5.1 Temporary propping should be provided to the second floor window head of the chamfered wall of the front elevation to prevent further loss of brickwork.

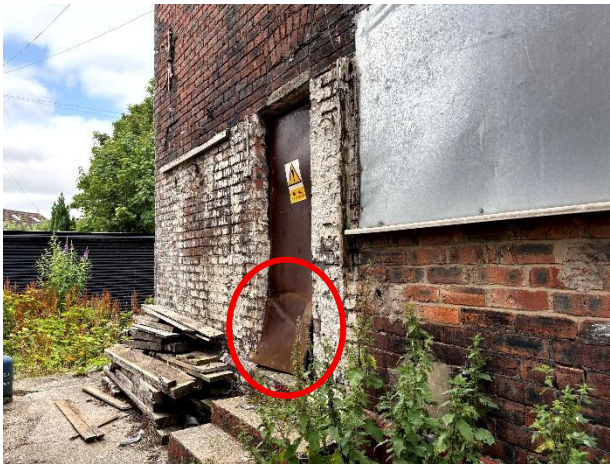
The gable wall remained in a similar condition to that recorded in 2024.

Gable wall and evidence of damage to doorway sheeting where unauthorised entry had occurred

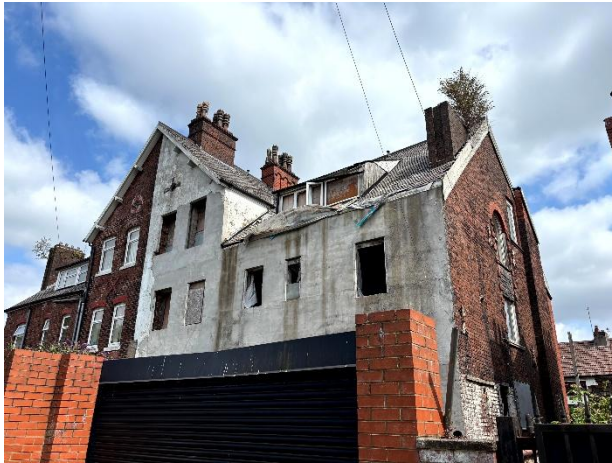
The rear elevation was structurally unchanged from the condition observed during our visit in 2024. It was apparent that some attempt had been made to provide sheeting over the upper storey windows to prevent water ingress; generally this had failed leaving the interior exposed to the weather once again.

Rear elevation

5.2 The temporary weatherproofing to the windows and eaves of the rear elevation should be renewed.

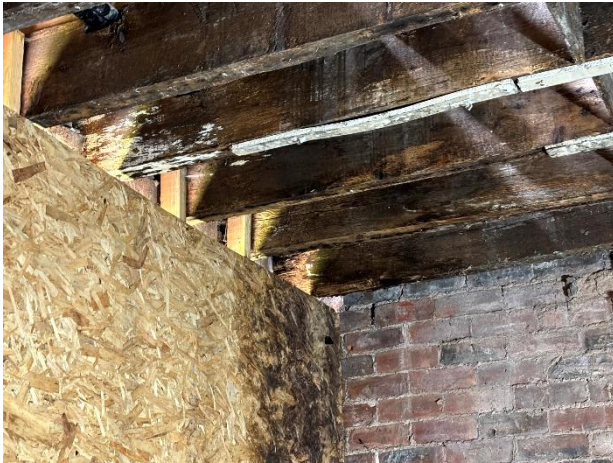
3.2.3 In the front lefthand room the water ingress at the front lefthand corner appeared to have become worse since our visit of 2024; the OSB screening across the removed bay window was wet and the floor joists above appeared to be suffering from increased effects of water ingress.

Deterioration of timber due to water ingress in front lefthand corner

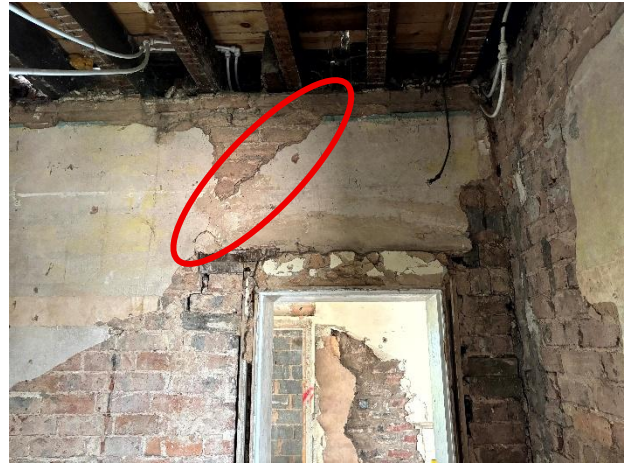
3.2.4 Stepped cracking was noted above the doorway into the stairwell of this room. Whilst this crack was not previously recorded, it is likely that it was present as it did not appear to be recent in its nature.

Cracking above doorway into stairwell from front lefthand room

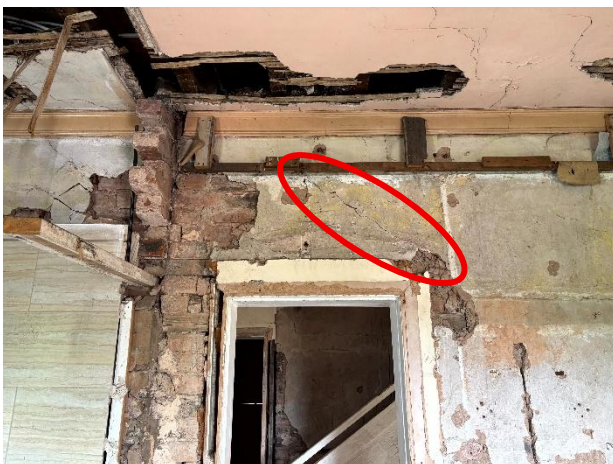
In the rear lefthand room cracking was noted above the doorway into the stairwell. As noted for the similar cracking above the doorway of the front lefthand room, this cracking showed no evidence of having occurred recently.

Cracking above doorway into stairwell from rear lefthand room

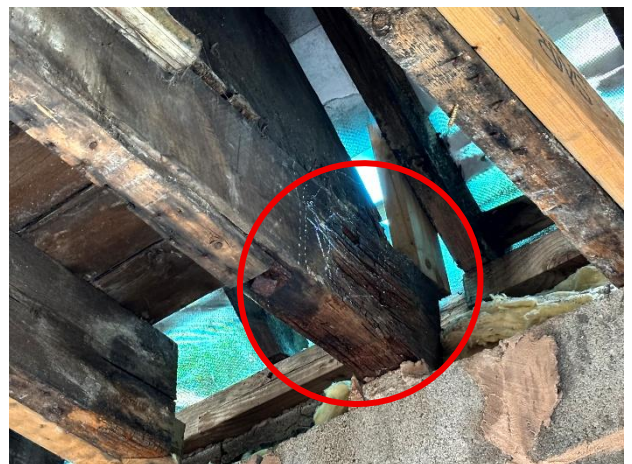
Along the rear elevation of this room it was noted that water was still leaking in from a small hole in the roof covering. It appeared that the additional protective measures for the eaves of the rear elevation had become locally damaged.

Water ingress affecting rear truss bearing
