# **Rochdale Cricket Lacross and Squash Club**

## **Flood Risk Assessment & Drainage Strategy**

**September 2026**

**Soul Padel Ltd**

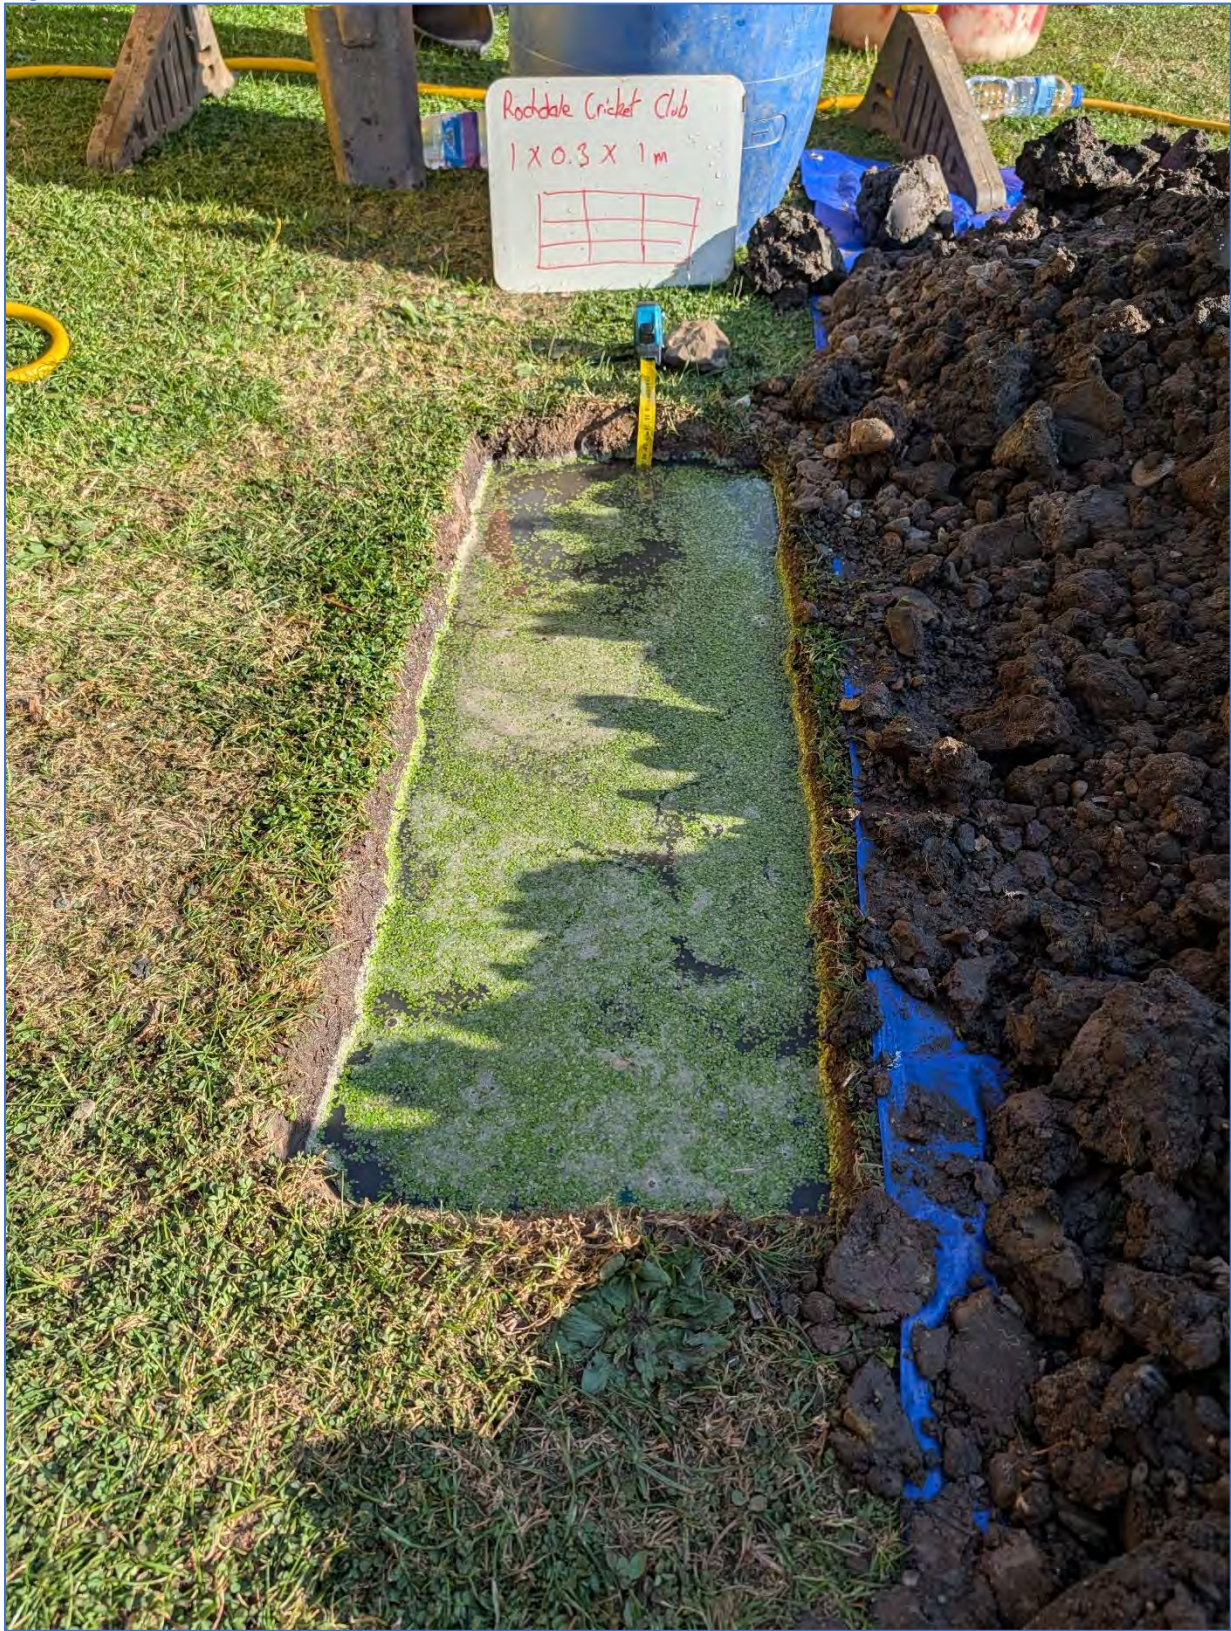
Figure 1 – Trial Pit

The trial pit was filled with 300 litres of water and was left for 15 hours over night where it only dropped by 330mm, demonstrating the unfeasibility of infiltration.

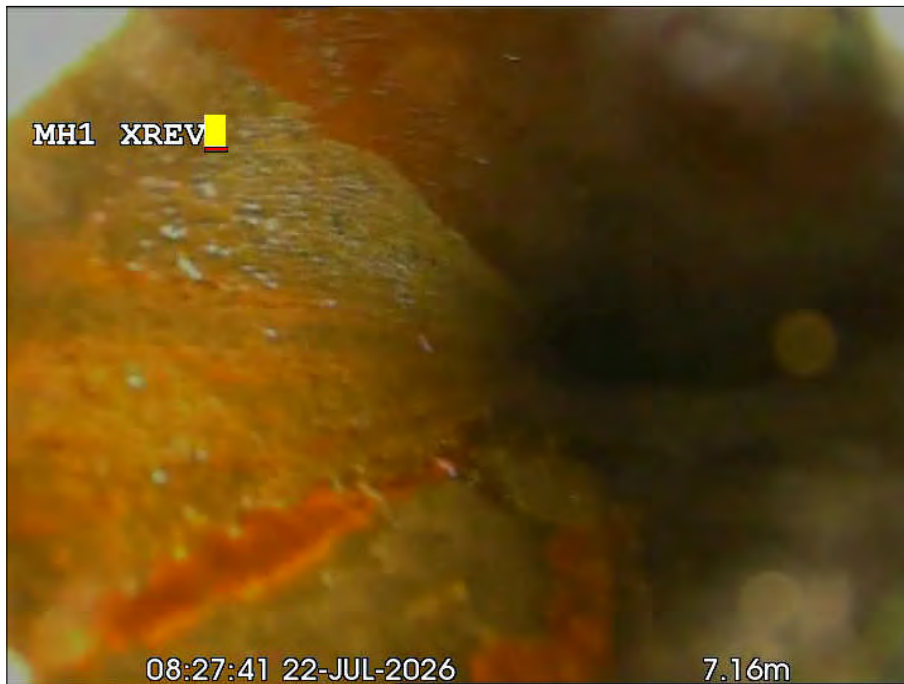
Photo: 226\_4a, 00:00:00  
2.7m, Debris silt, 10 % cross-sectional area loss, Start

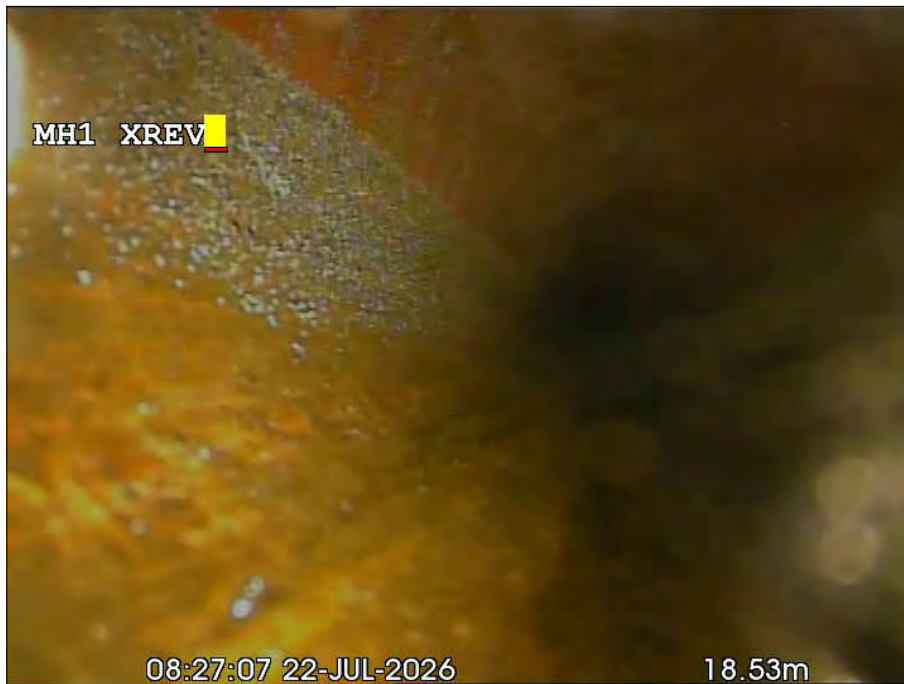
Photo: 21\_8a, 00:00:00  
17m, Debris silt, 10 % cross-sectional area loss, Start

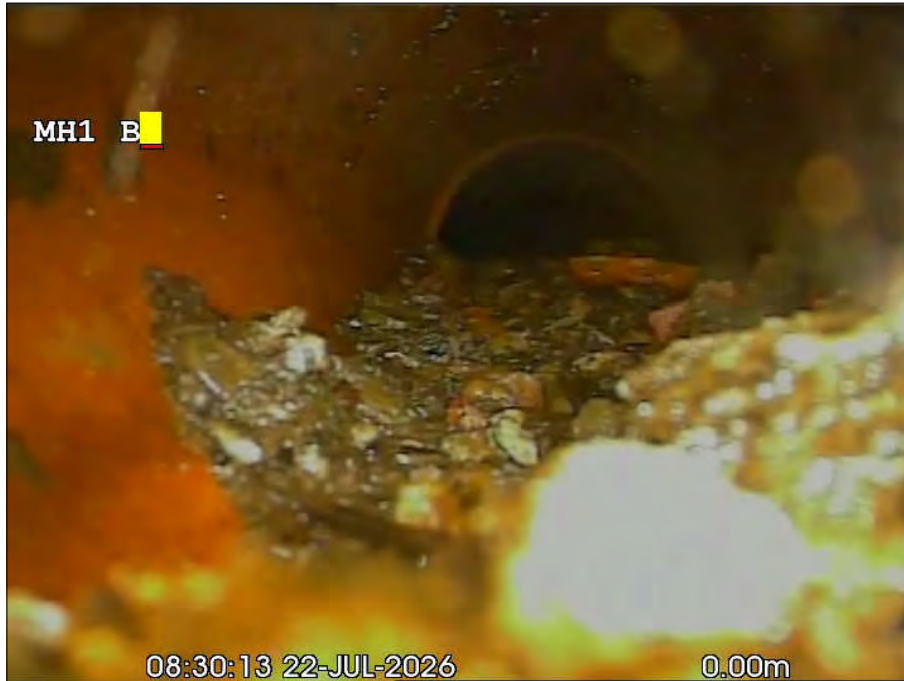
Photo: 230\_4a, 00:00:00  
0.1m, Debris, 10 % cross-sectional area loss, Start

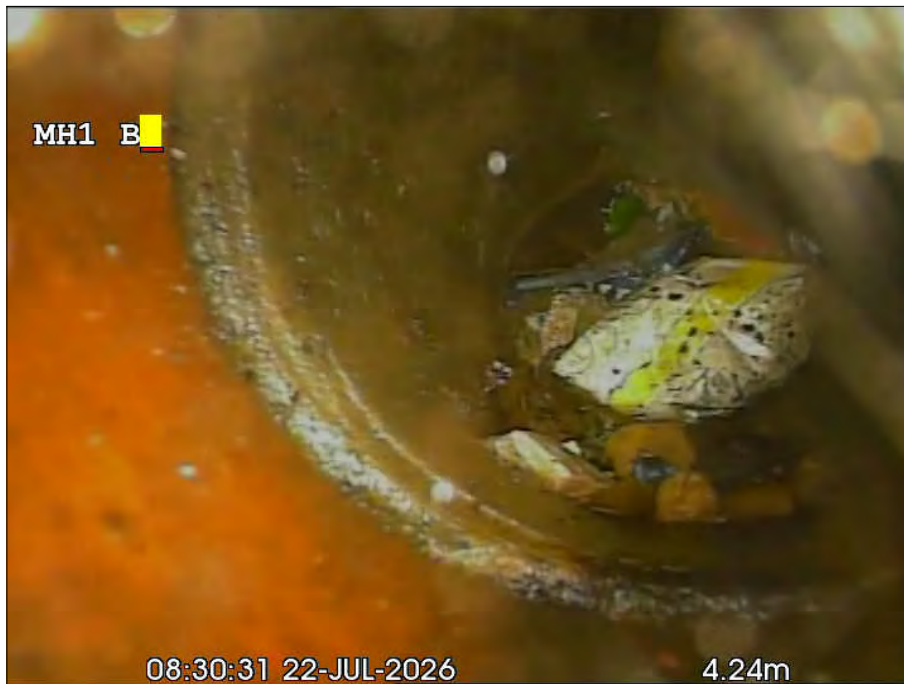
Photo: 234\_9a, 00:00:00  
4.3m, Joint displaced. Medium

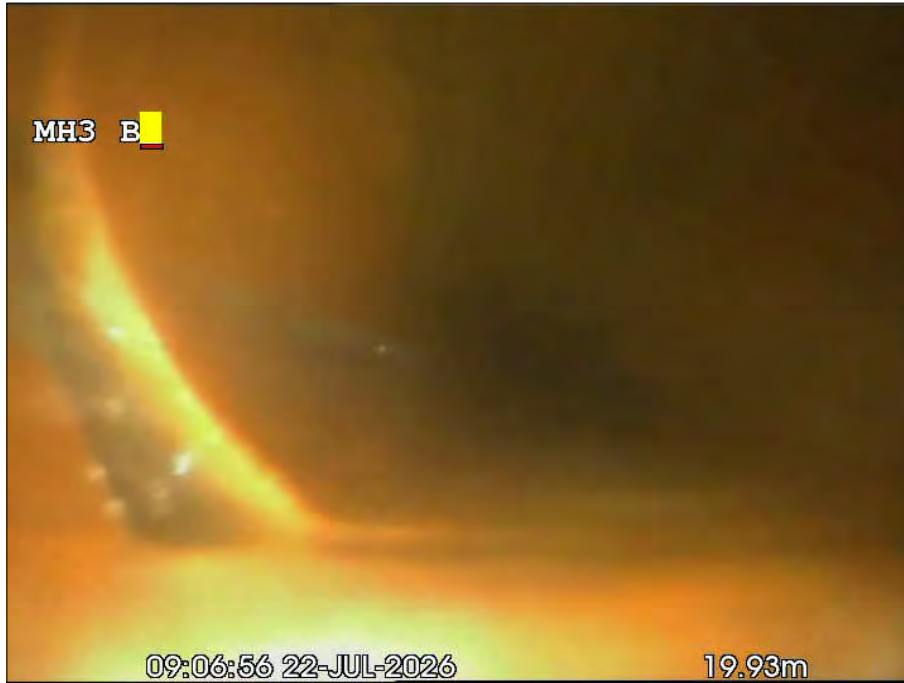
Photo: 7\_16a, 00:00:00  
20m, Joint displaced. Large

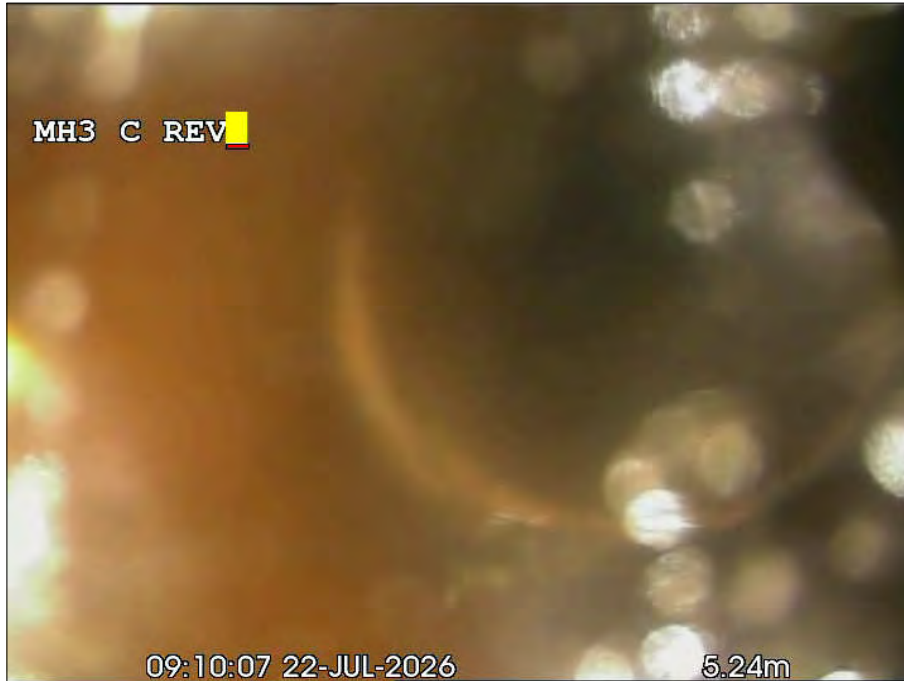
Photo: 78\_4a, 00:00:00  
5.3m, Joint displaced. Medium

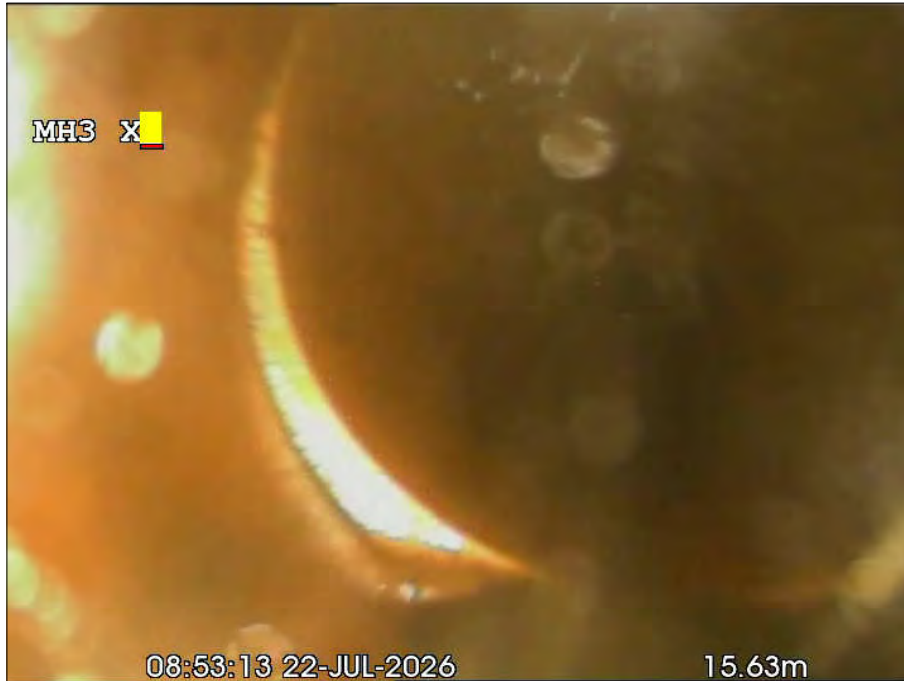
Photo: 11\_6a, 00:00:00  
15.7m, Joint displaced. Medium

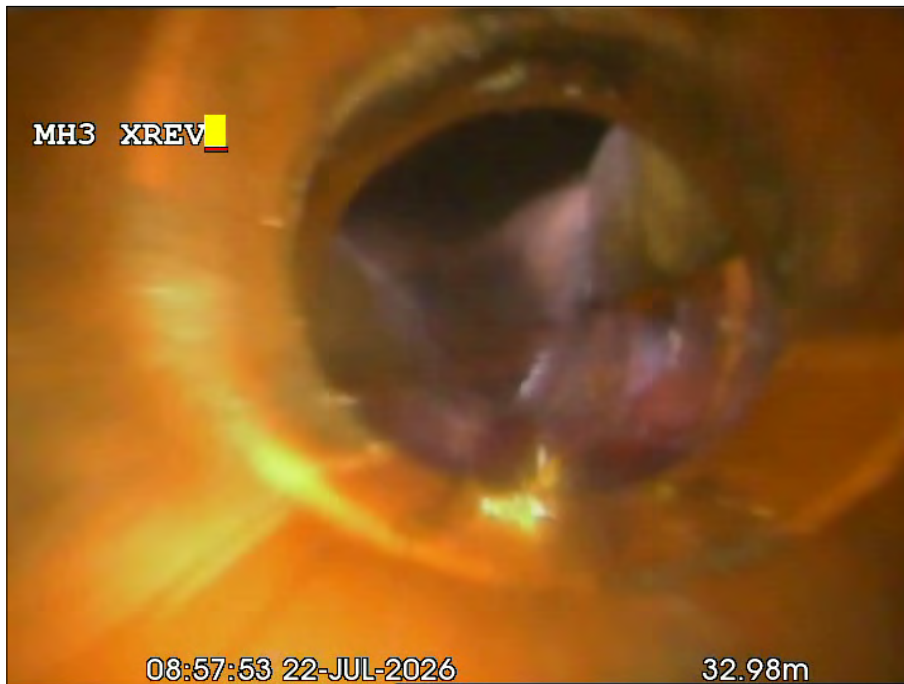
Photo: 11\_14a, 00:00:00  
34.1m, Joint displaced. Medium

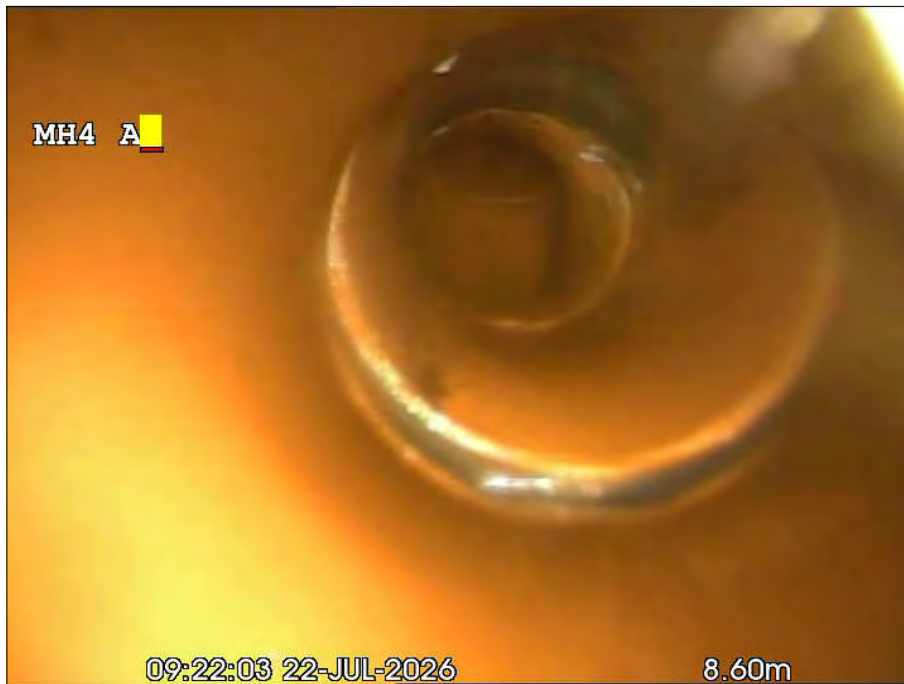
Photo: 12\_5a, 00:00:00  
8.4m, Joint displaced. Large

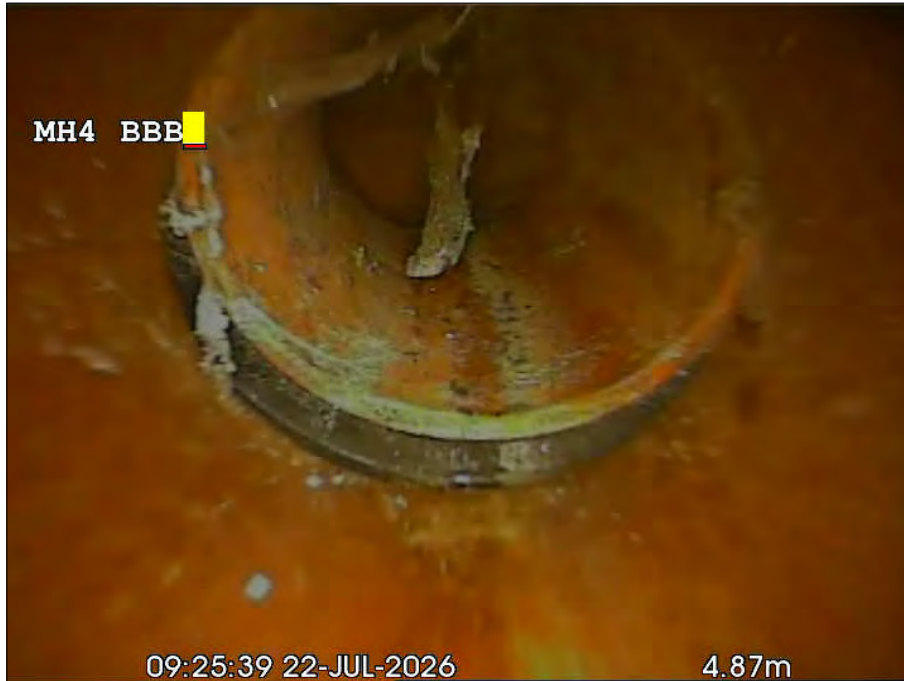
Photo: 112\_6a, 00:00:00  
5m, Joint displaced. Large

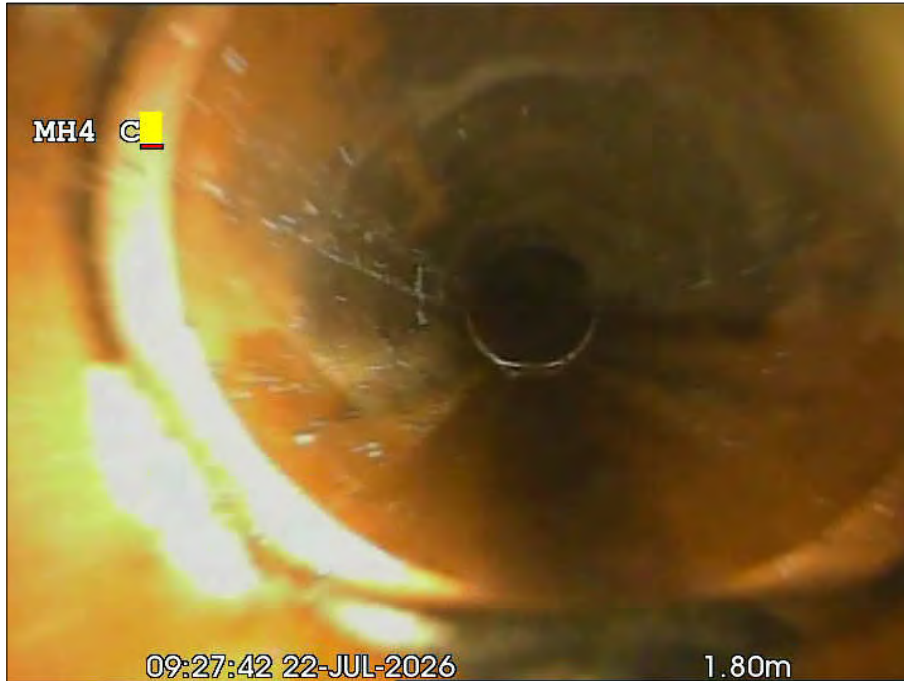
Photo: 17\_4a, 00:00:00  
1.9m, Joint displaced. Medium

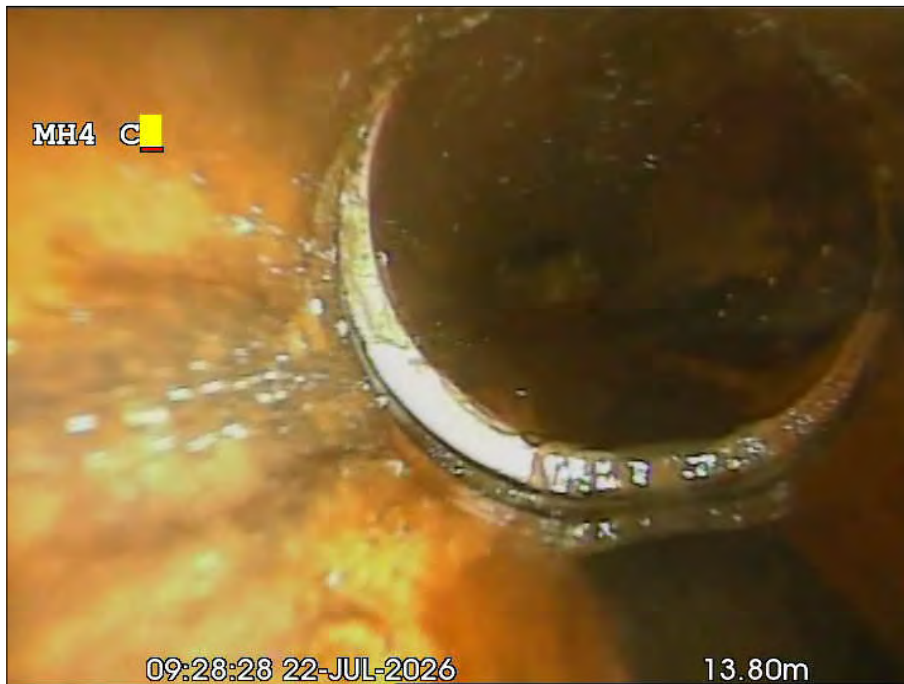
Photo: 17\_7a, 00:00:00  
14m, Joint displaced. Large

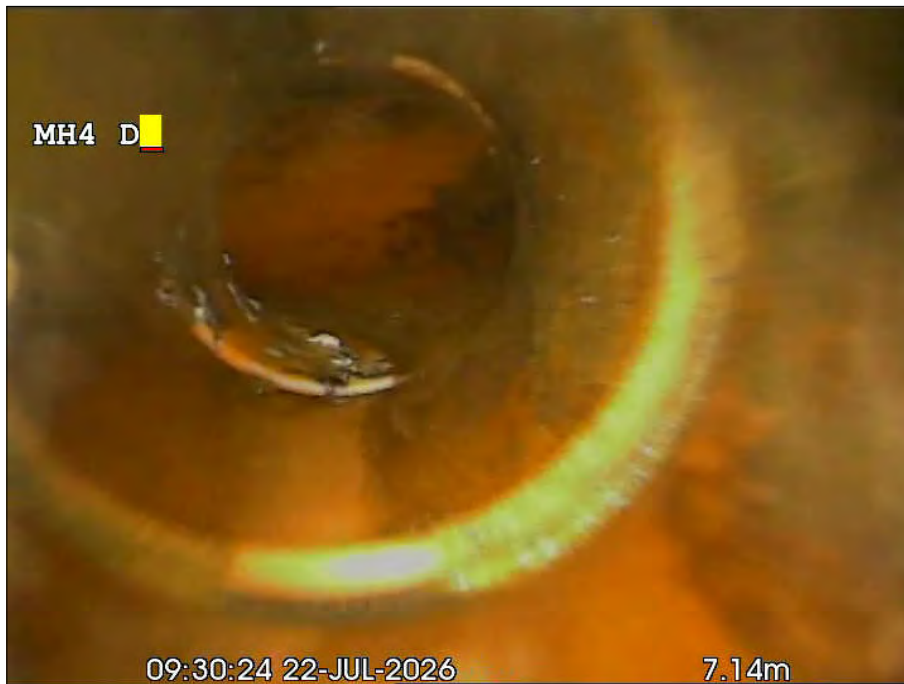
Photo: 18\_7a, 00:00:00  
7.2m, Joint displaced. Medium

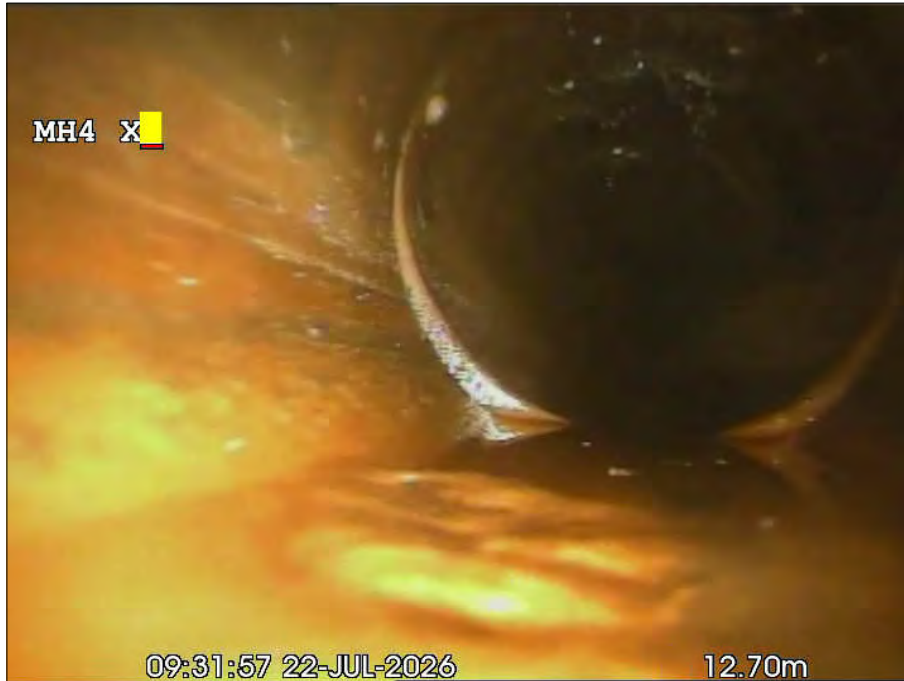
Photo: 146\_7a, 00:00:00  
13m, Joint displaced. Medium

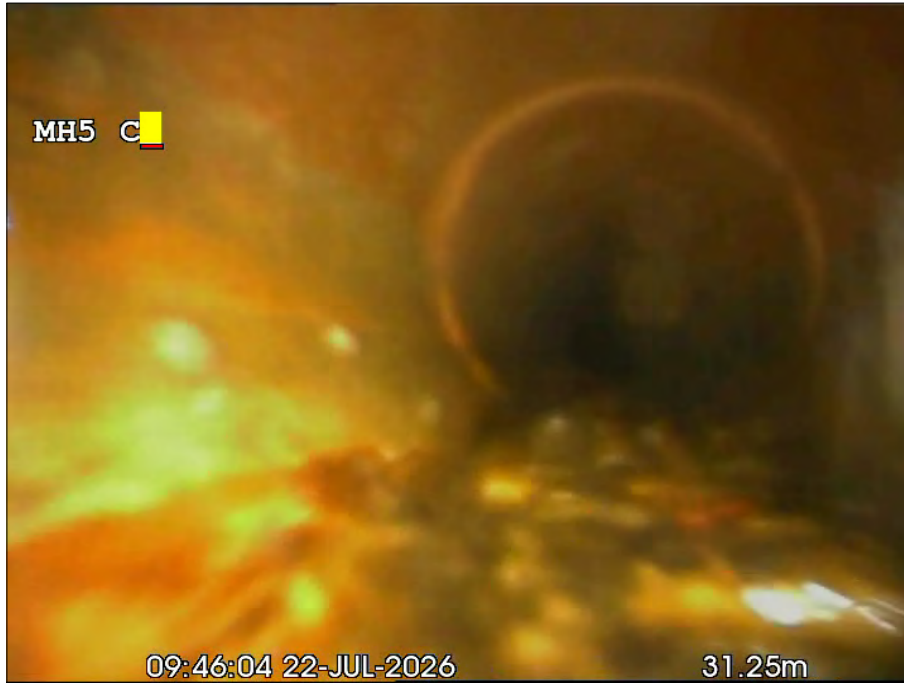
Photo: 24\_12a, 00:00:00  
31.3m, Debris silt, 5 % cross-sectional area loss, Start

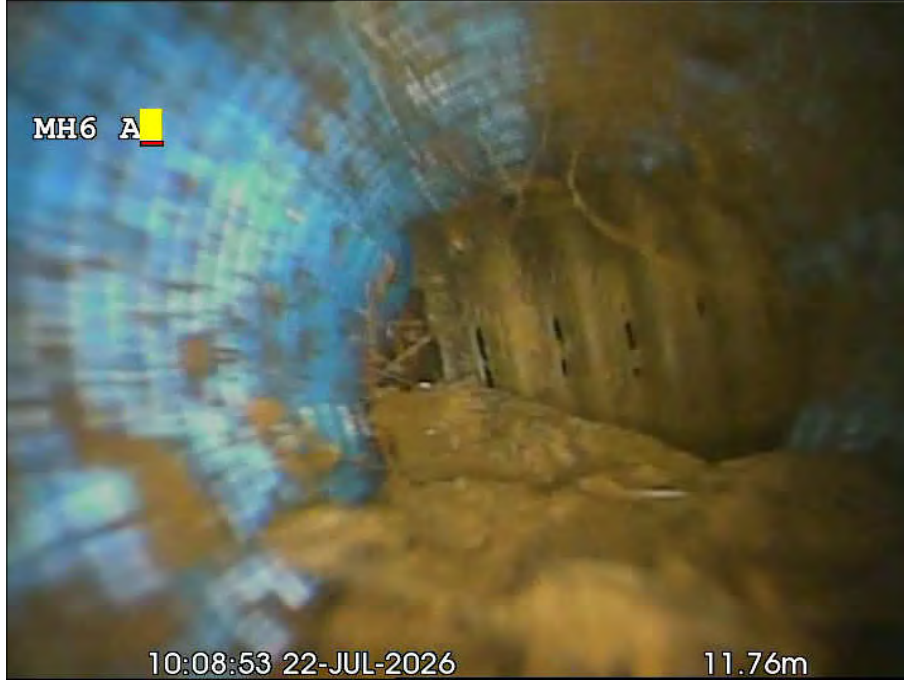
Photo: 28\_12a, 00:00:00  
12.55m, Obstruction, 95 % height/diameter loss

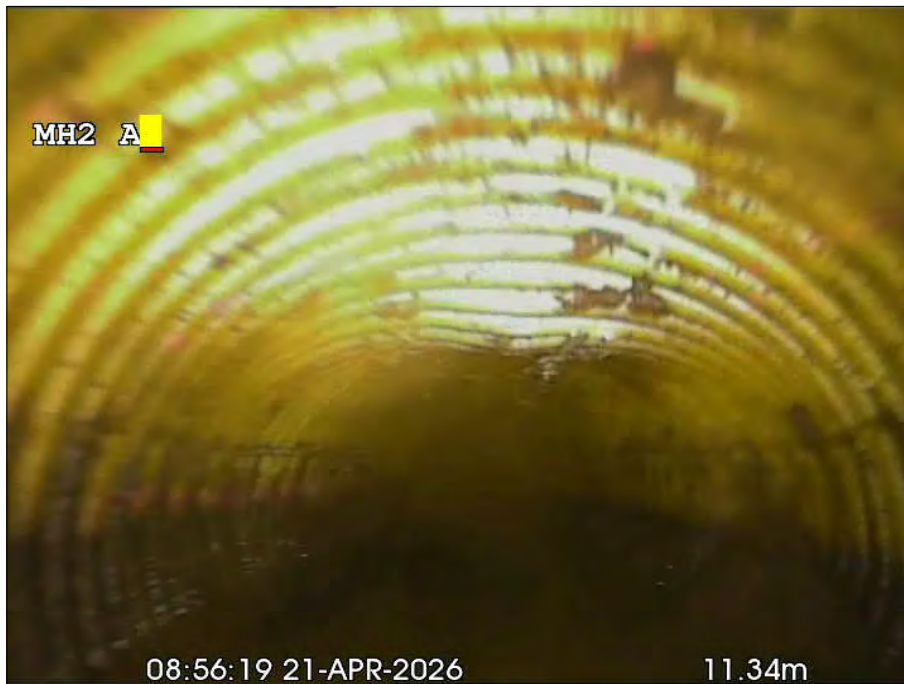
Photo: 270\_5a, 00:00:00  
11.4m, Sewer Deformed, 5 %

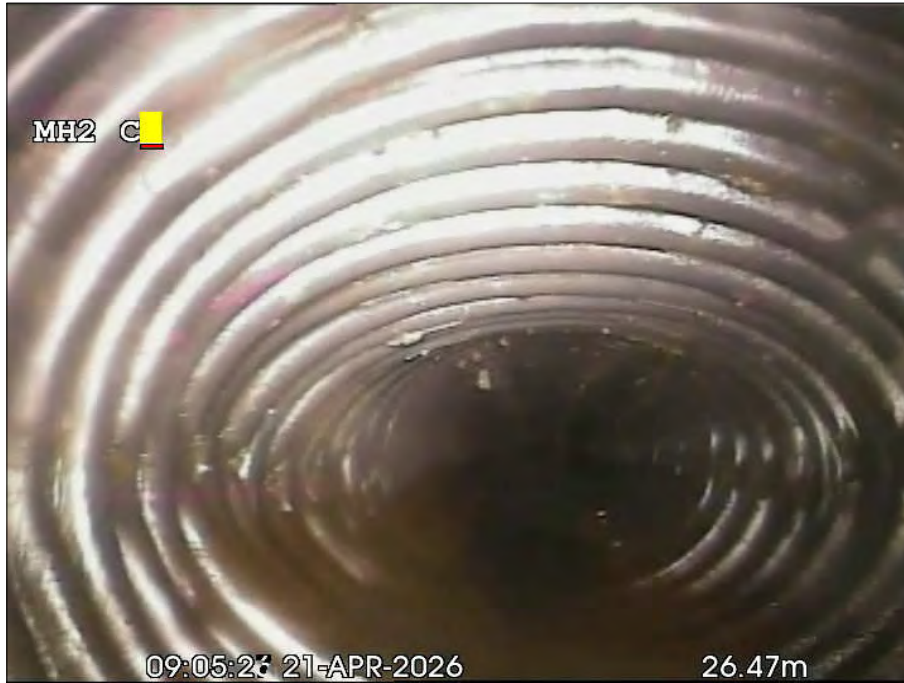
Photo: 296\_6a, 00:00:00  
26.5m, Sewer Deformed, 30 %
