# Contaminated Land Phase Two Intrusive Investigation for Proposed Residential development at 615 Edenfield Road, Rochdale, OL11 5XE.

Prepared for:

Building Design Services  
418 Bury Road  
Rochdale  
OL11 5EU.

September 2026

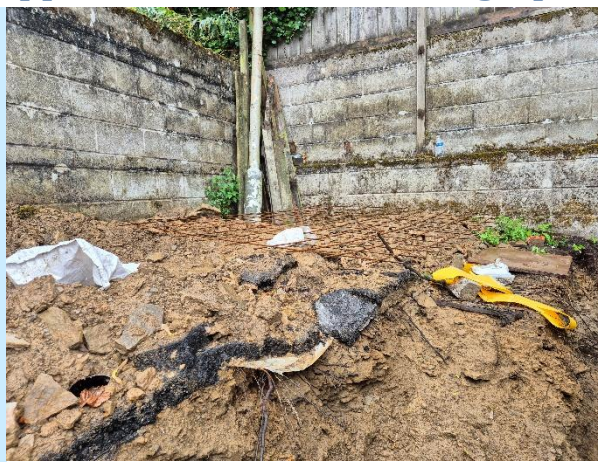
| <p><b>P1: TP1, Southwest corner surface level</b></p> | <p><b>P2: TP1 – face of banking/wall</b></p> |

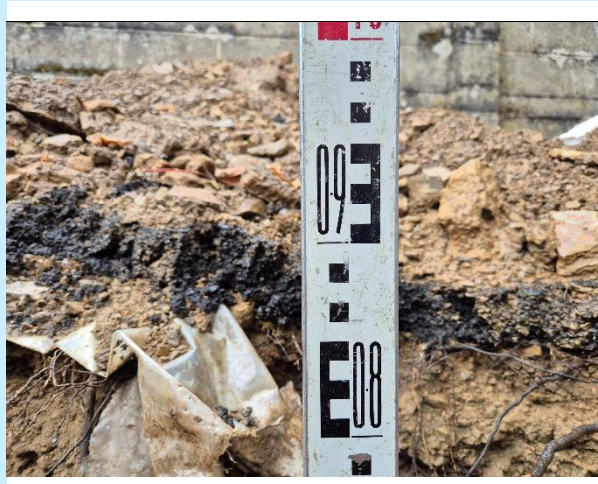
| <p><b>P3: TP1 – height of excavation and asphalt layer</b></p> | <p><b>P4: Sampling point, distance from the base</b></p> |

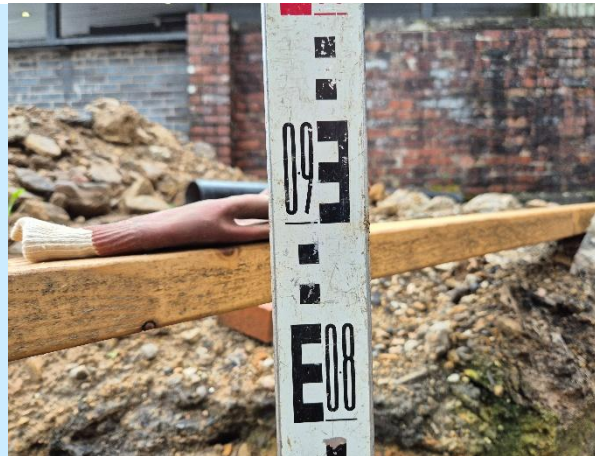
**P5: TP2, depth of wall**

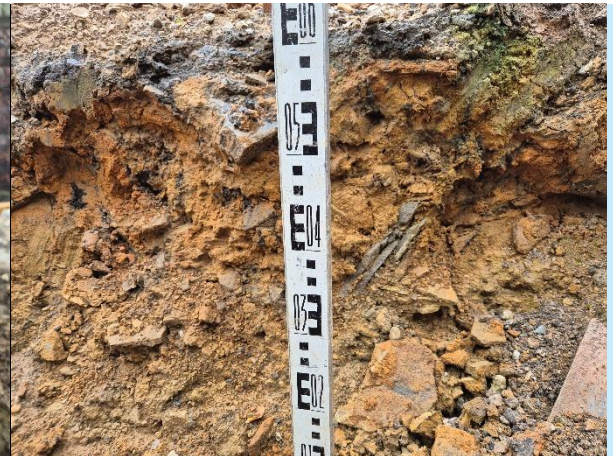
**P6: TP 2 face of banking**

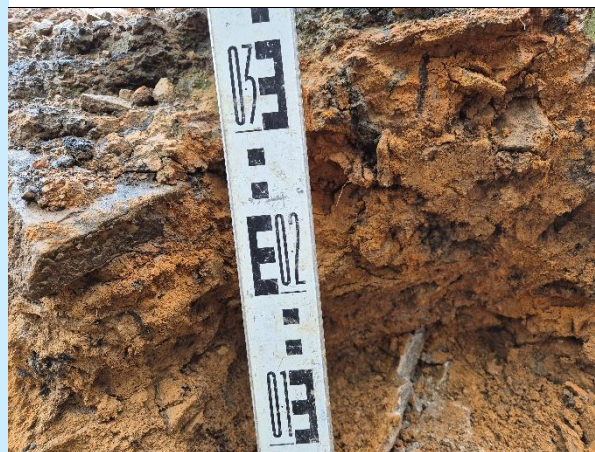
**P7: TP2 depth of sample**

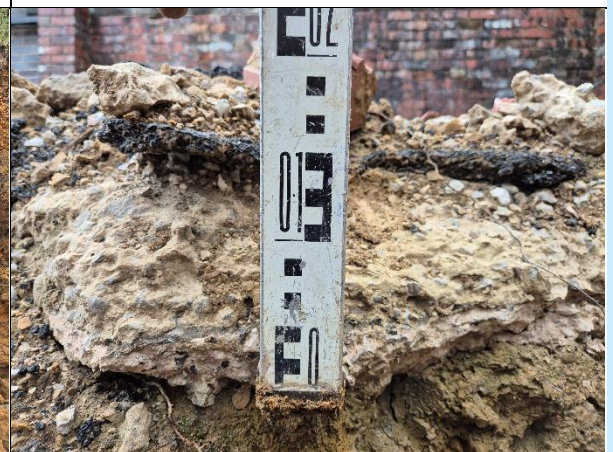
**P8: TP2 asphalt and concrete surface layers**

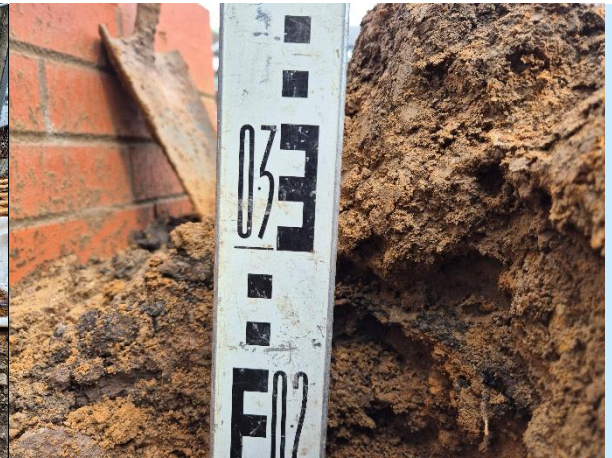
**P10: TP3A depth of sample A**

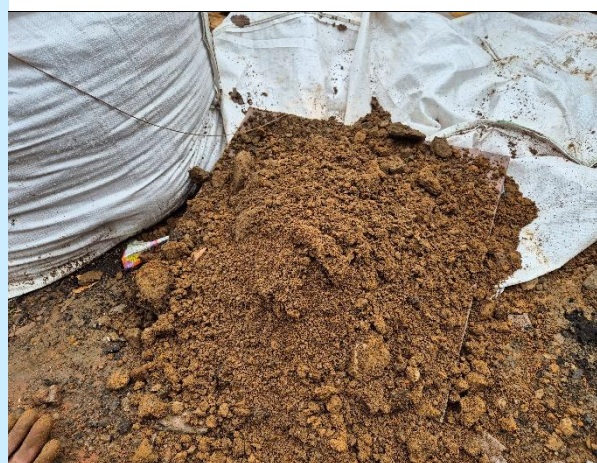
**P11: TP3 excavated material**

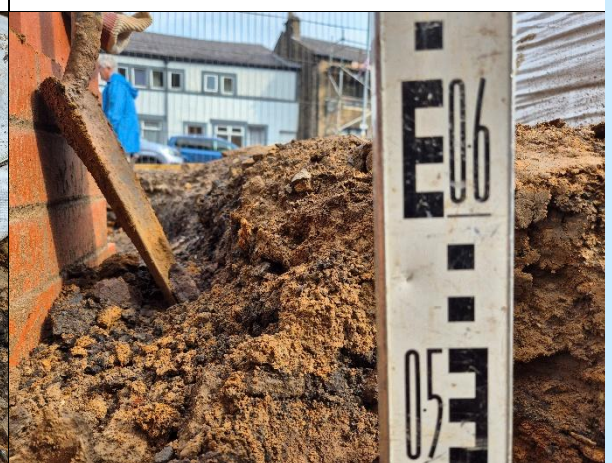
**P12: TP3B depth of second sample**

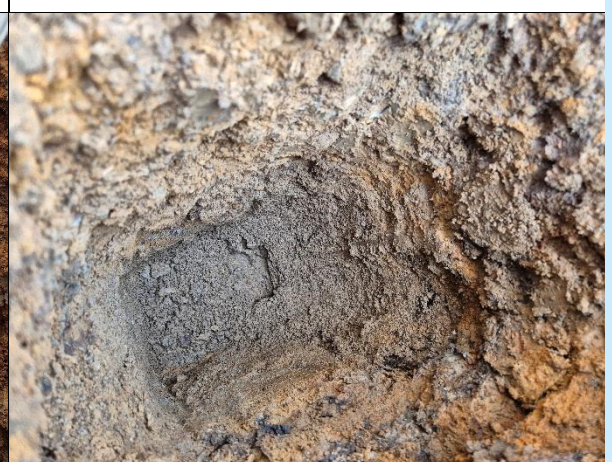
**P14: TP3 base of excavation.**
