Arboricultural Survey & Impact Assessment  
Eazy Cars Ltd  
Proposed Car Workshop  
Manchester Road  
Rochdale

Report Reference: AIA-1933-1  
11 April 2024

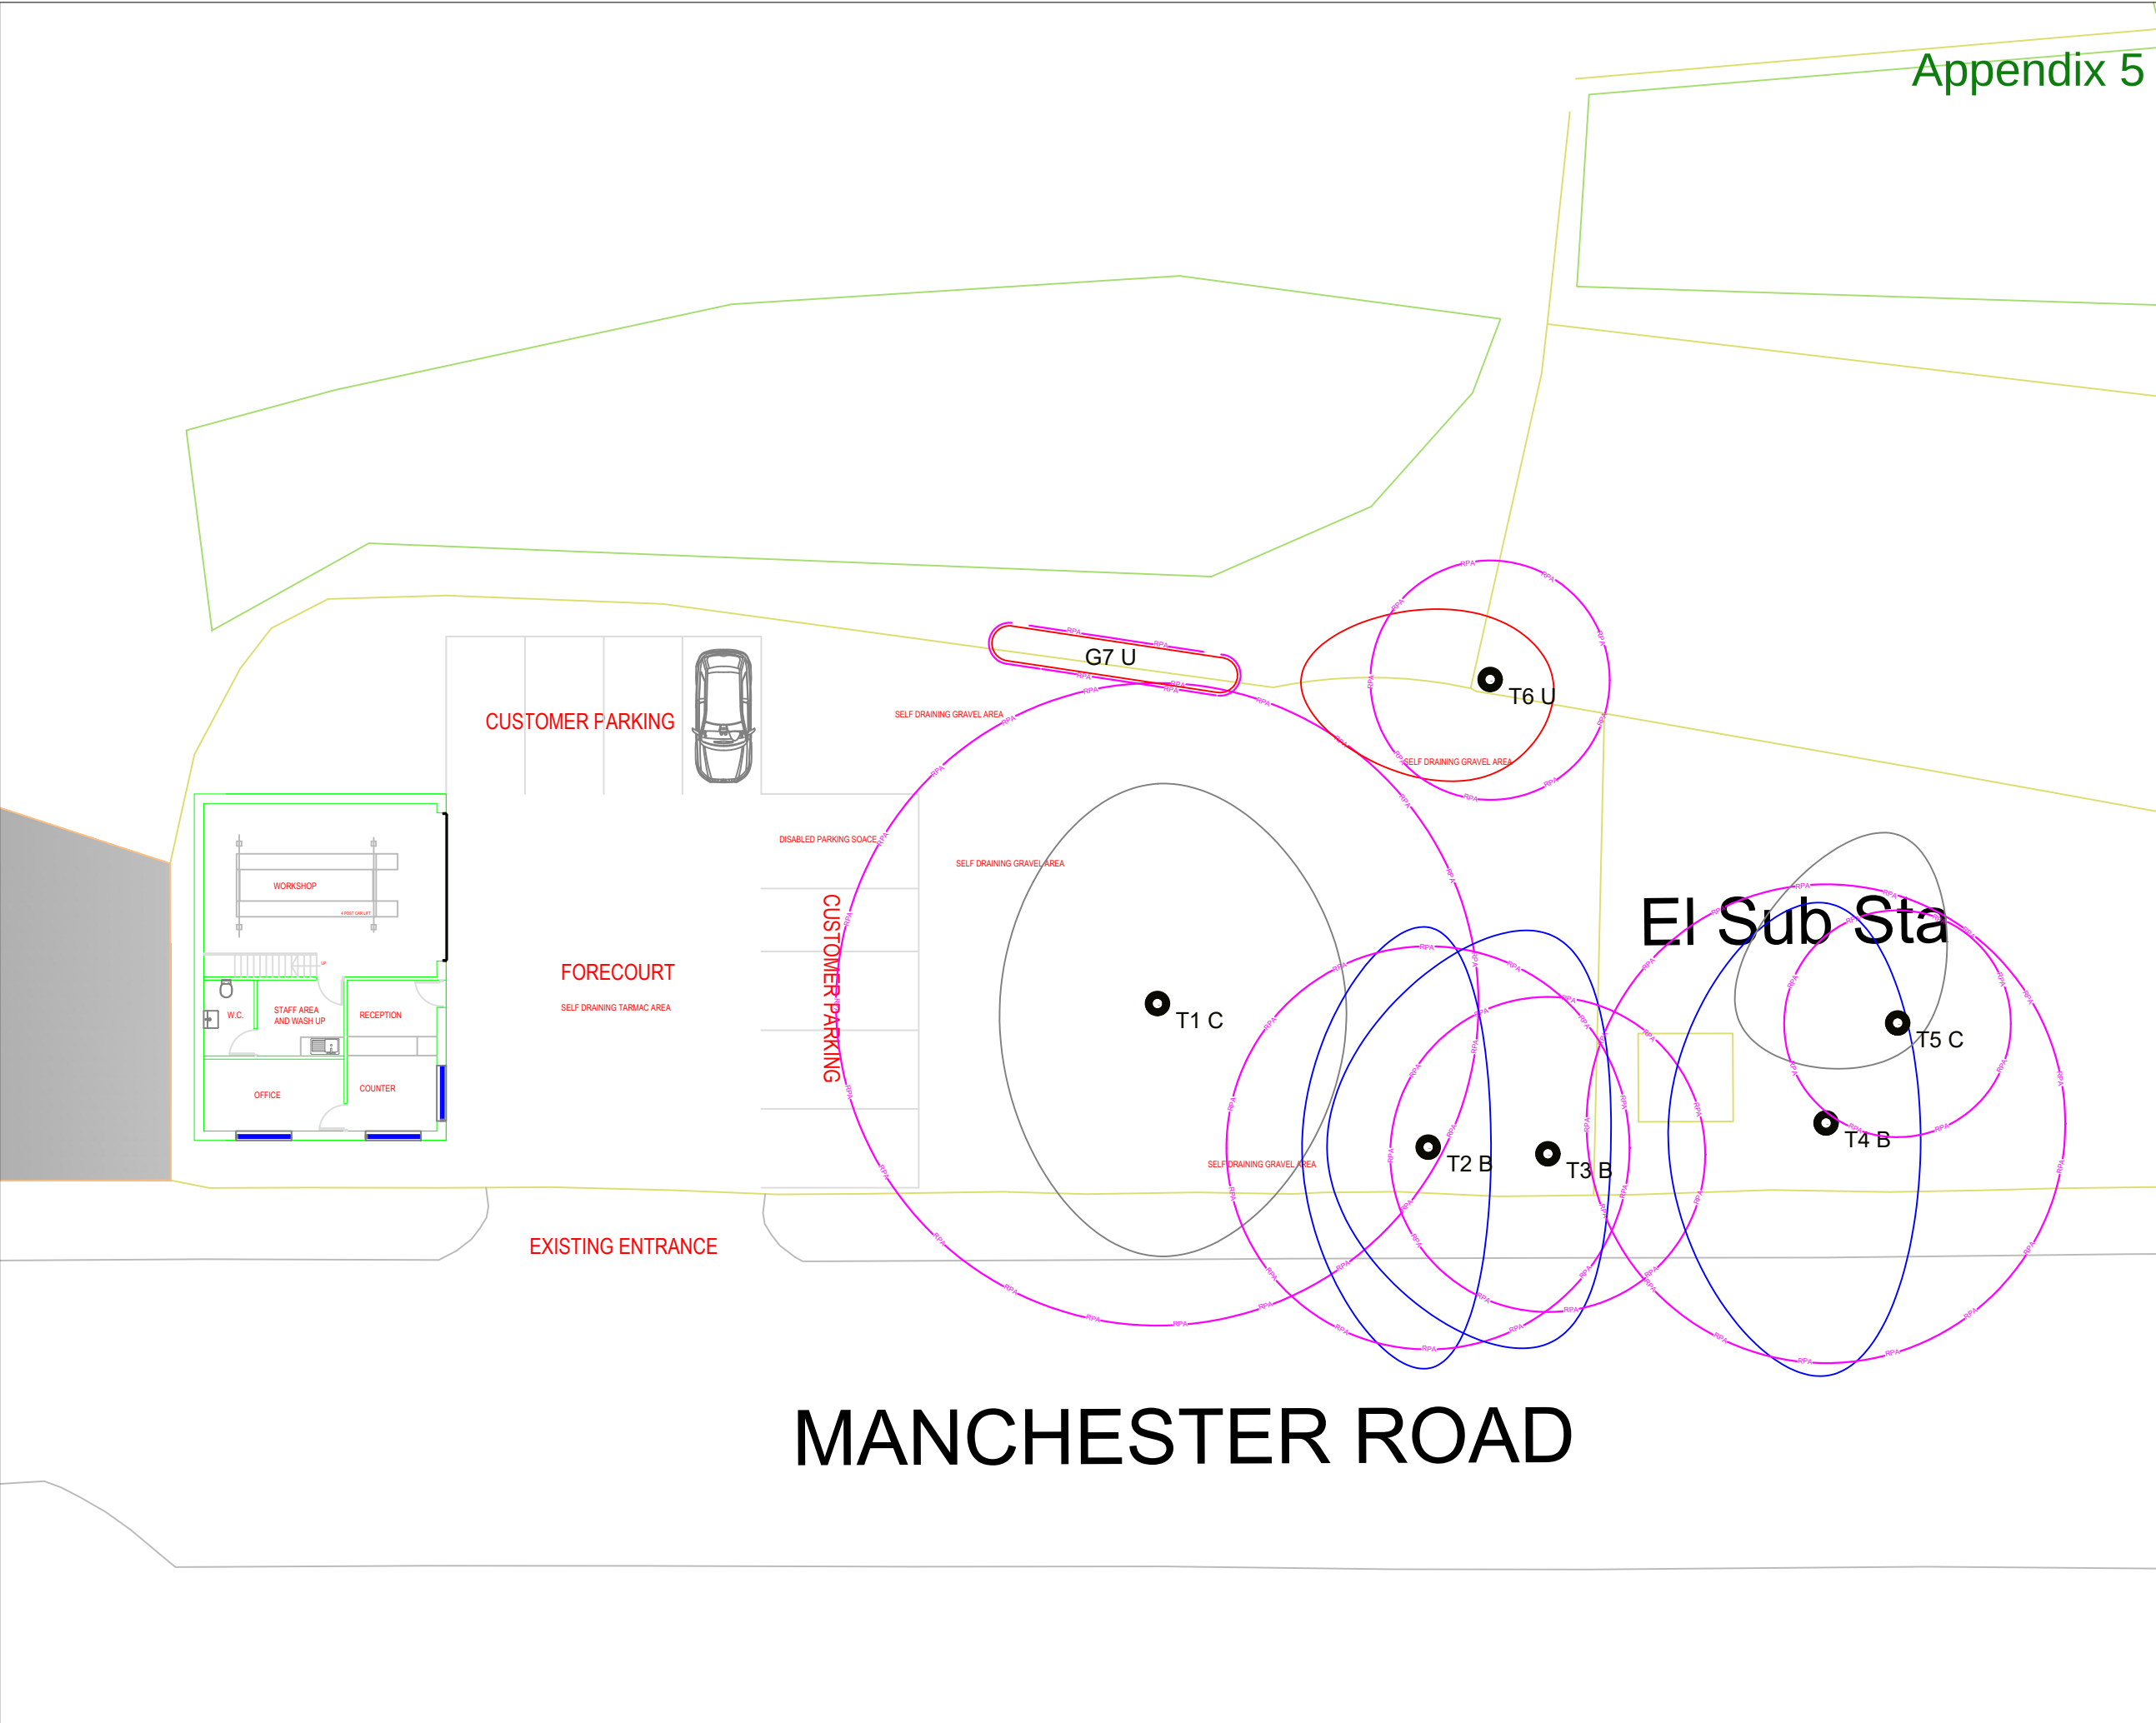
| Tree Impact Plan | | | |

- 3.3.2 As recommended in BS5837 we have plotted the RPAs (in magenta) onto the attached Tree Constraints Plan (TCP) taking full account of the surrounding topographical factors, tree condition and likely root disposition.
- 3.3.3 Save for Sycamore T1 there are no foreseeable conflicts between the proposed development and retained trees that cannot be addressed by customary tree protection measures.
- 3.3.4 In terms of the possible retention of Sycamore T1 which is unlikely to be achievable beyond the relative short term special measures would have to be incorporated in the form of "no dig construction" where customer parking would overlap the RPA of T1. Refer to paragraph 3.4.1 below.

- 3.4.1 If the LPA are minded to insist on retention of T1 the proposed customer parking will require new surfacing within the RPA of T1 amounting to approximately 6% of the RPA. This area will need to withstand the weight of vehicles without causing compaction to the underlying soils. As per BS5837 and Arboricultural Practice Note (APN12) the proposed surface will be constructed on a no dig basis. This matter can be addressed in the form of an Arboricultural Method Statement (AMS). It will be noted BS5837 paragraph 7.4.2.3 recommends new permanent hard surfacing should not exceed 20% of any existing unsurfaced ground. As such the necessary 6% incursion falls well within the recommended guidance. It is requested the LPA agree to condition an AMS and wider Tree Protection as part of a detailed planning permission.
