**ARBORICULTURAL REPORT  
AND  
ARBORICULTURAL IMPACT ASSESSMENT  
to BS 5837:2012  
at  
Dale Street  
Milnrow  
Rochdale  
Lancashire  
OL16 3LH**

**Client:**  
Howe Rigout  
& Construction

**JCA Ref:**  
22292/ME

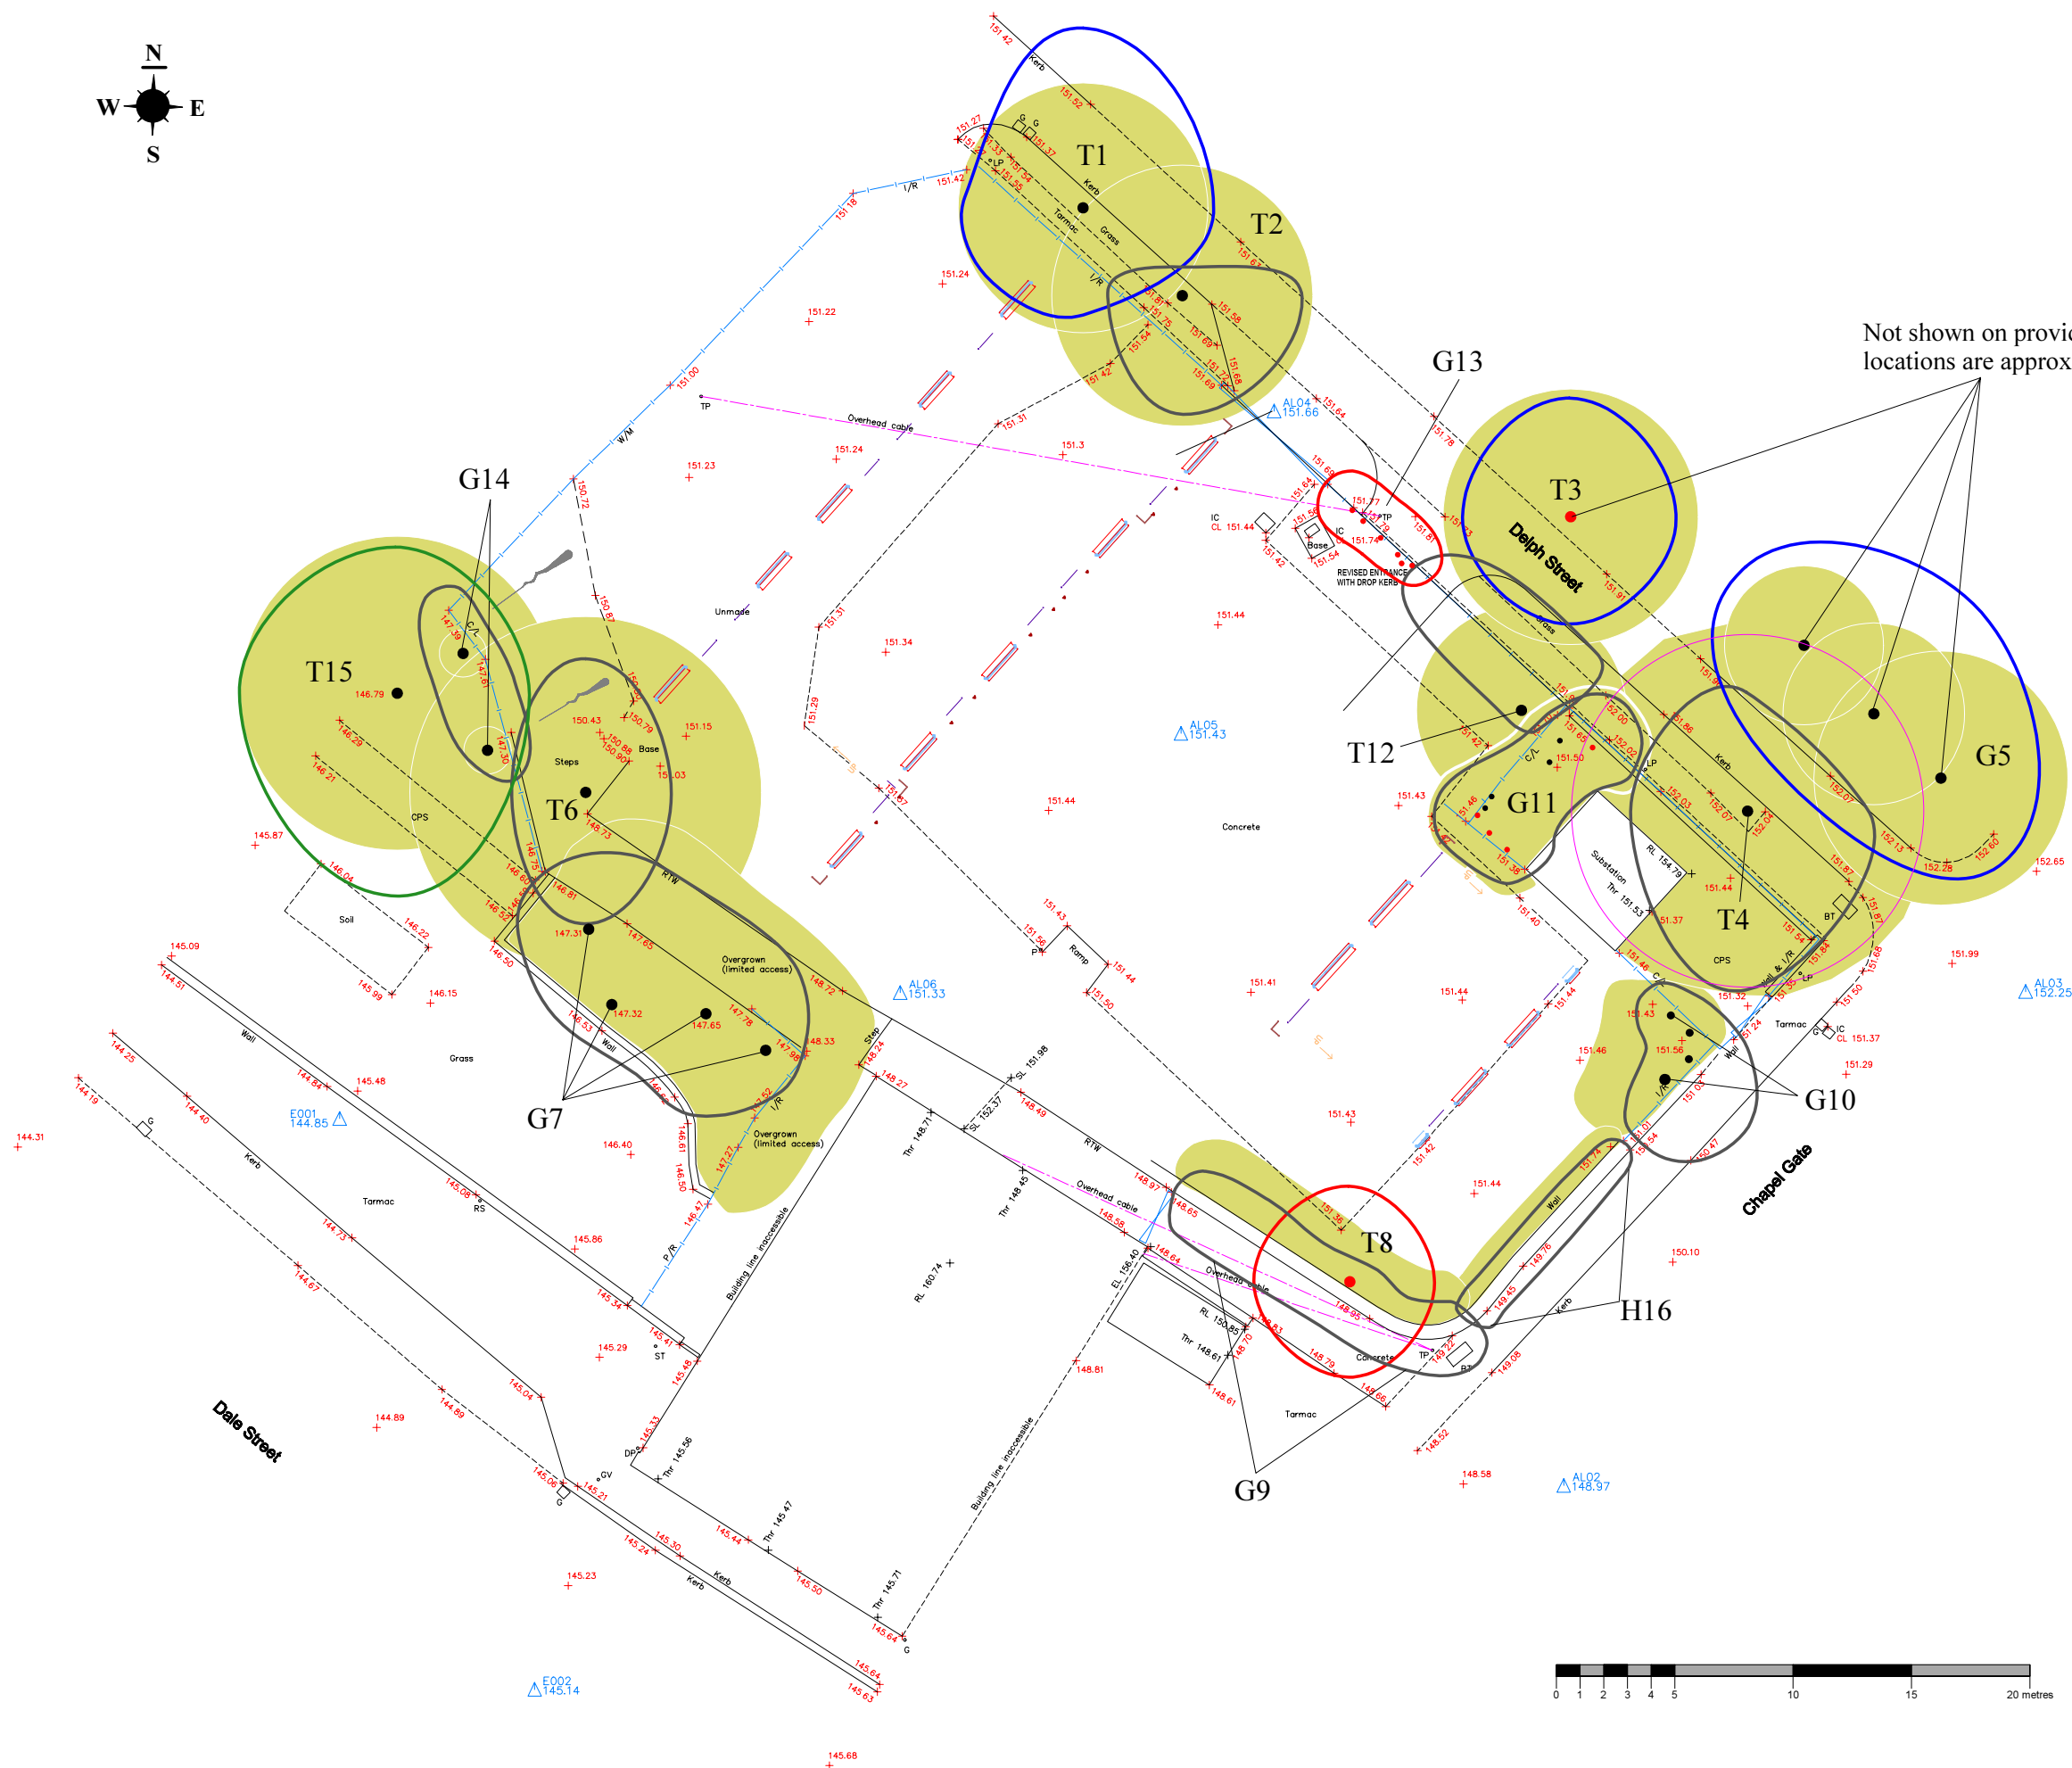
### Appendix 5: Tree Constraints Plan

Not shown on provided plan,  
locations are approximate.
