## **WORMS EYE**

Our Ref: Inchfield Close/OL11 5SB/2017  
Date: 26 April 2017

**2 INCHFIELD CLOSE, NORDEN, OL11 5SB**  
**COAL MINING RISK ASSESSMENT**

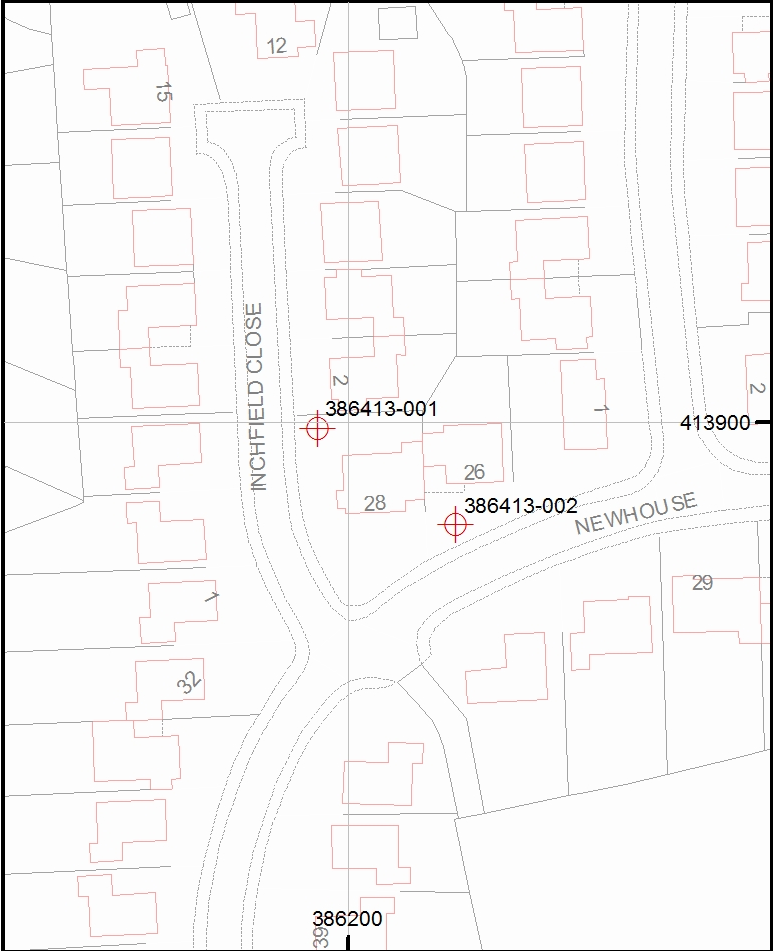
CA Plan Enlargement showing shafts 1 & 2

The Coal Authority indicate shaft 1 to be present near the southwest corner of the plot (2 metres off-site to the south) and another, shaft 2, about 18 metres southeast.

The Coal Authority have no further records for these shafts and therefore assumptions have to be made on a worst-case scenario.

A worst-case scenario would move the shaft to within 8 metres of the site, with a zone of influence potentially impinging onto the site by about 3.5 metres from the southeast corner.

The underlying clay would, however, be expected to stand at greater than 45° in the event of a collapse and it is considered unlikely that this shaft will be a risk to the development.

A worst case zone of influence were the shaft to collapse, would be 23 metres diameter, or 11.5 metres radius towards the site.

Taking into account the factor of inaccuracy and mapping errors, this gives a potential zone of influence towards the site at 22 metres radius.

If it were to collapse, the potential zone of influence would cover most of the site, with potential catastrophic effects on structures. The possible error in mapping, means the shaft could be present on site

The shaft 2 to the southeast is considered unlikely to pose a risk to the site. However, it would be sensible to avoid building within a 3 metre radius of the southeast corner.

Investigations will be required to design an appropriate remedial scheme.

There is a risk mainly from shaft 1. It is suggested a series of probes are drilled on a 1.5 metres grid, 15 metres (east) by 9 metres (north).

Mine shaft 1 is shown immediately south. To investigate this, drilling down to rockhead at 1.5 metres centres on a 15 by 15 metre grid is suggested.

Once this has been completed it should be possible to design a remediation scheme.
