**Project:** 20\_5837\_11\_35  
**Site:** Land off from Edenfield Road, Rochdale, OL11 5TT  
**Client:** Martin Hall

| Document Title: | Arboricultural Implications Assessment |

## Arboricultural implications assessment to BS 5837 2012 of trees at: The land off from Edenfield Road, Rochdale, OL11 5TT.

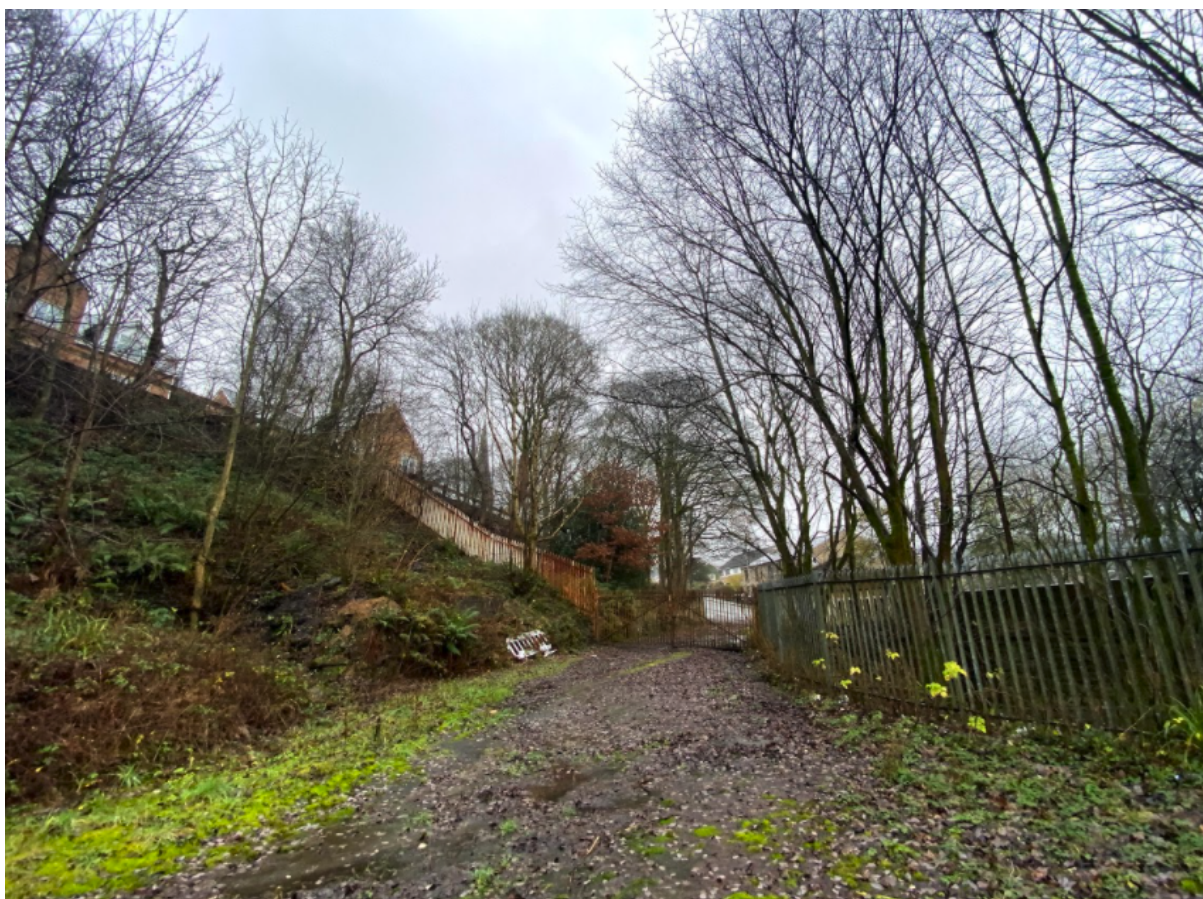
*Photographic plate showing self-set natural regeneration on the site boundary.*

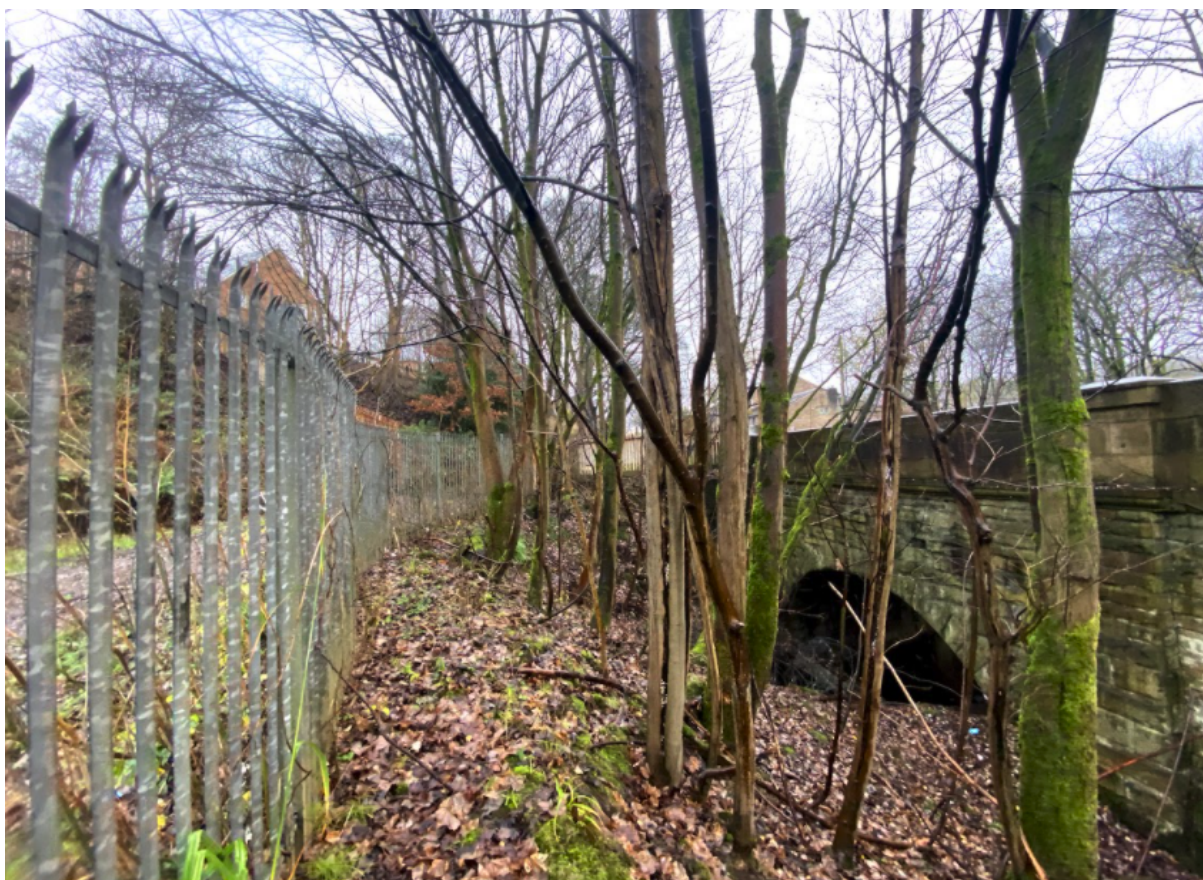
*Photographic plate showing self-set natural regeneration on the site boundary.*

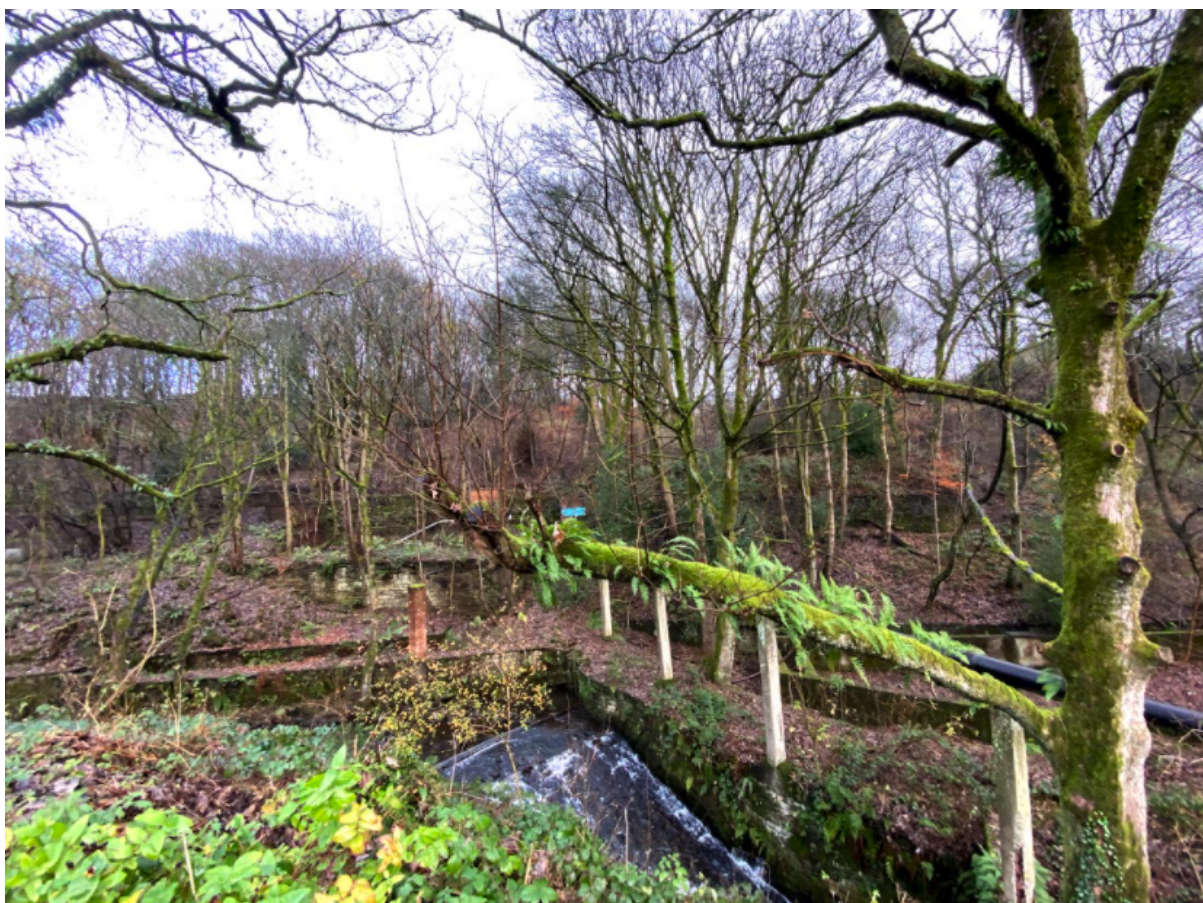
*Photographic plate showing self-set natural regeneration and woodland.*

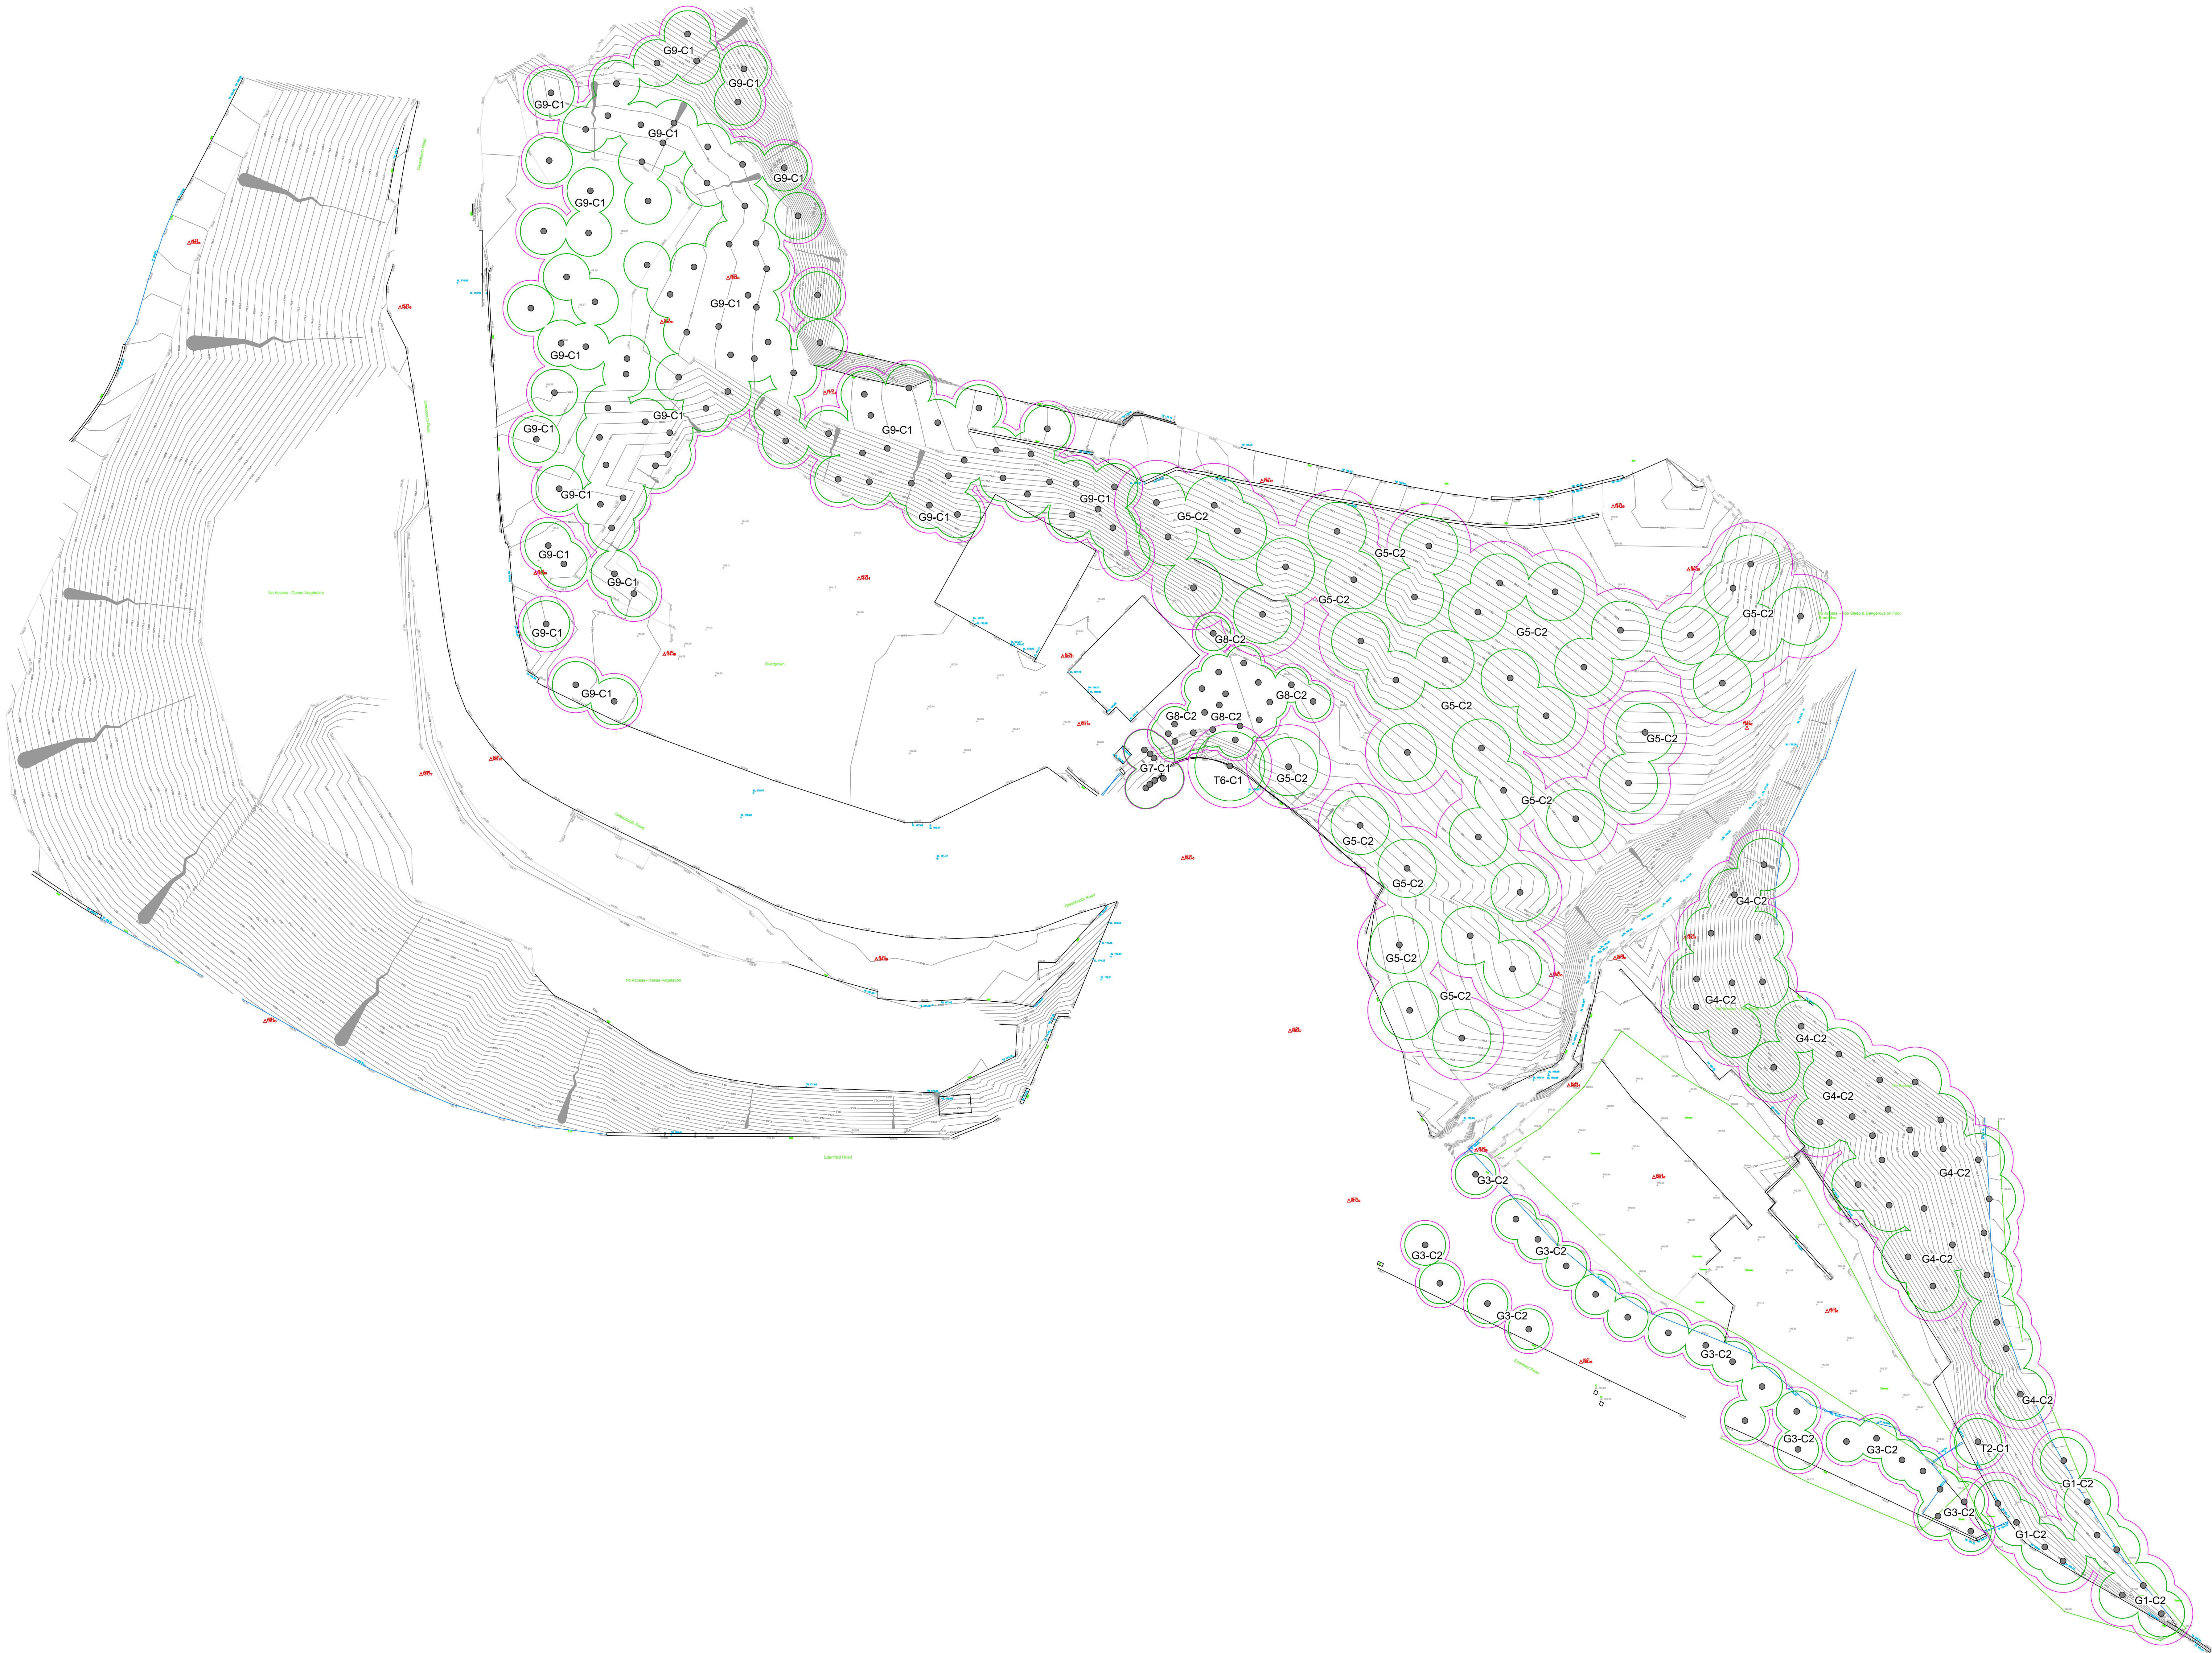
Drawing Number  
20\_5837\_11\_35

Tree Constraints Plan  
showing existing layout with  
tree categories and root  
protection zones.
