Project  
BAMFORD MEWS,  
ROCHDALE

Title  
TREE PROTECTION PLAN

2345-KC-XX-YTREE-TPP01Rev0

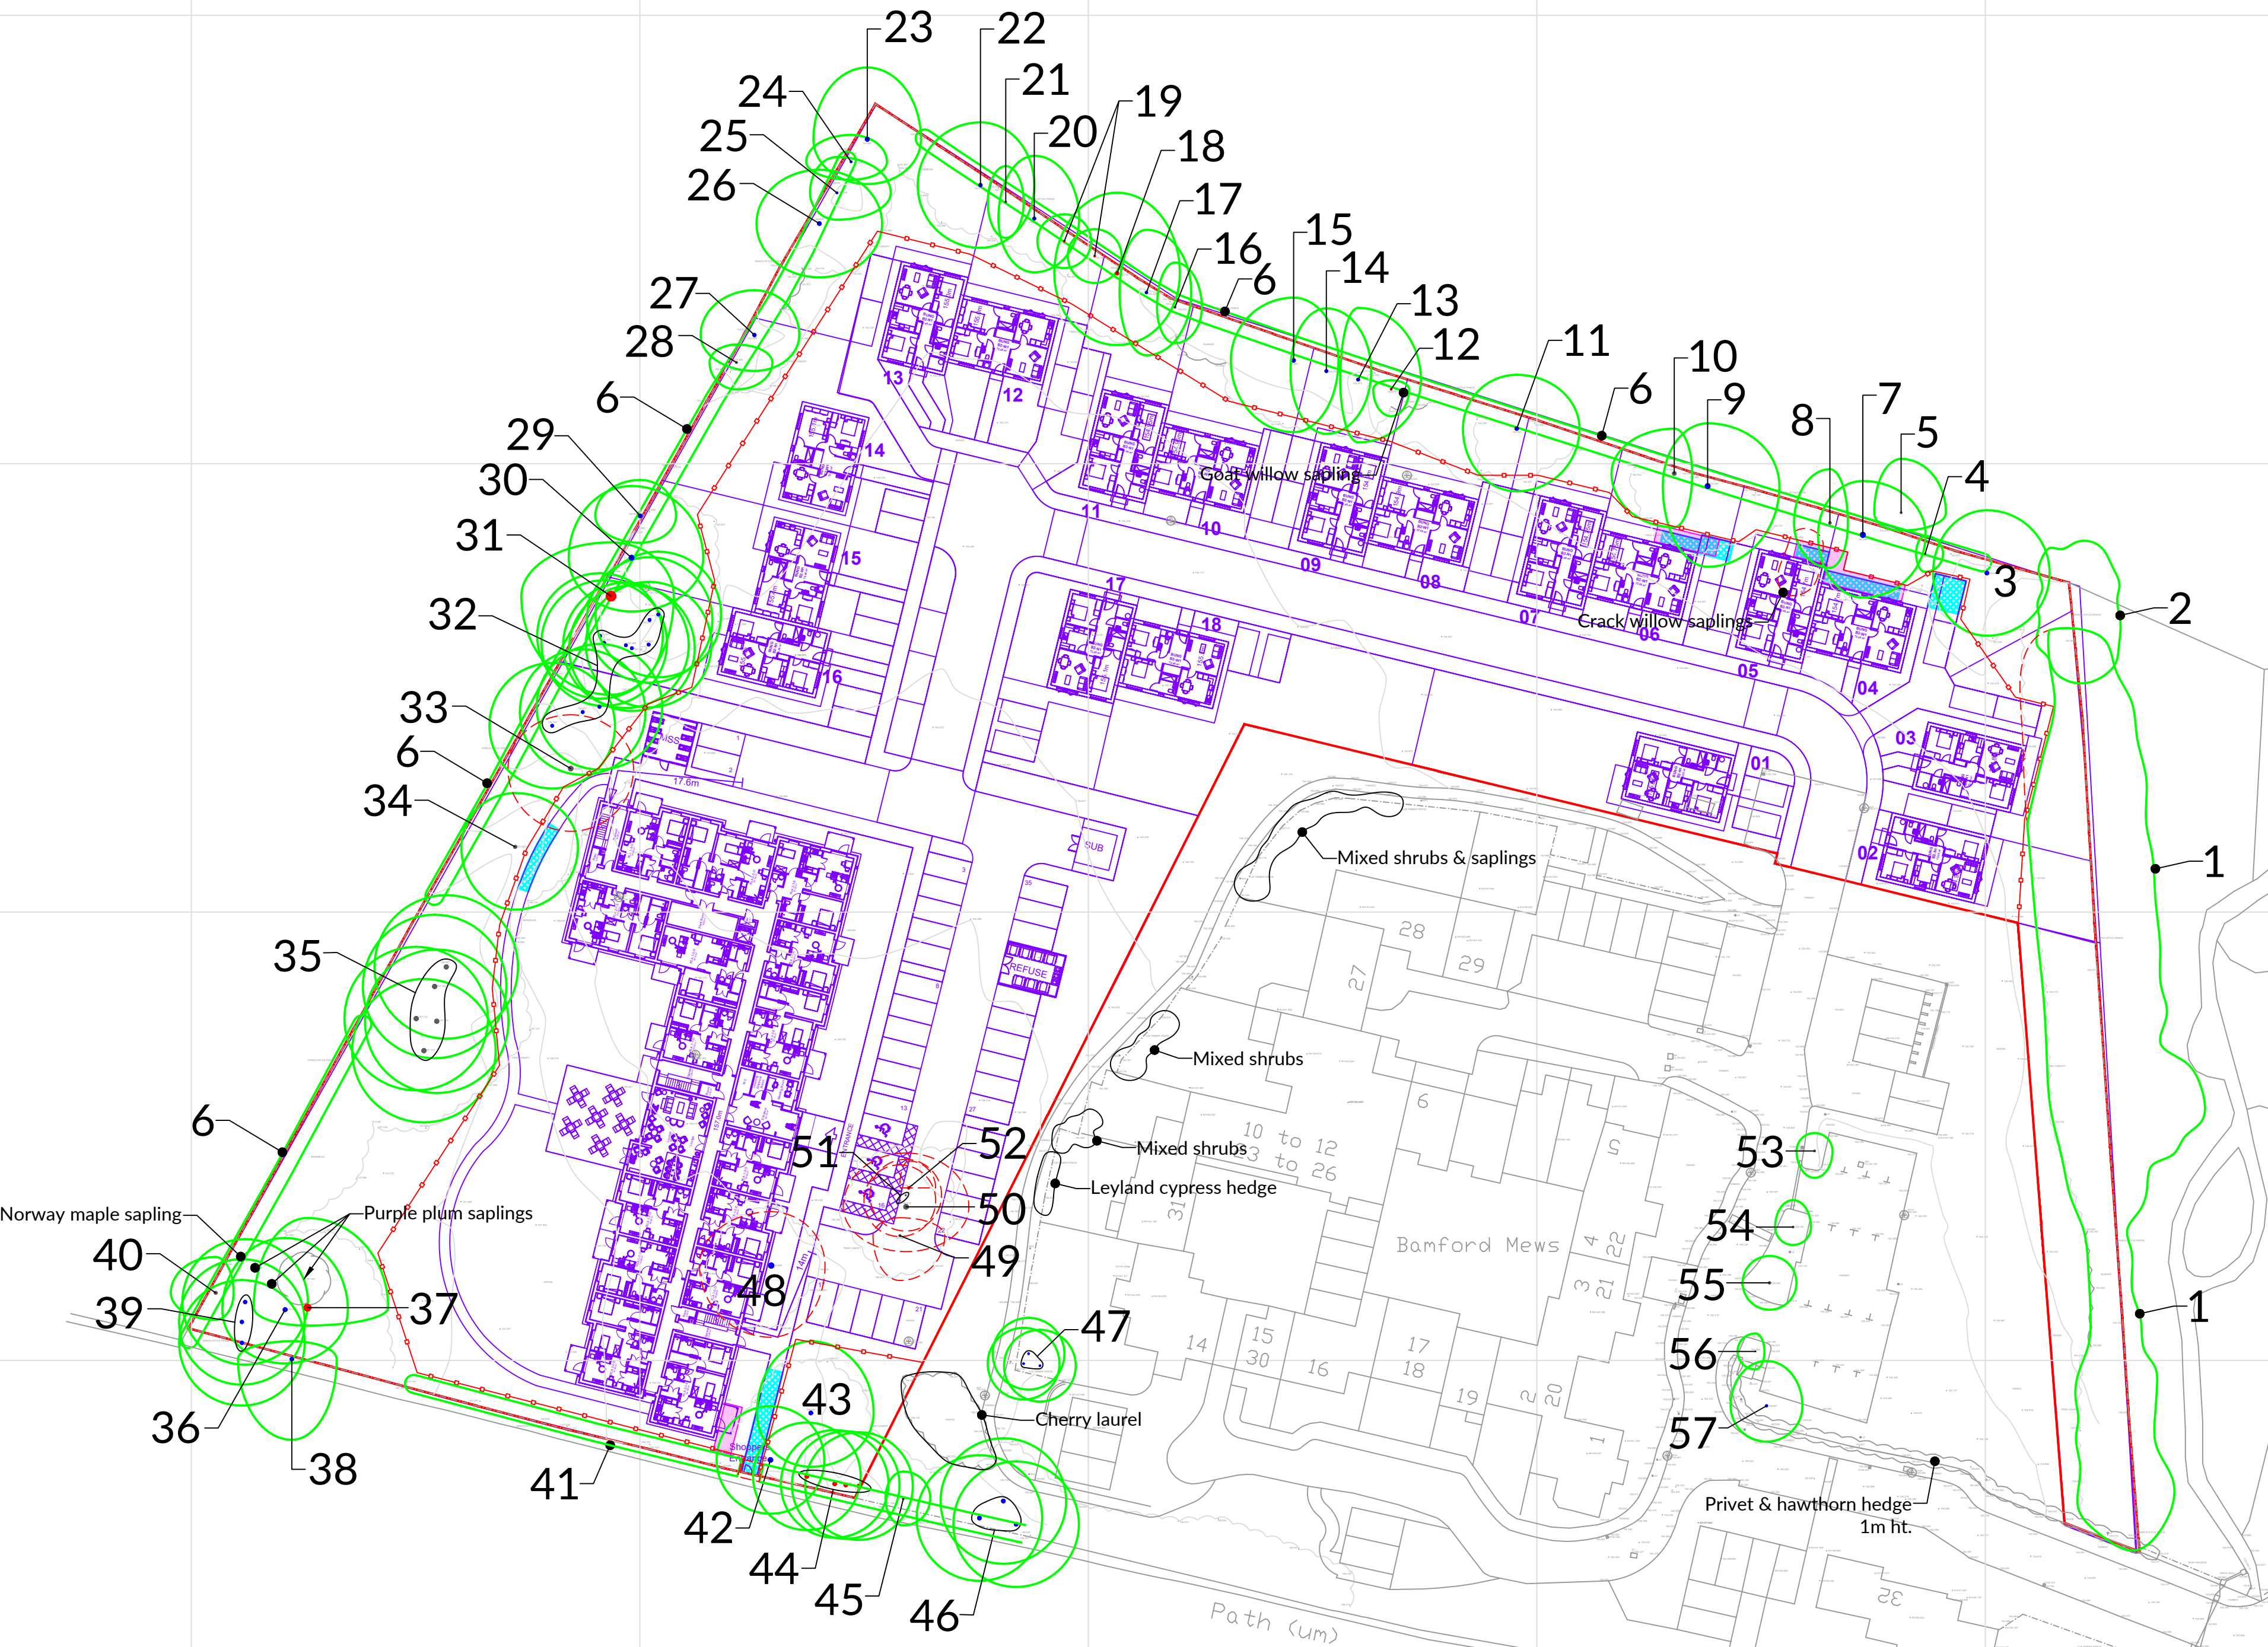
| Schedule of trees at Bamford Mews, Bamford | | | | | | | | | | | | | | | | | | | | |
|---|---|---|---|---|---|---|---|---|---|---|---|---|---|---|---|---|---|---|---|---|
| 1 | Mixed broadleaf tree belt | 11av | | | | | 30av | | | | 0 | - | S | B2 | >20 | Established belt of trees along western boundary. Black oxidation at tree belt, maple with occasional hawthorn. | Remove section as shown. | 3.60 | 41 | |
| 18 | Silver birch | 15 | 9 | 7 | 8 | 7 | 40 | | | | 1 | 2S | S | U | >10 | Lacking vitality. Black oxidation on lower stem indicates infection with honey fungus. Unsusled to long term retention. | Crown lift to 5m above proposed garden. Cut back to provide 3m clearance from proposed building. | 4.80 | 72 | |
| 31 | Crack willow | 19 | 6 | 7 | 11 | 10 | 113 | | | | 2 | 2E | E | U | >10 | Large example growing on western boundary. Primary failure of main trunk at circa 3m above ground level rendering subsidiary stem highly susceptible to collapse. Unsusled to long term retention in its current form. Pollarding would enable retention and regrowth whilst overcoming propensity to failure. | Pollard to circa 6m above ground level. | 13.56 | 576 | |
| 32 | Group of crack willow | 17av | | | | | 7av | 35av | | | 0 | - | S | B2 | >20 | Cluster of stems growing along western boundary. All attaining at size where stem failure is likely. Pollarding would enable their long term retention. | Crown lift to 5m above proposed garden. Cut back to provide 3m clearance from proposed building. | 4.20 | 55 | |
| 33 | Nonway maple | 16 | 6 | 7 | 7 | 7 | 53 | | | | 2 | 2S | S | C2 | >10 | Contributes to tree group but consists of multiple stems with narrow unions between them. These unions, on these species, are liable to failure as the tree matures. | Remove. | 6.36 | 127 | |
| 37 | Goat willow | 16 | 10 | 9 | 2 | 6 | | 15 41 36 47 32 | | | 0 | - | E | U | >10 | Stem failure has occurred and decay now at base. Lacking vitality. Coppicing would promote regeneration. | Crown lift to 5m above proposed garden. | 9.63 | 291 | |
| 44 | Group of ash | 15av | | | | | 6av | 45av | | | 3 | 3N | S | U | >10 | Group of ash trees on southern boundary. All showing signs of ash die back. Group includes occasional sycamore. | Crown lift to 5m above proposed pathway. | 5.40 | 92 | |
| 52 | Alder | 7 | 3 | 3 | 0 | 1 | 29 | | | | 1 | 1E | S | U | >10 | Extensive death of bark on what is left of the main stem. | Remove. | 3.48 | 38 | |
| 54 | Cherry | 5 | 3 | 2 | 2 | 2 | 20 | | | | 1.5 | 1.5E | Y | C1 | >10 | Lacking vitality. Black oxidation on stem indicative of bacterial canker. | Remove. | 2.40 | 18 | |
