06<sup>th</sup> October 2022

Bloor Homes North West  
2 - 4 Whiteside Business Park  
Station Road  
Holmes Chapel  
Cheshire  
CW4 8AA

## LAND OFF HOLLINGWORTH ROAD, LITTLEBOROUGH HYDROLOGICAL ASSESSMENT

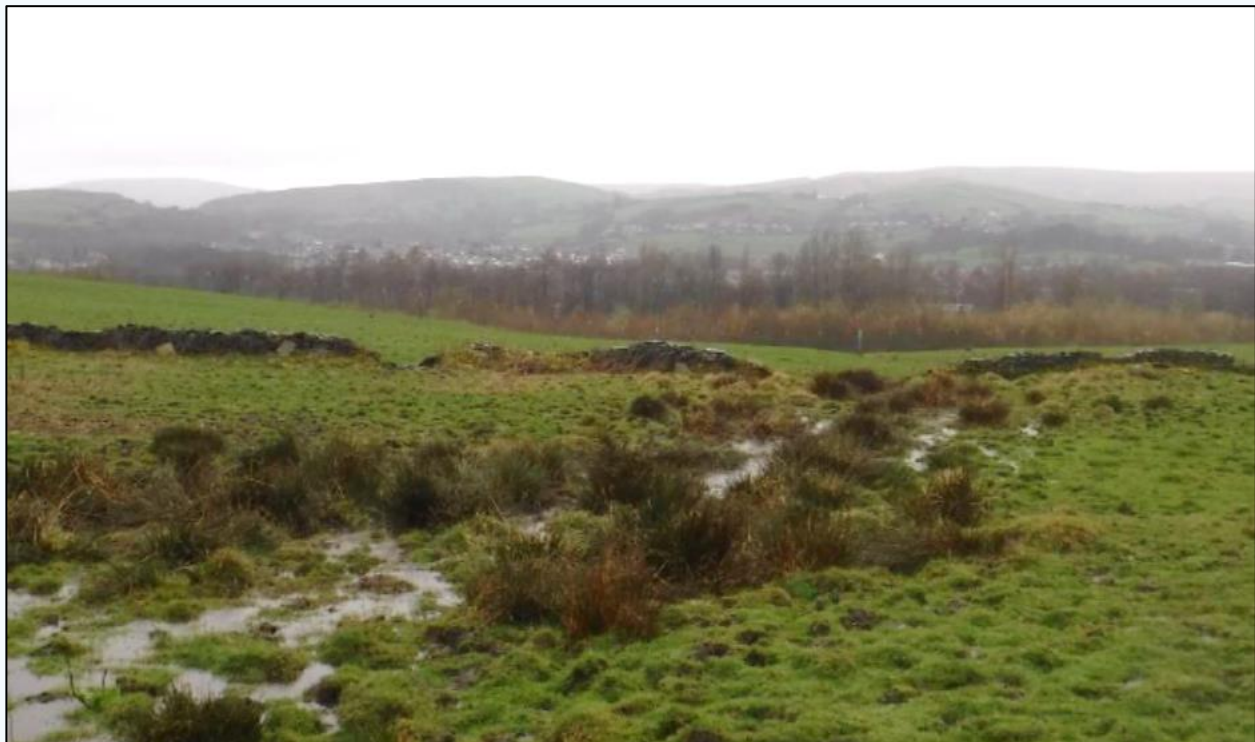
Figure 2: Photograph showing standing water taken during the walkover (Betts Hydro, 2019)

The Cranfield Soil and AgriFood Institute (CSAI), Soilscape viewer identifies the soils to be slowly permeable, seasonally wet, acid, loamy and clayey soils. The underlying strata appears to suggest that permeability is low, and the FEH soil factor of 0.4 suggests a low permeability for the area (0.1 is very high and 0.5 is very low permeability). This suggests that the site had a low permeability pre-development and overland flows will occur during periods of prolonged rainfall, which corresponds with observations during the site walkover, as shown in **Figure 2**.

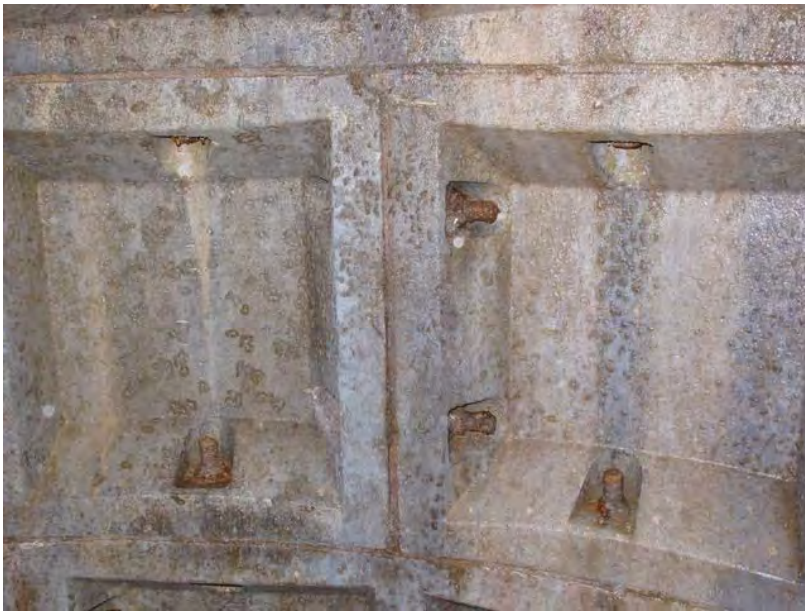
There is infiltration through some of the PCC bolted sections and minor rusting of the bolts and fasteners. None appeared to be missing or broken at the time of our inspection.

Typical Detail of PCC Bolted Sections and Fasteners.
