## Phase I GeoEnvironmental Desk Study

Oakenrod

Rochdale

**Report No. A4743/22**

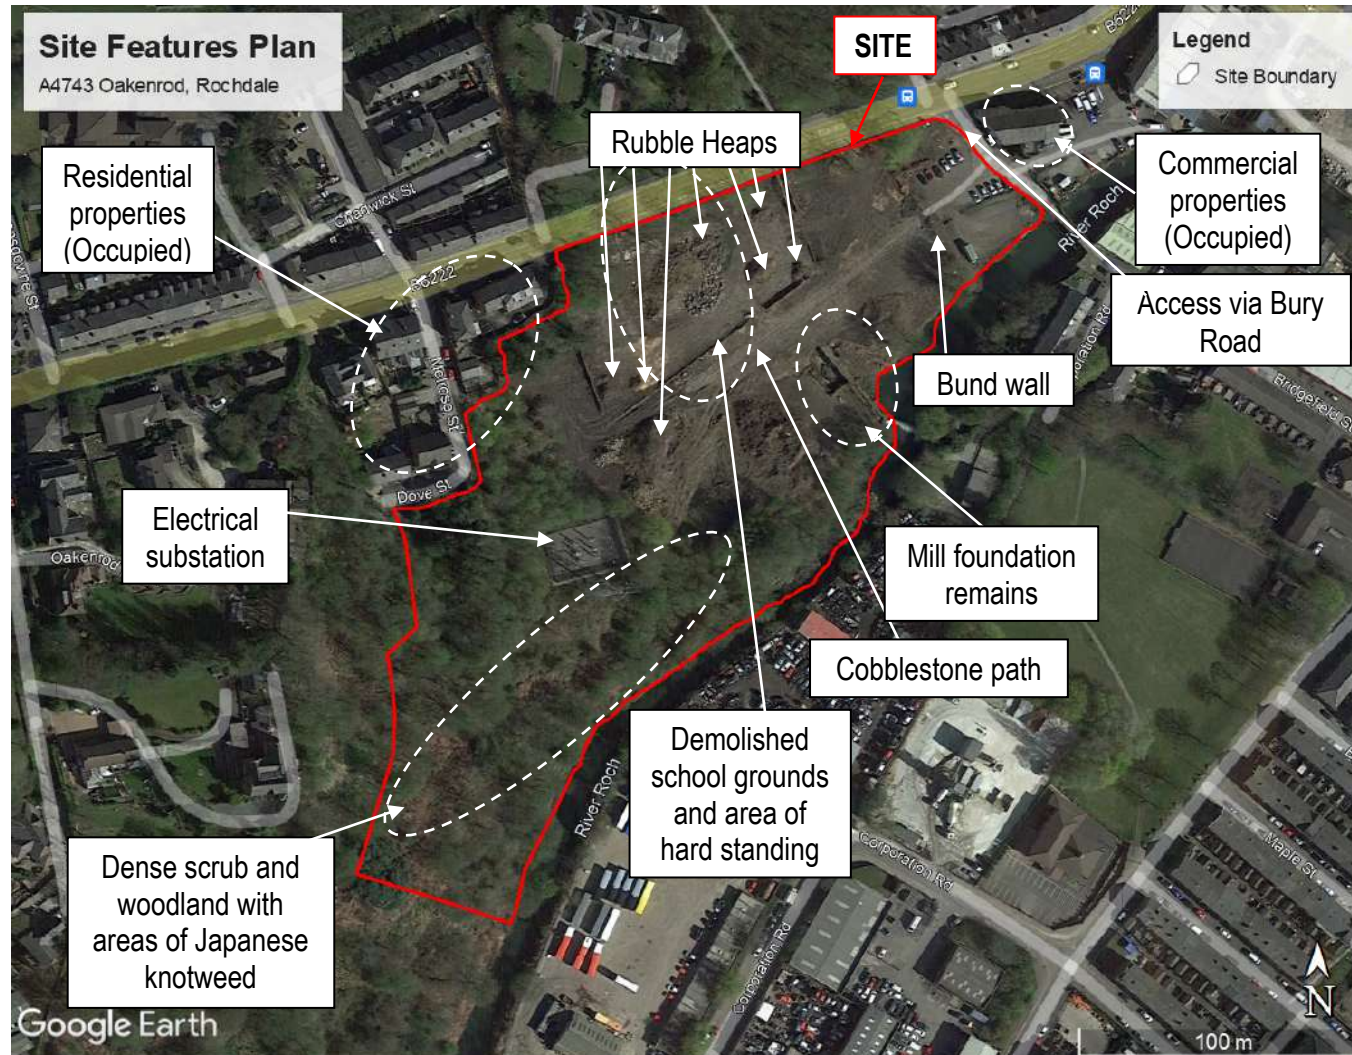
Figure 11: Site Features Plan

- 5.9 Brick building remains and foundations lie to the southwest of the site, near the west site boundary.
- 5.10 Car tyre pile located on south of site adjacent to electrical substation.

- 5.11 Mill structure foundations are situated to the east of the site, bordering the River Roch.
- 5.12 The site is demarcated by a mixture of hardstanding, brick walls, rubble heaps, a cobble path, dense scrub vegetation and woodland.

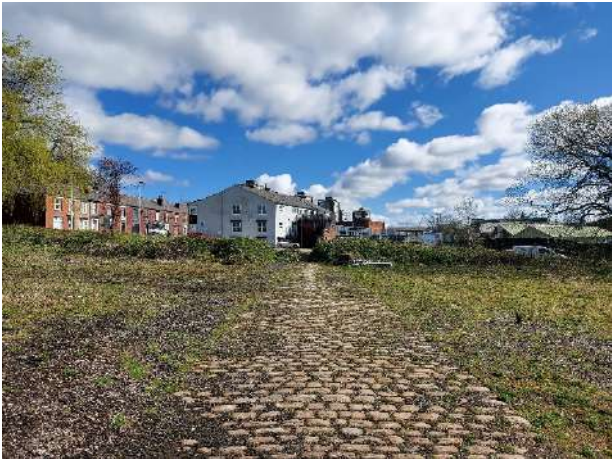
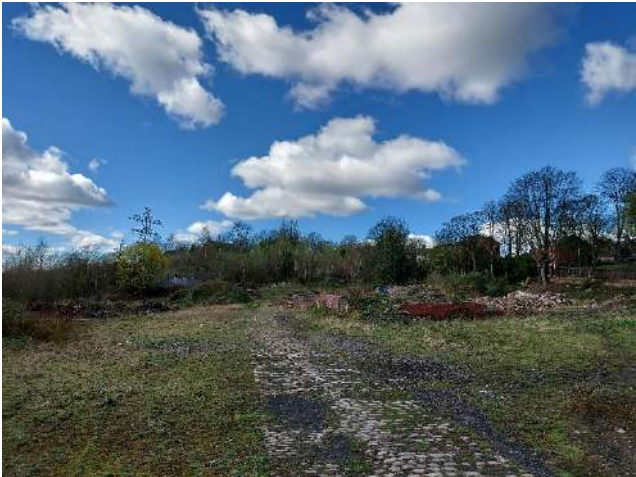
| <p><b>Plate 1 Viewing northeast showing the site access off Bury Road to the northeast of the site. Note bund wall running from northwest to northeast of site.</b></p> | <p><b>Plate 2 Viewing southwest showing the cobblestone road and school ground remains.</b></p> |

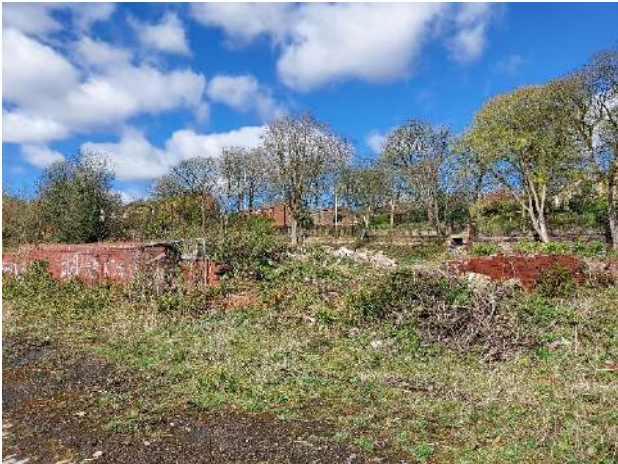
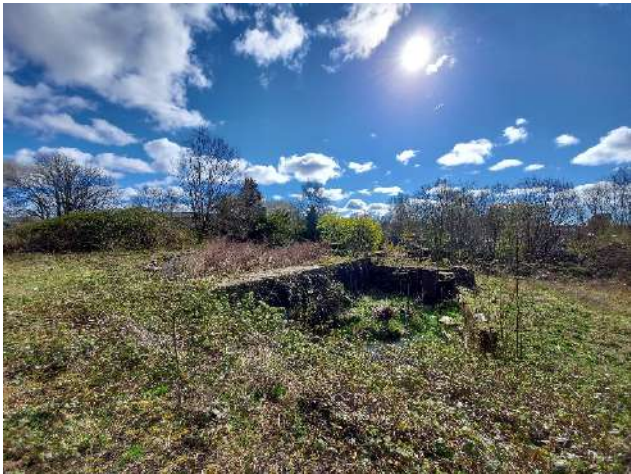
| <p><b>Plate 3 Viewing west/northwest of the site showing historic school walls, rubble heaps and northwest boundary.</b></p> | <p><b>Plate 4 Viewing east showing historic mill building foundations to the northeast of site and eastern side of site.</b></p> |

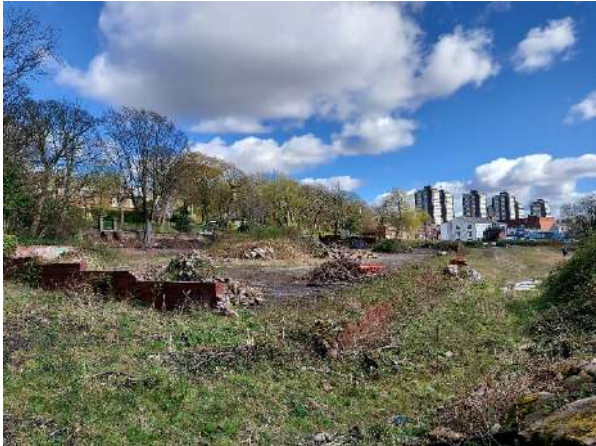
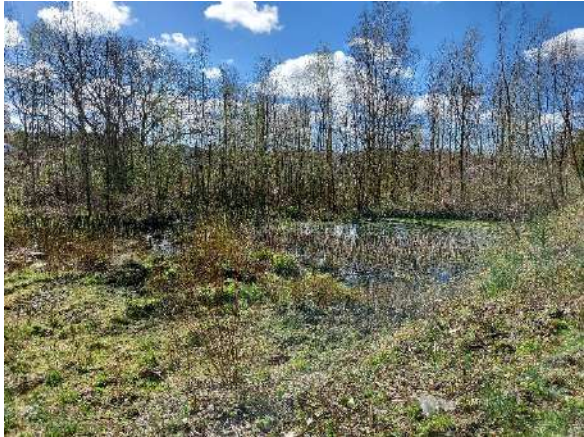
| <p><b>Plate 5 Viewing northeast showing southwest of historic school grounds with concrete hardstanding and rubble heaps.</b></p> | <p><b>Plate 6 Viewing southeast showing eastern side of the site. Note existing standing water mature trees along the eastern boundary.</b></p> |

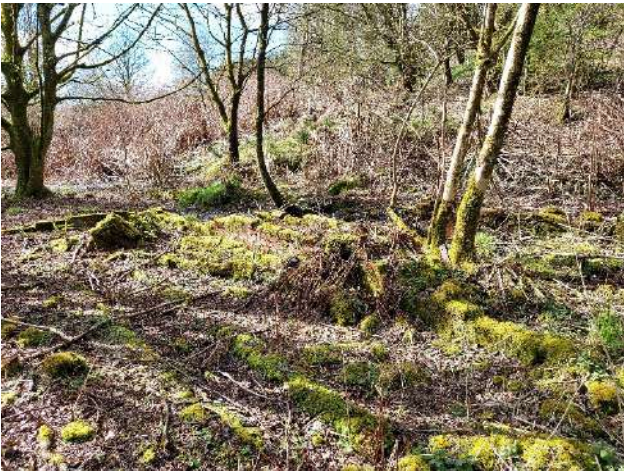
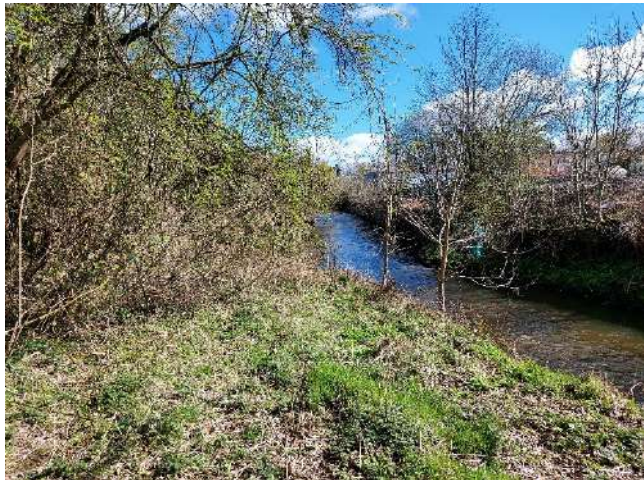
| <p><b>Plate 7 Viewing west showing brick building foundations to western boundary of the site. Note mature trees and dead Japanese knotweed.</b></p> | <p><b>Plate 8 Viewing northeast showing east site boundary. Note mature trees, river Roch running northeast to southeast along eastern boundary, and dense scrub with thick dead Japanese knotweed.</b></p> |

- 8.14 A Coal Mining Risk Assessment will need to be developed for the site, together with a Flood Risk Assessment.
- 8.15 An invasive plant survey is recommended as part of an ecological survey of the site.

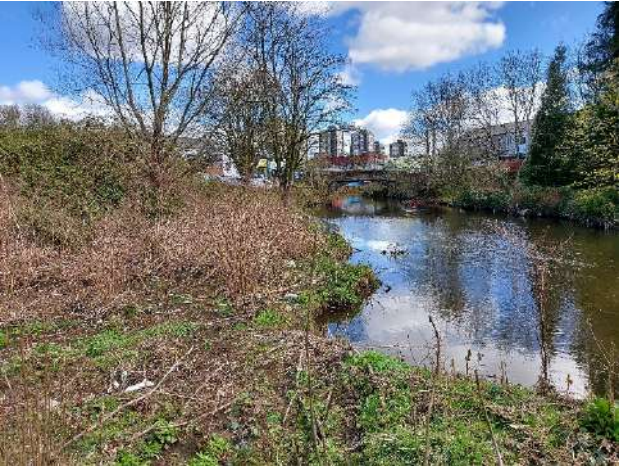
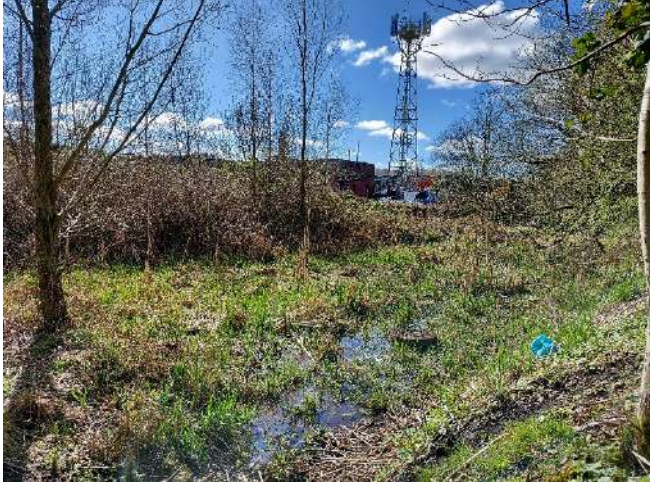
| <p><b>Plate 9 Viewing northeast showing the north-eastern boundary of site. Note the River Roch along northeast boundary, dead Japanese knotweed and Oakenrod bridge to very most northeast corner of site.</b></p> | <p><b>Plate 10 Viewing southeast showing south-eastern boundary of site. Note low lying wetland adjacent to River Roch.</b></p> |
