## Preliminary Ecological Appraisal and Roost Assessment

Hillcrest, Hillcrest Road, Rochdale, OL11 2QB

3rd July 2024

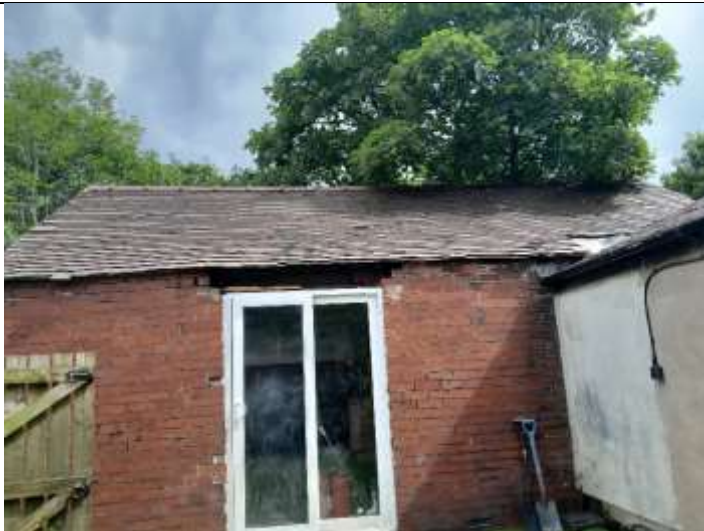
| | <ul style="list-style-type: none"> <li>• Damage to the brick walls of the southern elevation of the brick walled section of B1. This creates crevices and gaps suitable to support roosting crevice dwelling bats. this damage also allows gaps below the end tiles and allows access beneath the tiles for crevice dwelling bats.</li> <li>• There are several lifted tiles on all roof structures of the building creating gaps suitable for crevice dwelling bats.</li> <li>• There is a gap that runs along the end tiles of the southern facing roof structure of b1 that allow access below the tiles that allow internal access for crevice dwelling bat species.</li> <li>• There is a gap between the brick walls and the lifted flashing on the southern and western adjoining section of the garage. This creates a suitable roosting feature for crevice dwelling bats.</li> <li>• The western gable is in good condition with no visible roosting features for bats. Similarly the southern gable end has no visible suitable bat roosting features.</li> </ul> <p><u>Bats Roosting B1 (internal)</u></p> <p>There is no loft space within B1 and the ceilings are vaulted and easily assessed from the ground. The ceiling consists of wooden boards and is well sealed, with no visible gaps or crevices.</p> <p>There are high levels of sunlight within the space that makes the interior sub-optimal for void dwelling bats.</p> <p>B1 has <b>moderate</b> habitat value for roosting bats.</p> <p><u>Bats Roosting B2 (residential dwelling)</u></p> <p>B2 is a cross gabled, two storey dwelling. the walls are rendered construction, the roof is constructed of slate and there are two brick chimney stacks.</p> |

Figure 4 – the overview of B1 and visible damage to the walls.

| <i>Recommendations</i> | <p><b>B1:</b> Two bat emergence/re-entry surveys are required on B1 during the active bat season to confirm presence/likely absence of bats roosting in or on the building. This survey visits should be completed during the optimal survey period mid-May to August inclusive. Sub-optimal: early May and September. Would require greater justification of timing e.g., weather conditions, known local bat activity.</p> <p>Three surveyors are required to provide full coverage of the building's elevations to look for emerging/re-entering bats. Infrared cameras should also be employed as part of the survey to see where any specific roost locations are located.</p> <p>If any bat roosts are confirmed from this survey schedule, a further survey will be required to inform an EPSL license application to Natural England. The bat license would be required to demolish B1 as it would involve the destruction of roosts. This is applied for with the help of a class 2 licensed bat ecologist after planning permission is granted, but before commencement of works.</p> |

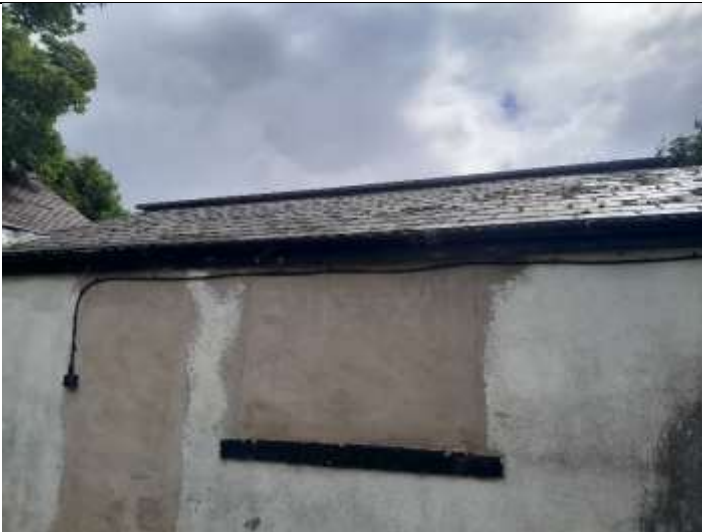
Figure 5 – the overview of the western facing roof structure of B1.

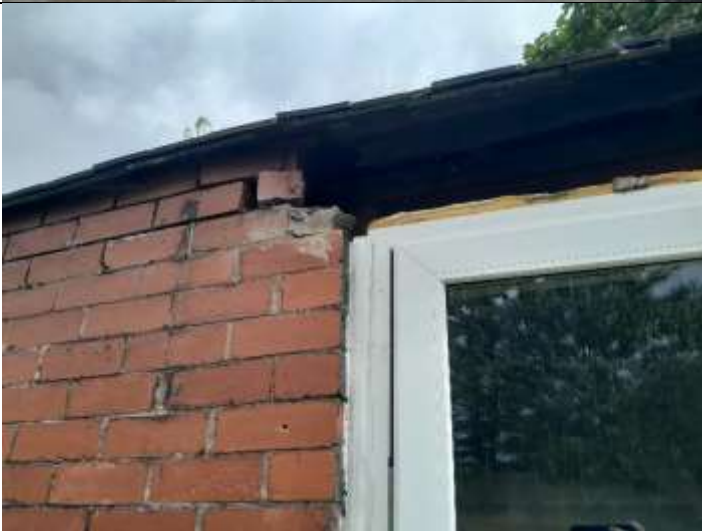
Figure 6 – the damage to the brick wall of B1.

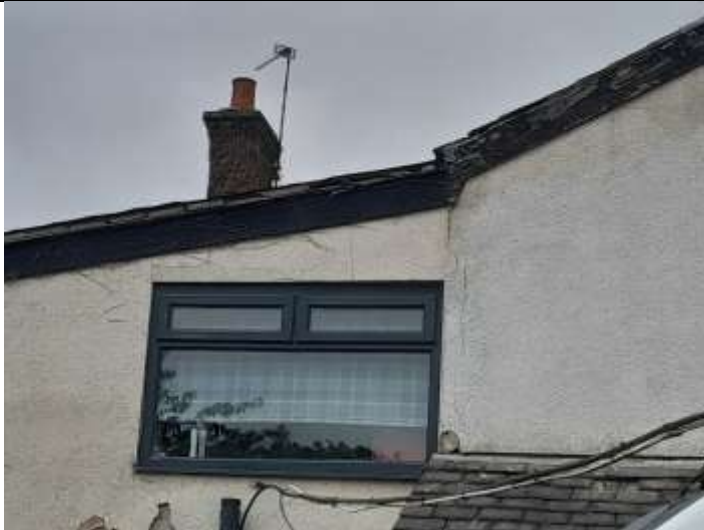
Figure 16 – the damaged mortar on the eastern section of B1.

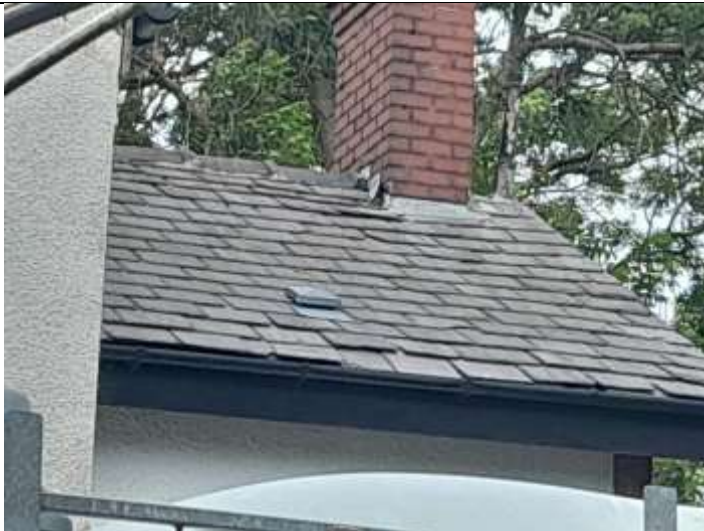
| | <p>Suitable bat roosting features identified:</p> <ul style="list-style-type: none"> <li>• There are several lifted tiles noted on all roof elevations on B1. These lifted tiles allow for suitable roosting features for crevice dwelling bats.</li> <li>• There are several sections of missing mortar below the ridge line on the western and eastern elevations of B2. These allow suitable crevices for roosting bats.</li> <li>• There are damaged sections of wooden bargeboard on the eastern and southern roof structure of B1. These damaged sections allow access below the tiles for roosting bats. the remainder of the wooden boards have gaps beneath the wood and the walls that also allow roosting features for small numbers of bats.</li> <li>• There is damaged section of mortar on the eastern elevation of the building that allow crevices suitable for roosting bats.</li> </ul> <p><u>Bats Roosting B2 (internal)</u></p> <p>There is one loft within B2, accessible via a loft hatch. The floor is unboarded with no safe access available, and therefore the loft was assessed from the hatch. The loft has bitumen felt lining present, with wooden timber beams and a large presence of mineral wool insulation.</p> <p>No bat evidence such as droppings or staining was observed.</p> <p>Suitable bat roosting features observed:</p> <ul style="list-style-type: none"> <li>• Sections of damaged lining allow internal access for bats.</li> <li>• There are areas of sunlight observed entering the loft near to the eaves of the eastern elevation.</li> <li>• The interior was assessed to be 18°C and 72% humidity.</li> </ul> <p>B2 has <b>high</b> value for roosting bats.</p> |

Figure 17 – the lifted tiles on the eastern roof of B2.

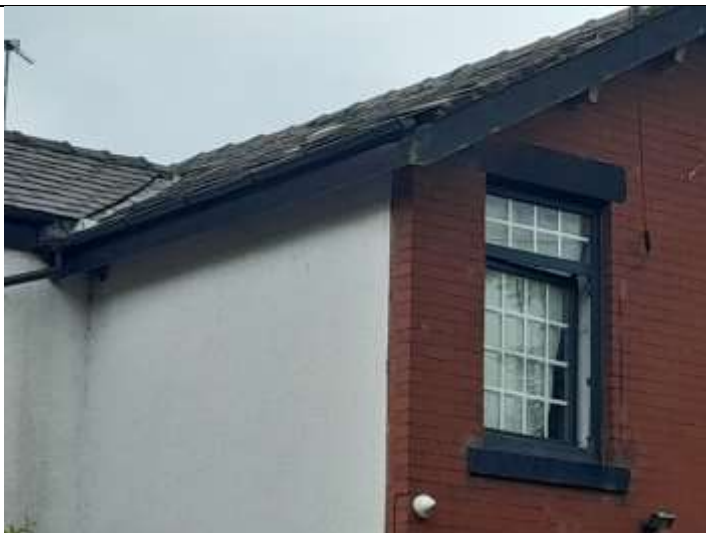
Figure 18 the damaged mortar on the eastern roof structure of B2.
