**Arboricultural Impact Assessment  
54 Norden Road  
Rochdale**

Report Reference: AIA-1548-1  
2 July 2022

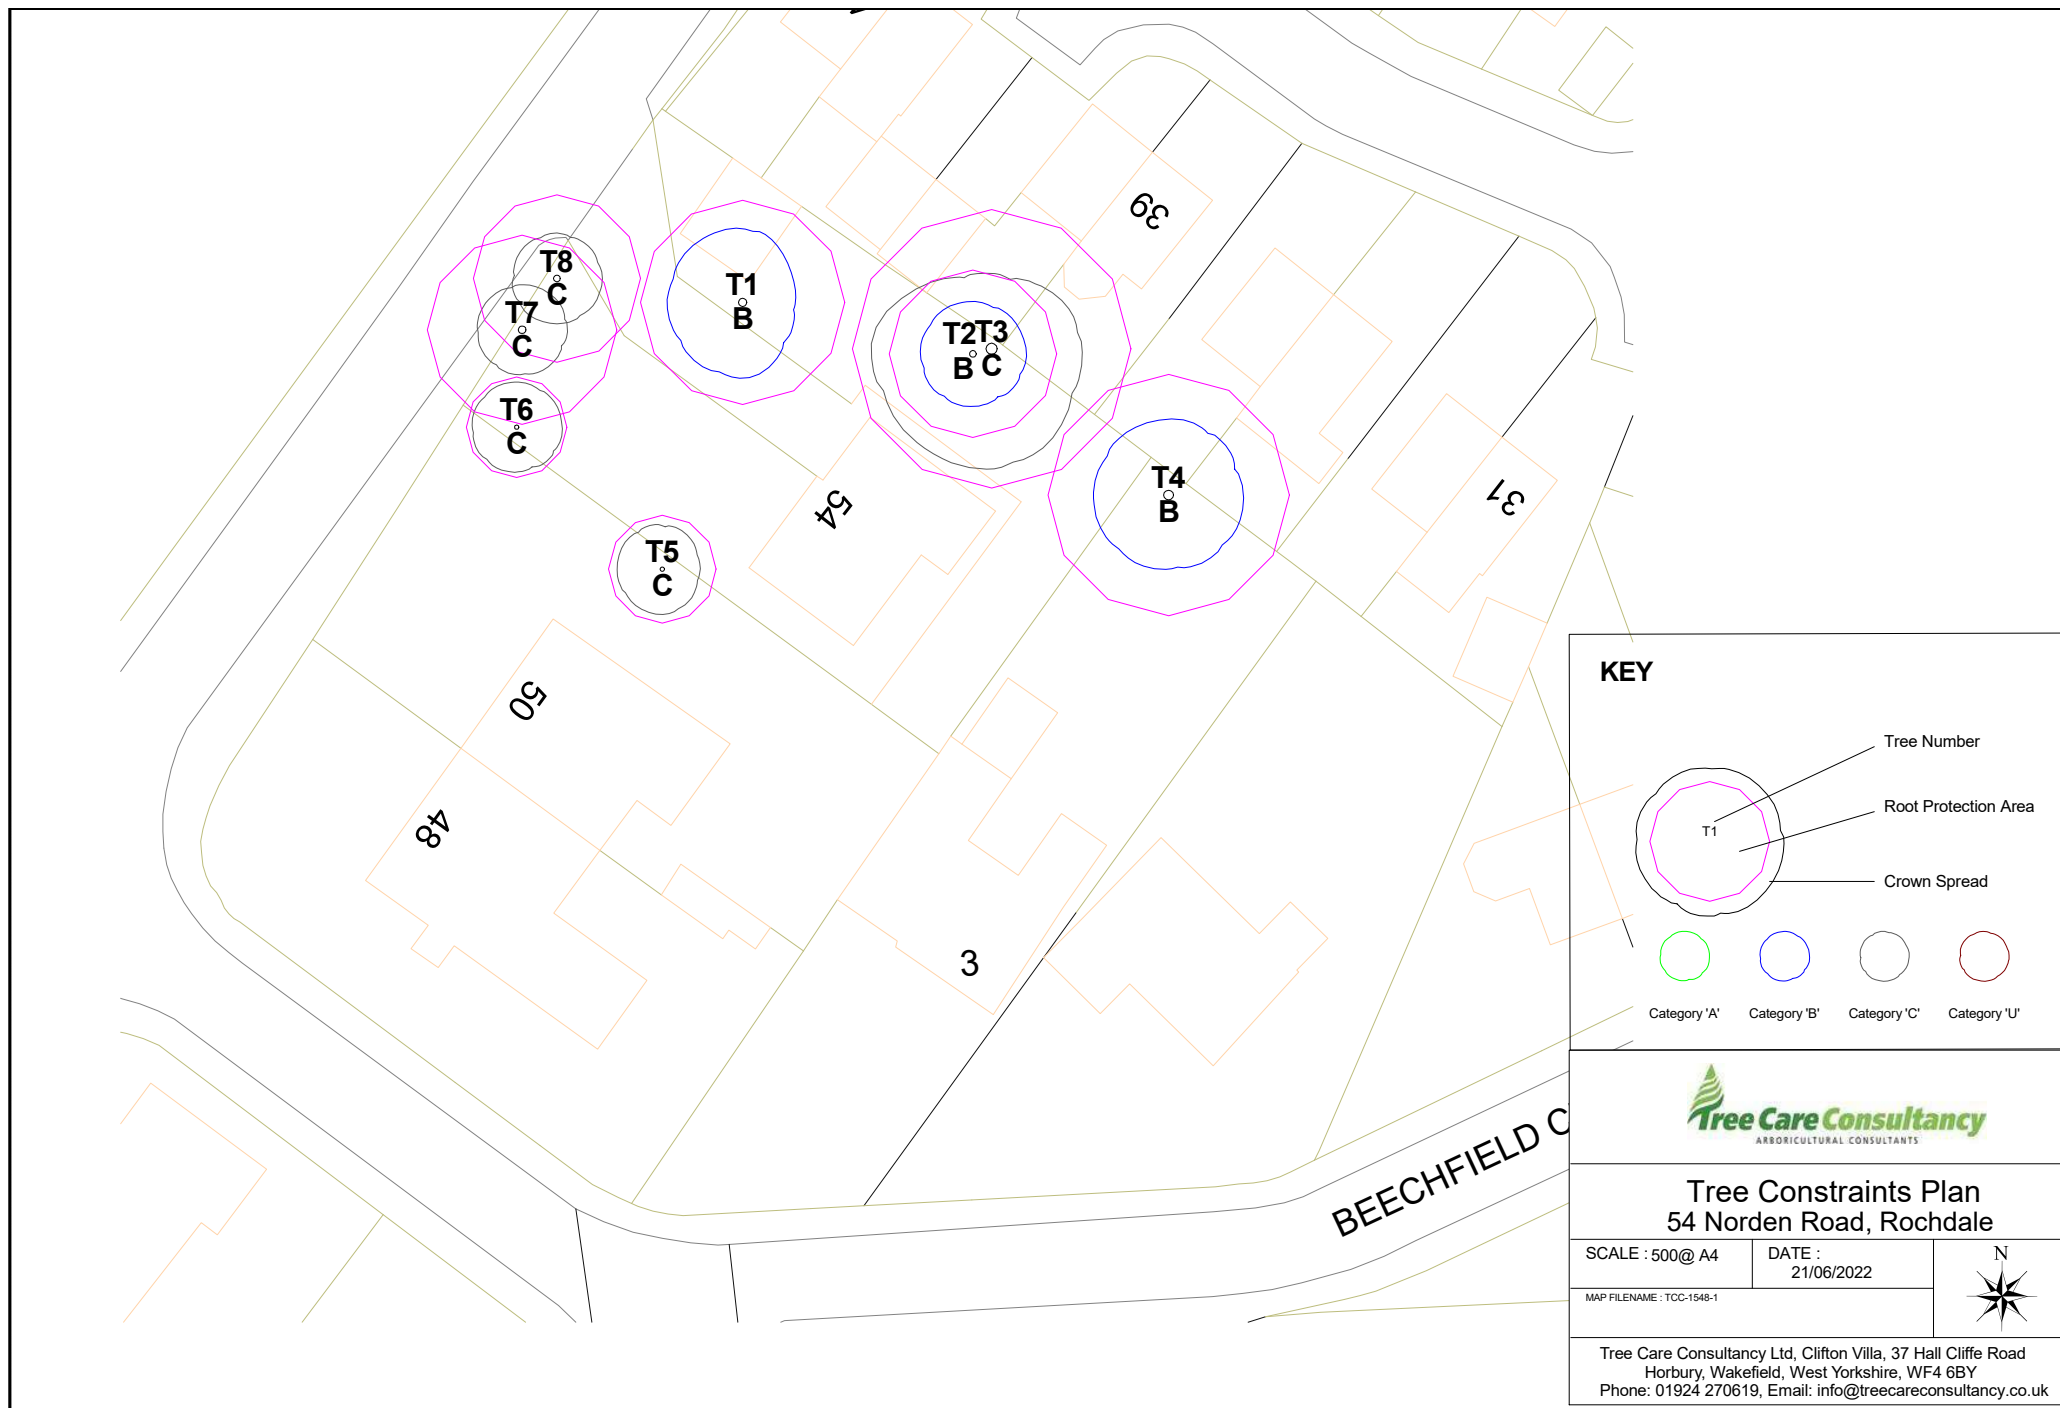
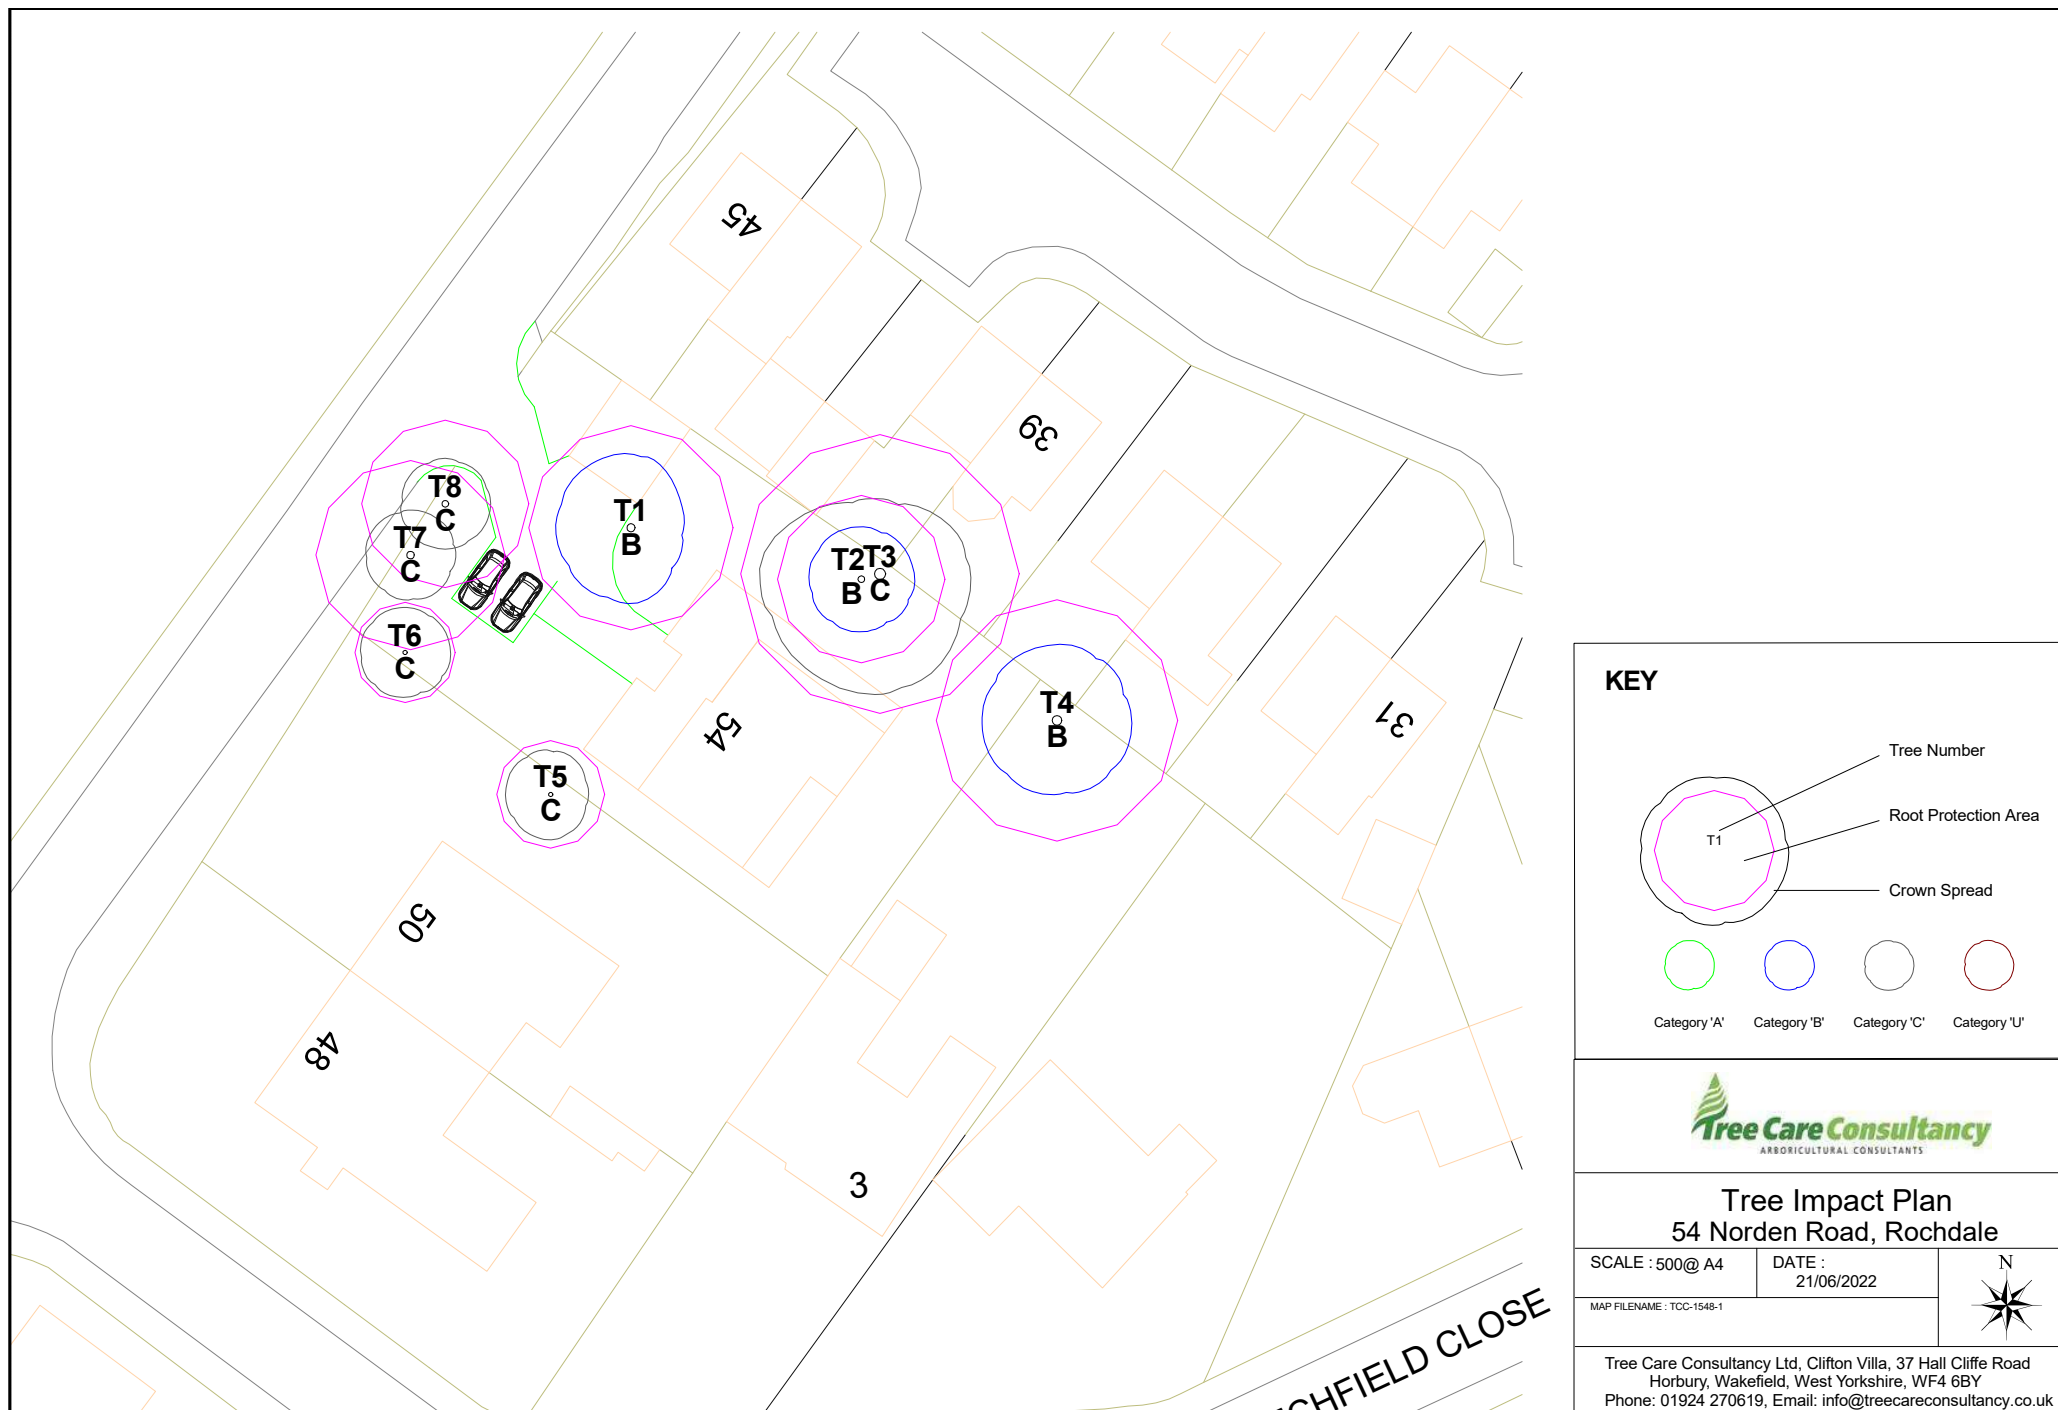
## Tree Impact Plan 54 Norden Road, Rochdale

- 3.4.3 As previously mentioned, the proposal would have encroached upon the RPA of a low-quality Ash tree, T3. However this tree is recommended for removal on arboricultural management grounds irrespective of the proposed development and as such should not control development.

- 3.4.4 It will be noted the footprint of the proposed extension will theoretically require a minor incursion within or stand close to the RPA's of retained moderate category "B" trees T1 and T2. Additionally 2No. parking spaces will encroach within the RPA's of low quality category "C" Cypress trees T7 and T8.

- 3.4.5 Dealing firstly with Sycamore T1 the degree of encroachment will be approximately 1%, a proportion of which is already overlaid by hard surfacing where rooting volume is likely to be much reduced. As such construction of the extension foundations is unlikely to cause any demonstrable harm to the health and longer term viability of this tree.

- 3.4.1 Turning to the Lime T2 the degree of encroachment will be approximately 0.5%. Taking account of the strong growing condition of the specimen (and the markedly improved growing conditions this tree will derive from the removal of Ash T3) the tree will readily overcome any minor impacts associated with construction activities close to its RPA provided appropriate tree protection measures are adopted within an Arboricultural Method Statement controlled by planning condition. As such construction of the extension foundations is unlikely to cause any demonstrable harm to the health and longer term viability of this tree.

- 3.4.1 1no. car parking space is proposed within the RPA of 2No. low quality category "C" Cypress trees T7 and T8. In order to limit disturbance to the rooting volume of these retained trees the incorporation of a "minimal dig methodology geogrid system" will provide scope to sustain both trees. It is presumed this is a matter the Local Planning Authority would be agreeable to conditioning as part of a detailed planning permission.

- 3.5.1 Crown lifting of T1 is required to allow for unhindered vehicular movement within the site during the period of construction. A crown lift of 4m will provide the desired clearance.
- 3.5.2 The off-site Maple T5 is beginning to encroach upon the existing building and will need drawing back to facilitate scaffolding access in order to construct the extension. Drawing back of the crown by approximately 1.5m will provide adequate clearance.
- 3.5.3 With the exception of the off-site Maple T5 which will require periodic pruning to abate a nuisance retained trees can be expected to grow to their overall dimensions subject to routine crown lifting and cleaning maintenance. Such pruning works would be carried out in accordance with BS3998:2010 recommendations for tree work.
