# Contaminated Land Phase One Desk Study for proposed residential development on land at Gate Street, Rochdale, OL11 1PN.

Prepared for

James Campbell Associates Ltd,  
Campbell House,  
173 Rochdale Road,  
Firgrove,  
Rochdale,  
OL16 3BN.

October 2023

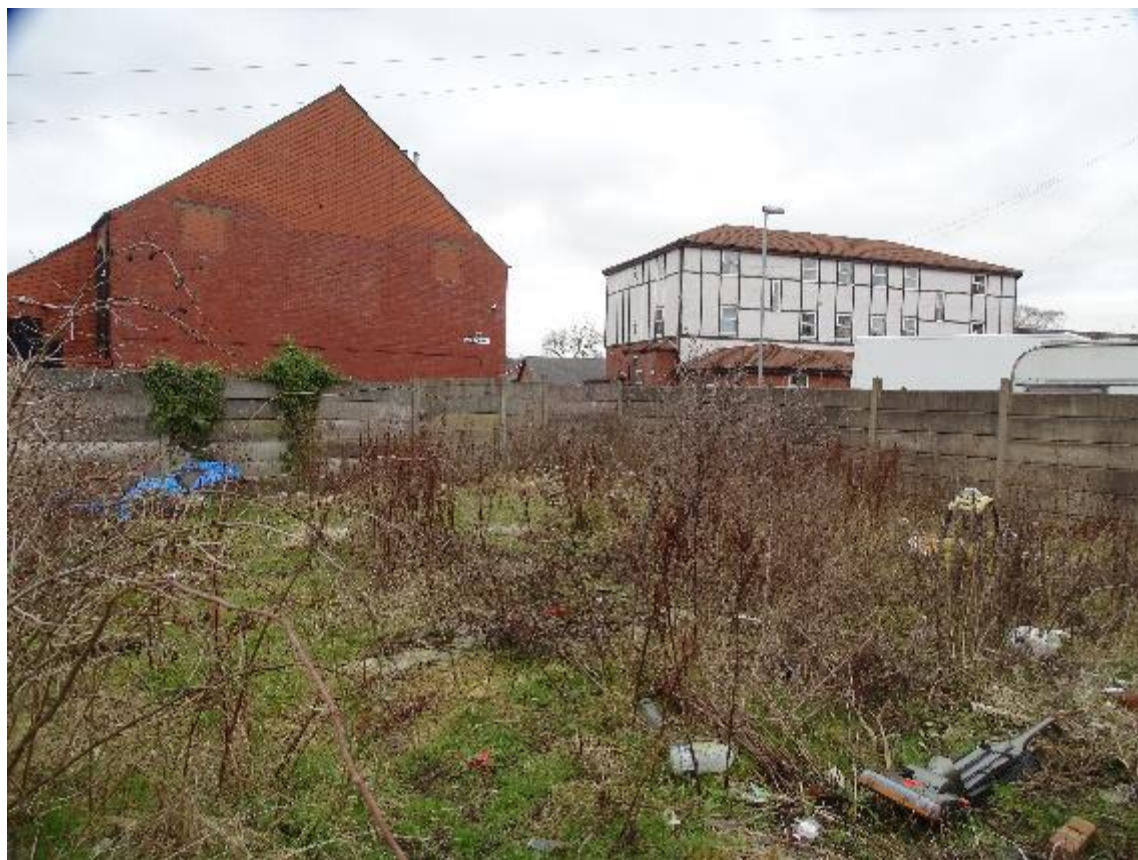
Southwest to north east across the site

The site is overgrown across its entirety. There is some evidence of the former building still on site with some rubble in places. In addition, some rubbish/litter and waste wood were seen across the site.
