# Heywood Stores Manchester Road

Bat Roost Tree Survey  
October 2022

# Site Inspection Report

**Site Inspection reference** SI-6197-02

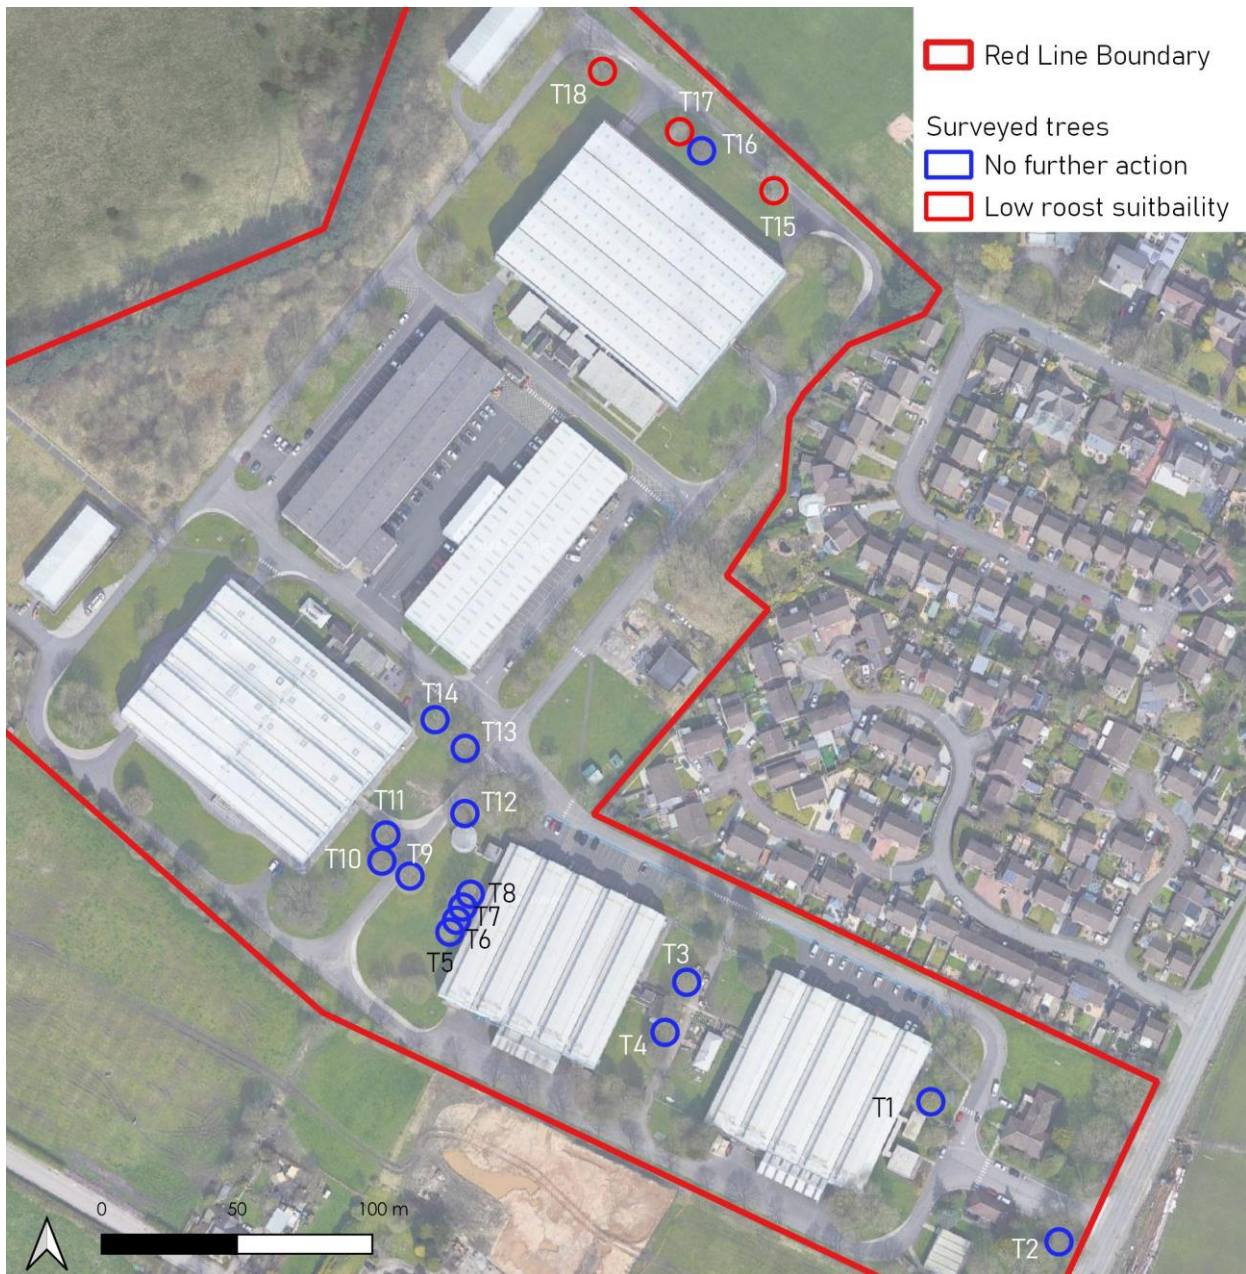
**Figure 1** Plan showing tree labels and 3 trees assessed as offering features of low suitability

Three trees have been assessed as offering features of low bat roost suitability. Inspection of trees with features of low suitability has shown no evidence of use by roosting bats, however bats display very low fidelity to tree roost features and as such further precaution should be taken with these trees at the time of tree works.

The three trees assessed as offering features of low bat roost suitability should be dismantled or pruned in sections, slowly lowered and left in situ on the ground for a period of 24 hours before being removed from Site.
