**Angela Graham Bat Consultancy Service Limited**

**Second dusk emergence survey of  
house and attached barn,  
Langley Lane Farm,  
Langley Lane,  
Middleton,  
M24 5LJ**

**Survey Date: 24/7/24**

**Report Date: 14/8/24**

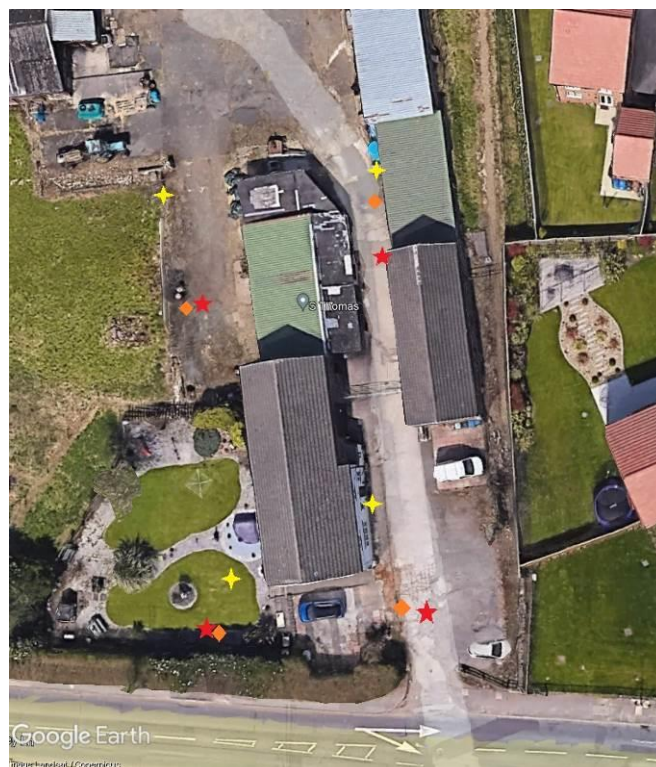
Fig. 1.

At the time of the survey there was continuous bright lighting in the hay-loft area of the barn immediately to the east, causing a degree of light-spill onto the buildings being surveyed.

While this is probably insufficient to deter bats from roosting in association with those buildings, it certainly would impact brown long-eared bats if they happened to be roosting in the illuminated building.

Change the timing of the security lighting in the hay-loft of the barn to the east to come on no earlier than 11pm and go off by 3 pending an internal inspection of the building to confirm there is no evidence of roosting by the brown long-eared bat. The exterior should also have a preliminary survey. Do nothing else with respect to the barn until it has been inspected.

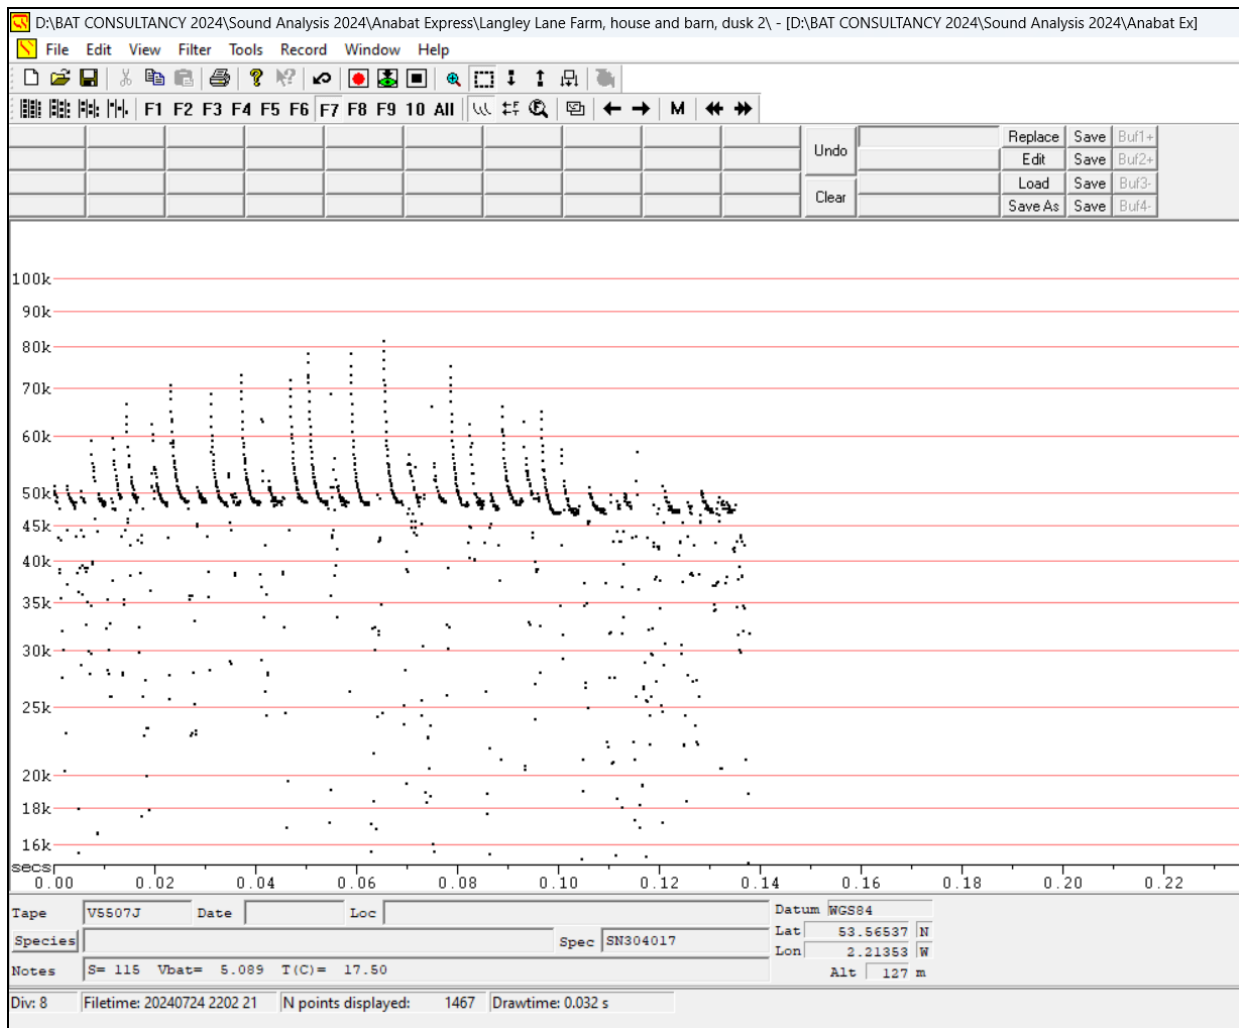
Two common pipistrelles at 22.02
