# DALE STREET, MILNROW

## Preliminary Bat Roost Assessment Report

*February 2024*

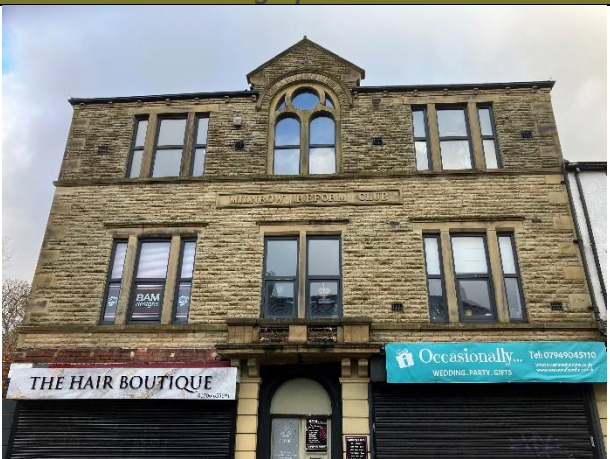
3.2.6. A crevice was located above a window on the southern aspect, created between lintel and external wall and appears to lead updates (see PRF4).

- 3.2.7. Numerous small grates were present on the southern aspect but was considered unsuitable for bat access due to the size of the entrance points.

| Feature | Photograph |
|---|---|
| Southern aspect of the building | |

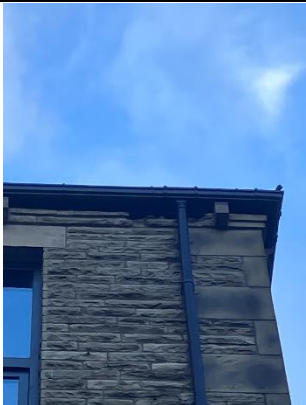
| <p><i>PRF1</i></p> | |

3.2.3. Multiple points of missing sections of stones at the top of the building were identified and it is not possible to confirm whether these points will provide internal access or a PRF. See PRF1 on the map for locations.

- 4.1.1. If the external PRFs identified during the survey are to be impacted by the proposed development, further surveys are recommended:
- 4.1.2. The building was found to provide bat roosting potential and therefore, in accordance with Best Practice guidance (Collins, 2023) further nocturnal/ re-entry surveys should be undertaken between May-September (inclusive) to determine usage by roosting bats. It was assessed as moderate bat roosting potential; therefore, a minimum of two further surveys are recommended, with at least one survey completed between May-August.

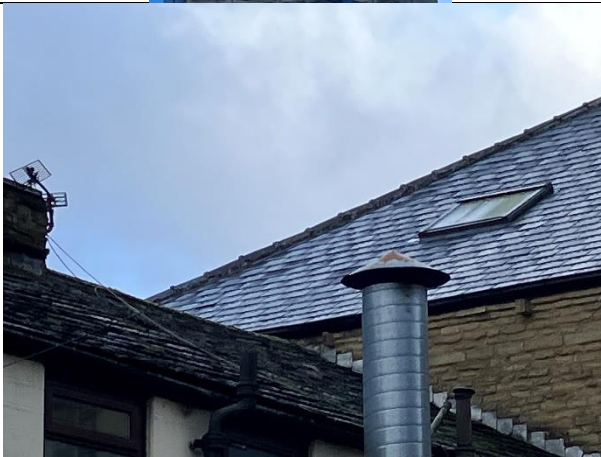
| <p><i>PRF2</i></p> | |

3.2.4. The roof is pitched comprising of slate tiles, with eight skylights situated on the eastern and western aspect which were fully flush to the tiles. Generally, the roof appeared to be in good condition, where it was possible to inspect. It is possible some defaults in the roof structure were present on the southern aspect. One lifted slate tile was identified on the eastern aspect (see PRF2).

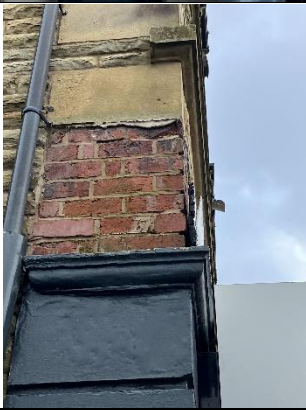
| <p><i>PRF3</i></p> | |

3.2.5. Additional PRFs was present in relation to the wooden fascia boarding, where gaps were observed between the board and brickwork which may provide suitable crevice for roosting bats. PRF3 relates to a crevice situated between a small wooden panel which was located under plasterboard to the south.

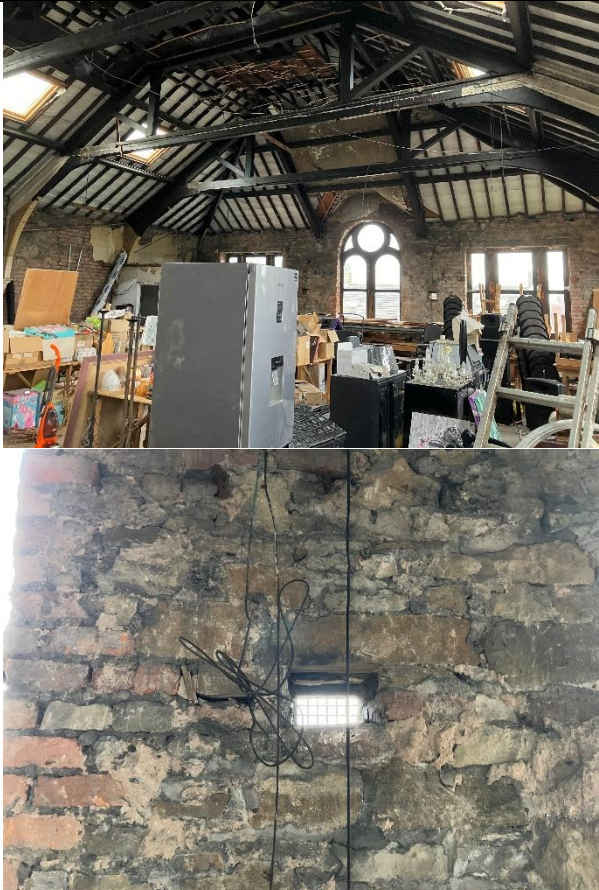
- 3.2.9. The third floor comprised one room with the exposed roof structure, with no loft present. The roofing felt comprised a breathable membrane and was in good condition. The room was natural well-lit. The brick work within the large room comprised bare red brick walls which were in average condition, though some crevices within the brick work was observed which may provide suitable conditions for roosting bats. In addition, some holes were identified that may lead to a cavity but was not possible to inspect. Suitable crevices were also present within the wooden joists of the main timber frames.

| <p><i>Internal of the upper floor.</i></p> | |

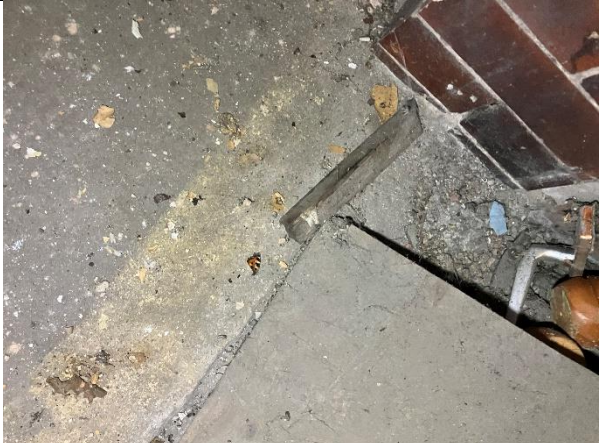
- 3.2.10. Butterfly parts were located on the southern aspect of the room, mainly concentrated on the south western corner. However, no bat droppings were identified across the room, but two rodent droppings recorded.

| <p><i>Butterfly wings</i></p> | |

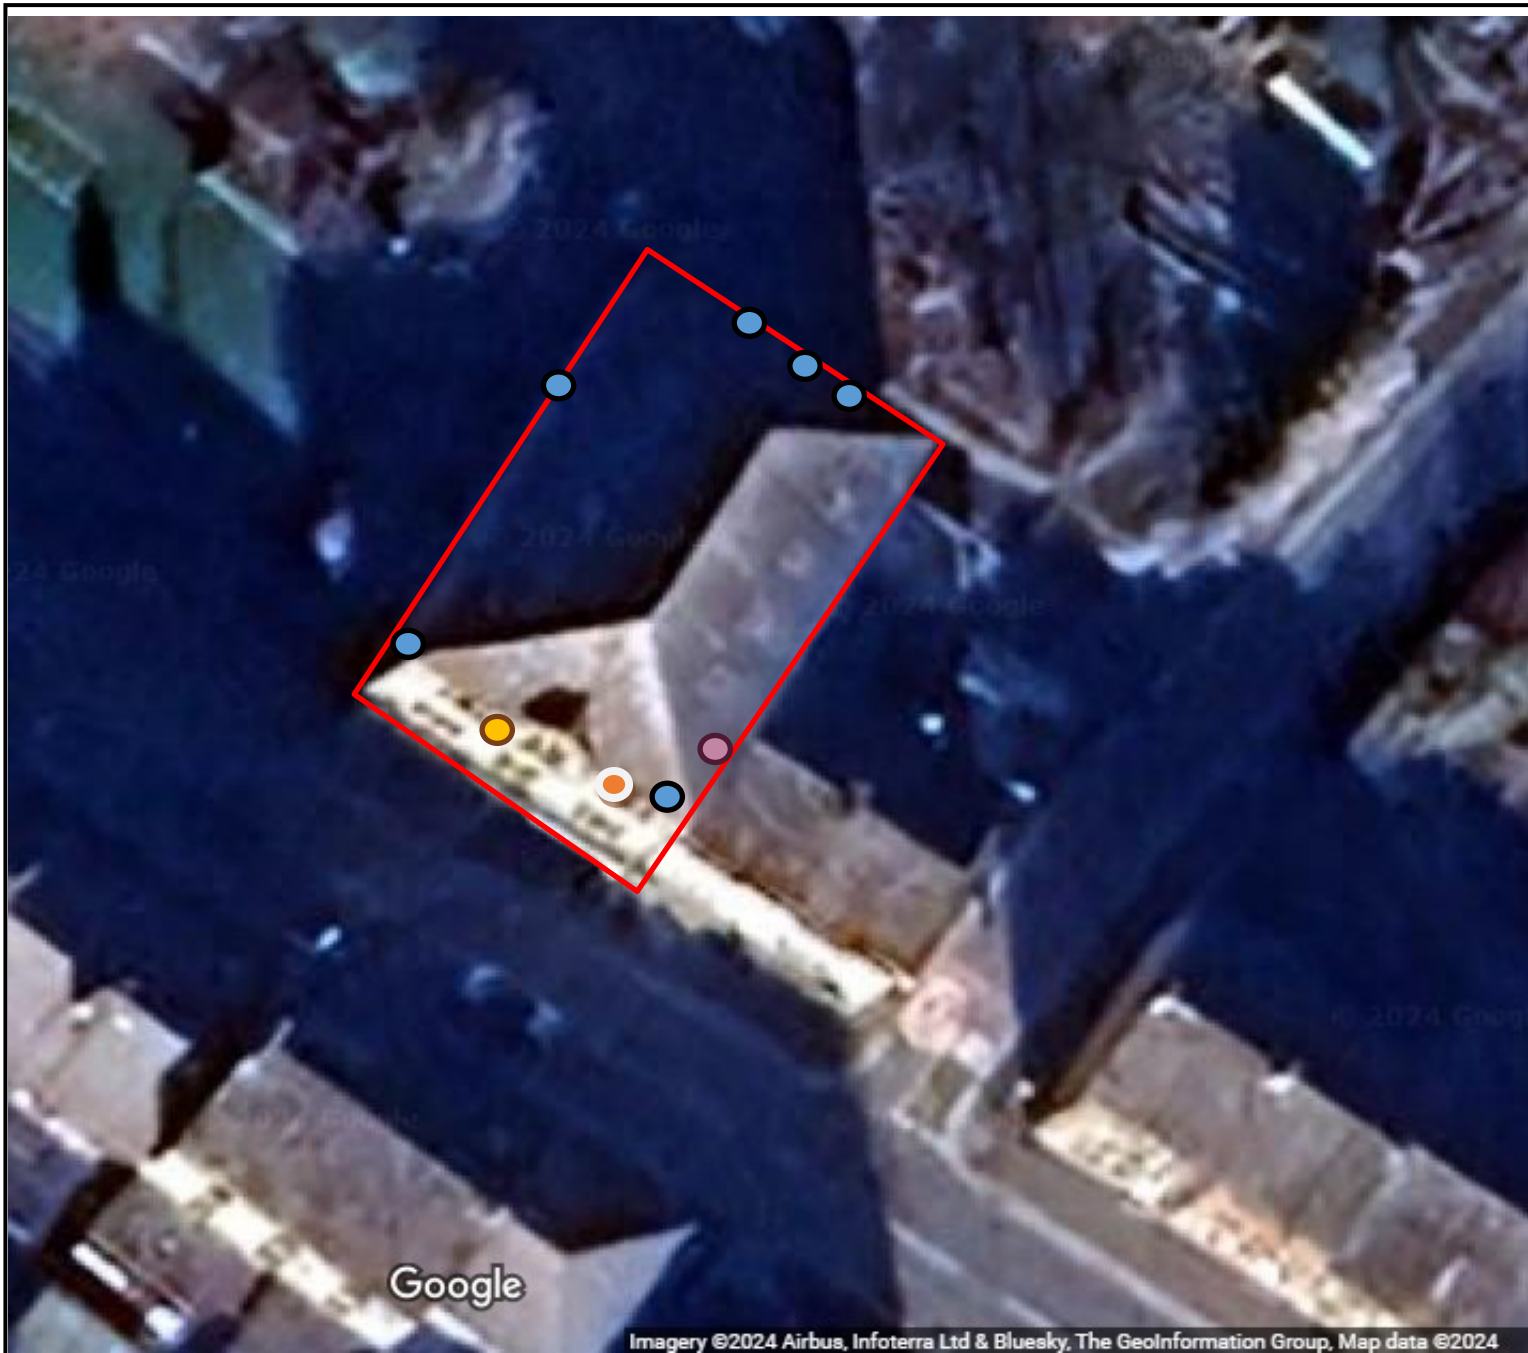
Potential Roosting Feature Map

PF1—Missing parts of bricks
-

PRF2—Lifted tile
-

PRF3 - Wooden panel feature
-

PRF4—Crevice in lintel and external wall
