## Heritage Statement

8-9 Paul Row,  
Temple Lane,  
Littleborough,  
OL15 9QG.

## Descriptive Survey

Site Address: 8 Paul Row, Rochdale, OL15 9QG.

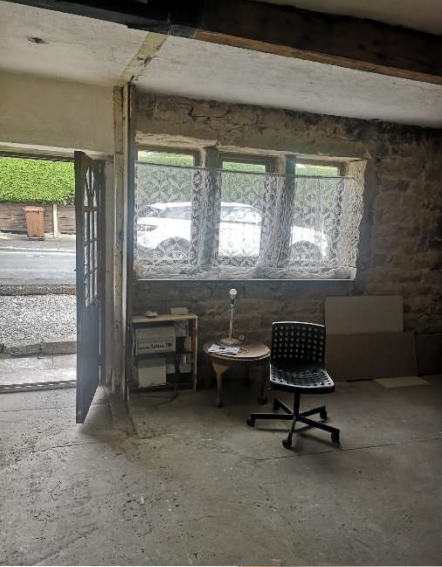
| Photo | Description | Proposed Changes | Effect of the Proposal |
|---|---|---|---|
| | Image 1A; This image illustrates the existing front elevation timber windows, existing timber door and the existing stone faced wall. The windows are estimated to be from the 19th Century and original to the dwelling. The timber doors is estimated to be from the early 21st century. The stone faced wall is estimated to be from the early 19th century and to be original to the dwelling. The image also illustrates the existing ceiling finishes and softwood beams, these are estimated to be from the early 19th century and are expected to be original to the dwelling. | There are to be no changes to the existing timber windows and the existing stone faced wall. The timber door is to be removed and is to be replaced with a door following the same uniform design as 1-7 Paul Row. | Removing the existing timber door which is out of character with the rest of Paul Row will re-instate a previously lost historic feature. It will also compliment the rest of the Row in restoring the cottage to its original appearance as well as maintaining the character of the row |

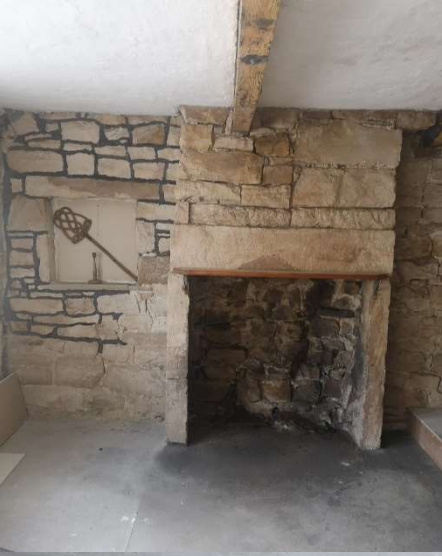
| Photo | Description | Proposed Changes | Effect of the Proposal |
|---|---|---|---|
| | Image 2A; This image illustrates the existing stone faced wall and the existing internal fire place. Both the existing wall and fire place are estimated to be from the early 19th century and be original to the dwelling. The image also illustrates the existing ceiling finishes and softwood beams, these are estimated to be from the early 19th century and are expected to be original to the dwelling. | There are to be no changes to either the existing wall or fireplace. | With maintain the original exposed fireplace and stone faced wall this will closely resemble the original appearance of the dwelling. |

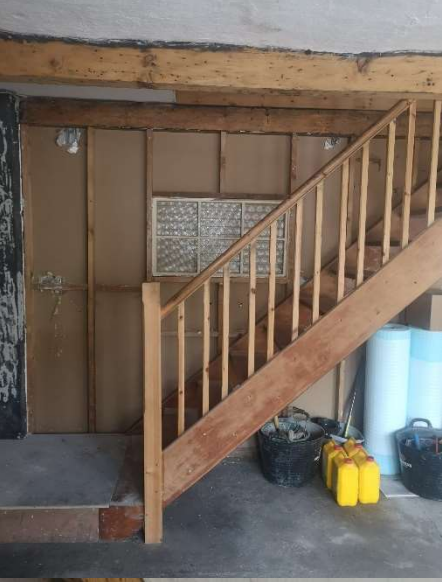
| Photo | Description | Proposed Changes | Effect of the Proposal |
|---|---|---|---|
| | Image 3A; This image illustrates the existing MDF staircase that is estimated to be from the late 20th century, and the separating wall between the lounge and the kitchen, the exposed stud wall is estimated to be from the late 20th century. The stud wall previously had a plasterboard and skim finish, however this was removed as it was compromised. The image also illustrates the back of the wall finishes of image 1B. The image also illustrates the existing ceiling finishes and softwood beams, these are estimated to be from the early 19th century and are expected to be original to the dwelling. | The existing stair case is to be maintained. The stud wall is to be maintained and to re-instate the previously removed plaster board and skim finish. | The effects of re-instating the plasterboard finish would be minimal as there is to be no damage of the existing material. |

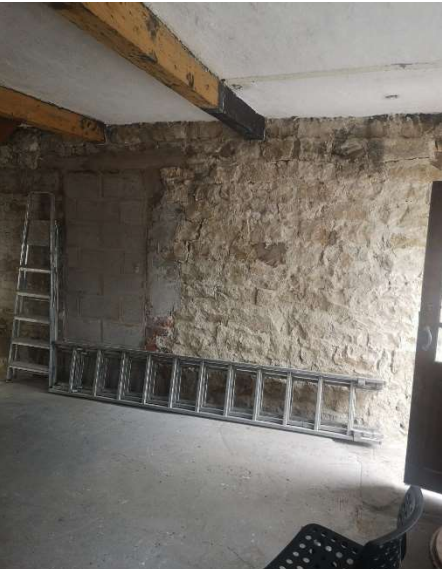
| | <p>Image 4A; This image illustrates the dividing wall between number 8 and 9 Paul Row. The wall is predominantly stone faced, with concrete blocks used in places. The stone faced wall is estimated to be from the 19th century, and is expected to be original to the dwelling. The blockwork is estimated to be from the early 21st century. The image also illustrates the existing ceiling finishes and softwood beams, these are estimated to be from the early 19th century and are expected to be original to the dwelling.</p> | <p>The existing block and stone faced wall are to be re-plastered using wash sand and cement and plaster. The existing beams and ceiling finishes are to be maintained.</p> | <p>The effect of plastering over the stone faced wall will result in the loss of some historic fabric, however plastering over stone faced walls is seen else where in the dwelling so the proposal keeps in character with other aspects the dwelling, it is also seen as a necessity due to the miss match appearance of the stone and block.</p> |

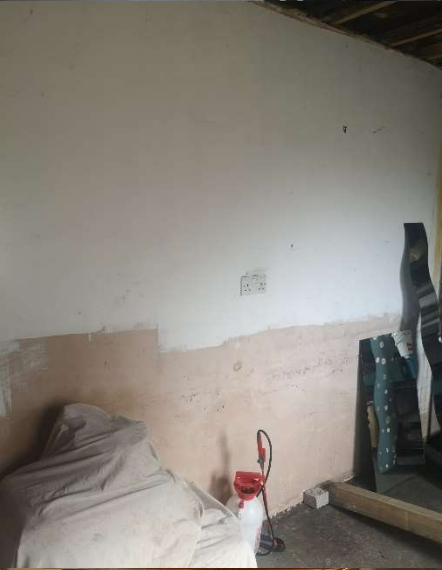
| | <p>Image 1B; This image illustrates the stud wall separating the kitchen and the lounge with a compromised plasterboard and skim finish. This is estimated to be from the late 20th century.</p> | <p>The stud wall is to be maintained however the plasterboard and skim finish is to be removed due to it being compromised. This is to be replaced with new plaster board and a new skim finish.</p> | <p>There is to be no effect on the dwelling as the materials that are being removed are to be replaced with the same material.</p> |

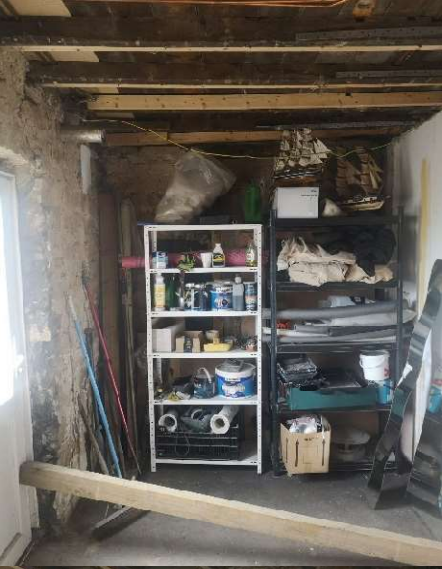
| | <p>Image 2B; This image illustrates the dividing wall between number 8 and 7 Paul Row. The wall is stone faced and is estimated to be from the early 19th century, it is also expected to be original to the dwelling. This image also illustrates the ceiling joists, these are soft wood. These are expected to be form the 20th century and not original to the dwelling.</p> | <p>There are to be no changes to the stone faced walls. The ceiling joists are to plaster boarded over and a new skim finish.</p> | <p>Plaster boarding over the ceiling joists will cause no damage to the existing beams.</p> |

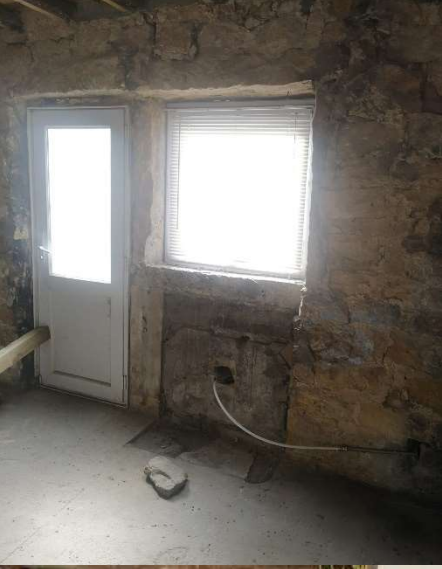
| | <p>Image 3B; This image illustrates the rear external wall, the wall is stone faced and is estimated to be from the early 19th century and is expected to be original to the dwelling. This image also illustrates a UPVC window, this is estimated to be from the late 20th century/early 21st century. This is not original to the dwelling house. This image also illustrates a UPVC door, this is estimated to be from the late 20th century/early 21st century. This is not original to the dwelling house.</p> | <p>The existing UPVC window is to be removed and replaced with a timber casement window side hung open/fixed. The existing UPVC door is to be remove and replaced with a timber external door. The stone faced wall are to be re-plastered using wash sand and cement and plaster.</p> | <p>Removing the existing UPVC door and window will restore the dwelling back to its original appearance.</p> |

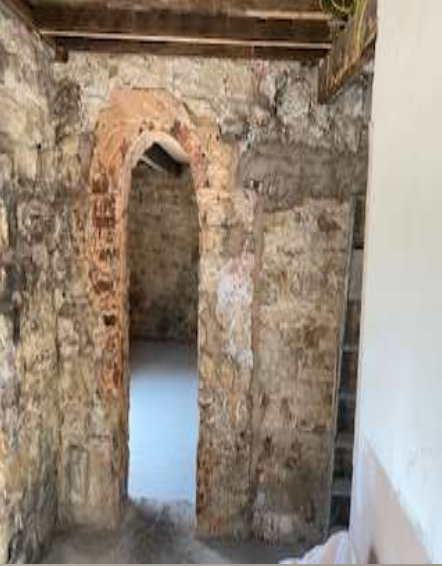
| | <p>Image 4B; This image illustrates the existing access to No.9 Paul Row from No.8 which is a brick constructed arch way that is estimated to be from the early 20th century when No.9 Paul Row was estimated to be constructed.</p> | <p>The arch way is to be blocked up to allow for the separation of the two dwellings. Concrete blocks will be used to close the archway. The existing stone faced wall is then to be re-plastered using wash sand and cement and plaster.</p> | <p>Some historic fabric wall be lost by removing the arch way, however this is not original to the dwelling house as No.9 Paul Row was constructed later than the rest of the row. The restoring of No.8 Paul Row back to a single dwelling will closely resemble the original layout of the dwelling.</p> |

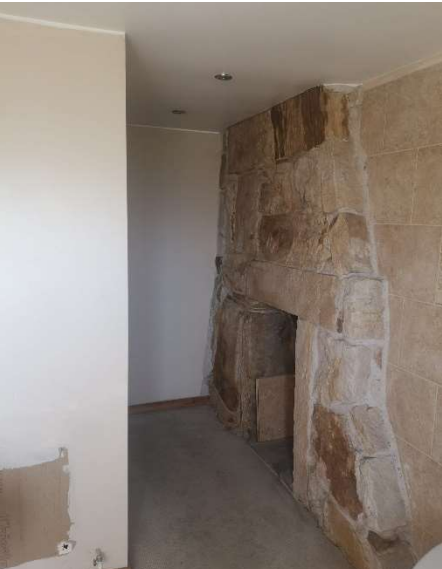
| | <p>Image 1C; This image illustrates the internal stone faced fireplace, this is estimated to be from the early 19th century and is expected to be original to the dwelling. This image also illustrates two stud walls with a plasterboard and skim finish, these are estimated to be from the late 20th century. This image also illustrates the dividing wall between No.8 and No.7 Paul Row, it has a ceramic tile finish that is expected to be from the early 21st century. This image also illustrates a plasterboard and skim finished ceiling, this is estimated to be from the late 20th century.</p> | <p>The stone faced fireplace, existing stud walls and their finishes and the existing tile finish are all to be maintained.</p> | <p>There will be no effect of maintaining the bathroom in its original condition.</p> |

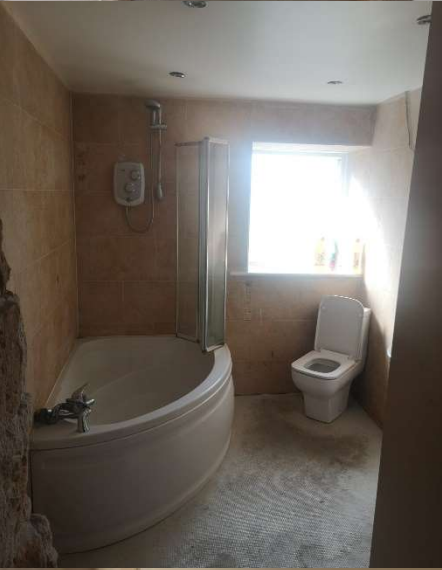
| | <p>Image 3C; This image illustrates a tiled wall finish, this is expected to be from the early 21st century. This image also illustrates the existing bathroom suite that is estimated to be from the early 21st century. This image also illustrates a plasterboard and skim finished ceiling, this is estimated to be from the late 20th century.</p> | <p>The bathroom suite, the plasterboard ceiling finish and the tiled finish are all to be maintained.</p> | <p>There will be no effect of maintaining the bathroom in its original condition.</p> |

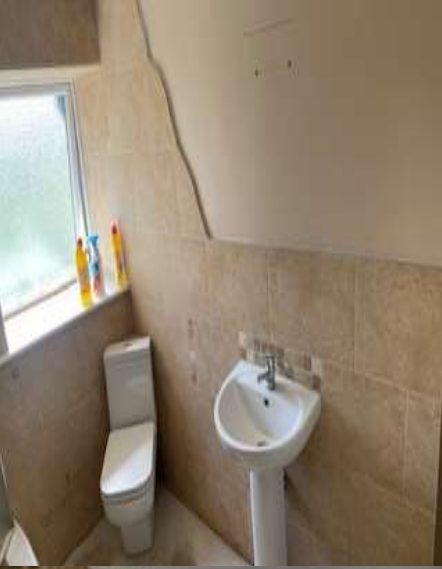
| | <p>Image 4C; This image illustrates a tiled wall finish, this is expected to be from the early 21st century. This image also illustrates the existing bathroom suite that is estimated to be from the early 21st century. This image also illustrates the existing UPVC window, this is estimated to be from the late 20th century/early 21st century.</p> | <p>The bathroom suite and the tiled finish are all to be maintained. The existing UPVC window is to be removed and replaced by a timber box sash window.</p> | <p>Removing the existing UPVC window will restore the dwelling back to its original appearance.</p> |

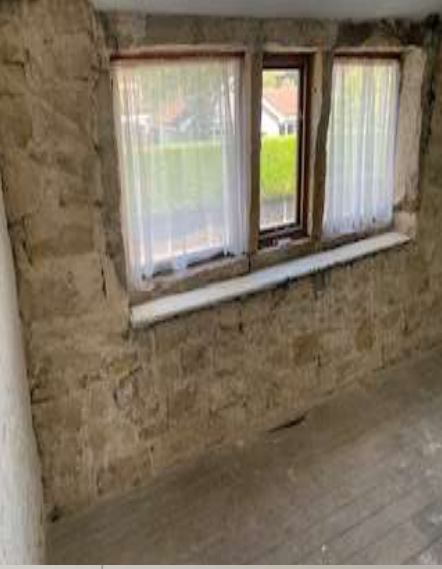
| | <p>Image 1D; This image illustrates the existing front elevation timber windows and the existing stone faced wall. The windows are estimated to be from the 19th Century and original to the dwelling. The stone faced wall is estimated to be from the early 19th century and to be original to the dwelling.</p> | <p>The timber windows and exposed stone face wall are to be maintained.</p> | <p>There will be no effect of maintaining the timber windows and exposed stone walls in there current condition.</p> |

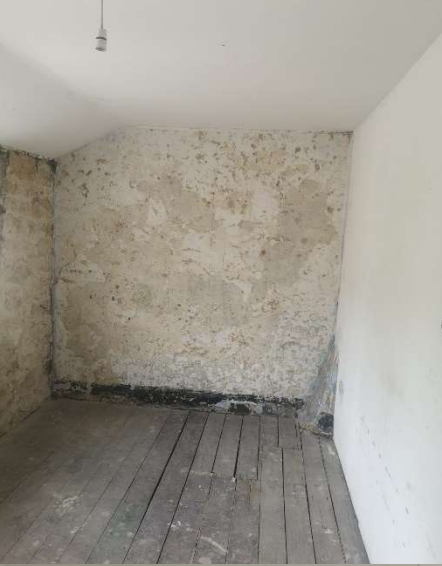
| | <p>Image 2D; This image illustrates the dividing wall between No.8 and No.7 Paul Row, this wall has a expected sand and cement plastered finish, this is estimated to be from the 20th century.</p> | <p>The sand and cement wall finishes are to be maintained.</p> | <p>There will be no effect of maintaining the wall finishes in there current condition.</p> |

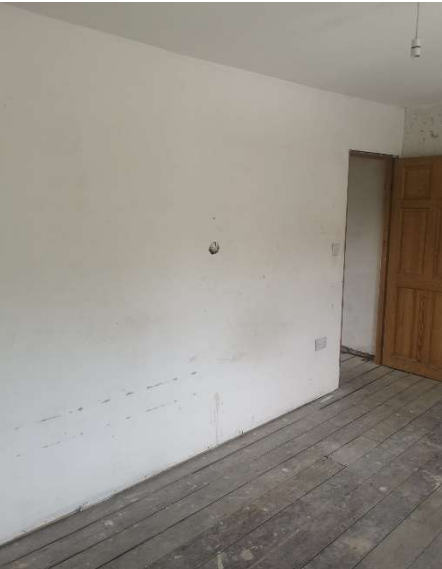
| | Image 3D; This image illustrates the internal stud wall separating the front bedroom from the landing, the wall has a plasterboard and skim finish and is estimated to be from the late 20th century. | The existing plasterboard wall finishes are to be maintained. | There will be no effect of maintaining the wall finishes in there current condition. |

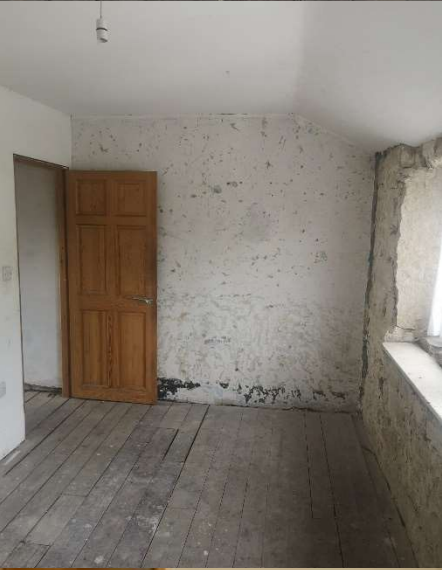
| | Image 4D; This image illustrates the dividing wall between No.8 and No.9 Paul Row, this wall has a expected sand and cement plastered finish, this is estimated to be from the 20th century. | The sand and cement wall finishes are to be maintained. | There will be no effect of maintaining the wall finishes in there current condition. |

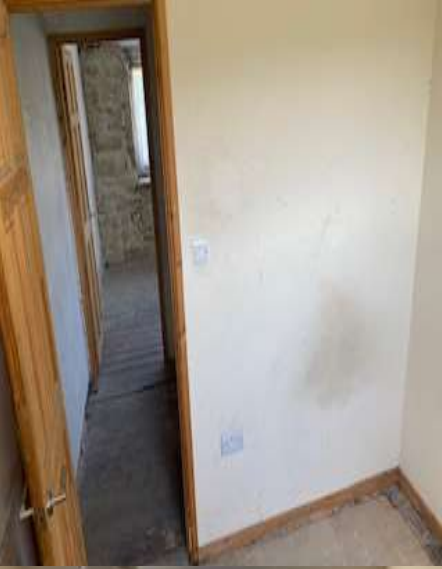
| | Image 1E; This image illustrates the internal stud wall separating the rear bedroom from the landing, the wall has a plasterboard and skim finish and is estimated to be from the late 20th century. | The existing plasterboard wall finishes are to be maintained. | There will be no effect of maintaining the wall finishes in there current condition. |

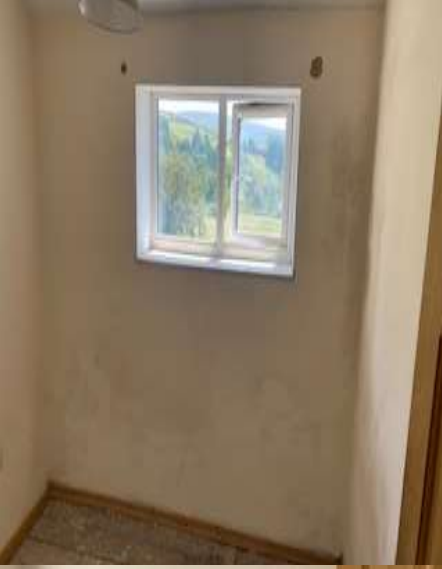
| | Image 3E; This image illustrates the rear external wall, this wall has a expected sand and cement plastered finish, this is estimated to be from the 20th century. | The sand and cement wall finishes are to be maintained. | There will be no effect of maintaining the wall finishes in there current condition. |

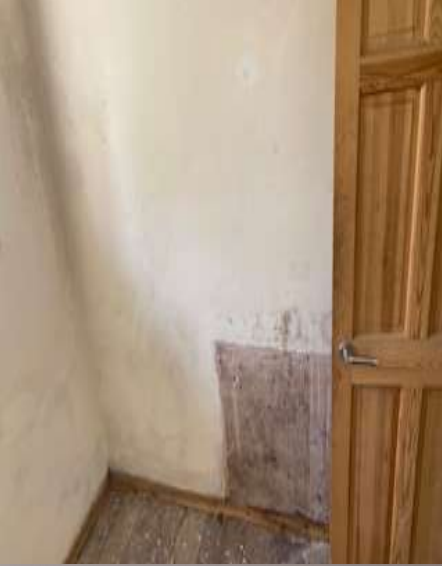
| | Image 4E; This image illustrates the dividing wall between No.8 and No.9 Paul Row, this wall has a expected sand and cement plastered finish, this is estimated to be from the 20th century. | The sand and cement wall finishes are to be maintained. | There will be no effect of maintaining the wall finishes in there current condition. |

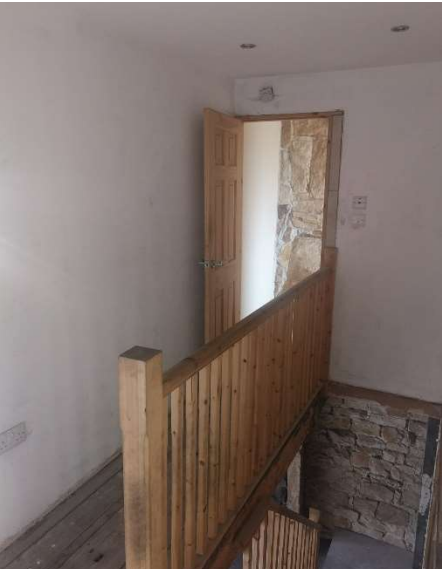
| | <p>Image 2F; This image illustrates the existing MDF staircase that is estimated to be from the late 20th century. This image also illustrates the existing stud walls separating the bathroom from the landing and the front bedroom from the landing, these walls both have a plasterboard and skim finish. These walls are estimated to be from the late 20th century.</p> | <p>The existing plasterboard wall finishes and the existing staircase are to be maintained.</p> | <p>There will be no effect of maintaining the wall finishes and stair cases in their current condition.</p> |

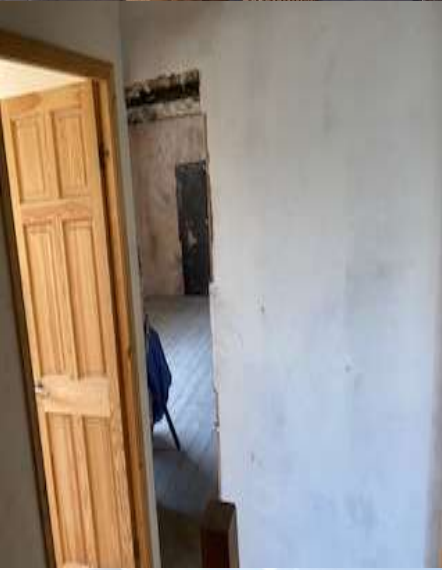
| | <p>Image 4F; This image illustrates the dividing wall between No.8 and No.9 Paul Row, this wall has an expected sand and cement plastered finish, this is estimated to be from the 20th century. There is also a narrow walkway allowing access to the first floor of No.9 Paul Row.</p> | <p>The existing sand and cement wall finish is to be maintained. The walkway is to be blocked up to allow for the separation of the two dwellings. Concrete blocks will be used to close the walkway. We will then continue the existing sand and cement plaster over the proposed blockwork.</p> | <p>Some historic fabric wall will be lost by removing the walkway, however this is not original to the dwelling house as No.9 Paul Row was constructed later than the rest of the row. The restoring of No.8 Paul Row back to a single dwelling will closely resemble the original layout of the dwelling.</p> |

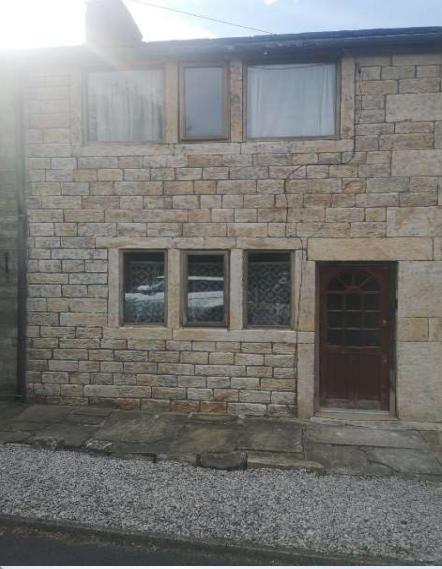
| | <p>This image illustrates the front elevation of the dwelling. The construction of the dwelling is using hammer dressed watershot stone with a graduated stone slate roof. The wall and roof construction are estimated to be from the early 19th Century. They are also expected to be original to the dwelling. This image also illustrates the external door with a square cut surround, this external door is timber and is estimated to be from the early 21st century. This image also illustrates the ground floor 3 light flat faced mullion window on the ground floor. This window is of timber construction and is estimated to be from the early 19th century and is expected to be original to the dwelling. This image also illustrates the 3 light flat faced mullion window on the first floor. This window is of timber construction and is estimated to be from the early 19th century and is expected to be original to the dwelling.</p> | <p>The existing windows, walls and mullions are all to be maintained. The only change to this elevation is to remove and replace the timber door with a timber door following the same uniform design as 1-7 Paul Row.</p> | <p>There will be no effect of maintaining the existing windows, walls and mullions in their current condition. Removing the existing timber door which is out of character with the rest of Paul Row will re-instate a previously lost historic feature. It will also complement the rest of the Row in restoring the cottage to its original appearance as well as maintaining the character of the row.</p> |

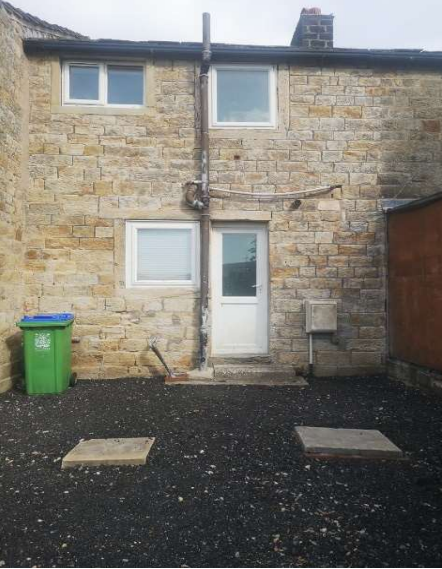
| | <p>This image illustrates the rear elevation of the dwelling. The construction of the dwelling is using hammer dressed watershot stone with a graduated stone slate roof. The wall and roof construction are estimated to be from the early 19th Century. They are also expected to be original to the dwelling. This image also illustrates the external UPVC door and is estimated to be from the late 20th century/early 21st century. This image also illustrates three UPVC windows, one on the ground floor and two on the first floor. These windows estimated to be from the late 20th century/early 21st century. These are not original to the dwelling house.</p> | <p>The existing walls and mullions are all to be maintained. The existing UPVC windows are to be removed and replaced with timber casement windows side hung open/fixed. The existing UPVC door is to be removed and replaced with a timber external door.</p> | <p>There will be no effect of maintaining the existing walls and mullions in their current condition. Removing the existing UPVC door and windows will restore the dwelling back to its original appearance.</p> |
