Our Ref  
422-CA-DAHIS-01-b

Date  
15/10/2024

**Re: Design, Access and Heritage Impact Statement – 190, 191 and 192 Dewhirst Road (collectively, the “Site”)**

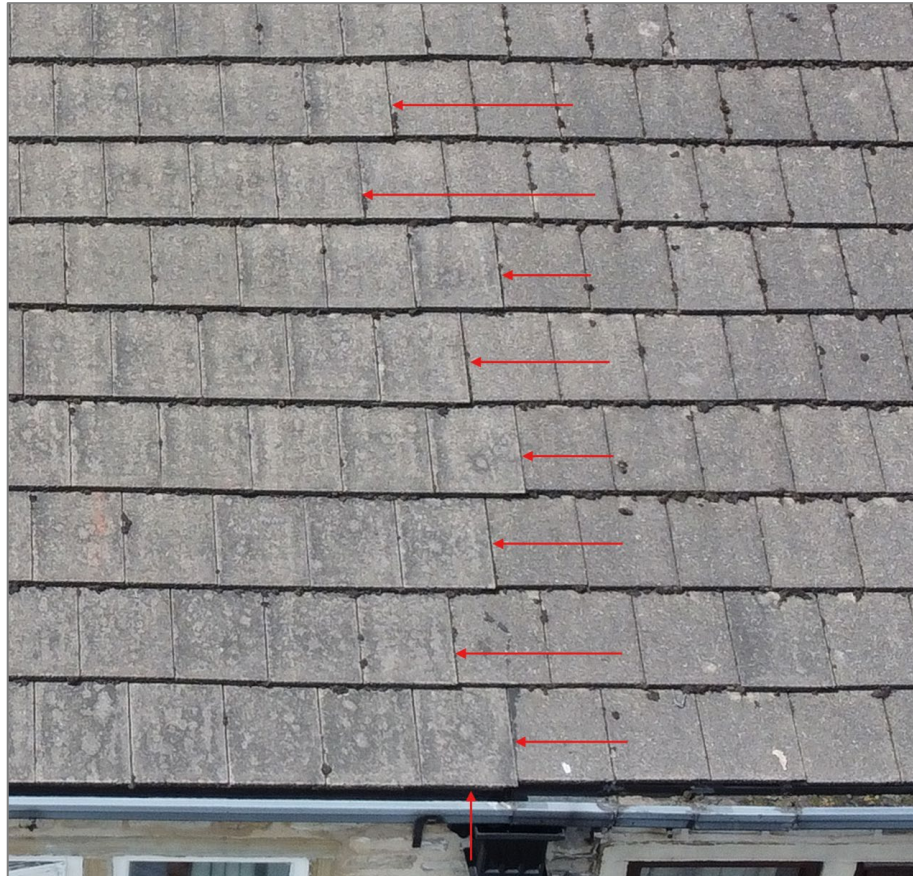
Fig 2

The existing materials comprise non-original roof tiles (two different types) as highlighted in Fig. 2. These concrete roof tiles were installed in the 1980s. Reference is made in Listed Building Consent application 22-00937-LBC to the tiles installed on 192 Dewhirst Road, these were specified as Grey Marley Modern Flat roof tiles. They are not slate tiles. Our own view is that notwithstanding the contents of the previous applications report - for which we make no claim to contrary - there is actually another type of tile installed to 190 Dewhirst Road (the southern side of the terrace) which was outside of the scope of that application, and when the terrace is viewed collectively, this harms the integrity and appearance of the Site.

Regarding the tiled finishes, of note is the quality of tile installed to 190 Dewhirst Road which seems to be deteriorating faster than the other tiles. They are of a smooth finish with a riven edge. All roofs have moss present on them and a not insignificant proportion of the tiles are cracked, albeit less on 190 Dewhirst Road.

Above: The arrows delineate the subtle change in appearance between two roof tiles found over the party wall between 190 and 191 Dewhirst Road. Also note the slightly longer dimensions of the tiles installed at 190 (left) compared to the tiles at 191 (right).

We propose a natural slate tile with a lifespan of between 50-100 years. Its appearance is of blue and grey. Del Carmen is a Spanish quarry renowned for extracting high-quality slate from a single, consistent vein. This slate's exceptional quality and unwavering consistency have earned official certifications, allowing its use in prestigious sites such as English Heritage, and Heritage Scotland. The excellent quality of SSQ's Del Carmen slate has resulted in regularly accepted specification and use as an alternative to indigenous slate by Heritage England and Heritage Scotland in a number of cases.

The manufacturer produces a range of dimensions for their slate tile range. We have specified 400mm x 250mm and the "Ultra" tile from this range. This is proposed as it is the most historically accurate dimension and when combined with a deeper headlap, it will provide better protection from the elements. Verges, ridges and flashings to be detailed per the drawings submitted with the application. Membrane to be removed, battens to be removed and both replaced and installed in accordance with the manufacturers instructions. No inappropriate bargeboards or verges to be installed. Remove all cement based mortars and repairs to verges, stacks and ridges prior to work.

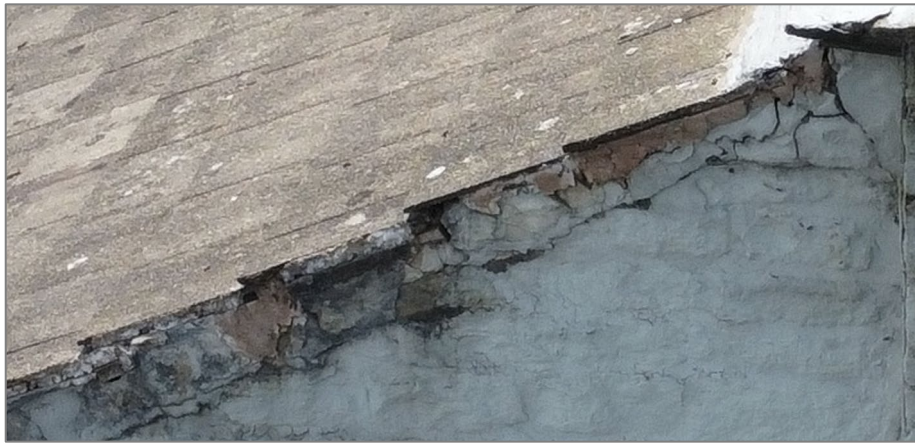
Fig 3

Above: Side elevation showing verge and junction between tiles and masonry wall which has been painted.

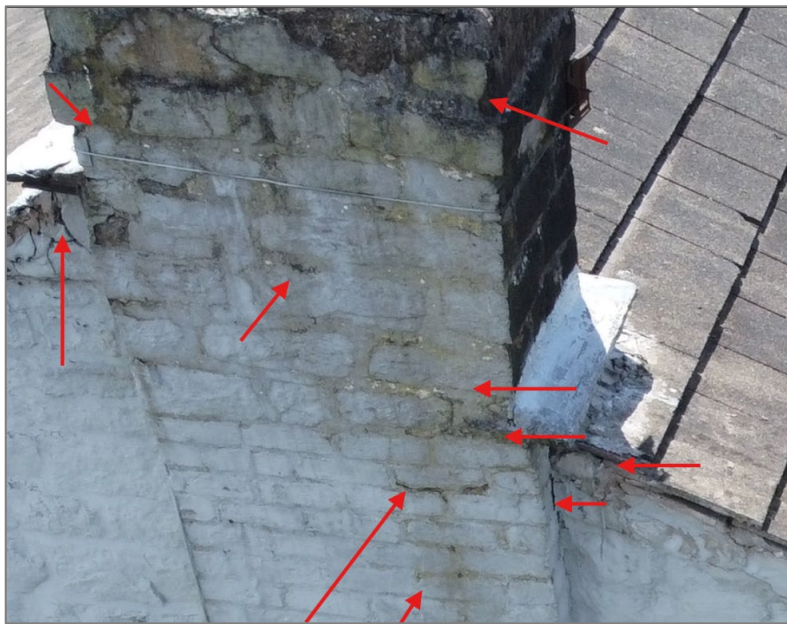
Fig 4

Repairs have been executed over prior decades in various fashions and methods. Notably there is a large quantity of cement based mortar applied to junctions for contemporary repairs, yet the properties appear to be built with a lime-based mortar. This has seemingly resulted in a cycle of failure within the mortar where the building is absorbing and repelling moisture at different rates and moving at different speeds. This is not unsurprising given that there are two mortar systems being used which often attempt to connect with one another during install and inevitably fail immediately thereafter. This is prominent along much of the side elevation verge where various informal repairs have been carried out but also on the primary pitches when the drone captured several photographs (see Fig. 5) where prominent chunks of mortar are falling off the chimney.

Above: Side elevation showing 192 Dewhirst Road and its shared chimney stack. Highlighted with red arrows are numerous points of failure which are either emerging, already failed, evidencing leaks/ingress, or show ad-hoc short-term repairs requiring rectification.

Similarly, there are dozens of different ages and types of mortar and flashings within close proximity of each other due to a multitude of ad-hoc repairs. C2, C3, C4 are proposed to be carefully dismantled, have their original bricks cleaned and set aside to be reused in the rebuilt chimney. Lime-based mortar. Remove all cement based mortars and repairs to verges, stacks and ridges prior to work.
