# BROOKES STREET MIDDLETON

## DESK BASED COAL MINING RISK ASSESSMENT

Job Number: LKC 22 1410  
Date: 11<sup>th</sup> July 2022  
Client: Tyson Construction

| <b>LK Consult</b> | | | |
|---|---|---|---|
| <b>Report Title</b> | Desk Based Coal Mining Risk Assessment | | |

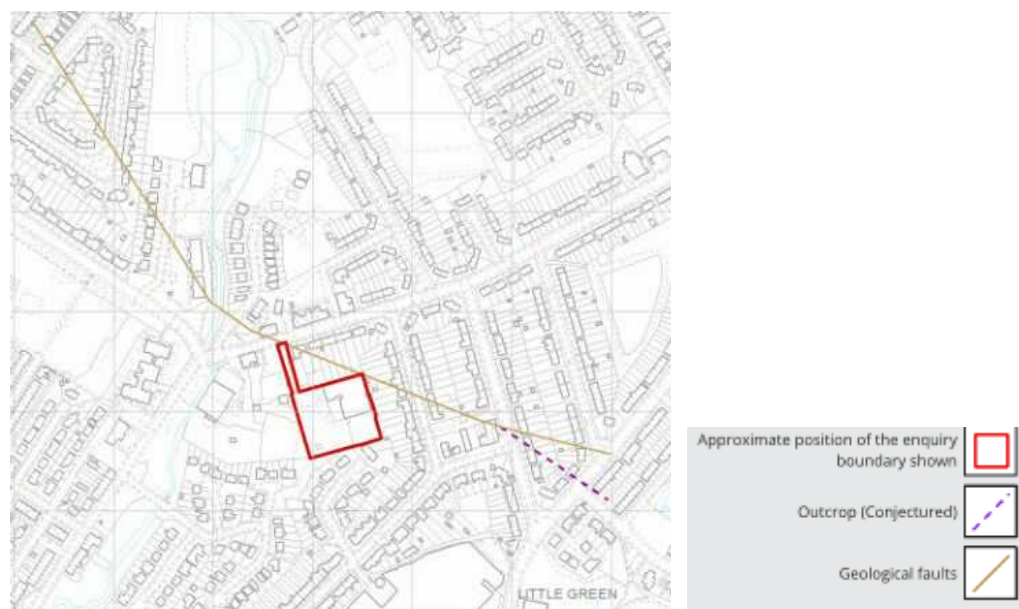
Plate 2-5: Extract from Coal Authority Consultants Coal Mining Report – Summary of Findings. showing outcrops.

| Mining Activity and Geology | |
|---|---|
| Geological faults, fissures and breaklines | Fault recorded across the northeast edge of site orientated northwest to southeast. |

Plate 2-5 shows an extract of the plan provided with the Coal Authority Consultants Coal Mining Report.

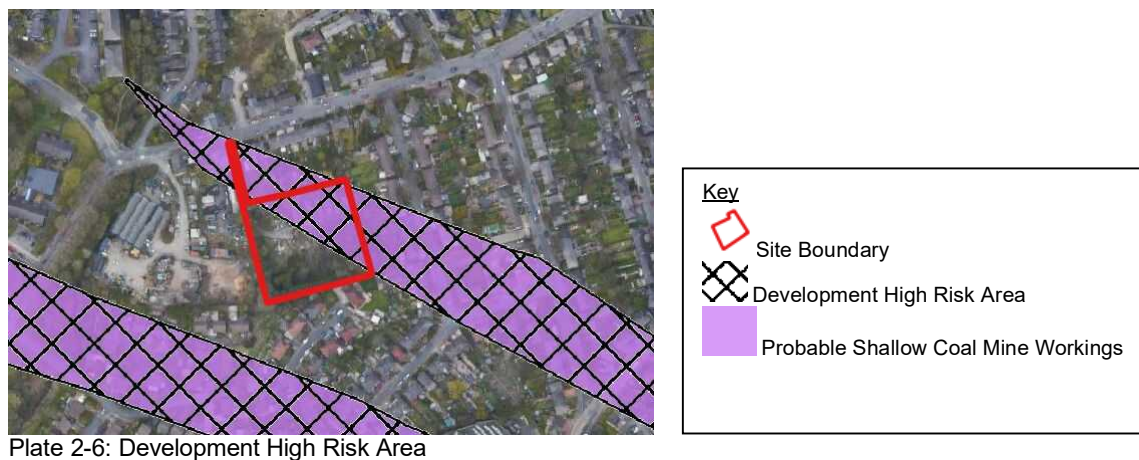
Plate 2-6: Development High Risk Area

The northeastern part of the site lies within a Development High Risk Area, shown as 'Probable Shallow Coal Mine Workings'. The remainder of the site lies outside the Development High Risk Area.
