# BS 5837:2012 Arboricultural Report: Tree Constraints Plan & Arboricultural Impact Assessment

Land adjacent to A4301 Waterfold Lane  
Heywood BL9 7JY

frh162021, amended version: frh602022

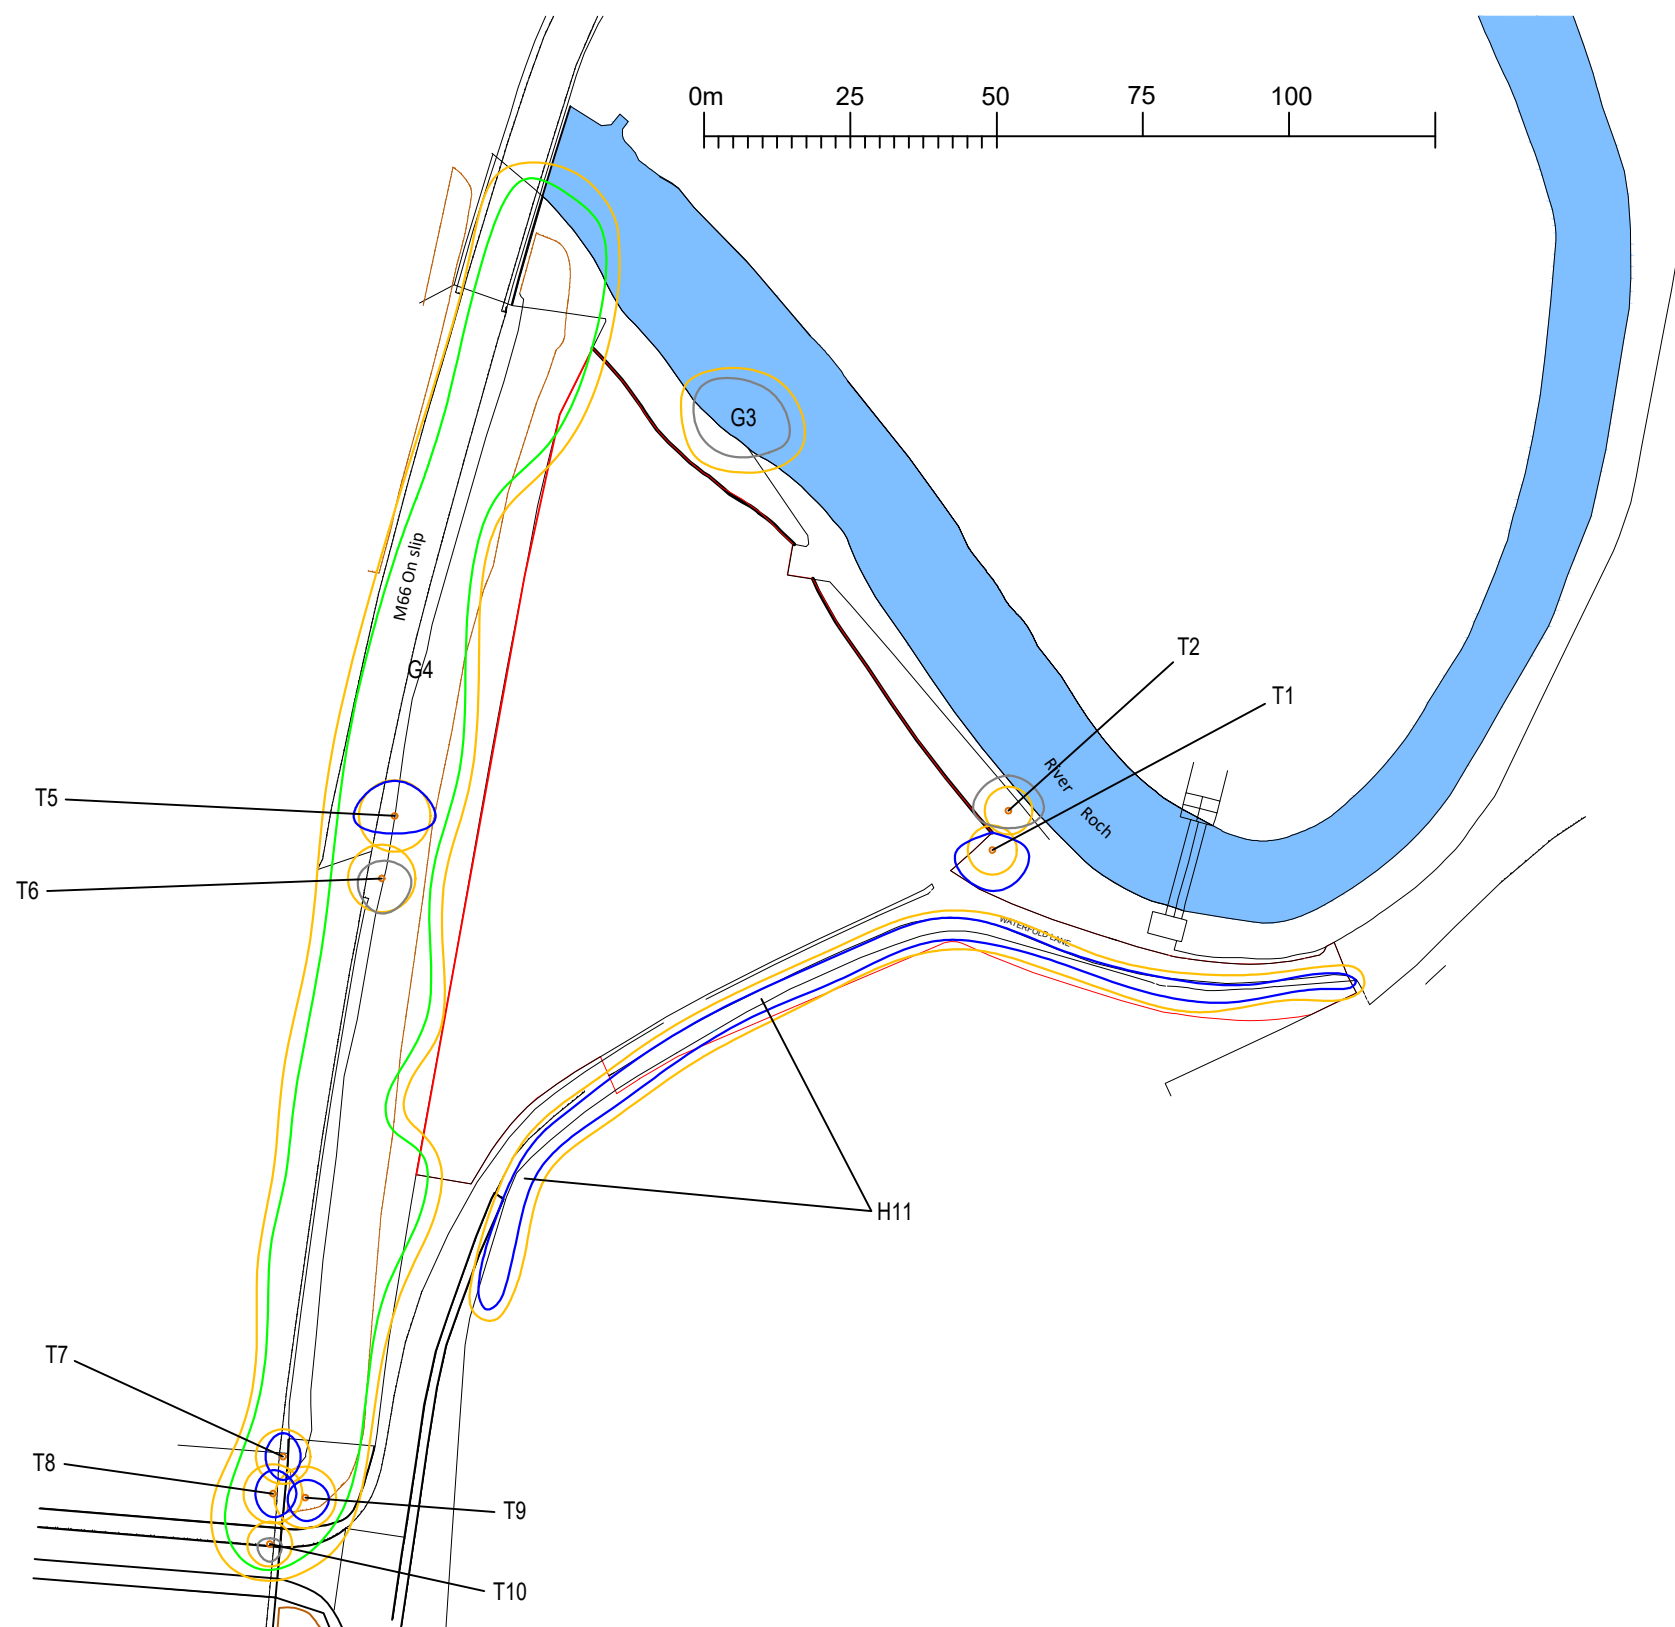
## Appendix 2: Tree Constraints Plan

- 4.3.1. No tree works are required at present. However, **G4, T5, T6, T7, T8** and **T9** are recommended for monitoring on a biennial basis due to their proximity to the M66.
- 4.3.2. Those trees which overhang public footpaths or public highways shall require future maintenance in order to maintain clearance heights for vehicular or pedestrian traffic. These heights should be 5.6m above a road and 2.5m above a footpath.
- 4.3.3. In addition, all trees to be retained within the site should be re-inspected on a regular basis, in the interests of risk management.

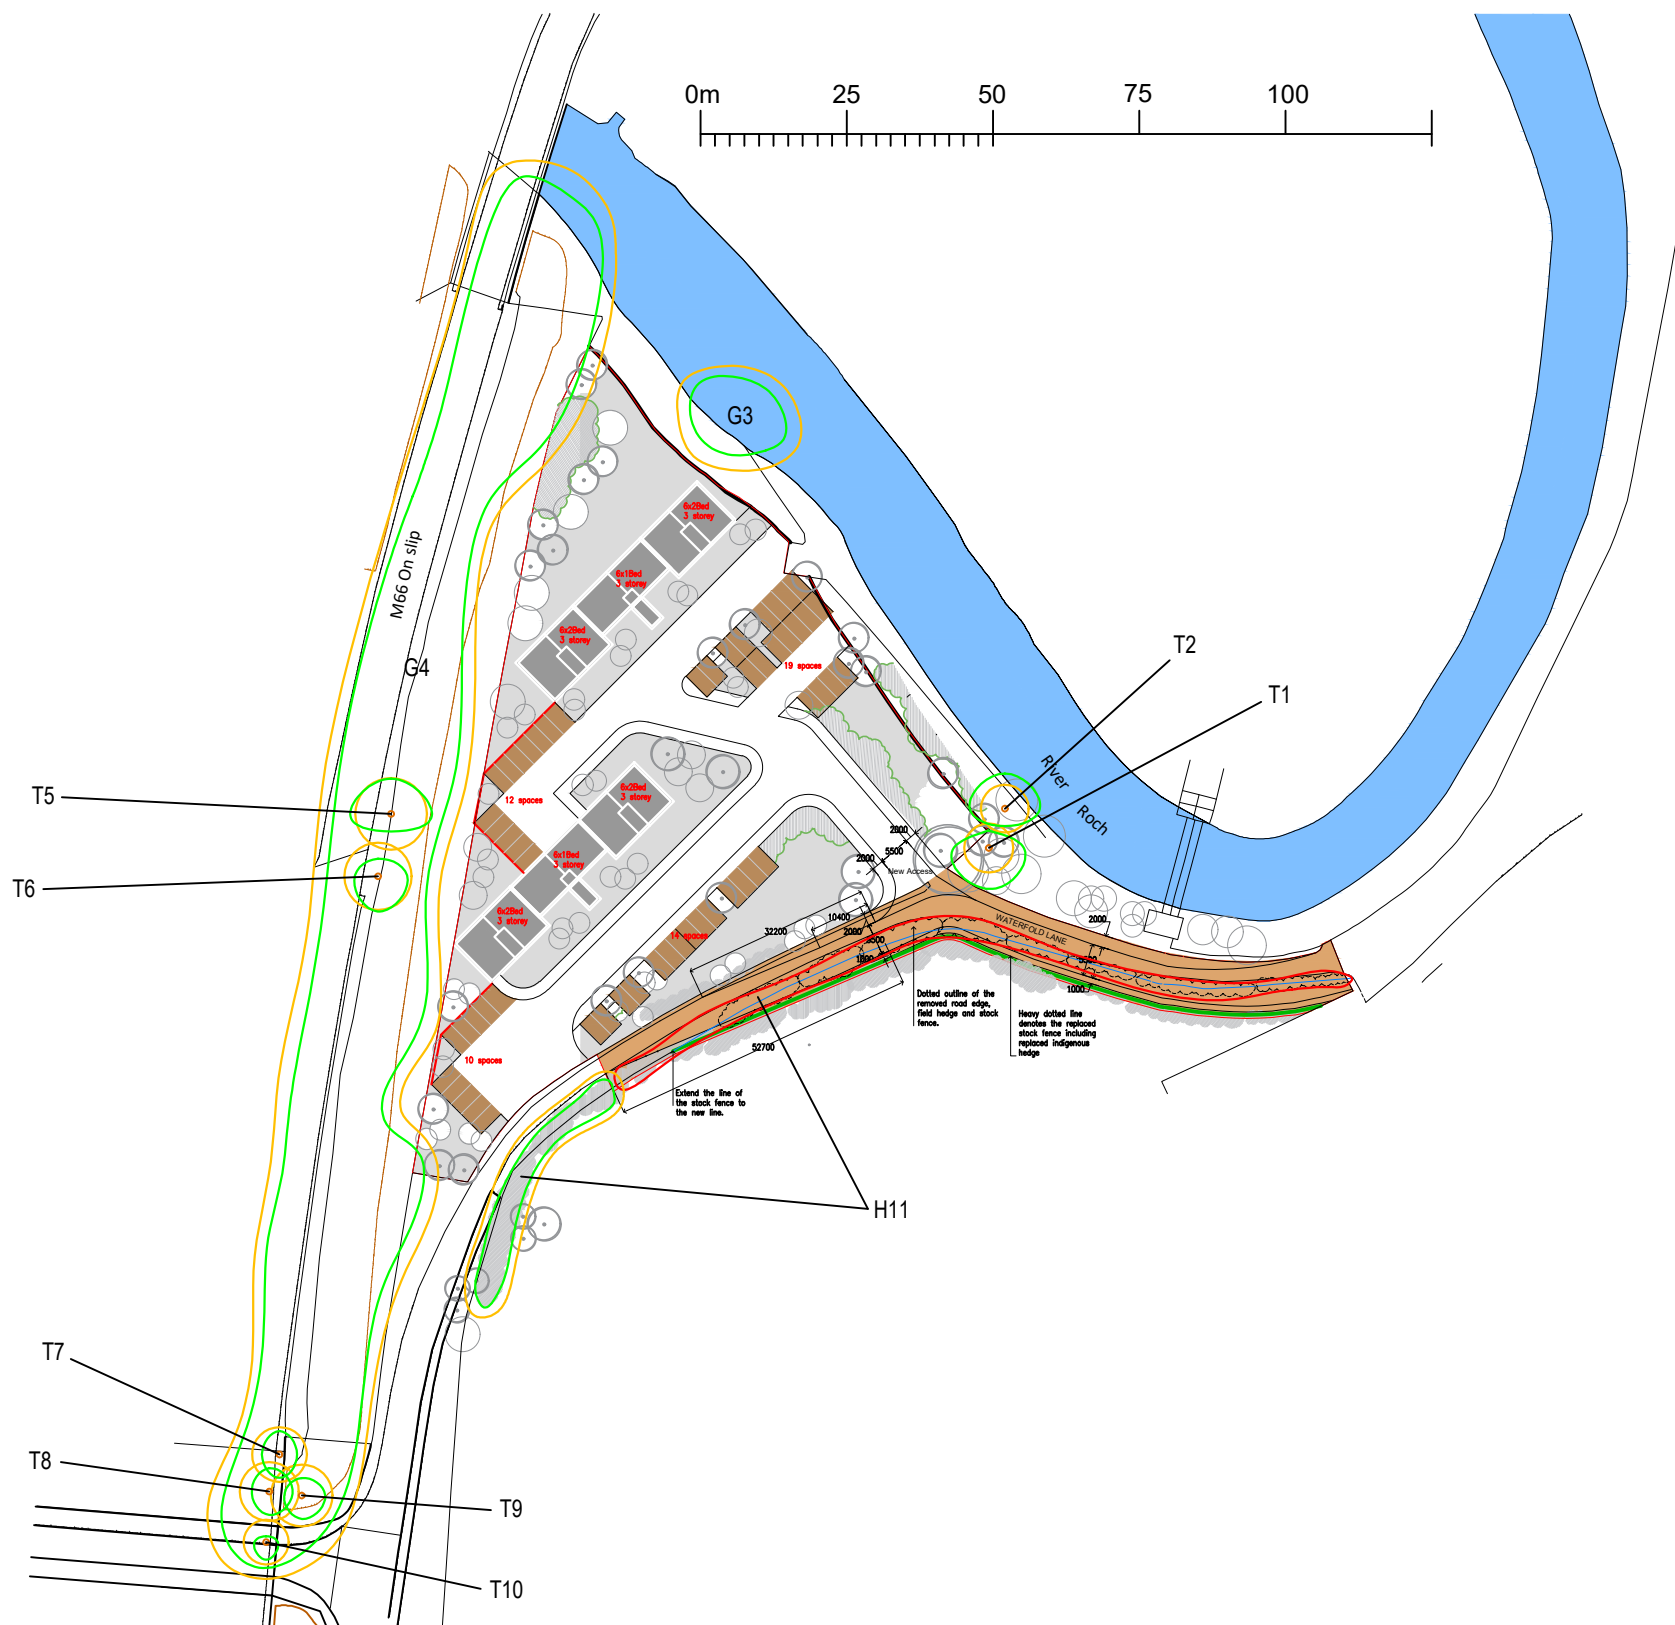
### Appendix 3: Arboricultural Impact Plan

- 5.2.1. A single section of **H11** is required to be removed in order to facilitate the widening of Waterfold Lane to increase visibility and access for the proposed junction. Please see **Appendix 3**.
- 5.2.2. Whilst the removal of vegetation will be of detriment to the arboricultural values of the site, it is recognised that the retention of vegetation is only one consideration in the design process. The loss of vegetation must be weighed against the benefits of the proposed development in the usual manner.
- 5.2.3. The removal of vegetation for development can often be mitigated (either partially or entirely) by the replacement of suitable specimens within a tailored **Tree Planting Scheme**. Whilst not always necessary, the planting of appropriate new tree species can greatly improve the aesthetic value of the surrounding area and may be conditioned in the usual manner.

- 7.4. A single section of **H11** is required to be removed in order to facilitate the widening of Waterfold Lane to increase visibility and access for the proposed junction. These are discussed in **Section 5** and detailed on the plan at **Appendix 3**.
