# **Site Tree Appraisal**

## ***5 Hillkirk Drive, Shawclough, Rochdale OL12 7HD***

Date: 11<sup>th</sup> November 2024

Ref: RTS/11112024

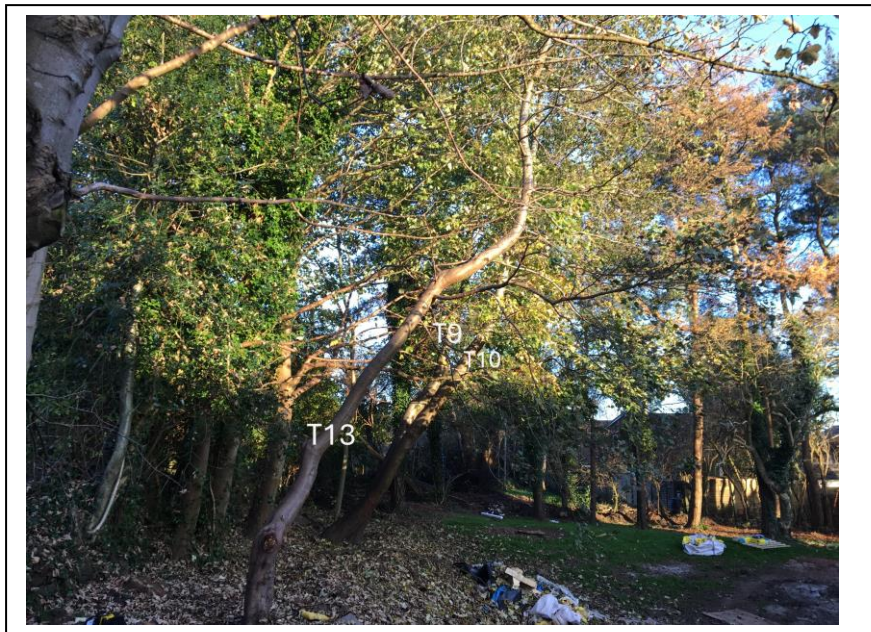
Photo 01:

- 3.3.1** The three Alder trees (T9, T10 & T13) have a significant lean towards the house (photo 01). Given the anticipated future growth of these two trees, it would be prudent to remove them as part of good management irrespective of the proposed extension works.

| Tree No | Species | Height (M) *<br>Crown Height above GL | DBH (mm) * | Crown Spread (M) * | Height to Lowest Branch (M)<br>Direction of Lowest Branch | Age Range | Condition | RPA Radius (M) | RPA Square metres | BS 5837 Category Rating | Observations and Comments |
|---|---|---|---|---|---|---|---|---|---|---|---|
| T9 | <b>Alder</b><br><i>Alnus glutinosa</i> | <u>17.0</u><br>3.0 | 300 | N – 1.0<br>S – 6.0<br>E – 6.0<br>W – 2.0 | <u>3.0</u><br>S | Mature | Fair | 3.6 | 40 | C1 | Asymmetric growth lean towards the house. |
| T10 | <b>Alder</b><br><i>Alnus glutinosa</i> | <u>17.0</u><br>6.0 | 300 | N – 1.0<br>S – 8.0<br>E – 1.0<br>W – 3.0 | <u>6.0</u><br>S | Mature | Fair | 3.6 | 40 | C1 | Asymmetric growth lean towards the house. |

| Tree No | Species | Height (M) *<br>Crown Height above GL | DBH (mm) * | Crown Spread (M) * | Height to Lowest Branch (M)<br>Direction of Lowest Branch | Age Range | Condition | RPA Radius (M) | RPA Square metres | BS 5837 Category Rating | Observations and Comments |
|---|---|---|---|---|---|---|---|---|---|---|---|
| T13 | <b>Alder</b><br><i>Alnus glutinosa</i> | <u>11.0</u><br>4.0 | 230 | N – 1.0<br>S – 6.0<br>E – 2.0<br>W – 4.0 | <u>3.0</u><br>S | Early<br>Mature | Fair | 2.7 | 22 | C1 | The tree has an asymmetric growth lean towards the south. |

| Tree | Tree Work | Priority |
|---|---|---|
| T5, T8, T9, T10 & T13 | Fell to ground level and grind out the remaining stumps. | Prior to any other site works |

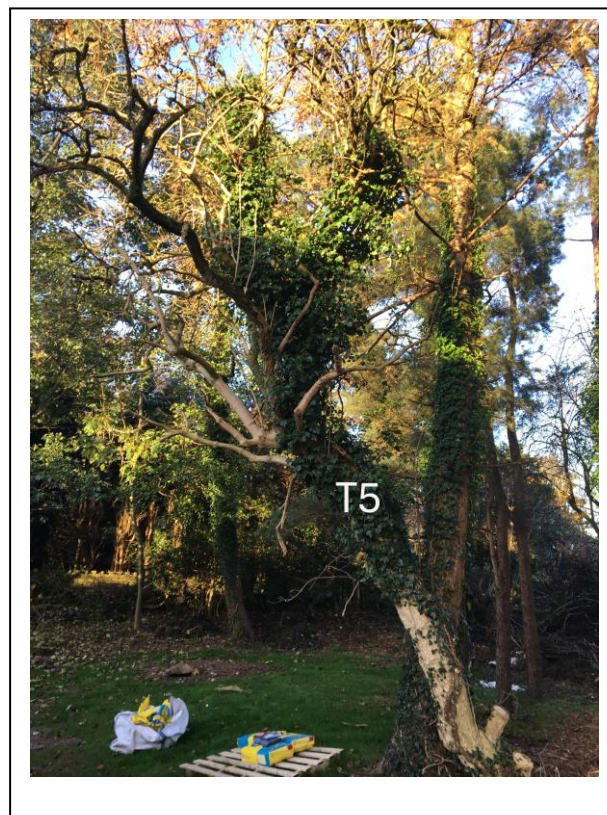
Photo 02:

- 3.3.2** The two Elderberry trees T5 and T8, dead and moribund respectively, again are recommended to be removed irrespective of the proposed extension works, (photo 02 & 03).

| Tree No | Species | Height (M) *<br>Crown Height above GL | DBH (mm) * | Crown Spread (M) * | Height to Lowest Branch (M)<br>Direction of Lowest Branch | Age Range | Condition | RPA Radius (M) | RPA Square metres | BS 5837 Category Rating | Observations and Comments |
|---|---|---|---|---|---|---|---|---|---|---|---|
| T5 | <b>Elderberry</b><br><i>Sambucus nigra</i> | <u>6.0</u><br>3.0 | 280 | N – 3.0<br>S – 3.0<br>E – 1.0<br>W – 4.5 | <u>1.5</u><br>N | Dead | Dead | N/A | N/A | U | A dead tree |

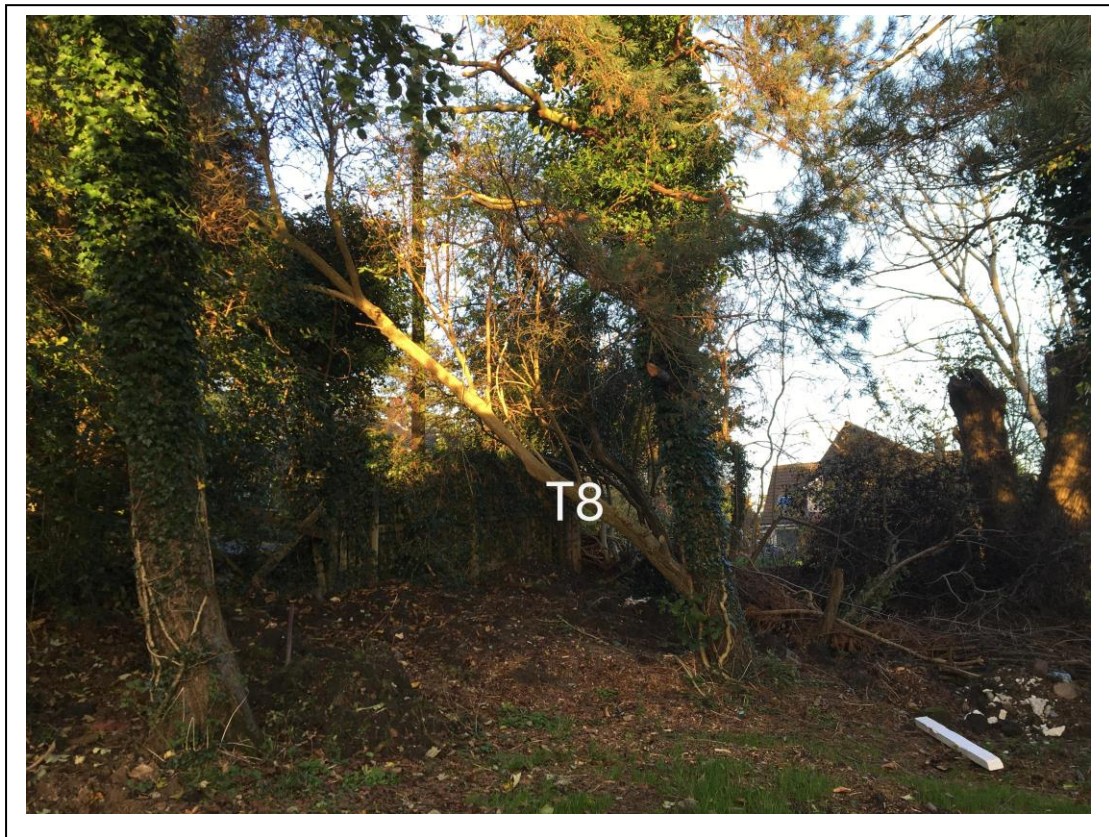
**Photo 03:**

| Tree No | Species | Height (M) *<br>Crown Height above GL | DBH (mm) * | Crown Spread (M) * | Height to Lowest Branch (M)<br>Direction of Lowest Branch | Age Range | Condition | RPA Radius (M) | RPA Square metres | BS 5837 Category Rating | Observations and Comments |
|---|---|---|---|---|---|---|---|---|---|---|---|
| T8 | <b>Elderberry</b><br><i>Sambucus nigra</i> | <u>10.0</u><br>4.0 | 200 | N – 9.0<br>S – 1.0<br>E – 2.0<br>W – 3.0 | <u>4.0</u><br>N | Moribund | Moribund | N/A | N/A | U | A moribund tree that has part fallen and is hung-up on adjacent trees. |
