Our Ref: BEK/22019/220801/SD Rev A

**BANK TOP FARM**

## Desktop Coal Mining Risk Assessment – Bank Top Farm, Hollingworth

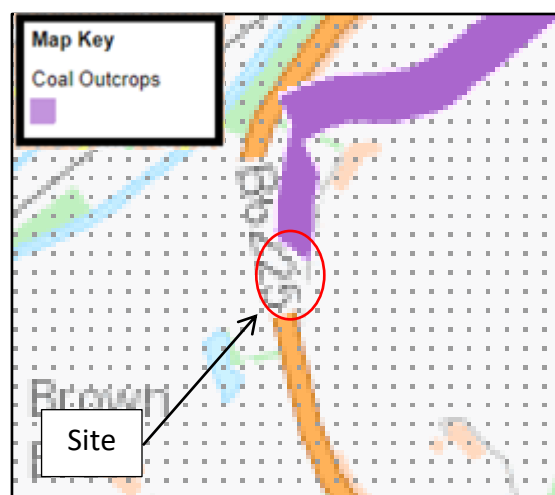
**Figure 6: Coal Outcrops Map**

Several maps extracted from the Coal Authority website are presented below. The Coal Authority Interactive Map indicates that there is an area in close proximity to the north of the site which is denoted as a 'Development High Risk Area'. It is possible that the north of the site is located within a 'Development High Risk Area'. Such areas are shown in Figure 5 below. Figure 6 (below) shows that a coal outcrop is situated in close proximity to the north of the site.

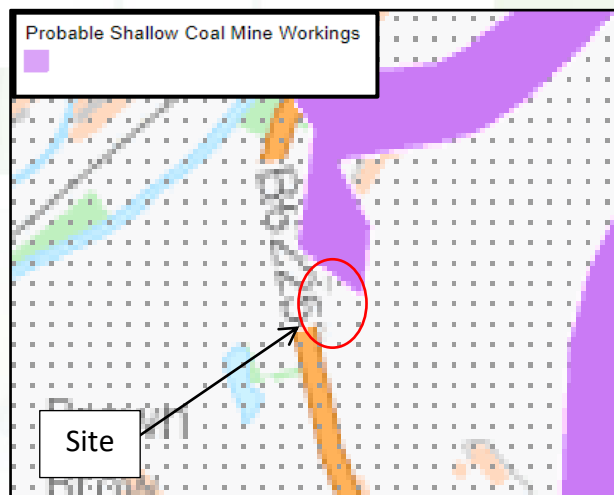
**Figure 8: Probable Shallow Coal Mine Workings**

Figure 7 shows that the site is not located within an area where 'past shallow coal mine workings' are present. Figure 8 shows that the site is located close to an area of 'probable shallow coal mine workings'.

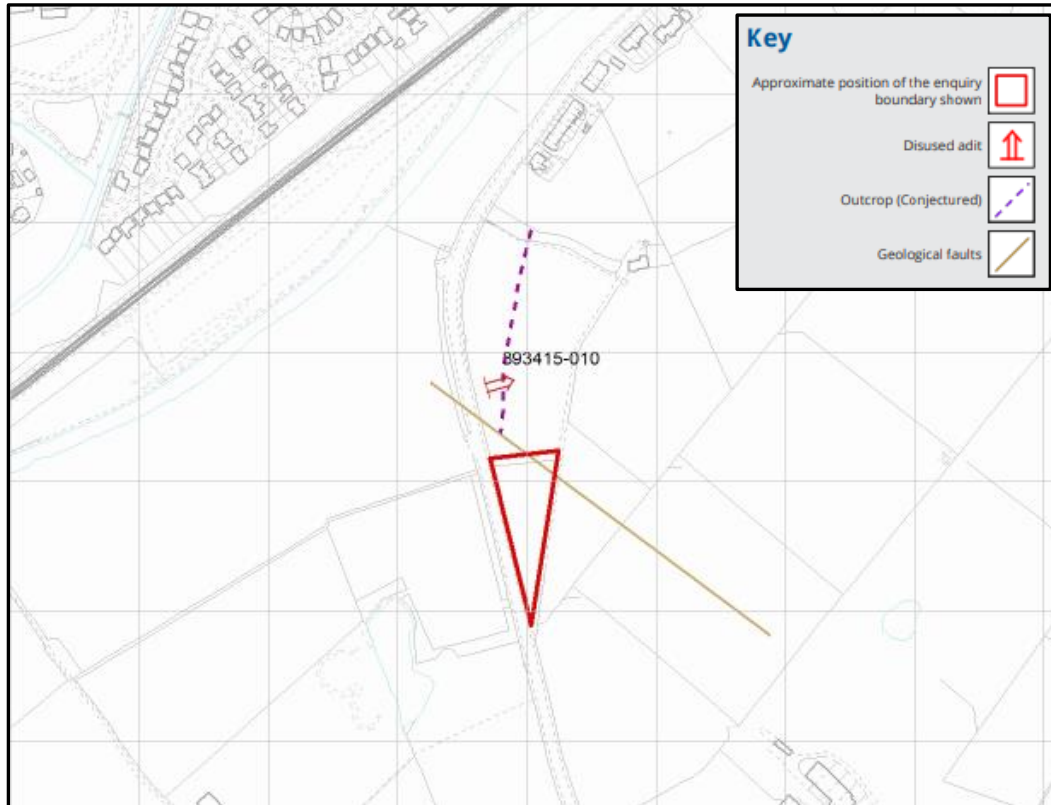
**Figure 14:** Coal Authority Summary of Findings

In addition to the presence of the adit to the north of the site, a geological fault is located in the north-eastern corner of the site and a coal outcrop (conjectured) is located to the north of the site as shown within the figure below:

A review of the bedrock geology of the site indicates that the site is underlain by Milnrow Sandstone with the north-eastern corner of the site shown to be Pennine Lower Coal Measures Formation. This correlates with the geological fault identified within Figure 14. Furthermore, the conjectured coal outcrop terminates at the geological fault line to the north of the site. The outcrop is identified to be the 'Upper Mountain' seam located some 18 m north of the development site with a bearing of 186°.
