COAL MINING RISK ASSESSMENT  
AT  
LAND ADJACENT TO 1018 EDENFIELD ROAD,  
NORDEN, ROCHDALE,  
OL12 7TR  
FOR  
MRS PEARSON  
REPORT REF: PRN 3528CMRA

# COAL MINING RISK ASSESSMENT

LAND ADJACENT TO 1018 EDENFIELD ROAD  
NORDEN, ROCHDALE, OL12 7TR

REPORT REF: PRN 3528CMRA

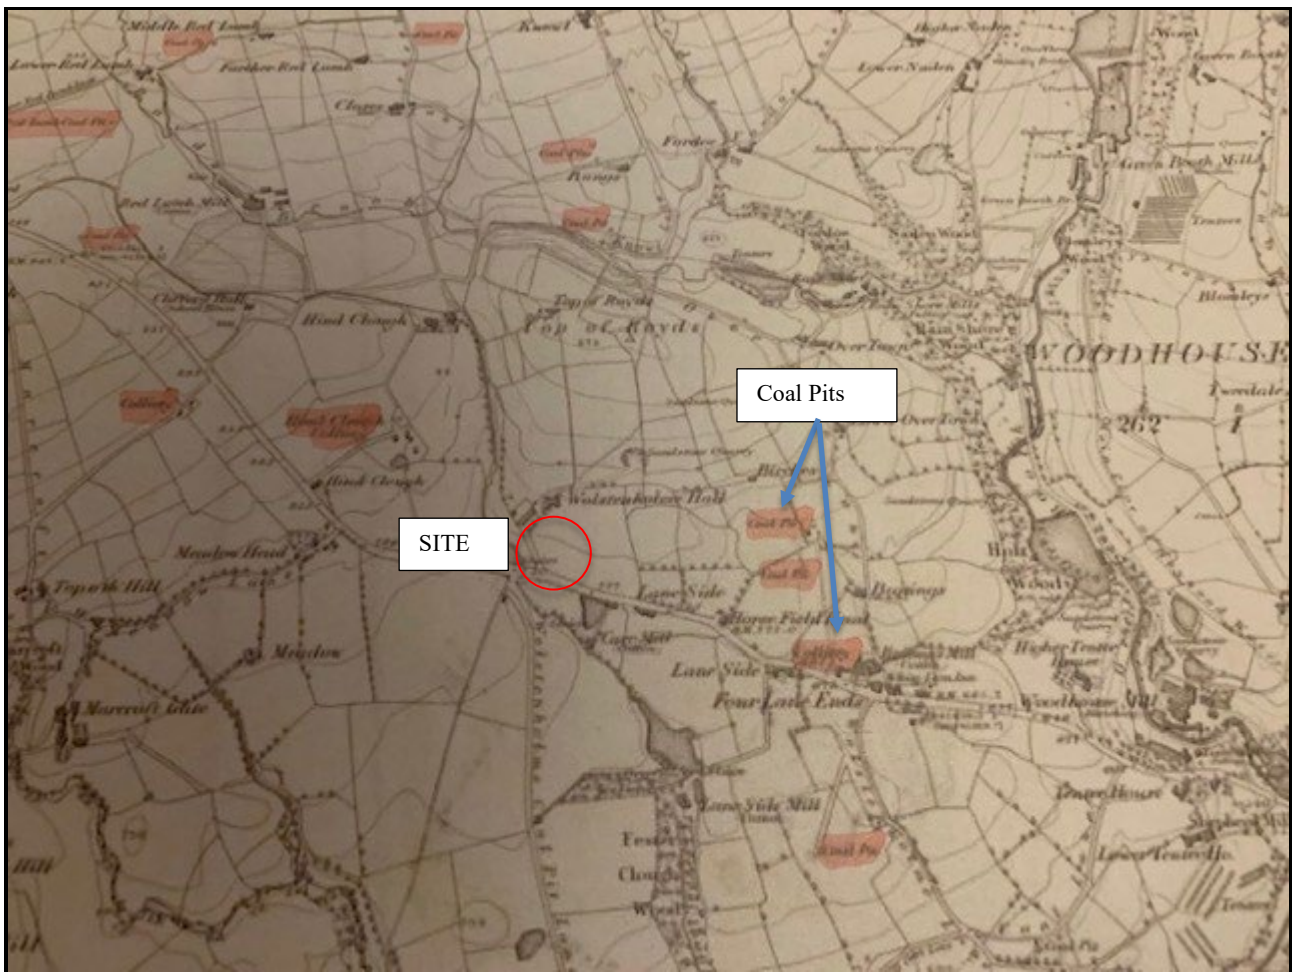
**Figure 4 OS Map 1854 with coal pits highlighted**

The OS map of 1854 indicates the area of the site to be generally open land with large numbers of coal pits and several local collieries at Lane Side, Hind Clough and Clifford Hall. By 1894 most of the small coal pits had ceased to exist with the collieries still working coal.

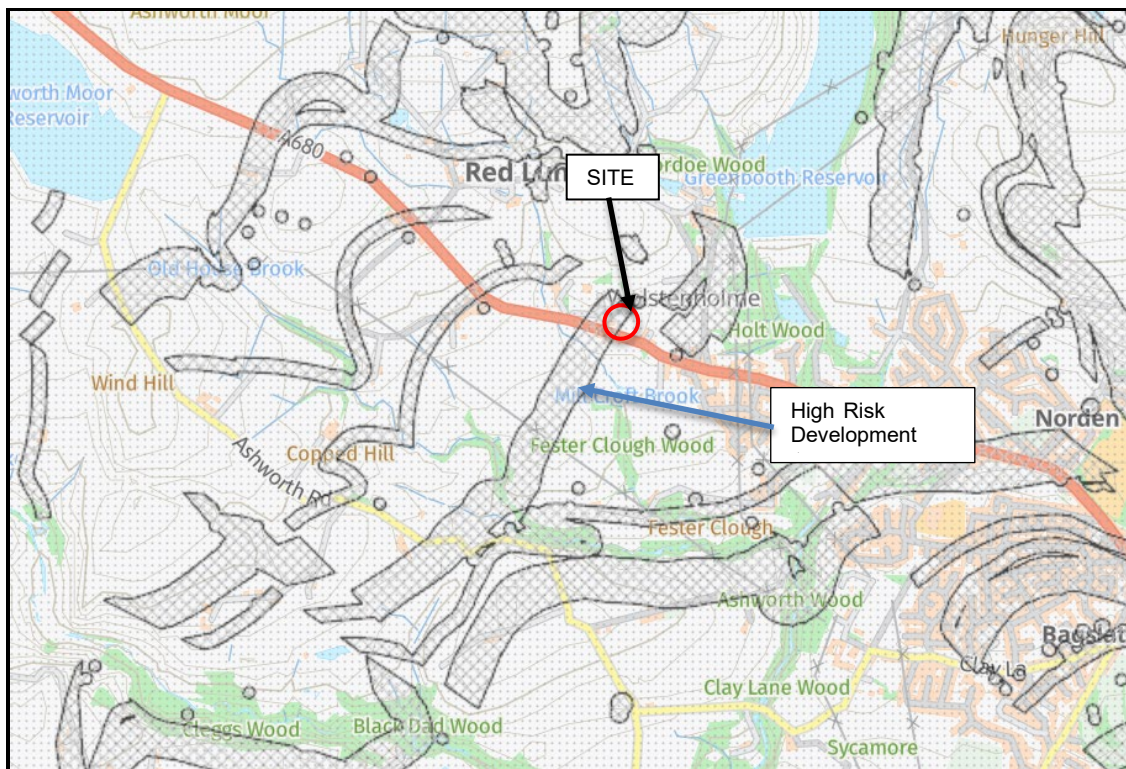
**Figure 9 High Risk Development Areas**

The Coal Authority indicate the site to lie within a high risk area for development as shown in Figure 6 and within an area of probable shallow coal mine workings as shown in Figure 9. Probable shallow coal mine workings contain locations and estimated extents of probable shallow underground workings for which no recorded plan exists, but where it is possible that workable coal at shallow depths has been mined before records were kept.

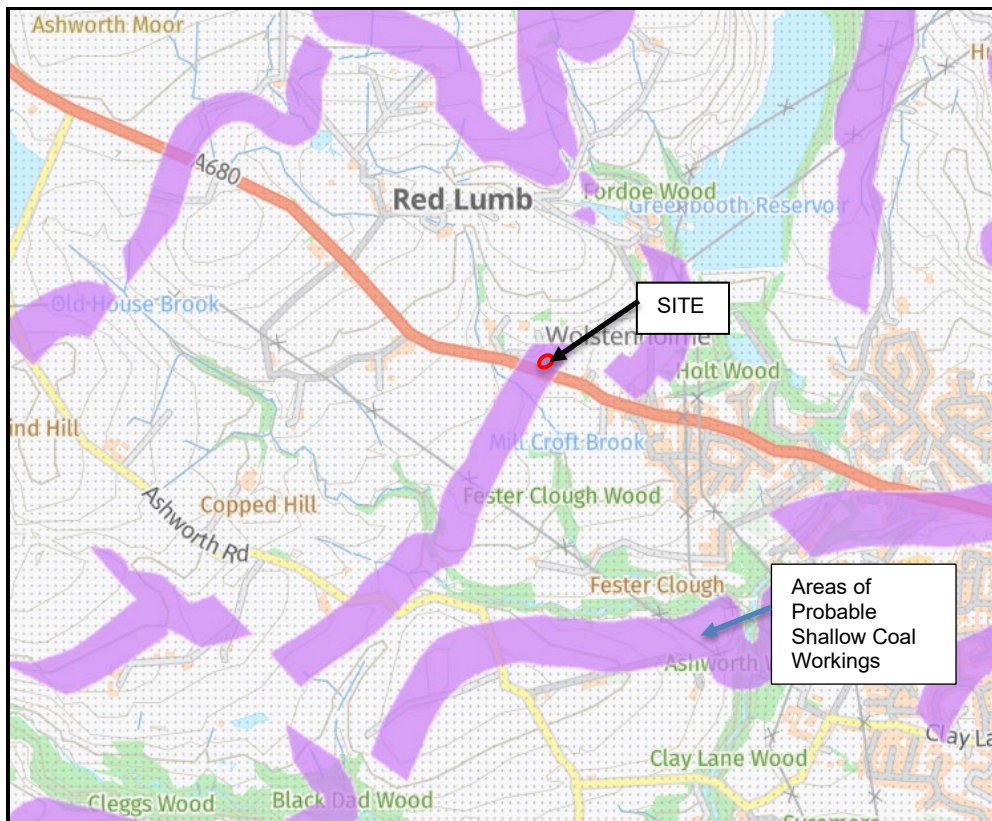
**Figure 12 Areas of Probable Shallow Coal Mine Workings**

There is a **high risk** that the site has been undermined at <30m depth bgl. Any voids remaining in workings at this depth may, depending on coal thickness mined, migrate by successive roof collapse and reach the ground surface to cause subsidence in the future and damage to overlying structures.

It is only possible to determine the risk by drilling rotary boreholes to a depth of at least 30m bgl.

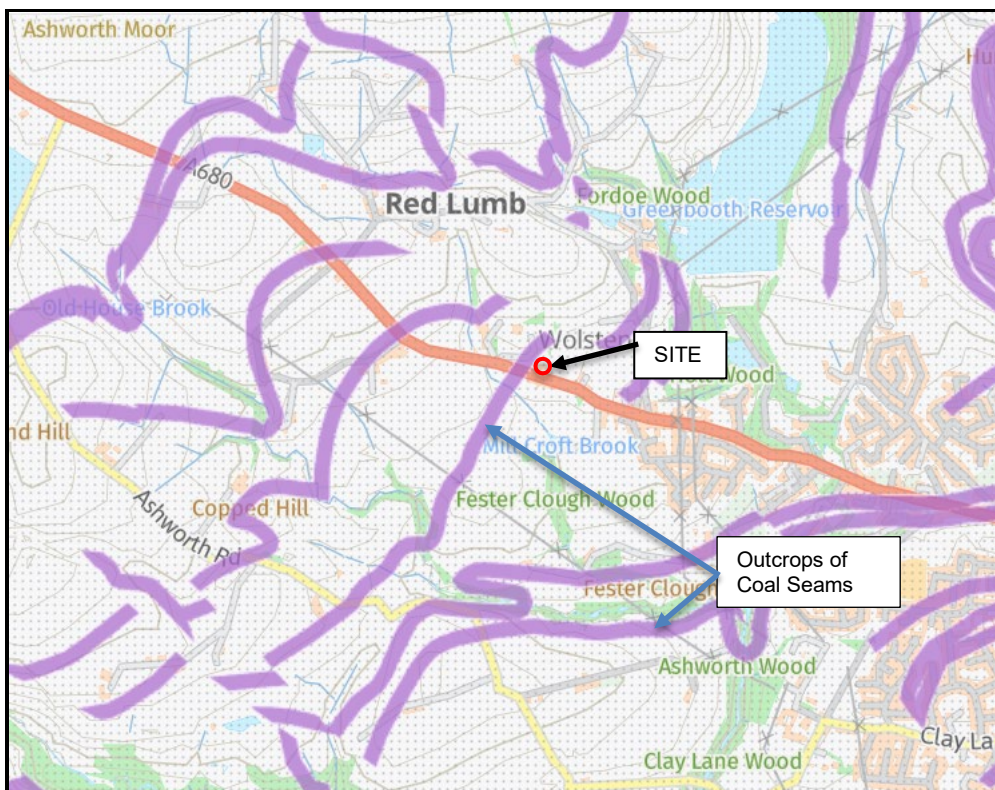
**Figure 13 Plan of Coal Seams Outcrop**

The maps of the BGS indicate the site is immediately underlain by the Woodhead Hill Sandstone underlain by older strata containing the 6inch Coal and the Sand Rock Coal which dip to the south east and underlie the site at shallow to circa 50m bgl. The maps of coal seam outcrops provided by the Coal Authority differ significantly from the BGS and indicate the presence of at least 4 coal seams outcropping to the north west of the site and dipping to the south east and lying beneath the site, as shown in Figure 13.

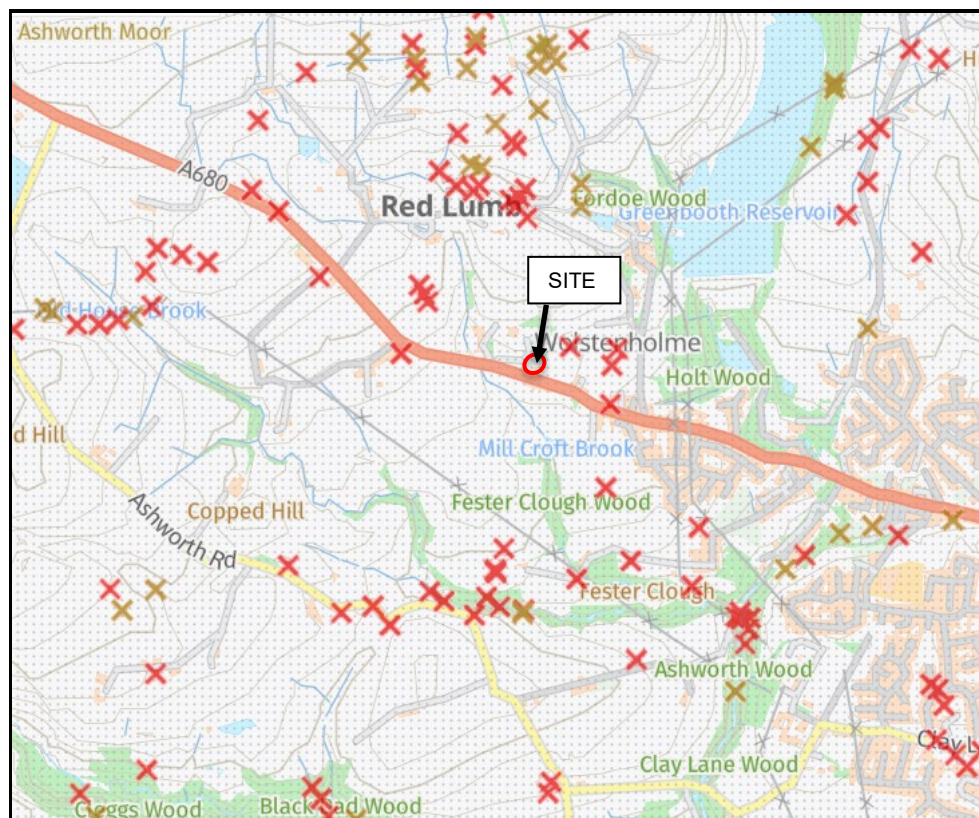
**Figure 14 Plan of Mine Shafts**

The closest Mine Shafts are presented in Figure 14 to the west and east of the site and lie at a distance where they will not detrimentally affect the stability of the site.

There is a **low risk** that mine shafts and adits may cause ground subsidence and affect the stability of the site in the future. The Coal Authority records are incomplete and any circular features detected on site should always be assessed by an engineer in case it represents an unrecorded mine shaft.
