**Site Tree Appraisal**  
***4 Gipsy Lane, Rochdale OL11 3HA***

**“BS 5837 2012: Trees in Relation to Design, Demolition and Construction – Recommendations”**

Date: 17<sup>th</sup> October 2022

Ref: RTS/17102022

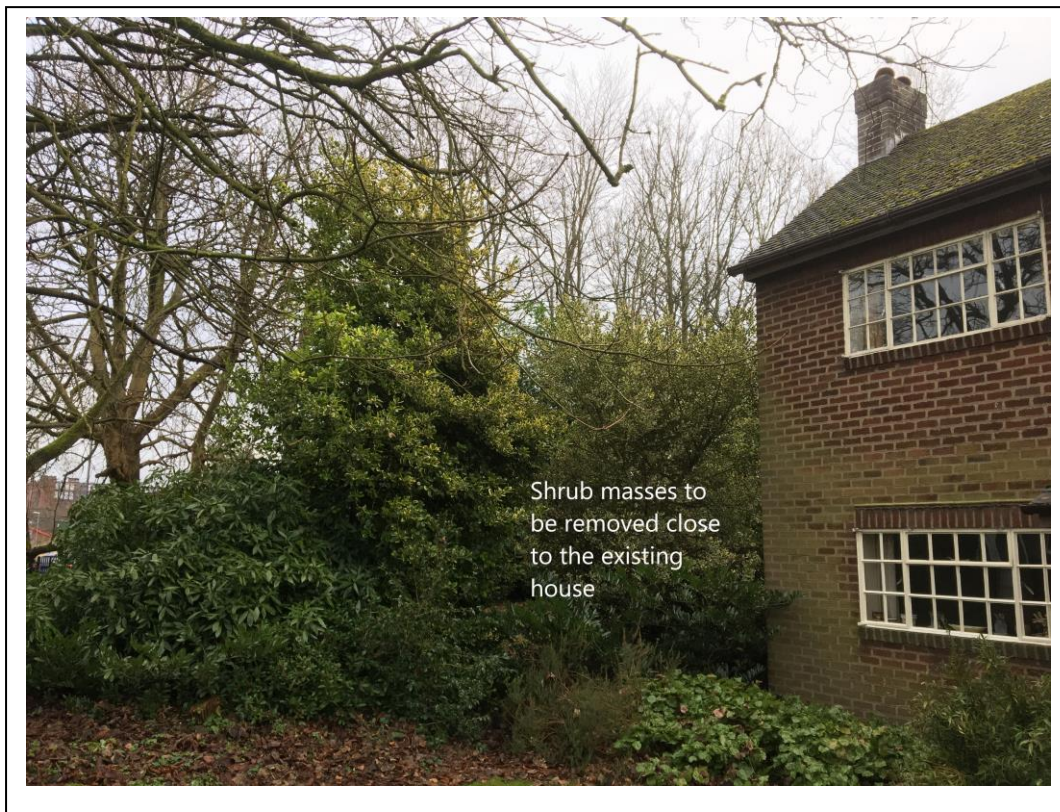
### Photo 01:

- 3.3** None of the significant trees on the site will require removal to facilitate the proposed property extension. However, one poor quality Cotoneaster shrub (SH18) and other insignificant garden shrubs (photo 01) will need to be removed in order to allow sufficient work space to construct the property extension. All small shrub masses that are located within the area enclosed by the recommended tree protection fencing (RTS/17102022/TPP 003), are to be removed in order to provide adequate work space for the construction contractors.

### General garden shrubs

| Tree | Tree Work | Priority |
|---|---|---|
| SH18 and other general shrub masses within the area enclosed by the recommended tree protective fencing (RTS/17102022/TPP 003) | Fell to ground level and grind out the remaining stumps. | Prior to any other site works |
