## Heritage, Design and Access Statement for Middleton Memorial Gardens.

Middleton Memorial Gardens  
Manchester Old Road  
Middleton  
M24 4EB

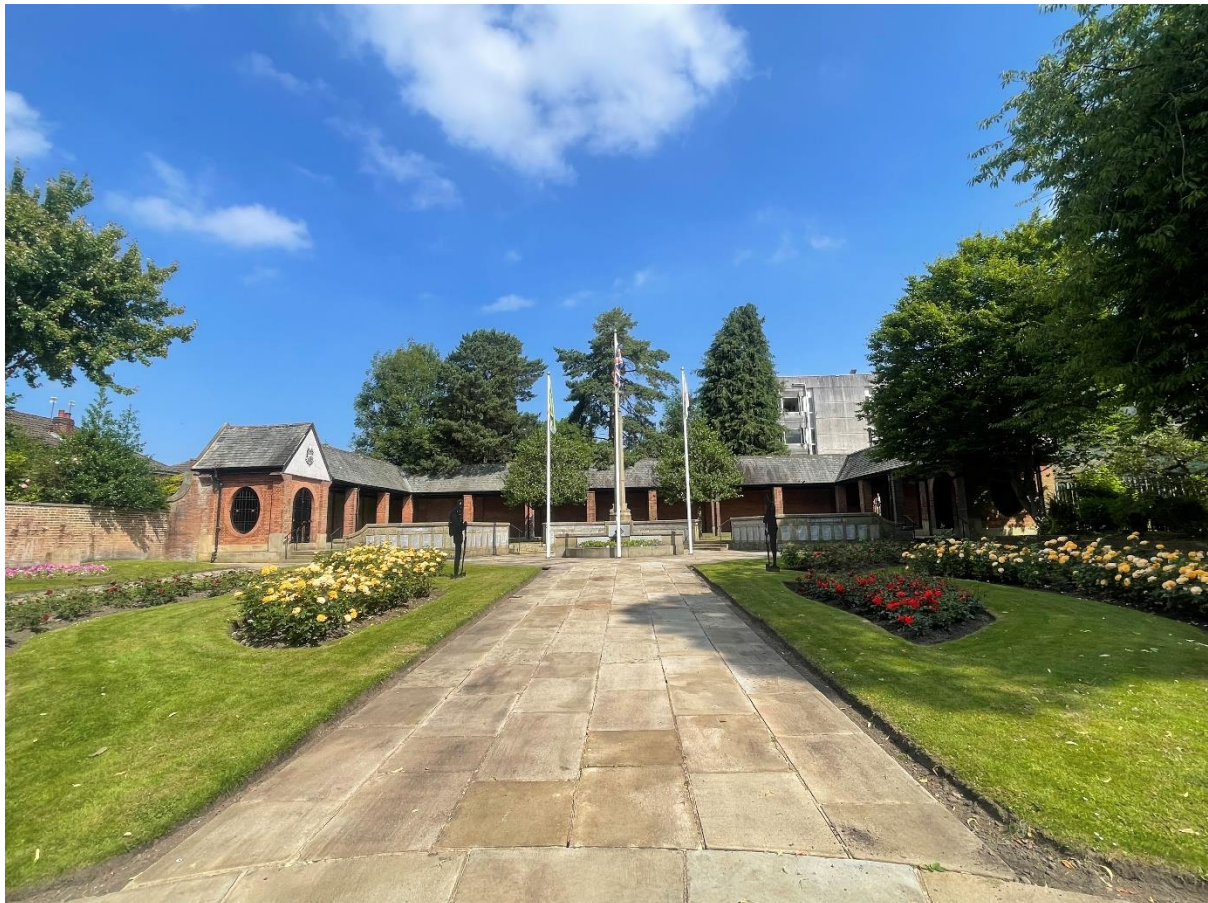
Front Elevation Middleton war Memorial JS
