# ARBORICULTURAL IMPACT ASSESSMENT

Hopwood Hall College (Chapel),  
Rochdale Road,  
Middleton,  
Manchester,  
M24 6XH

**ISSUE DATE**  
23.02.2024

**SEED REF**  
[1697b-AIA-V1-B]

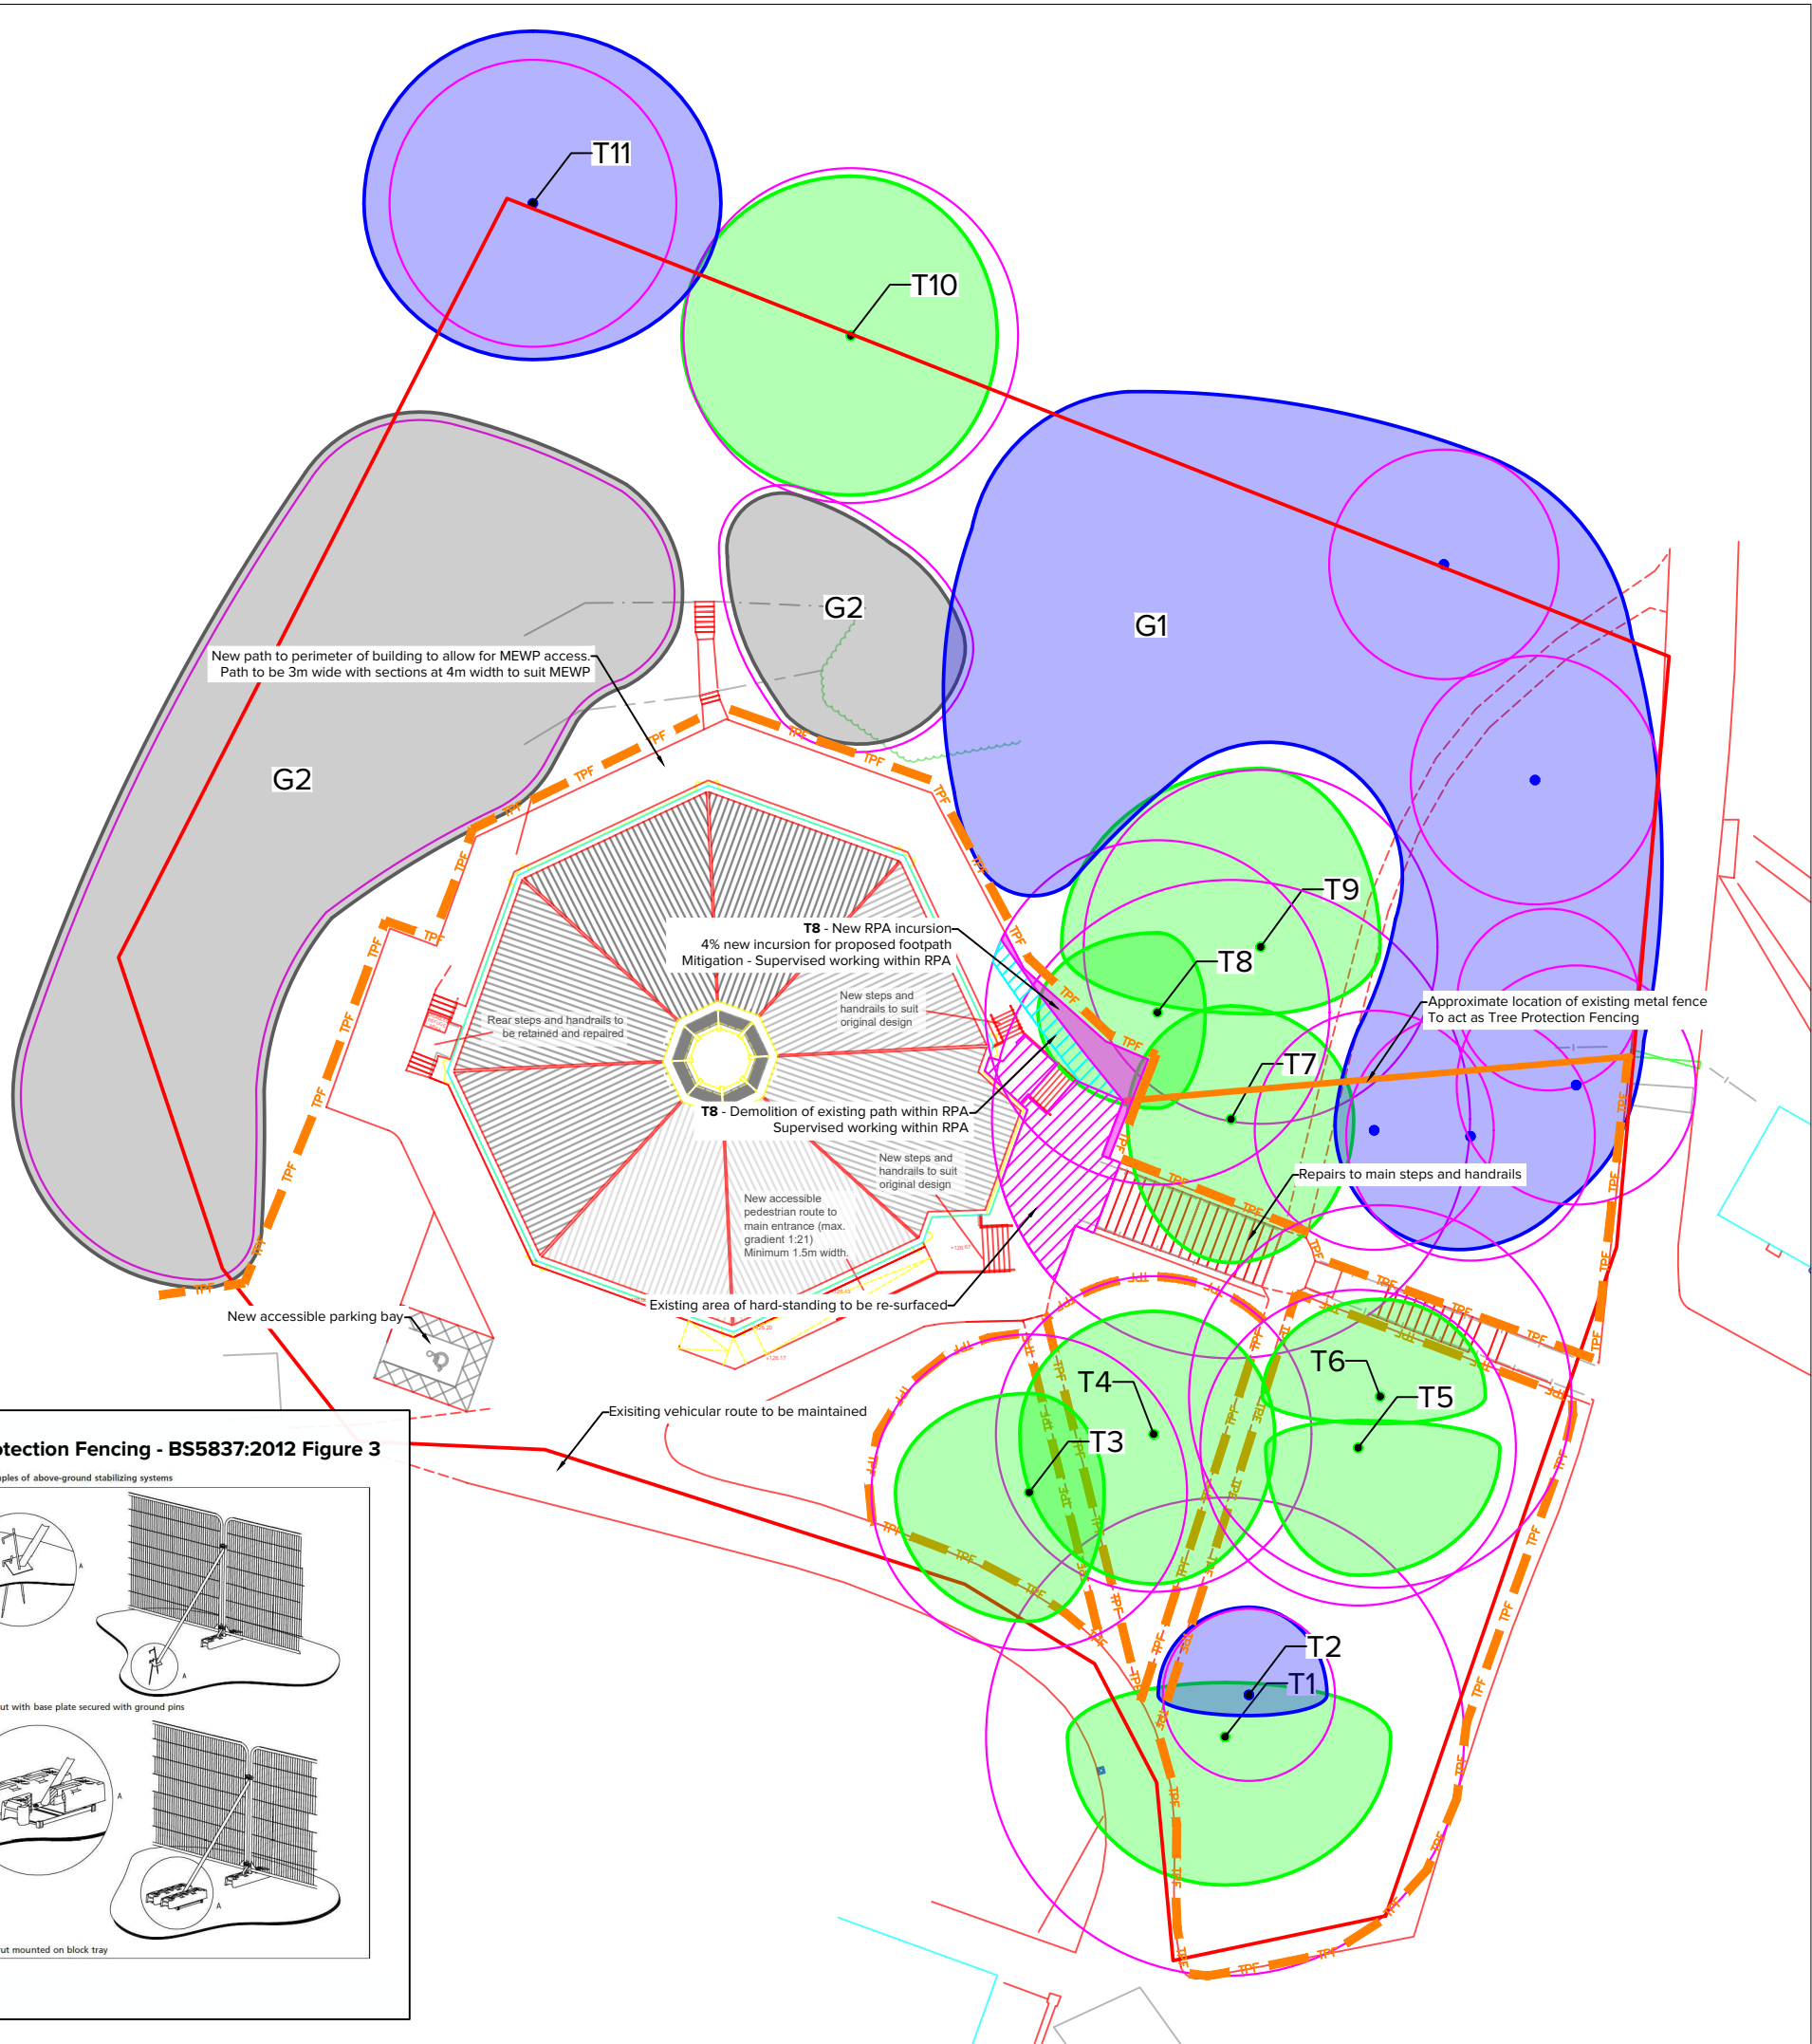
TITLE  
Arboricultural Impact & Tree Protection Plan

There is one new RPA incursion as a result of the Proposed Development:

- **T8 (Common lime)** - New incursion of 15.9m<sup>2</sup> within total 366m<sup>2</sup> – 4% new incursion for footpath.

As part of the development proposals an area of existing footpath within the RPA of T8 is to be demolished. If undertaken with due care, then this will not have a detrimental impact upon the retained tree. An example methodology for the process is provided within the tree protection section of this AIA.

Mitigation – Minor incursion supervised working within RPA.

The removal of existing surfacing within the RPAs of retained trees should be carried out with arboricultural supervision.

The removal of existing surfacing should be carried out beginning closest to the trees and working backwards, away from the trees, so no machinery stands on the exposed ground. The use of large plant machinery should be avoided where possible.

Tree Protection Fencing should be in place during the removal of the existing surfacing and moved accordingly to protect the exposed ground as the removal progresses. Where new surfacing is to be laid, the existing sub-base should be retained and augmented as required.
