Phase I Geoenvironmental Site Assessment  
Harrow Avenue, Rochdale

Reference: 17-039-R1-1  
Date: July 2023

# PHASE I GEOENVIRONMENTAL SITE ASSESSMENT

Land off Harrow Avenue  
Rochdale  
OL11 4DS

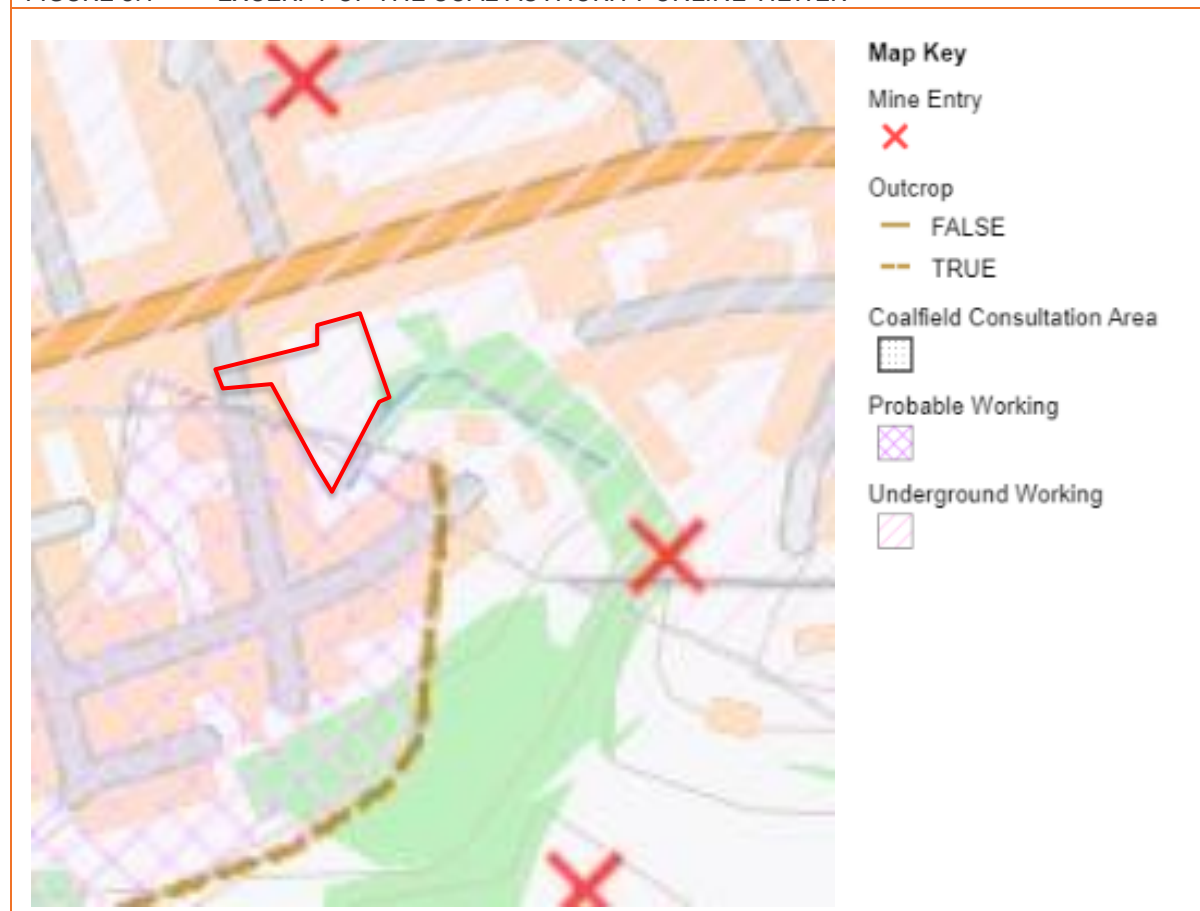
FIGURE 5.1 EXCERPT OF THE COAL AUTHORITY ONLINE VIEWER

In the first instance, E3P has reviewed the Coal Authority Online Viewer and an excerpt of this is presented as Figure 5.1. This map shows an area of probable workings in the south of the Site which is noted to be within a Development High Risk Area. Underground workings are recorded across the majority of the Site in the central and northern sector. A coal outcrop is recorded to the southeast of the site and mine entries are shown to the north and south of the Site.

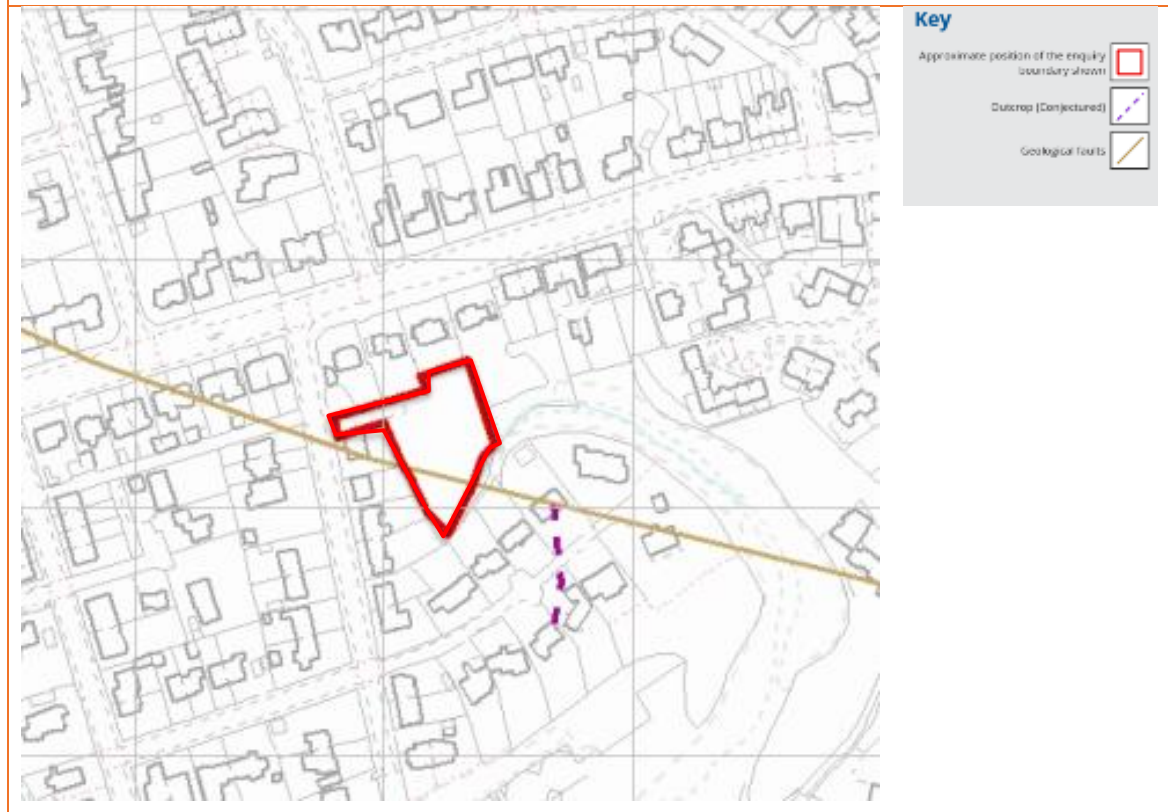
FIGURE 5.2 COAL AUTHORITY PLAN FOR THE SITE

The Coal Authority plan referenced: MR-LARGE-PLOT-51003364149001 shows the fault on Site and a conjectured outcrop located circa 35 m to the southeast.

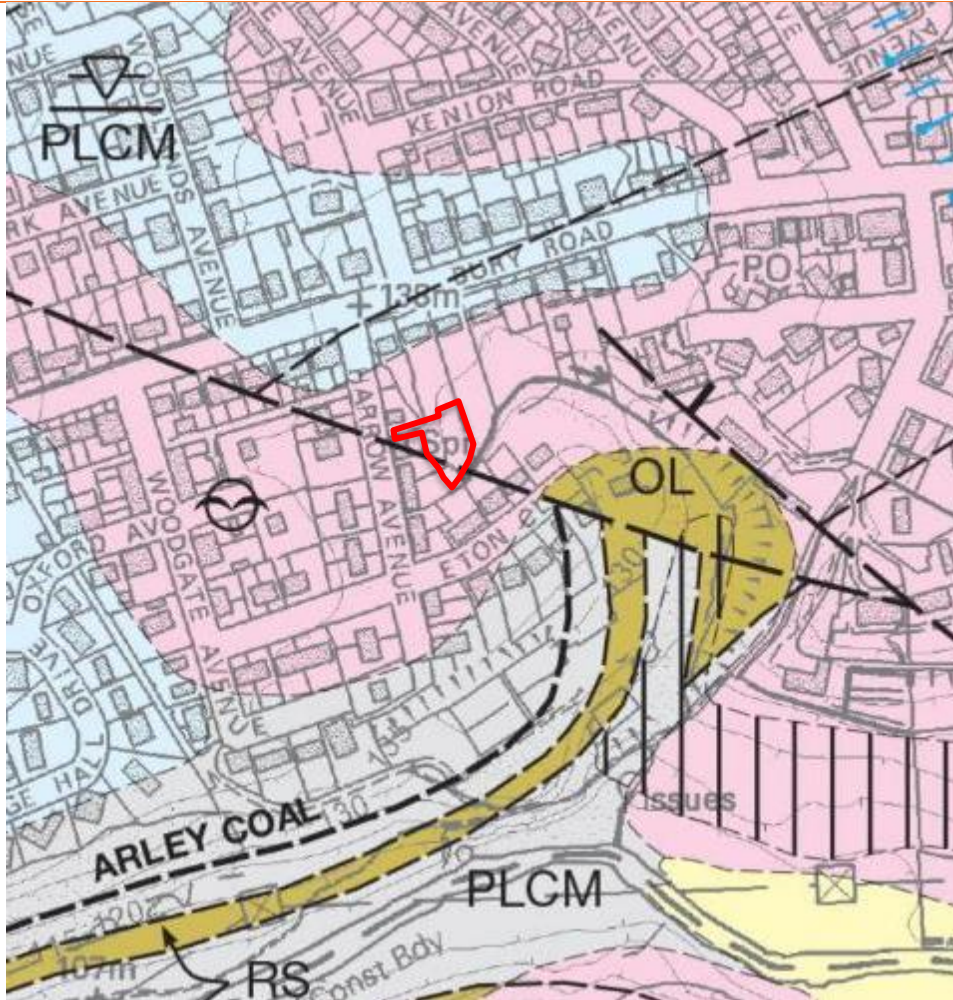
FIGURE 5.3 PHOTOGRAPH OF THE 10,000 PLAN FOR THE SITE

Figure 5.3 is a photograph of the 1:10,000 plan for the Site which shows the Arley coal outcrop to the southeast of the subject Site. The strata appear to dip to the northwest beneath the Site. This seam may therefore pose a risk to the subject site.

The on-site fault is shown with the downthrow to the southwest.

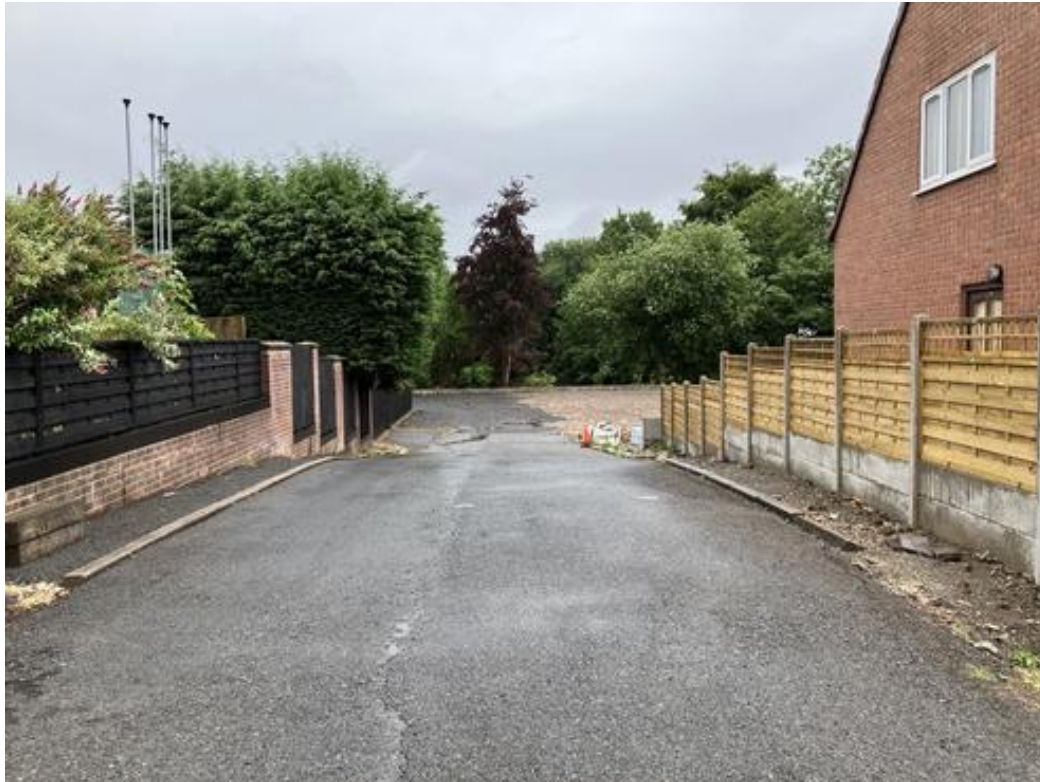
PLATE 1      ACCESS FROM HARROW AVENUE

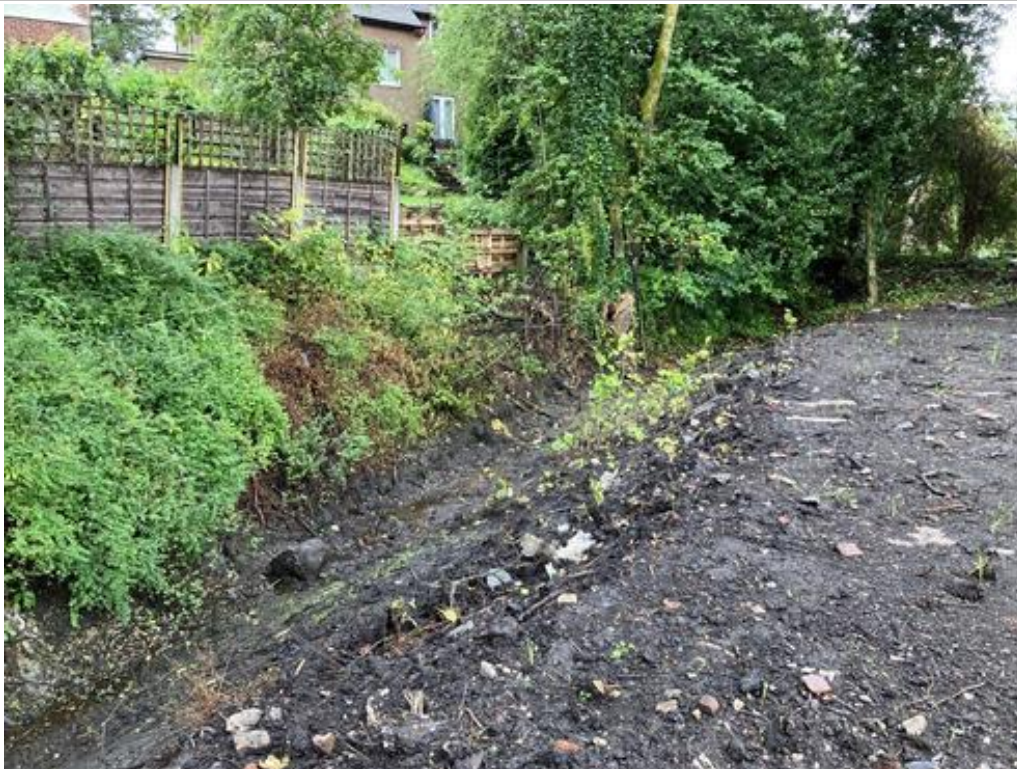
PLATE 2      EMBANKMENT TO STREAM ALONG THE SOUTHEAST BOUNDARY

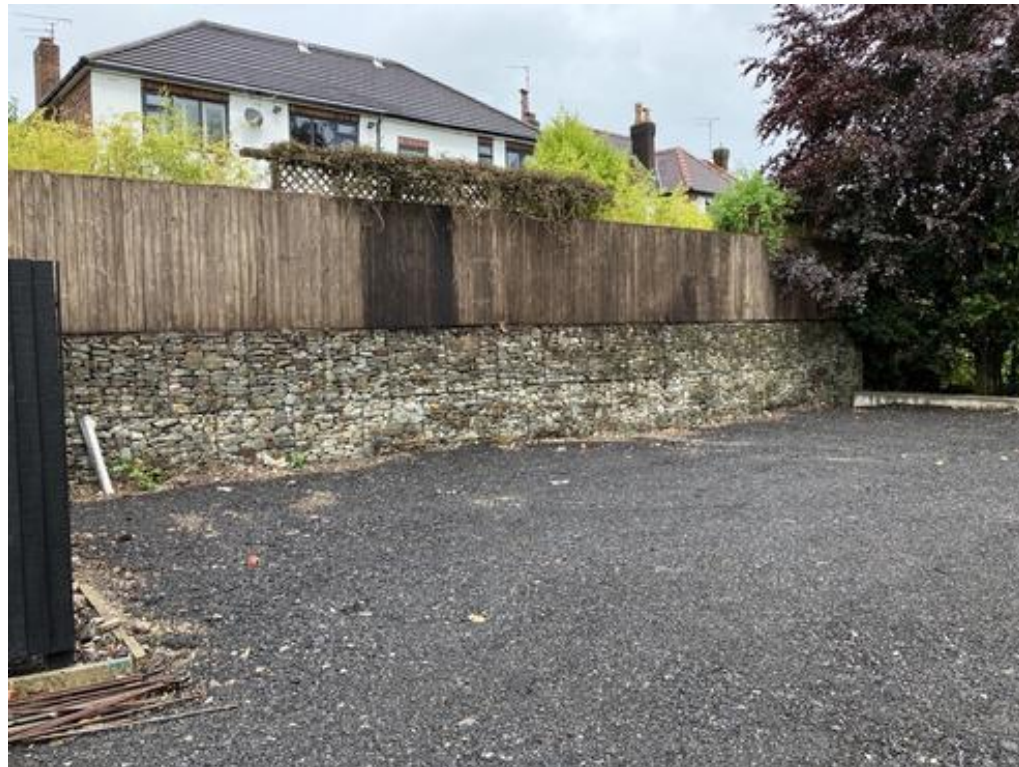
PLATE 4 GABION WALL – NORTHERN BOUNDARY

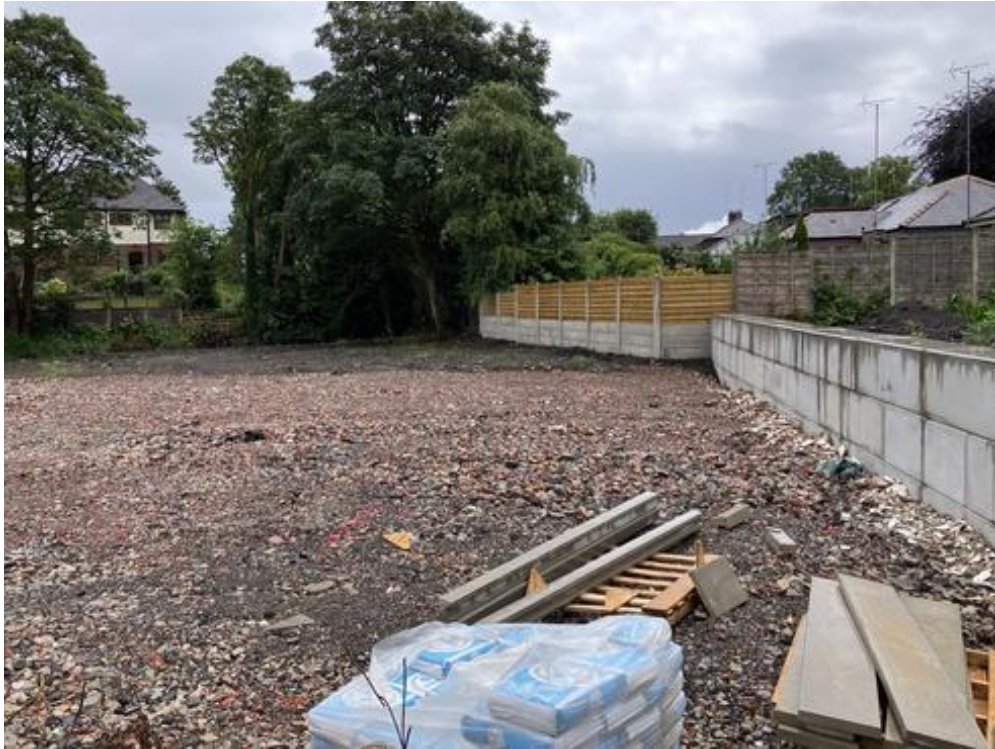
PLATE 5      CONCRETE RETAINING BLOCKS – WESTERN BOUNDARY

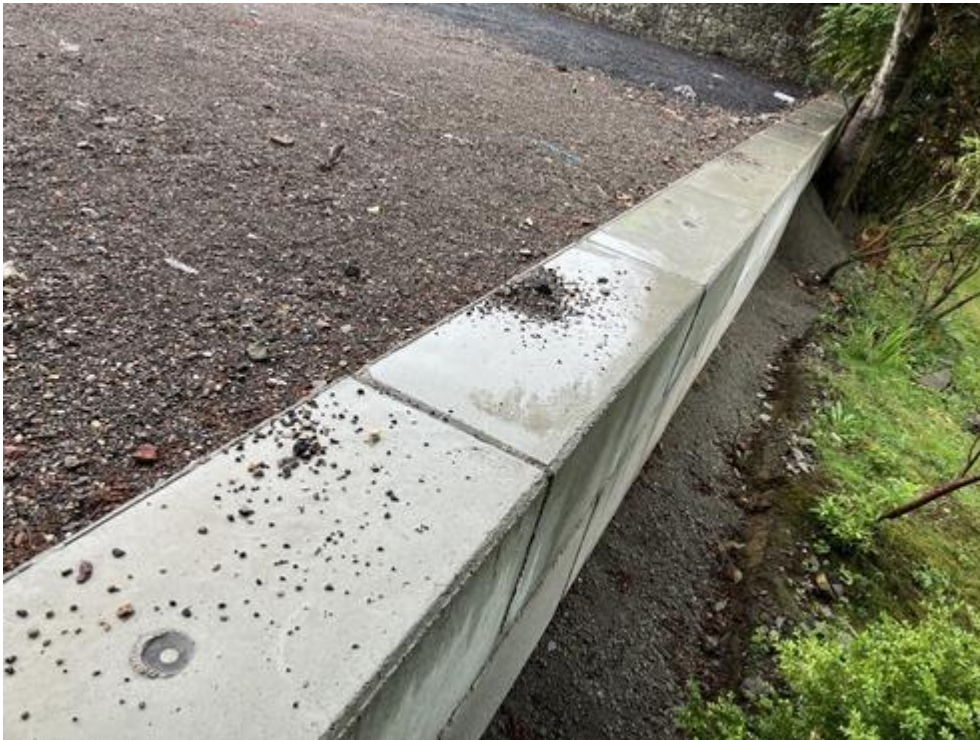
PLATE 6      CONCRETE RETAINING BLOCKS

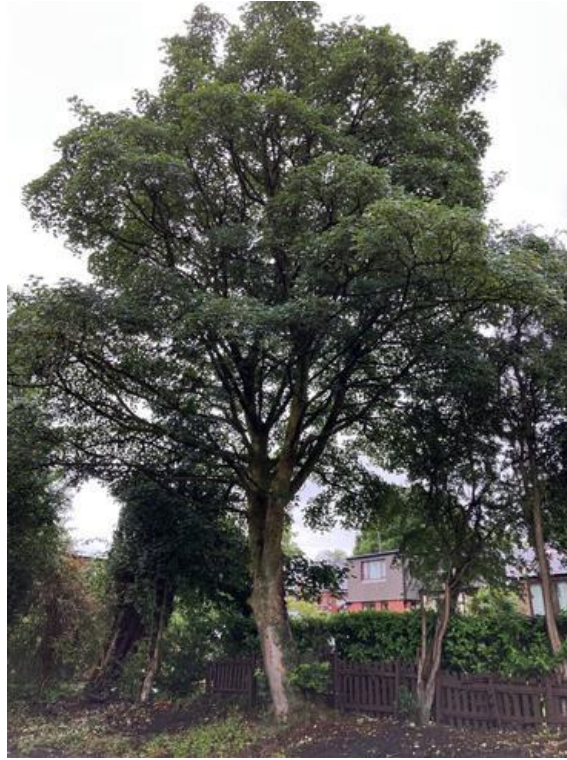
| <b>Geological</b> | <p>A volume change potential assessment may be required and given that the Site is lined by mature and semi-mature trees, consideration of the potential water demand of trees affecting foundations should be considered.</p> <p>Localised organic deposits may be present in the location of infilled field boundaries and adjacent to the stream along the southeast boundary.</p> |

PLATE 7      MATURE TREE – SOUTHERN BOUNDARY

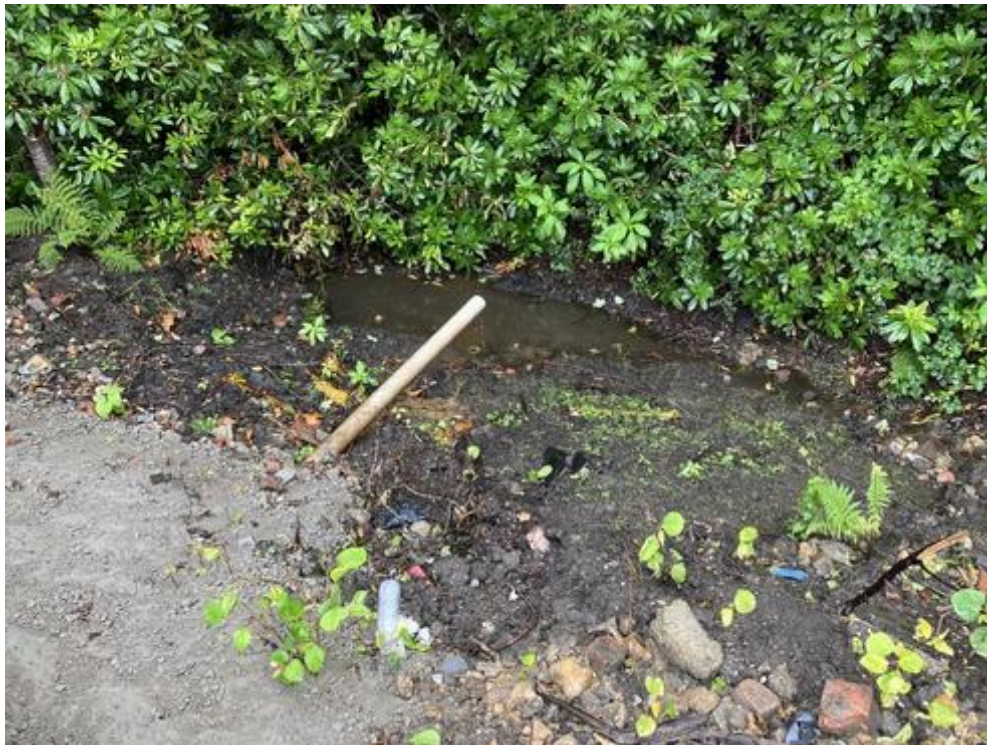
| <b>Drainage</b> | No manholes were identified during the site walkover. A drainage pipe was noted entering the stream in the south of the Site. |

PLATE 8      DRAINAGE PIPE TO BROOK
