# Preliminary Roost Assessment

Outbuilding to the rear of  
Longley Hey Farm

Littleborough

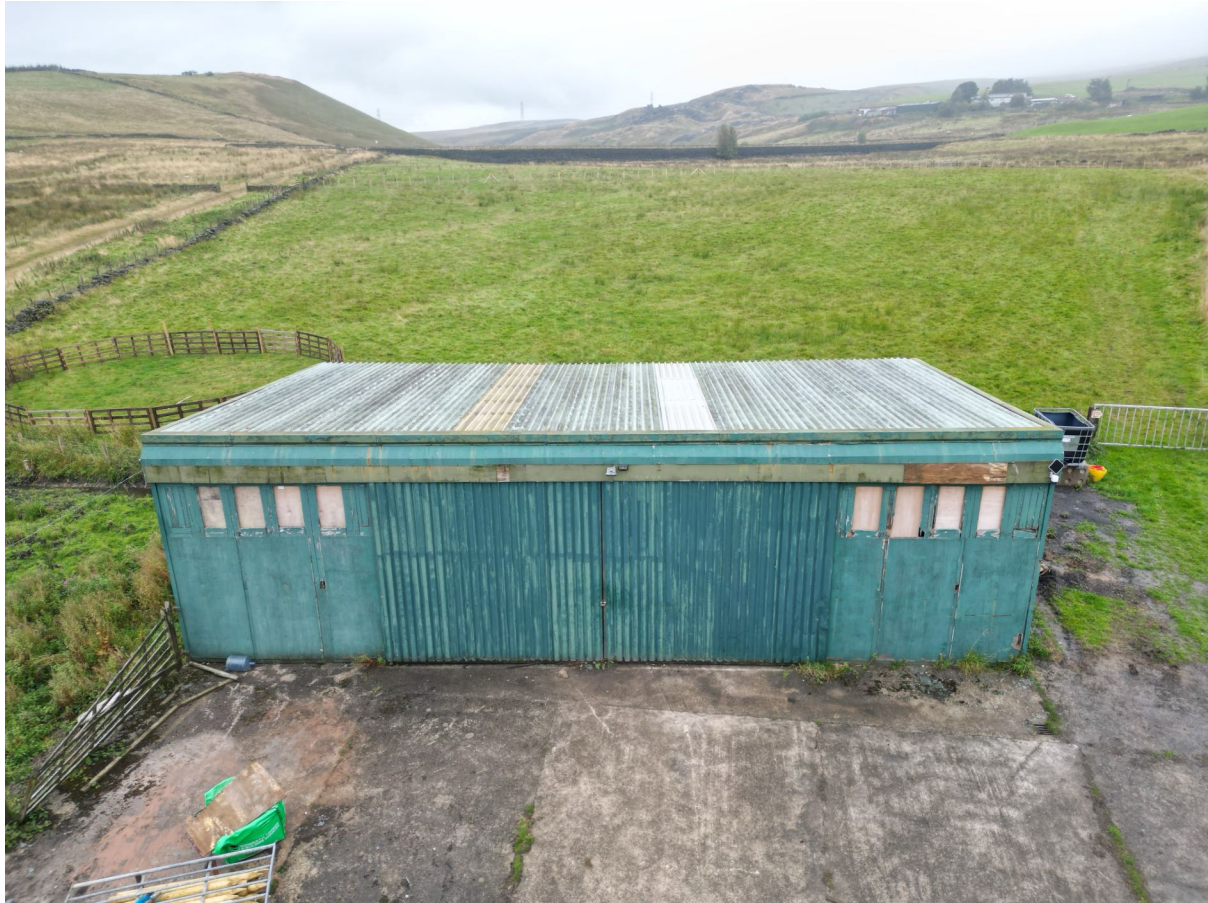
3.1a – Looking north toward the front of outbuilding.

The building has a single pitched corrugated steel roof with steel fascia to the front and sides, and timber fascia boards to the rear. Rear and side walls are a single layer of solid concrete blocks, front walls are single layered timber board with corrugated steel sliding doors.

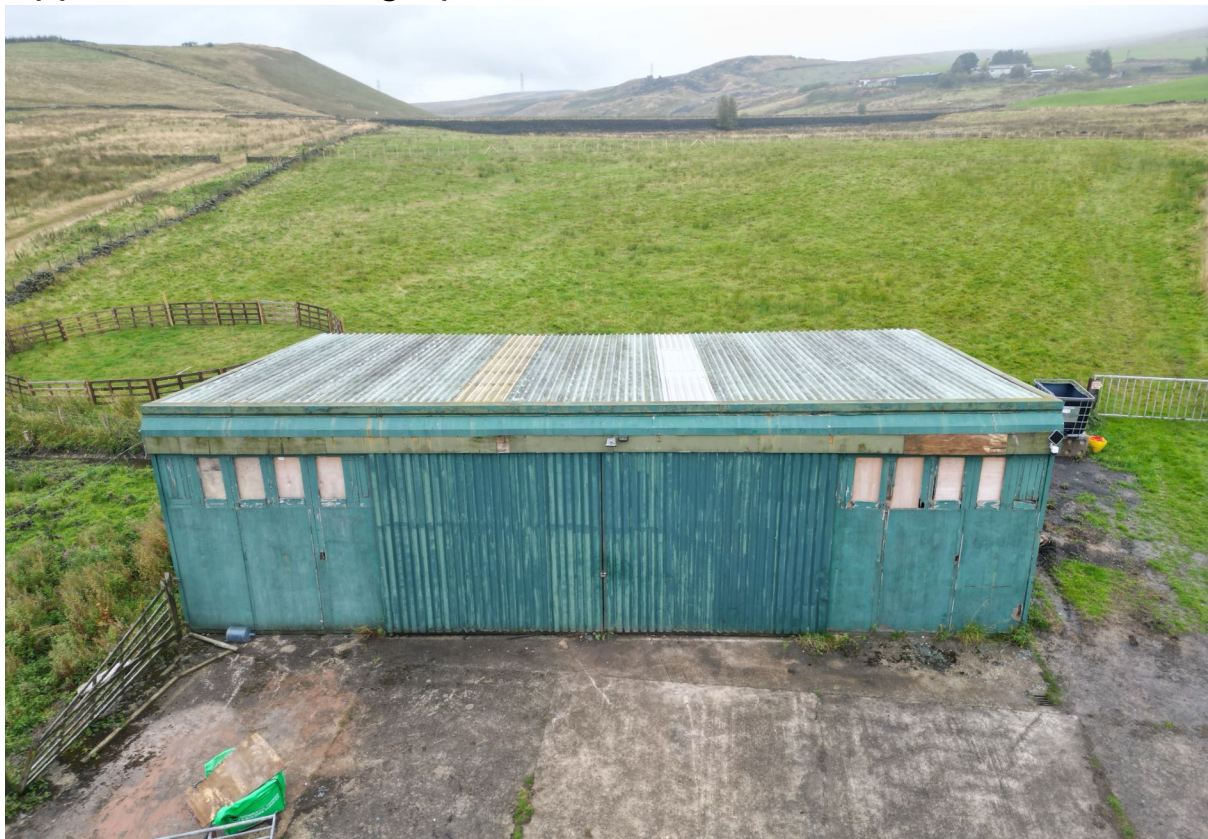
1 – The front of the building.

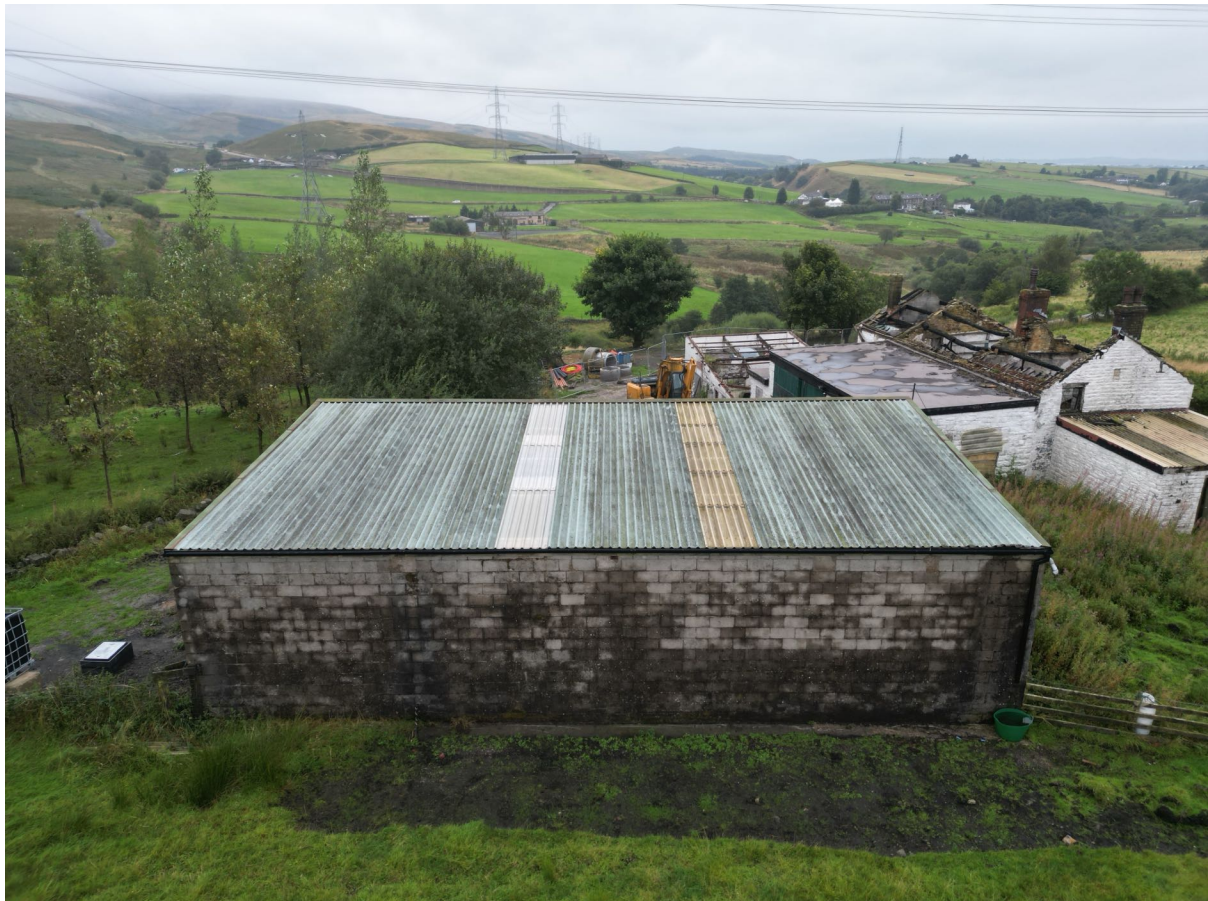
2 – The rear of the building.

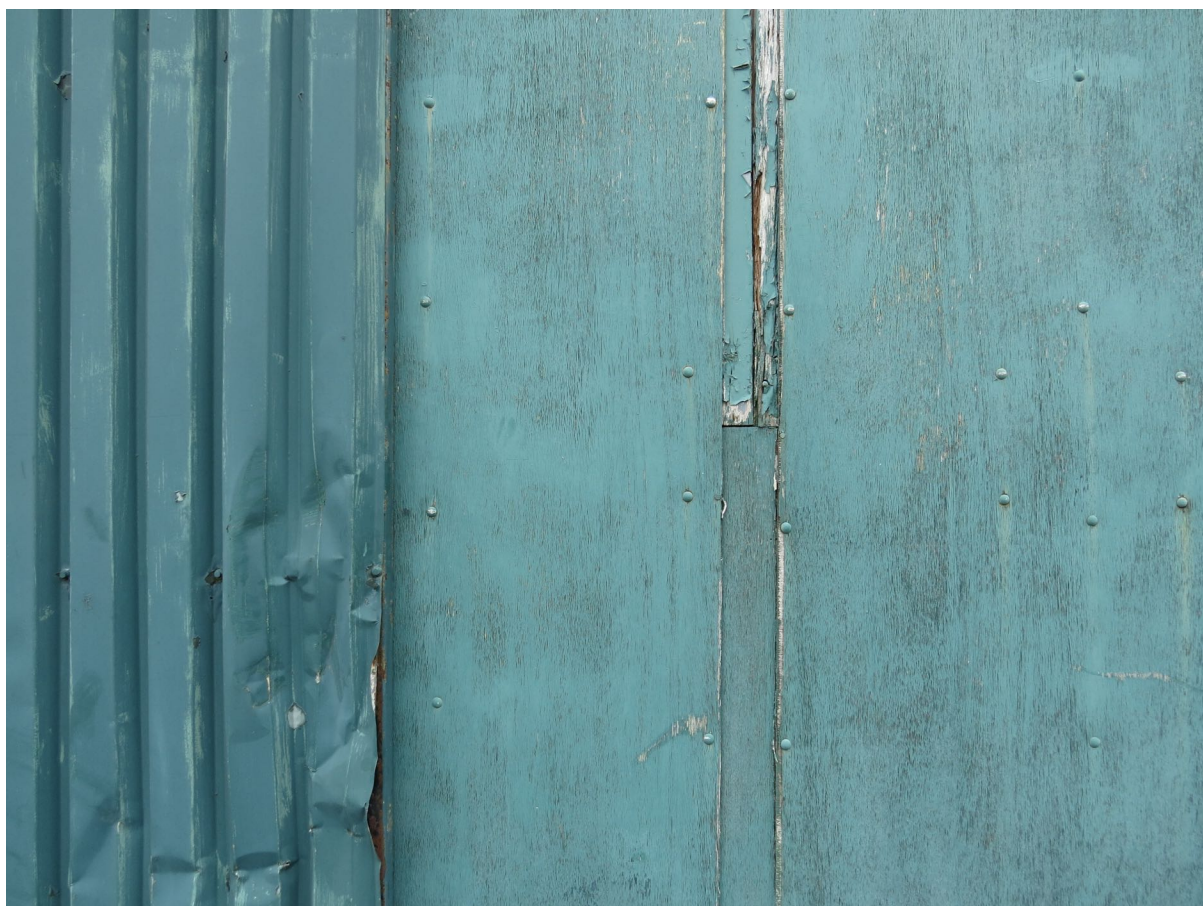
3 – The front walls are a single layer of timber boarding, sliding doors are corrugated steel.

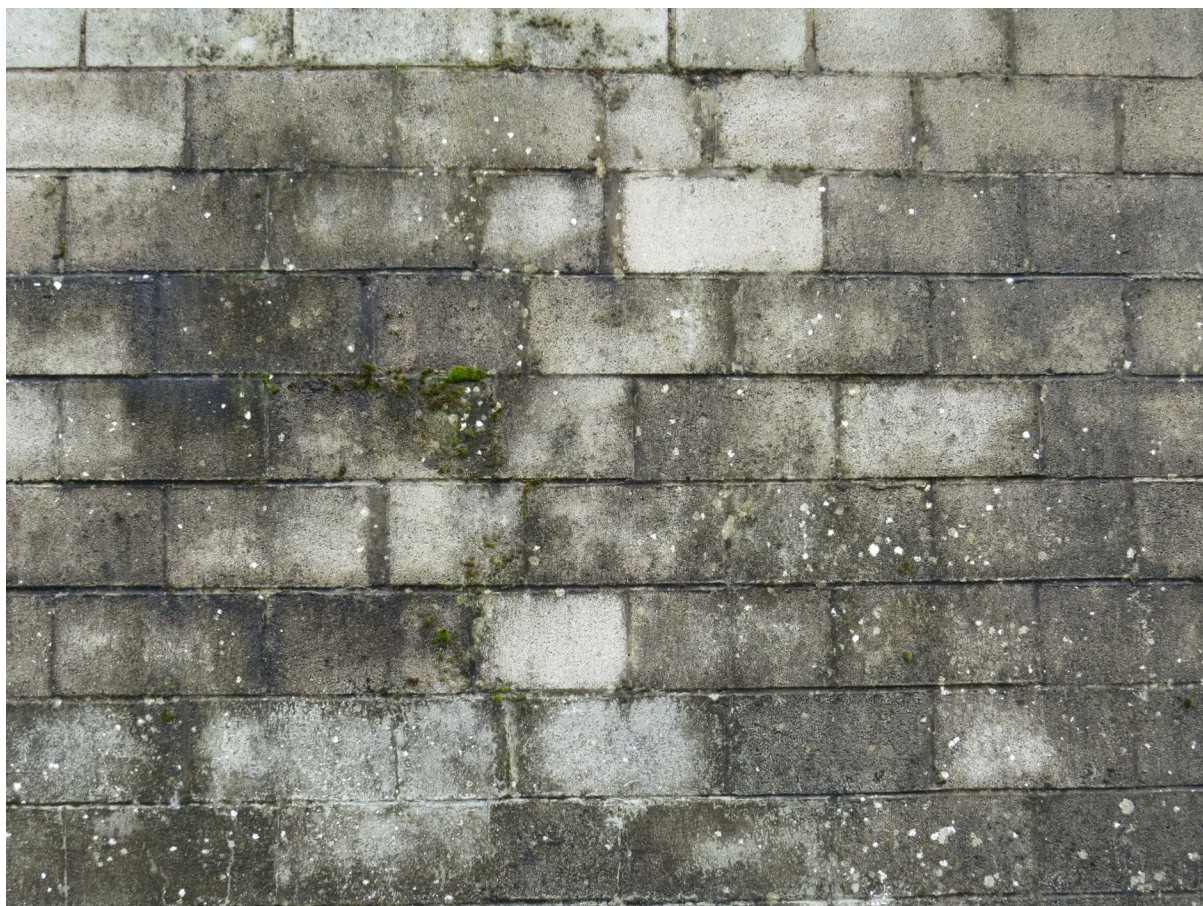
Walls are solid concrete blockwork with no insulating cavity. External walls are in good condition, with no cracks, or missing mortar which could be used by crevice dwelling bats. Internal walls are bare concrete blockwork, with no enclosed spaces or crevices suitable for use by roosting bats.

4 – Side and rear walls are a single layer or solid concrete blocks.

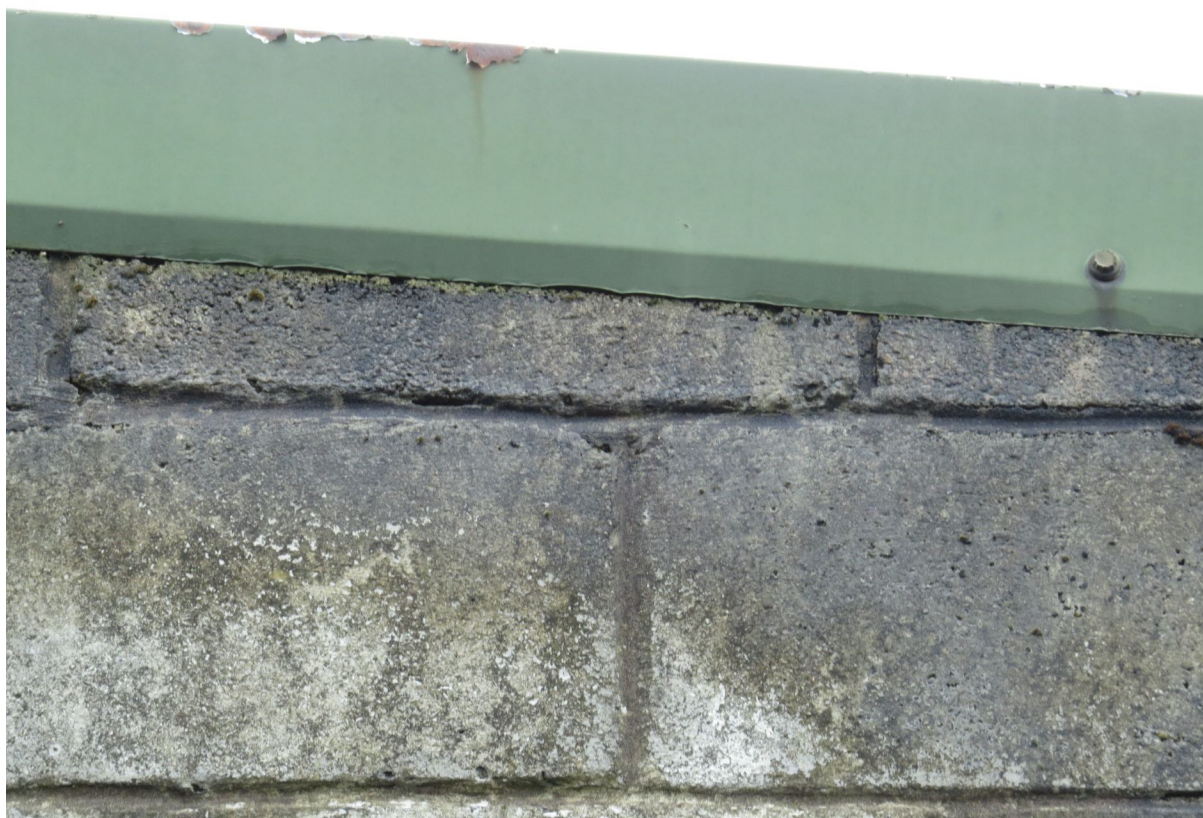
There are no features externally, which are suitable, or likely to be used by roosting bats; roof panels are in good condition, and fascia panels and boards are fixed tightly against the walls.

5 – Steel fascia panels are fitted tightly.

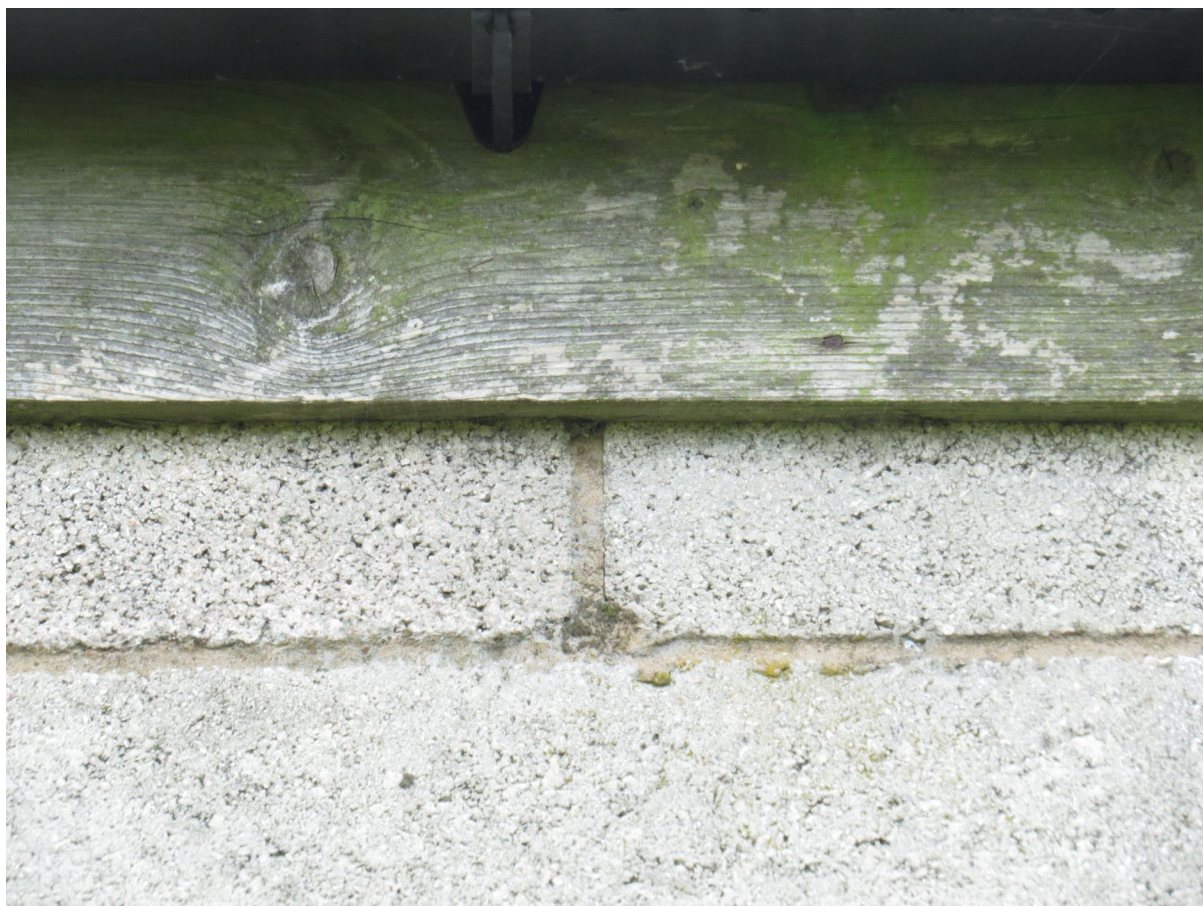
6 – Timber fascia are fitted tightly.

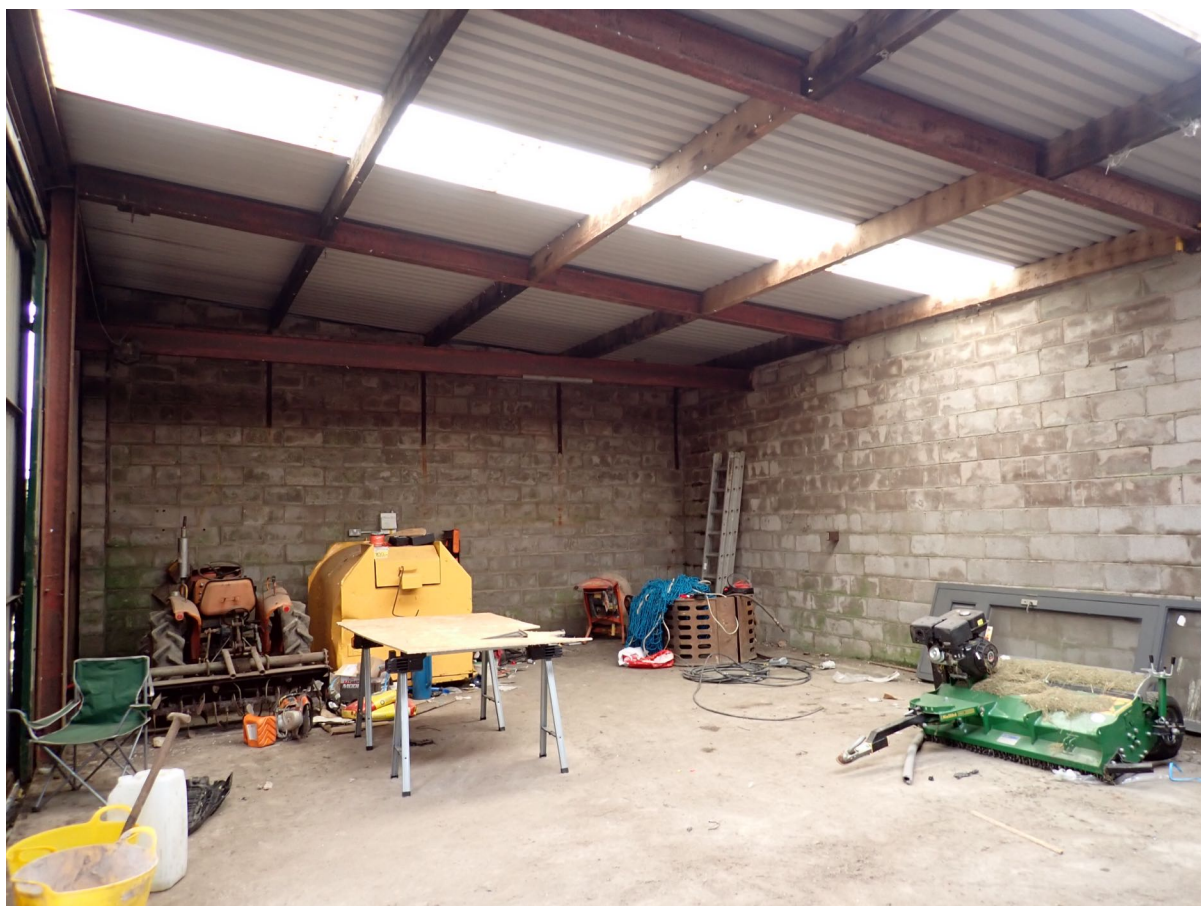
The building has no roof void, no enclosed crevices, or other suitably enclosed features which could be used by roosting bats. Additionally the building is well-lit by natural light, and subject to regular disturbance.

7 – The building has no enclosed spaces and is well-lit by natural light.

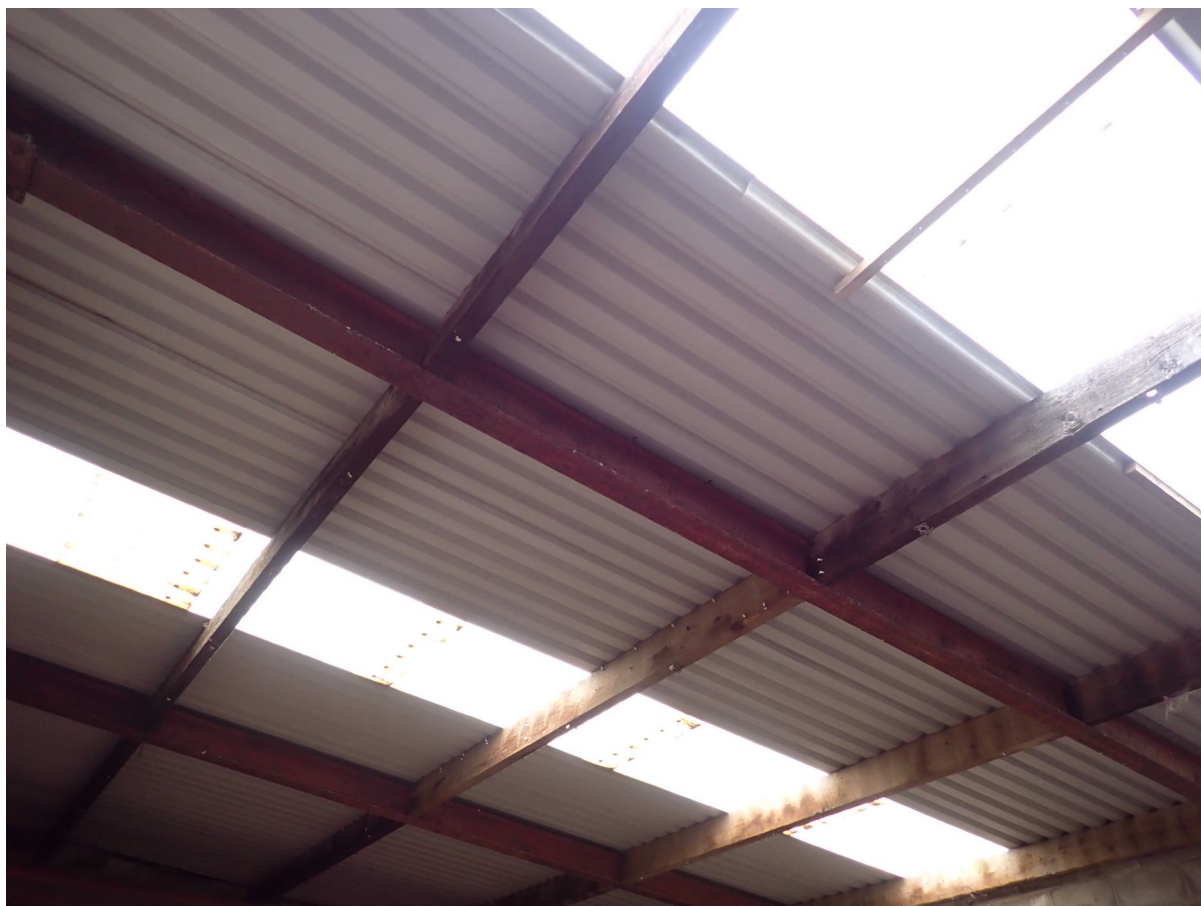
Internally the building consists of a single large open storage space, and has no internal roof void, or other enclosed areas. The roof has a simple steel and timber structure. The roof is not lined and the underside of roofing materials and supports is exposed. Walls are bare concrete blockwork, with no insulation or internal lining.

8 – The roof has a simple steel and timber structure with no insulation.

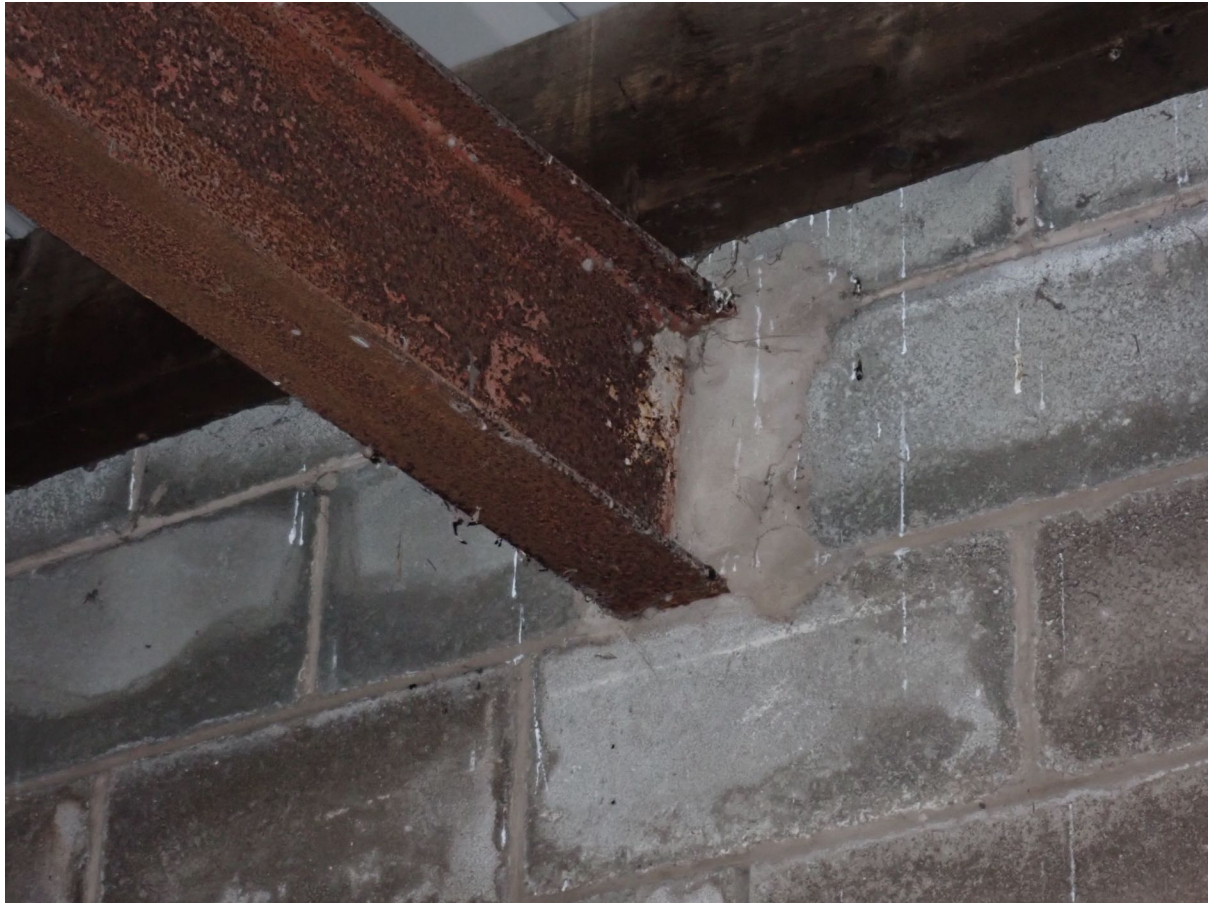
The top of walls at the eaves are exposed to the elements, and any gaps between roofing materials and concrete blockwork, are either filled with cement, or open to the elements, and do not provide sufficient shelter to be used by roosting bats.

9 – Steels are fixed into walls with cement, with no suitable gaps between materials.

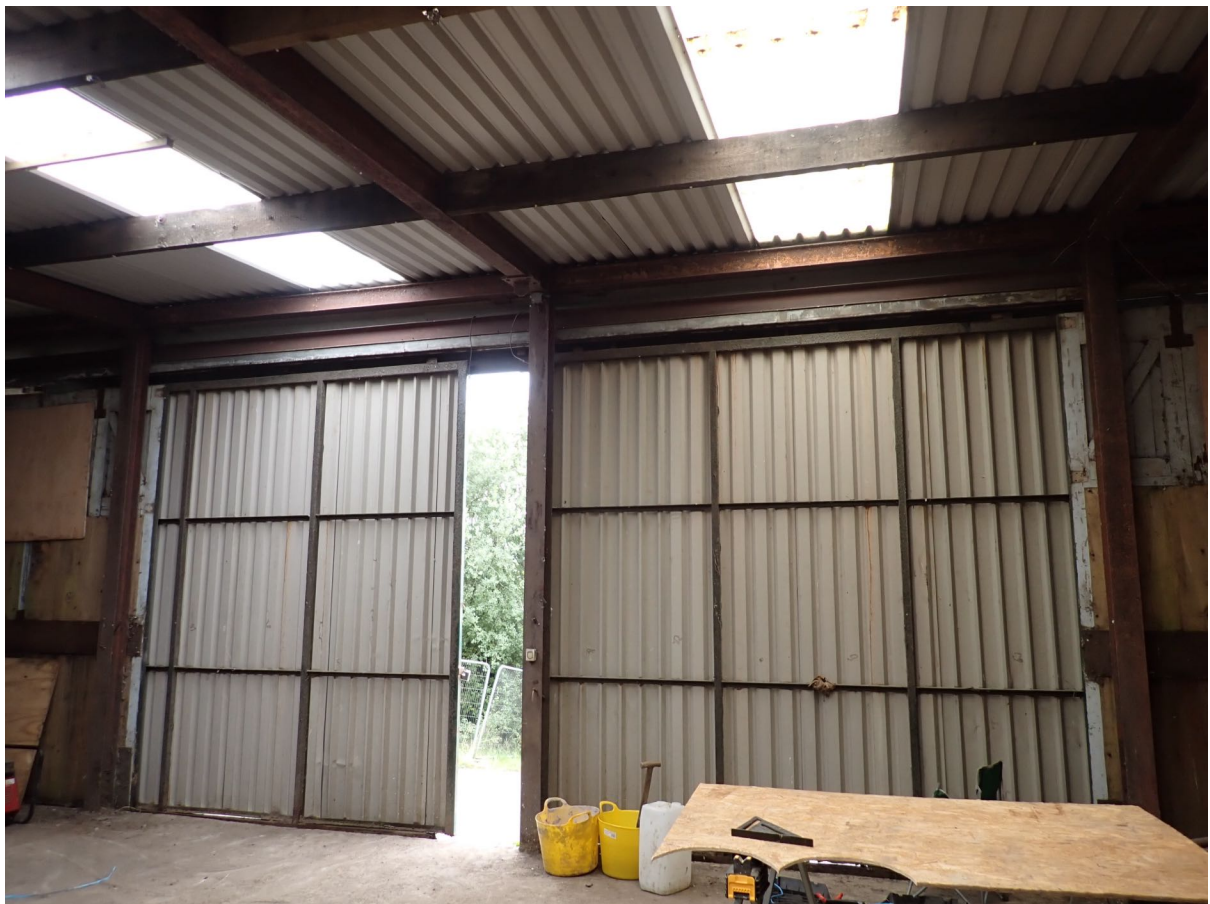
10 – The front doors and walls are of single layered materials with no enclosed crevices.
