Preliminary Roost Assessment and Ecological Walkover

The Farmhouse, Littleborough

Reference: 81-315-R1-1

Date: June 2023

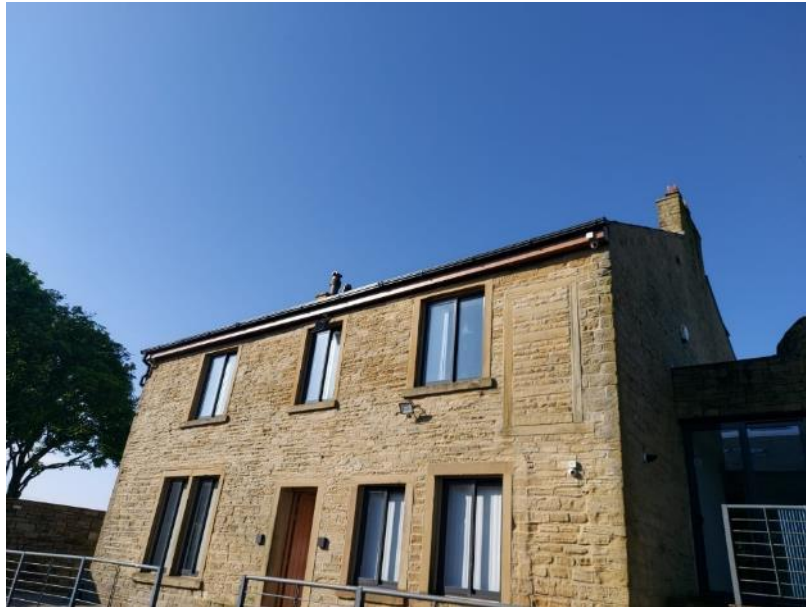
PLATE 1      SHOWING NORTH EASTERN ASPECT OF BUILDING 1

Building 1 (B1) was a residential building located in the south of the site. B1 was a three-storey building, constructed of stone with a pitched tiled roof. No loft void was present as it had previously been converted into an attic bedroom and ensuite. It had been noted during the survey that the roof had been previously covered in tarpaulin and may need to be replaced.

The stonework was in good condition with no cracks or gaps that could support crevice dwelling bat species. The windows were also in good condition.

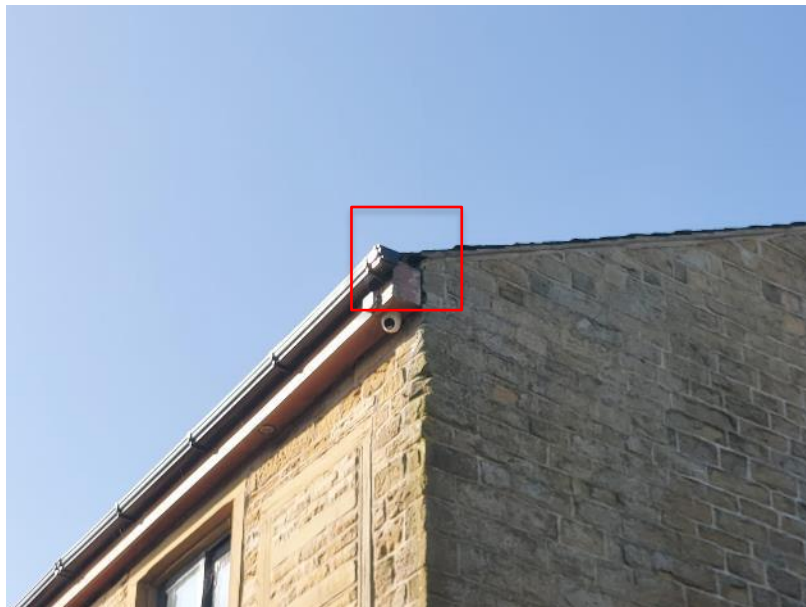
PLATE 2      SHOWING FEATURE ON NORTH WEST ASPECT

A gap approximately 10 cm across was present between the eave and soffit on the gable end of the north west facing aspect of the building. This feature may be used on a regular basis by bats. It should however be noted that starling were seen flying in and out of the gap, and as such the building supports nesting birds.

All three buildings were assessed as having Moderate bat roosting potential. As such, two nocturnal bat surveys are required on the buildings between May and September, with at least one of the surveys between May and August. If bats are identified roosting within the building, a third survey would be required to characterise the roost, a European Protected Species Licence would also be required and would require up to date surveys from the survey season prior to the application submission.

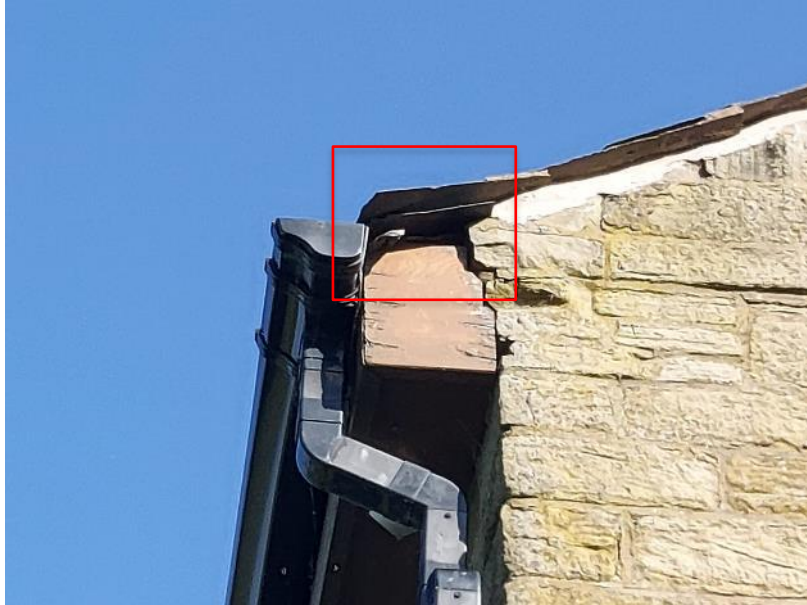
PLATE 3      SHOWING FEATURE ON SOUTH EAST ASPECT

A gap approximately 10 cm across was present between the eave and soffit on the gable end of the south east facing aspect of the building. This feature may be used on a regular basis by bats crevice dwelling bats such as common and soprano pipistrelle.

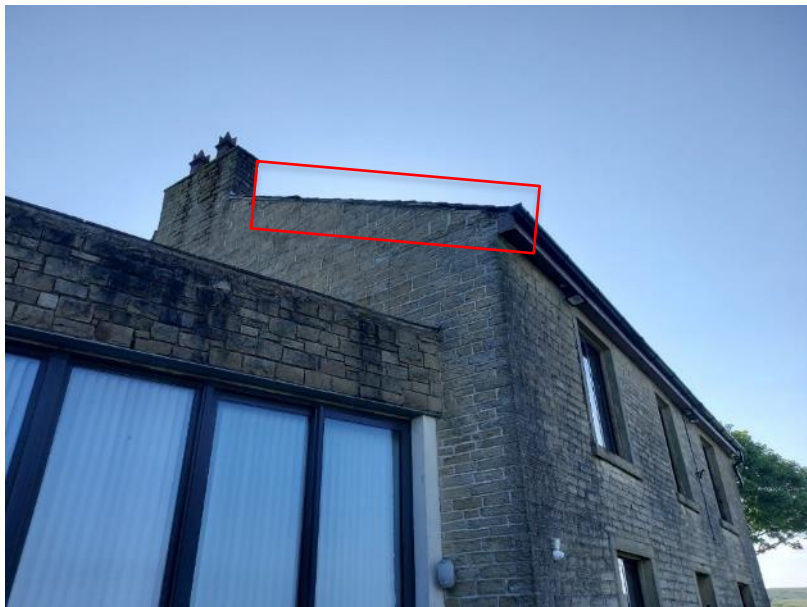
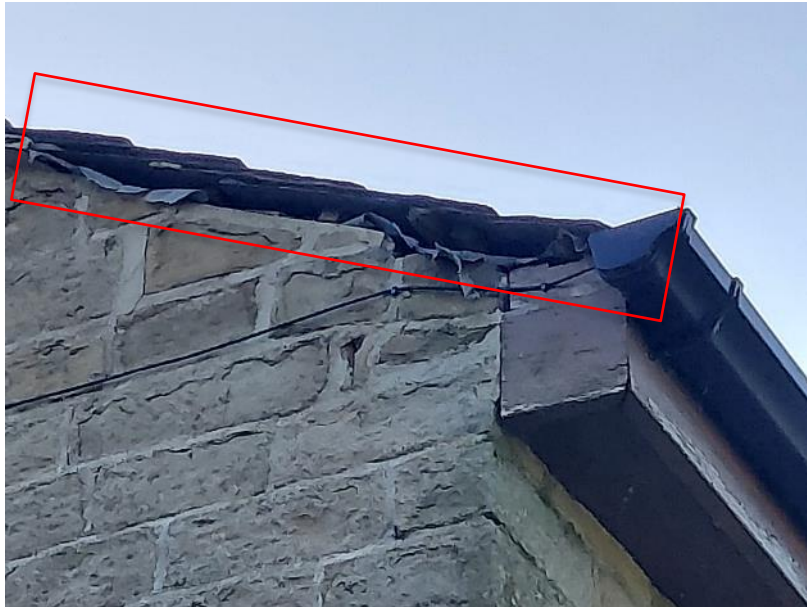
Gaps were present between the roof tiles and brickwork on the gable end of the north west facing aspect of the building. These features may be used on a regular basis by bats. A lifted tile was also noted near to the chimney, which may have the potential to support crevice-dwelling bat species on an occasional basis.

PLATE 4      SHOWING GAP BETWEEN ROOF TILES AND BRICKWORK ON NORTH WEST ASPECT

PLATE 5      SHOWING CLOSE UP OF GAPS ON NORTH WEST ASPECT

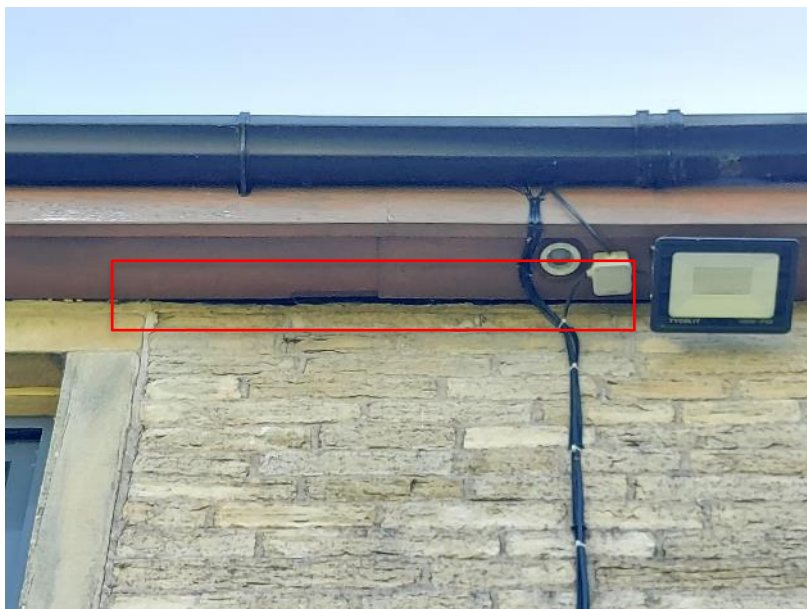
PLATE 6      SHOWING GAP BETWEEN BRICKWORK AND SOFFIT BOX

A gap was present between the brickwork and soffit box on the south west facing aspect of the building, which may have the potential to support crevice-dwelling bat species on an occasional basis. The gap may lead to additional features beneath the soffit, which may support regular roosting bats.

Overall, Building 1 (B1) was assessed as having **Moderate** bat roosting potential due to the multiple gaps on the gable ends of the building and gaps between brickwork and soffit box. B1 also has the potential to support nesting birds.

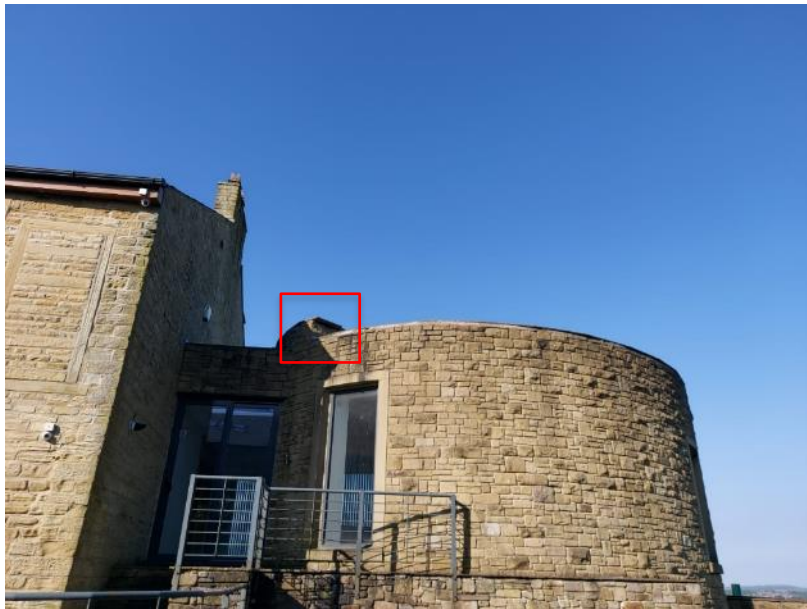
PLATE 7      SHOWING NORTH EASTERN FACING ASPECT OF BUILDING 1A

Building 1a (B1a) was an annex adjacent to the main residential building B1, constructed of stone with a flat roof. No loft void was present. It had been noted during the survey that B1a was due to be demolished.

The stonework was in good condition with no cracks or gaps that could support crevice dwelling bat species. The windows and door were also in good condition.

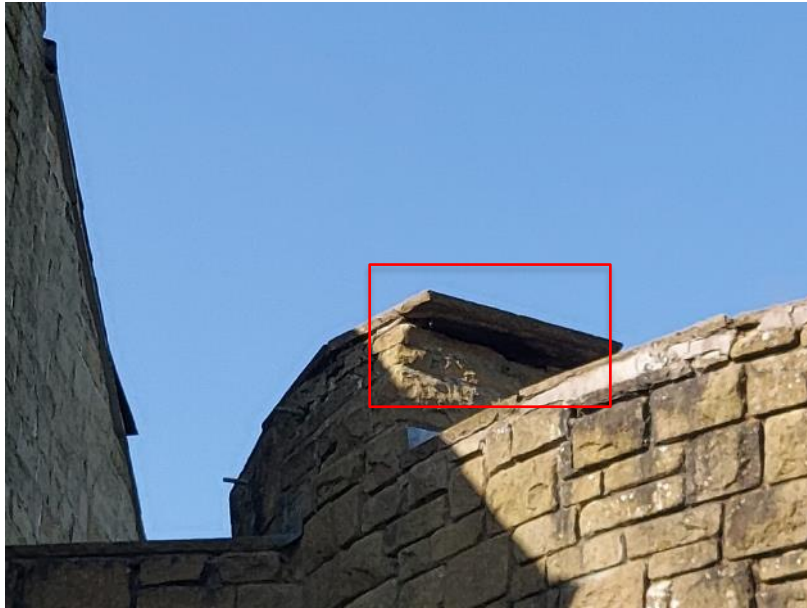
PLATE 8      SHOWING GAP BETWEEN ROOF TILE AND BRICK WORK

A gap between a roof tile and brickwork was present on the north east facing aspect that could support crevice dwelling bat species on a regular basis. Nesting birds may also make use of this feature.

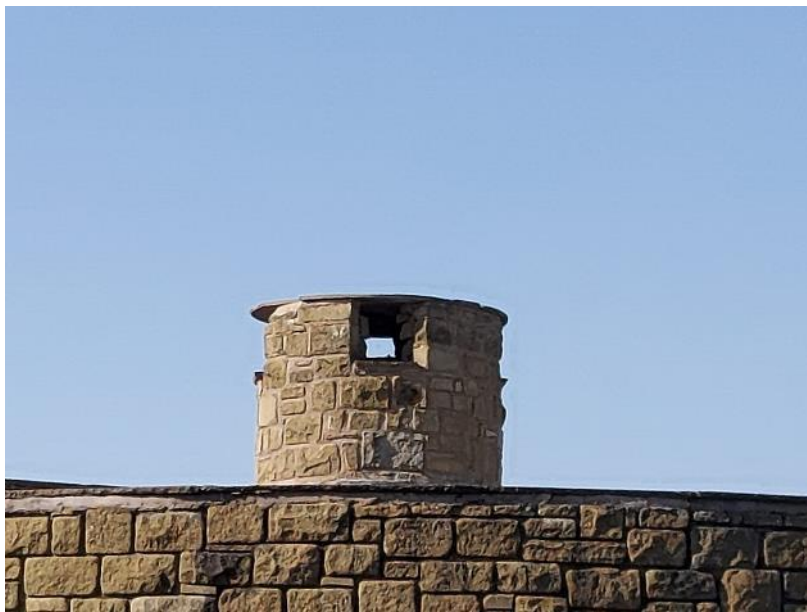
PLATE 9      SHOWING CHIMNEY AT CENTRE OF BUILDING 1A

A chimney with four entrances was noted which may be used on a regular basis by a large number of bats. It was assumed that no access into the building internals for bats was possible due to being sealed off prior renovations, as evidenced by signs of damp on the interior of the building below the chimney.

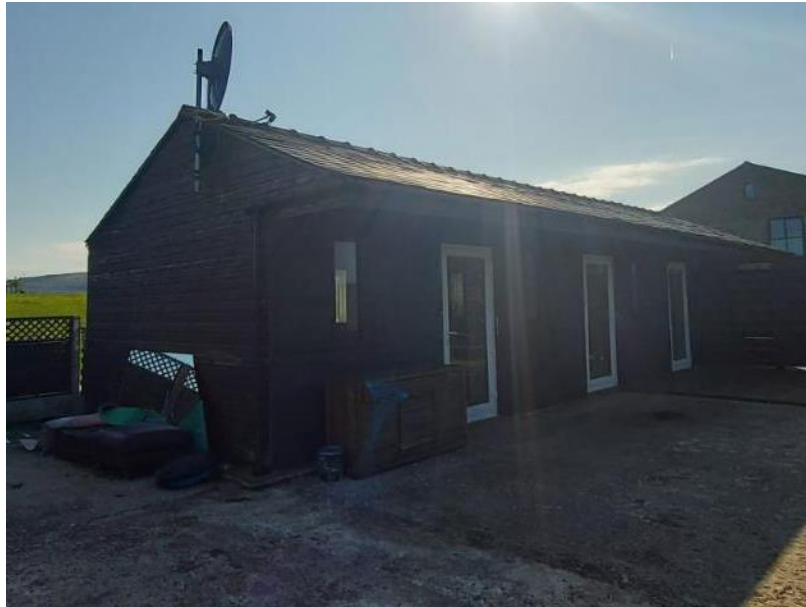
PLATE 11      SHOWING BUILDING 2

Building 2 (B2) was a converted stable constructed of wood panelled walls with a pitched tile roof. No loft void was present. It had been noted during the survey that B2 was due to be demolished.

The woodwork was in good condition with no cracks or gaps that could support crevice dwelling bat species. The windows and door were also in good condition.

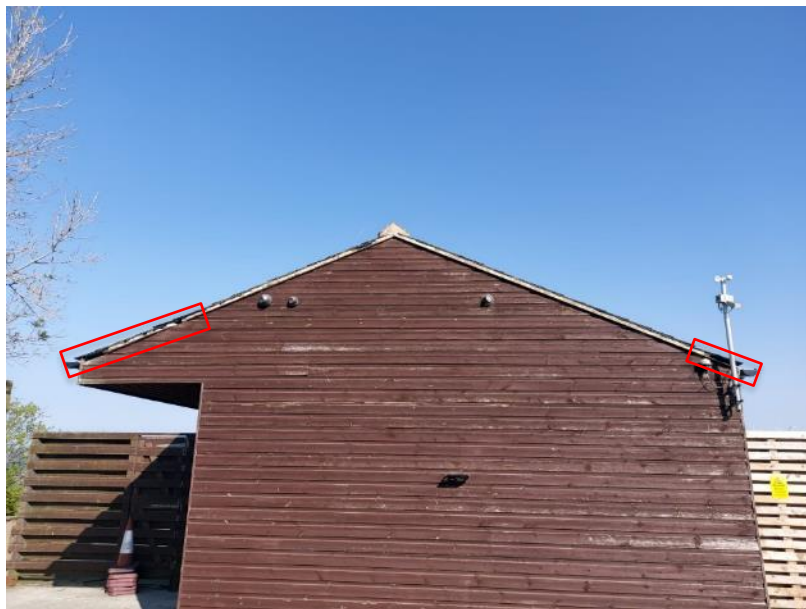
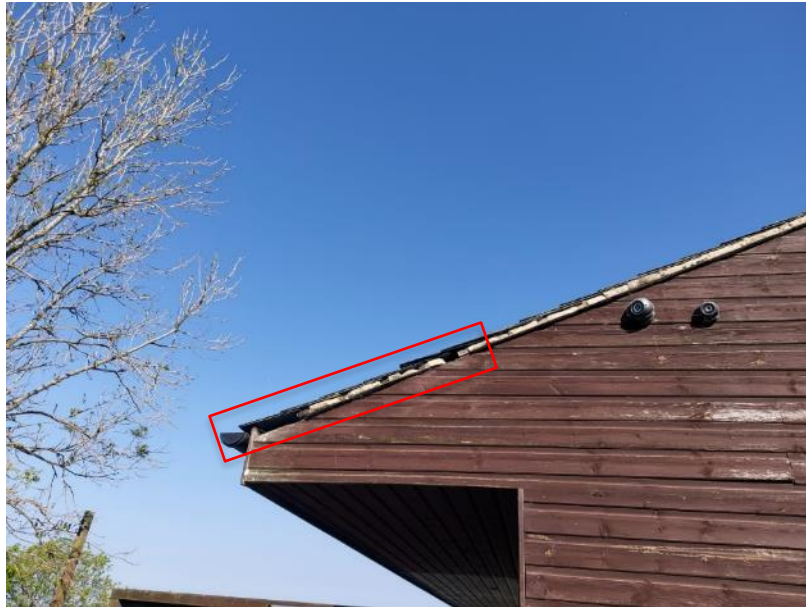
Gaps were present between the roof tiles and woodwork on the gable end of the south east facing aspect of the building. These features may be used on a regular basis by bats.

PLATE 12      SHOWING GAPS BETWEEN ROOF TILES AND WOODWORK

PLATE 13      SHOWING CLOSE UP OF GAPS BETWEEN ROOF TILES AND WOODWORK

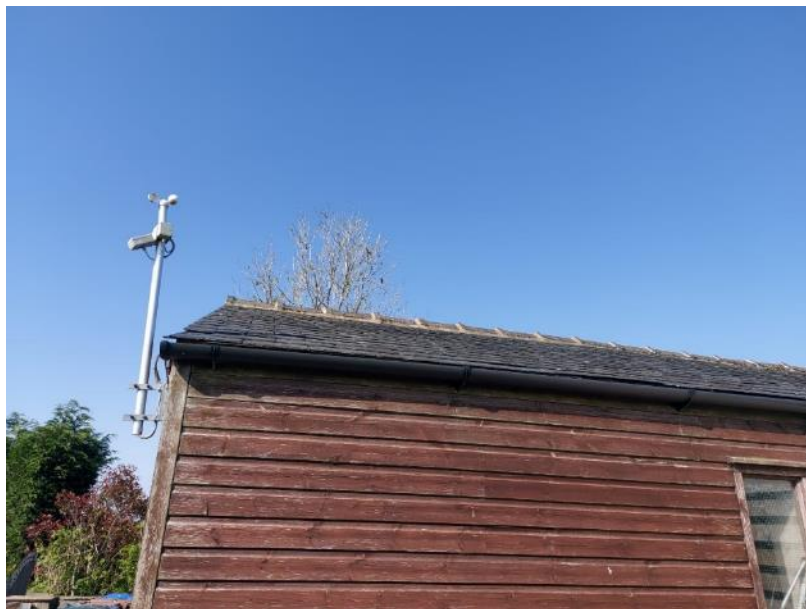
PLATE 14      SHOWING LIFTED TILES ON NORTH EAST FACING ASPECT

Lifted roof tiles were present on the north east facing aspect of the building. These features may be used on a regular basis by bats.

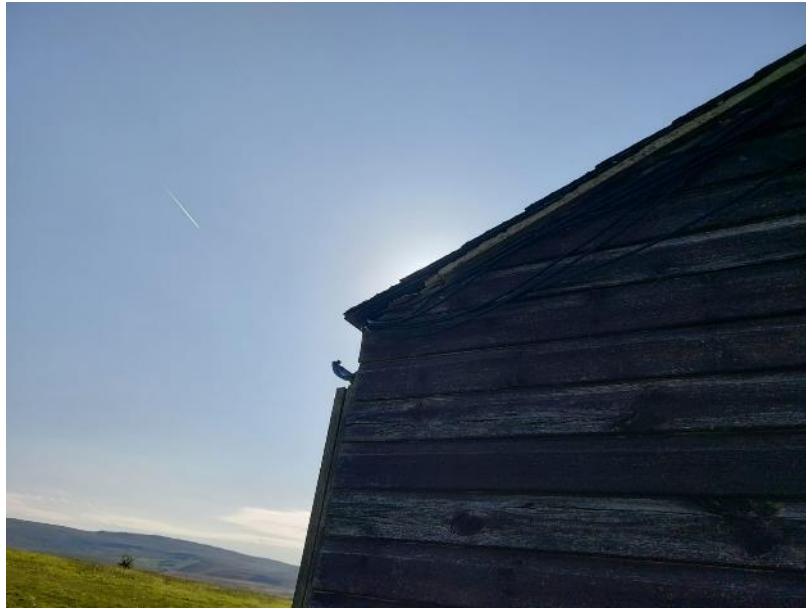
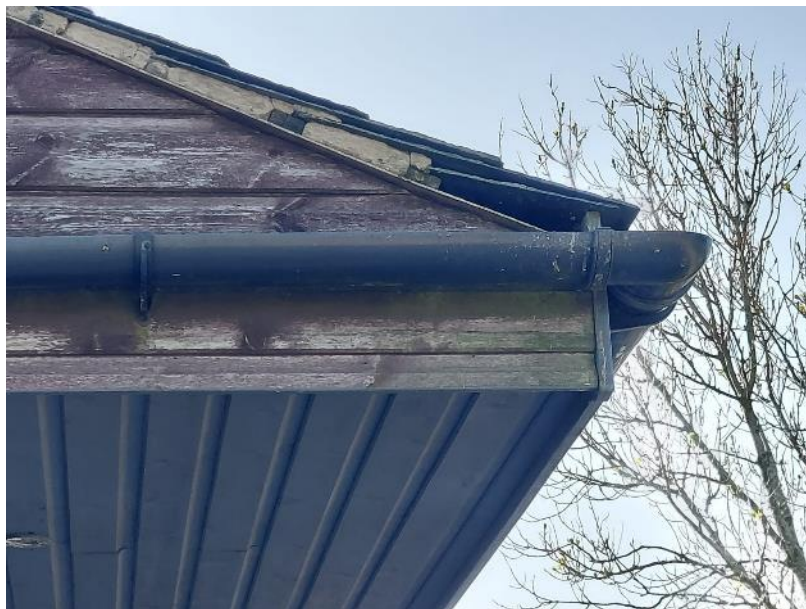
Gaps were present between the roof tiles and woodwork on the gable end of the north west facing aspect of the building. These features may be used on a regular basis by bats.

PLATE 15      SHOWING GAPS BETWEEN ROOF TILES AND WOODWORK

PLATE 16      SHOWING GAPS BETWEEN ROOF TILES AND WOODWORK
