# ARBORICULTURAL IMPACT ASSESSMENT AT A VAN STORAGE FACILITY, JOHN MILNE AVENUE, ROCHDALE

Prepared for Lysander

**By A.T. Coombes Associates Ltd.**

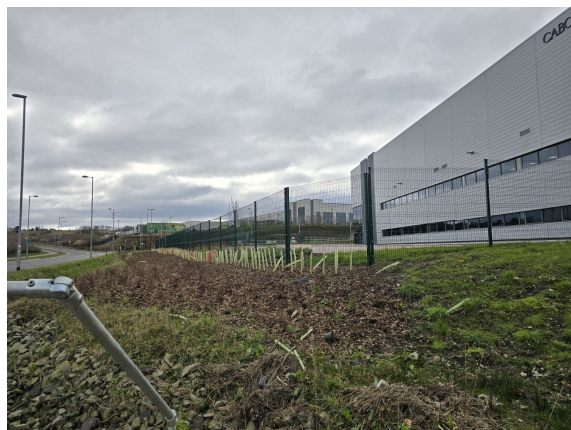
- 2.1 The site includes a, newly constructed, large industrial unit or warehouse building and associated hardstanding. The building is shown in figure 1 is enclosed by a security fence. There are no trees within the fenced compound. However, beyond the northern boundary is a row of trees edging Low Lane. The eastern end is shown in Figure 2.

Fig 1: The frontage of the building onto John Milne Avenue

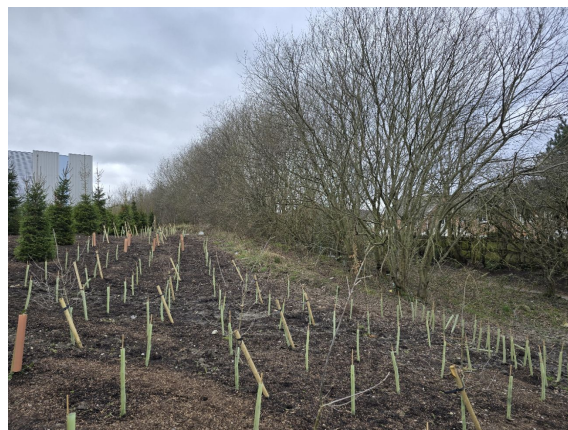
Fig 2: Outside the compound is an area of recent landscape planting and a row of willow edging the eastern end Low Lane.

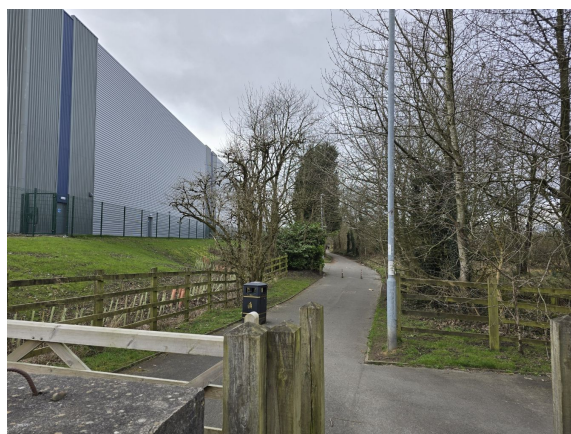
Fig 3: The junction of Low Lane and John Milne Ave

- 2.3 As shown in Figures 3 and 4 the lane is edged with trees including sycamore, ash, wild cherry, oak, hawthorn and willow. There is an old hawthorn hedge on the southern boundary of the lane which is shown in figure 5. Land to the north of the lane has a range of broadleaved trees including the row of Wild cherry and oak shown in figure 6.

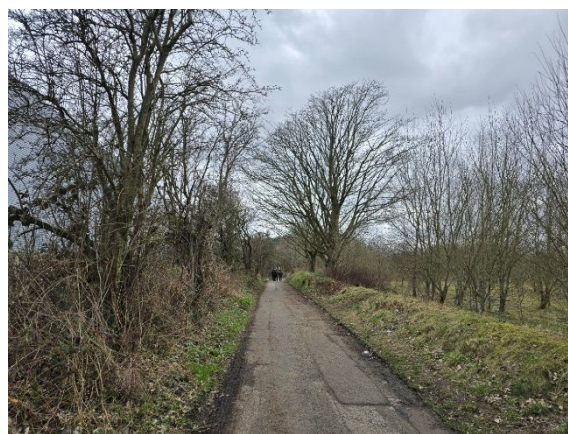
Fig 4: Scattered trees edging the lane.

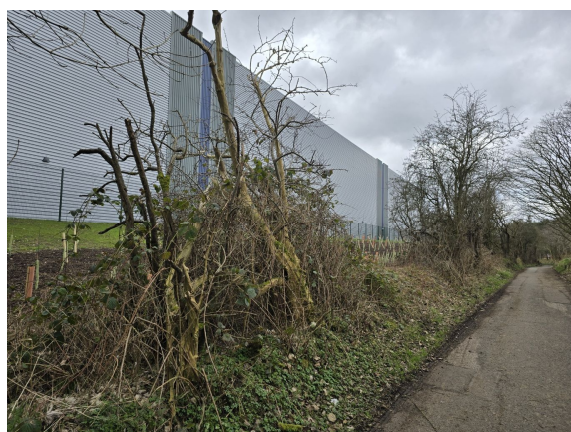
Fig 5: An old hawthorn hedge runs along the southern boundary of the lane it has gaps and some of the hawthorn are in poor condition

- 6.1 No tree work has been specified in column 12 of Appendix 1 for arboricultural and health and safety reasons other than the hawthorn hedge (G2) in Low Lane is in poor condition and as a minimum should be checked for dead stems likely to fall on the path. The hawthorn could also be coppiced the gaps filled with new planting. However, this is not needed for remediation as there will be no tree losses but purely for good arboricultural management.

- 6.2 If required, a suitable species mixture for gapping up is as follows:
- 40% Hawthorn (*Crataegus monogyna*)
  - 20% Blackthorn (*Prunus spinosa*)
  - 10% Field Maple (*Acer campestre*)

- 10% Hazel (*Corylus avellana*)
  - 10% Holly (*Ilex aquifolium*)
  - 10% Crab Apple (*Malus sylvestris*)
- 6.3 Plants to be of bare rooted transplants (60 to 90cm) protected individually using spiral shelters (600mm x 38mm) supported by 90cm bamboo canes. This would be planted in random mixture in a double staggered row at 0.5m spacing. The exact quantities and location of gapped up sections need be determined in advance.

- 6.4 The hedging must be maintained for a 5-year period. Work will include keeping an area of 1m in width centred along the length of the hedgerow free from weed growth using either herbicide or mulch, checking supports and guards and replacing any failures during the period with trees of the same species and quality.

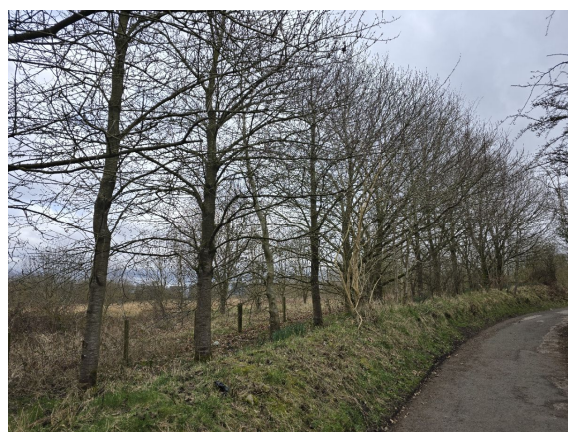
Fig 6: A row of Wild cherry and oak on the north side of the lane
