## Preliminary Ecological Appraisal and Roost Assessment

Rainshore House, Over Town Lane, Norden, Rochdale, Greater Manchester OL12 7TQ

18<sup>th</sup> April 2024

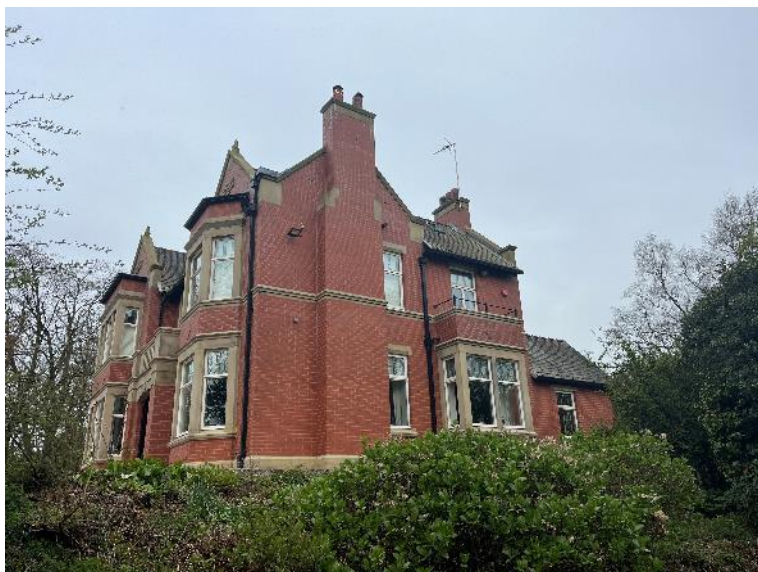
**Photo 1:** B1 – facing the eastern elevation.

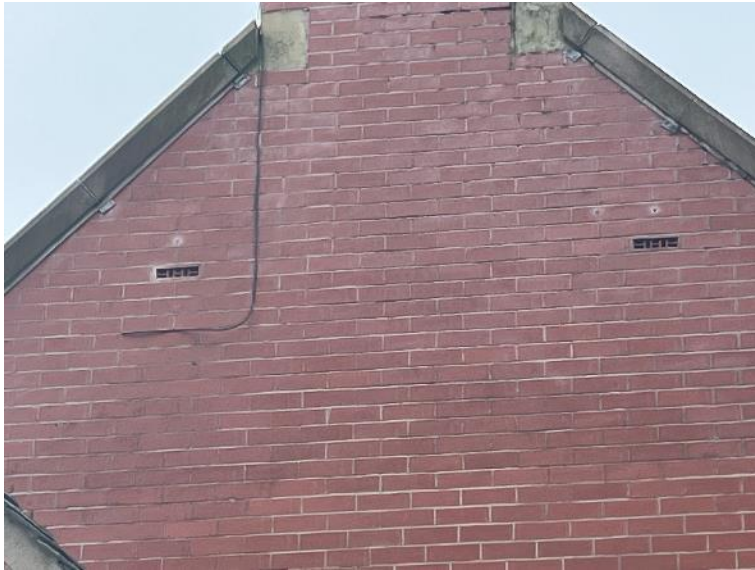
**Photo 3:** B1 – vents – northern elevation.

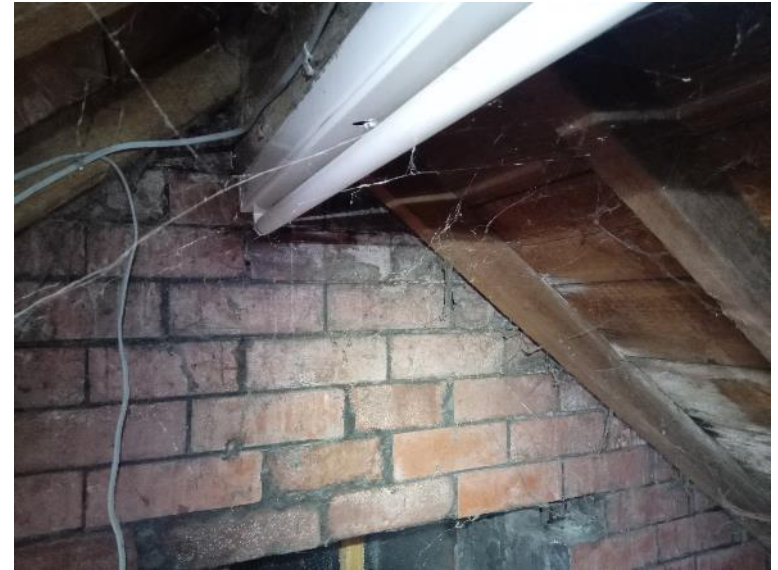
| | <p>➤ <u><b>Interior:</b></u> There are four accessible loft voids within the building, accessible hatches, the rest of the ceilings are vaulted. The roof structures internally look to be tightly clad internally, with wooden sarking. One of the loft voids (the main void) has a window which spills light into the void, likely suboptimal for void-dwelling species. The floor of the voids is covered in fibre wool membrane with boarding in places. No bat evidence was found internally of the loft voids (i.e., droppings, urine stains, feeding remains).</p> <ul style="list-style-type: none"> <li>▪ (Main loft void) - Approximate internal dimensions: 5m long x 7m wide x 2m high (floor to ridge height).</li> <li>▪ (Main loft void) - Internal conditions: temperature 9.0°C, humidity 58.2%.</li> <li>▪ (Smaller loft voids) - Approximate internal dimensions: 2m long x 1m wide x 1.5m high (floor to ridge height).</li> <li>▪ (Smaller loft voids) - Internal conditions: temperature 7.4°C, humidity 62.3%.</li> </ul> <p>➤ <u><b>Suitability Assessment:</b></u> B1 has <b>moderate</b> value for roosting bats. The gaps between the roof tiles are likely to support crevice-dwelling species of bats, possibly for transient periods, but possibly more frequently, and for larger numbers, given the number of gaps. The internal loft voids look to be tightly sealed, but bat presence within cannot be entirely discounted at this stage.</p> <p><b>B2 (on-site annexe):</b></p> <p>➤ <u><b>Exterior:</b></u> B2 is a brick-built annexe building with a pitched roof clad in slate roof tiles. The supporting walls were found to be intact without missing mortar or crevices, however, vents are present along the eastern and western elevations of the building which may support bat ingress. The majority of the roof tiles lie flush, however, a two very small and shallow gaps were recorded between the roof tiles, which are likely to be suboptimal due to their shallow depth creating poor thermal qualities, with them subject to inclement</p> |

**Photo 4:** B1 – main loft void.

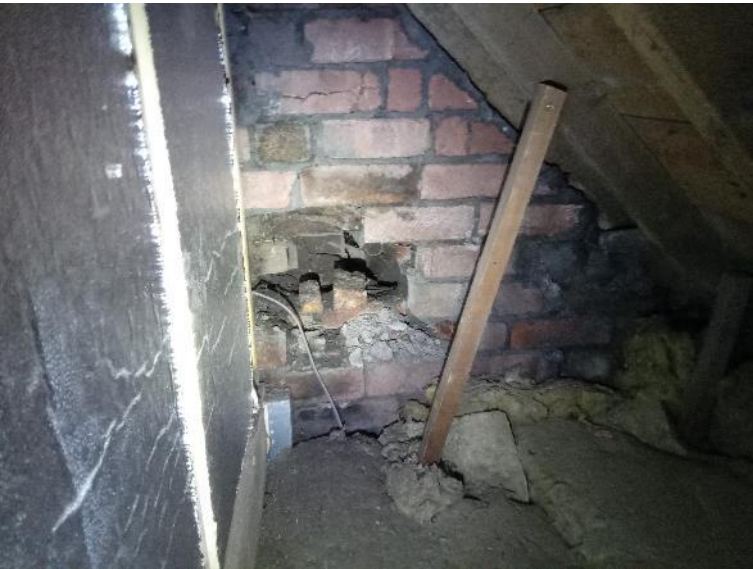
**Photo 5:** B1 - smaller loft void.

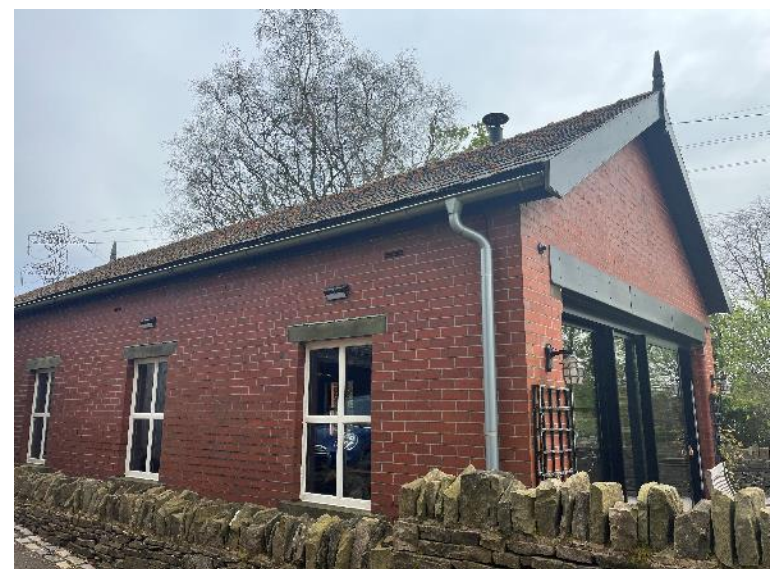
**Photo 6:** B2 – southern and western elevations.

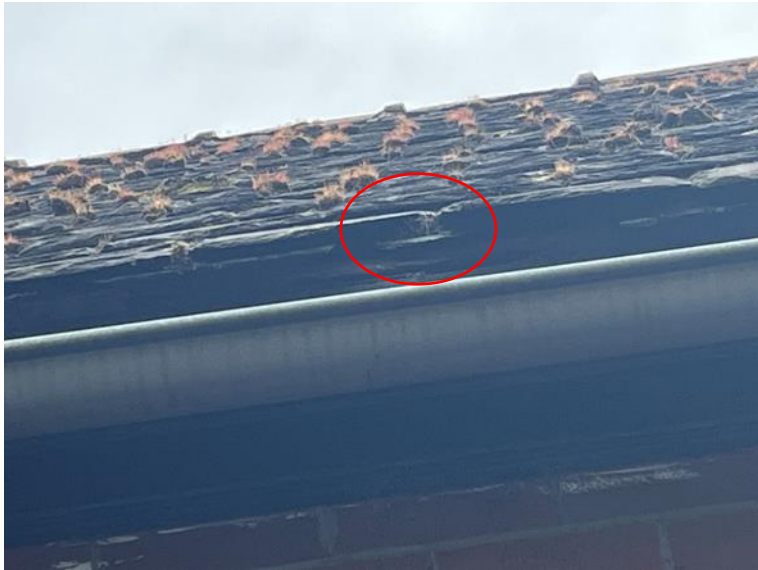
| | <p>weather. No other suitable bat roost features were recorded externally. No external evidence of roosting bats was recorded along the exterior of the building (i.e., oil stains, droppings along ground-level windowsills/doorframes).</p> <p>➤ <u>Interior:</u> There are no loft spaces within B2, the roof structure is exposed within the void. The wooden sarking internally of the void looks to be tightly sealed, without ingress opportunities. Furthermore, the void is filled with daylight spill due to the windows and glass doors. No bat evidence was found internally of B2 (i.e., droppings, urine stains, feeding remains).</p> <ul style="list-style-type: none"> <li>▪ Approximate internal dimensions: 14m long x 8m wide x 4m high (floor to ridge height).</li> <li>▪ Internal conditions: temperature 8.6°C, humidity 55.2%.</li> </ul> <p>➤ <u>Suitability Assessment:</u> B1 has <b>low</b> value for roosting bats. The sparse gaps between a few of the tiles look to be shallow and suboptimal, subject to inclement weather and thermal fluctuations, suboptimal for roosting bats other than for transient periods. There are also a few vents, but these are likely to be subject to daylight internally.</p> <p><b>B3 (on-site garage):</b></p> <p>➤ <u>Exterior:</u> B3 is wooden-built garage building, with a pitched and gabled roof clad in cement roof tiles. The wooden supporting walls and cladding were found to be intact and without features. The roof tiles were found to lie flush, without gaps large enough to support crevice-dwelling species, or void-dwelling entry. No suitable bat roost features were recorded externally. No external evidence of roosting bats was recorded along the exterior of the building.</p> |

**Photo 7:** B2 – gap between tile along western elevation.

| <i>Recommendations</i> | <p><b><u>Roosting bats:</u></b></p> <p><b>B1 and B2:</b> In the event of any structural works to these buildings (i.e., works to the roof, loft voids, supporting walls), Bat Emergence Re-entry Surveys (BERS), will be required and this report should be updated.</p> <p><b>B3:</b> In the unlikely event that a bat or evidence of bats is discovered during the development all work must stop and a bat-licensed ecologist contacted for further advice.</p> <p><b>In the event of any tree pruning/felling, a separate GLTA should be undertaken for the site trees, due to be impacted.</b></p> <p><b><u>Foraging and commuting bats:</u></b></p> |

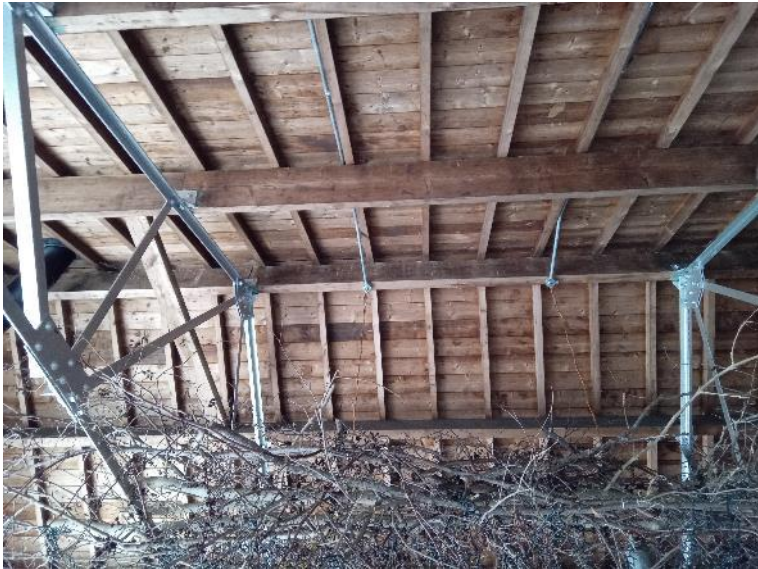
**Photo 9:** B2 – interior.

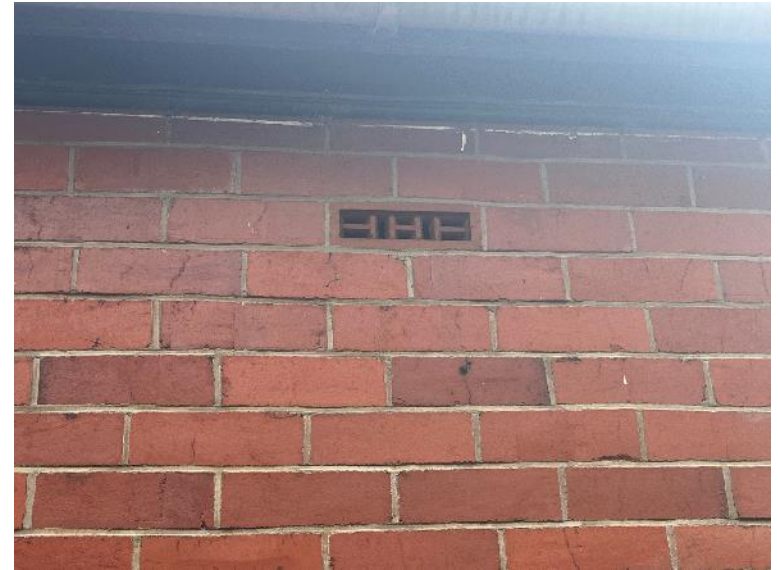
**Photo 8:** B2 – northern elevation vent.

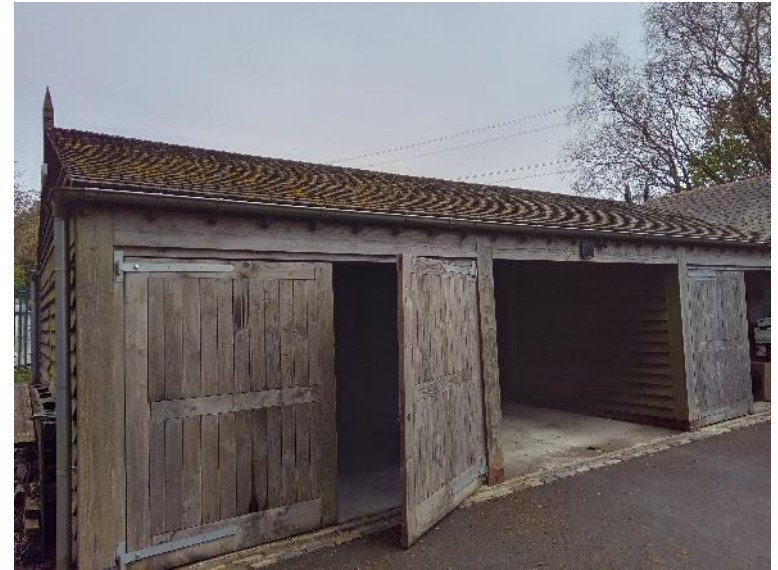
**Photo 10:** B3 – southern elevation.

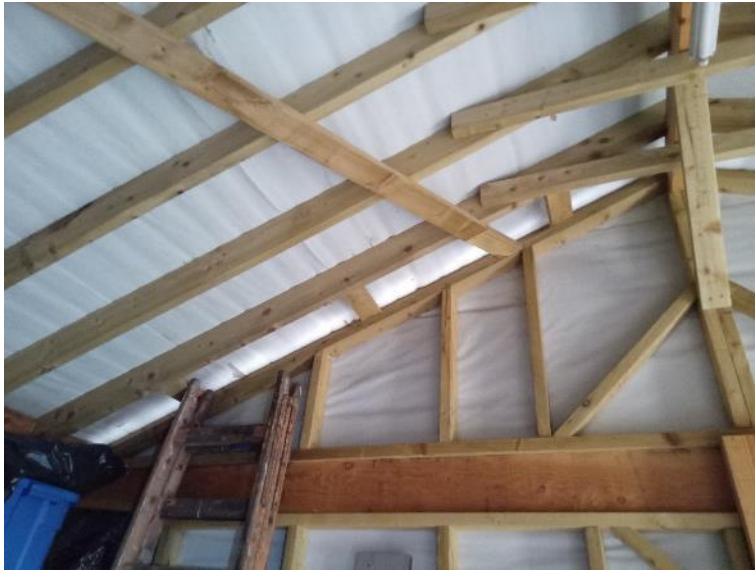
| | <p>➤ <u><b>Interior:</b></u> There are no loft spaces within B3, the roof structure is exposed within the void. The roof is lined with breathable membrane which is intact. The structure looks to be tightly sealed. Furthermore, the void is filled with daylight spill in a section due to an open section of elevation.</p> <ul style="list-style-type: none"> <li>▪ Approximate internal dimensions: 10m long x 6m wide x 3m high (floor to ridge height).</li> </ul> <p>➤ <u><b>Suitability Assessment:</b></u> B3 has <b>negligible</b> value for roosting bats, based on a lack of suitable roost features and evidence in or around B3.</p> <p><b>Trees:</b></p> <p>➤ Given the number of on-site trees, the trees were not subject to a separate Ground Level Tree Assessment (GLTA).</p> <p><u><b>Foraging and commuting bats:</b></u></p> <p>On-site habitats include a vegetated garden, which is of low value for local foraging and commuting bats. However, this habitat could be used by bats dispersing from nearby roosts.</p> |

**Photo 11:** B3 – interior.

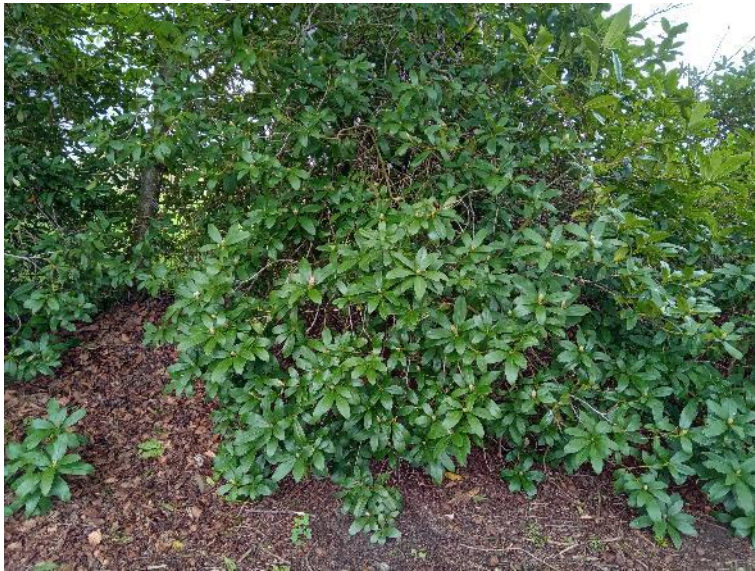
| <i>Summary of Survey Findings</i> | <p>Common rhododendron <i>Rhododendron ponticum</i> was recorded in a few locations across the site. Large stands were located across the northern, eastern and southern boundaries (approximate grid references (central point of stands): SD 85308 15098, SD 85320 15060, and SD 85312 15044), with two separate bushes across the site (approximate grid references: SD 85251 15042, and SD 85301 15072). This species is listed as a Schedule 9 species on the Wildlife and Countryside Act, 1981.</p> <p>No other problematic invasive non-native species were recorded on-site.</p> |

**Photo 17:** Common rhododendron within the site.

| <i>Recommendations</i> | <p><b>Rhododendron present on-site will be sensitively removed prior to the commencement of works to prevent the spread of a non-native, invasive species listed on Schedule 9 of the Wildlife and Countryside Act, 1981.</b> The rhododendron will be removed using hand tools only. The most effective method of removal is through hand pulling, which results in minimal soil disturbance. Hand-pulling young shrubs will typically result in the full removal of the shrub and associated root network, which will prevent the re-establishment. Mature shrubs are likely to have a deeper and more established root network unlikely to be removed in full by hand pulling alone. Where there are mature shrubs, removal should be aided using hand tools to expose the root network in full so the entire shrub and associated roots</p> |

| | <p>can be removed. The rhododendron should then be disposed of in line with appropriate controlled waste measures.</p> <p><b>Development works will not commence until rhododendron has been successfully removed from the site.</b></p> |

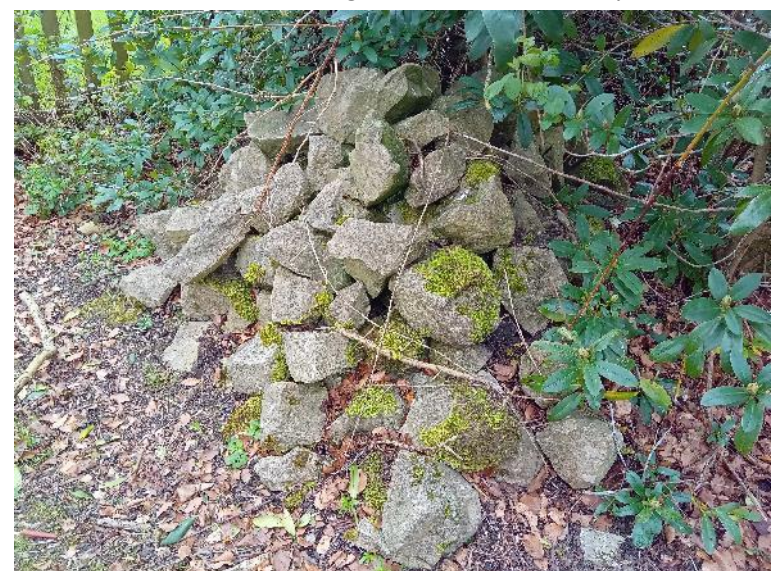
**Photo 18:** Rubble pile.

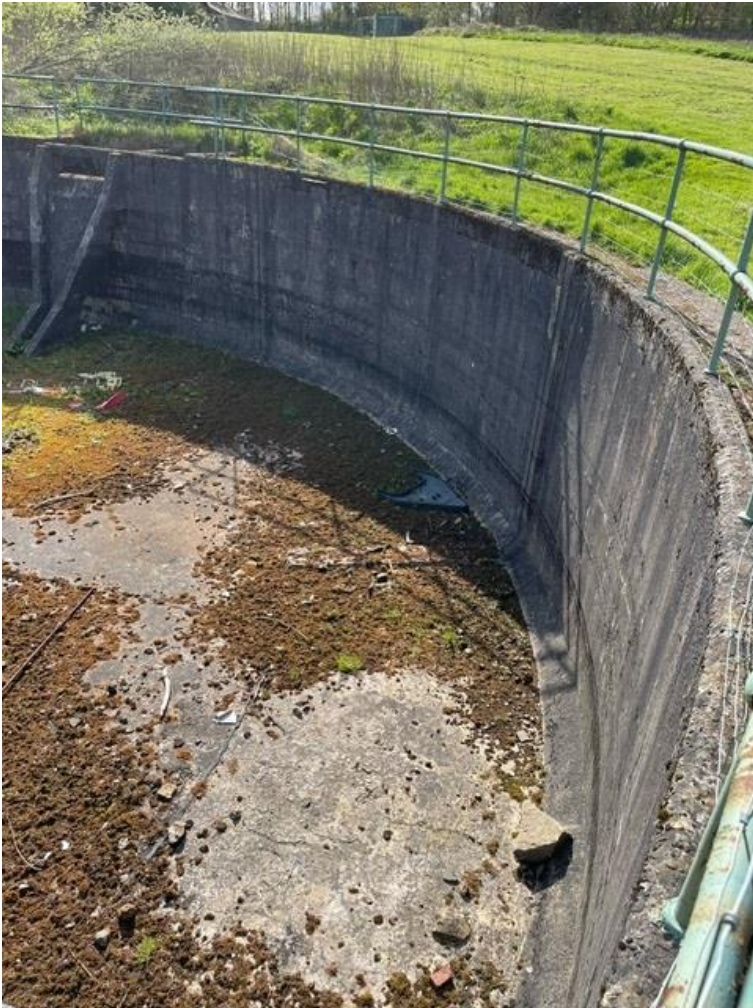
**Photo 19: W1 - drain ~38m northeast of the site boundary.**
