Touchstones Art Gallery, Rochdale  
Alterations and Repairs to Roof Zone 2

Heritage, Design and Access Statement

For Rochdale Development Agency

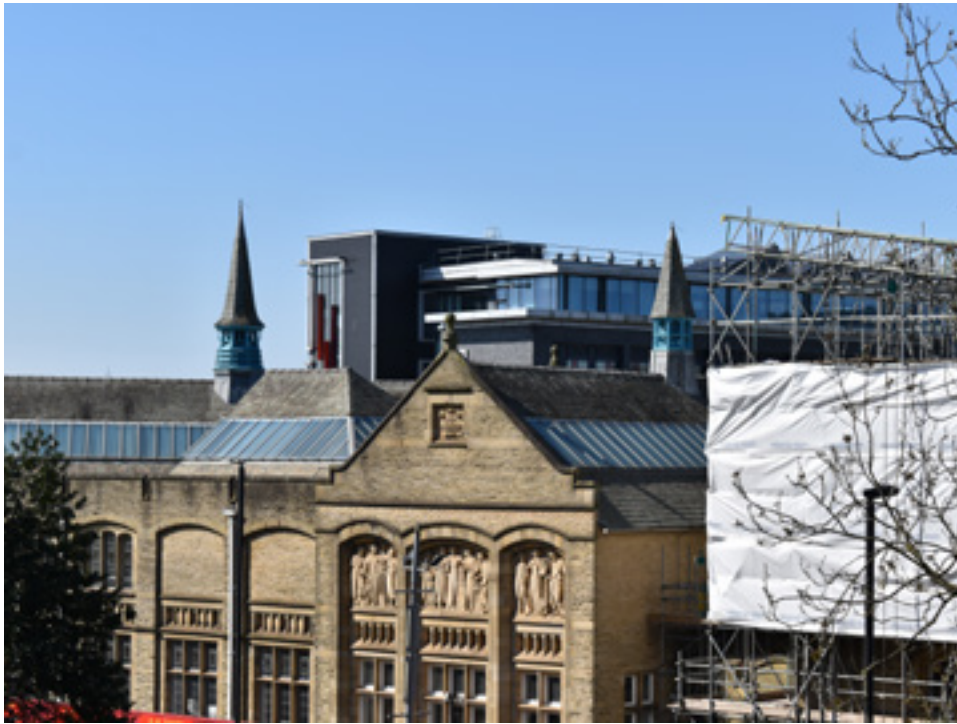
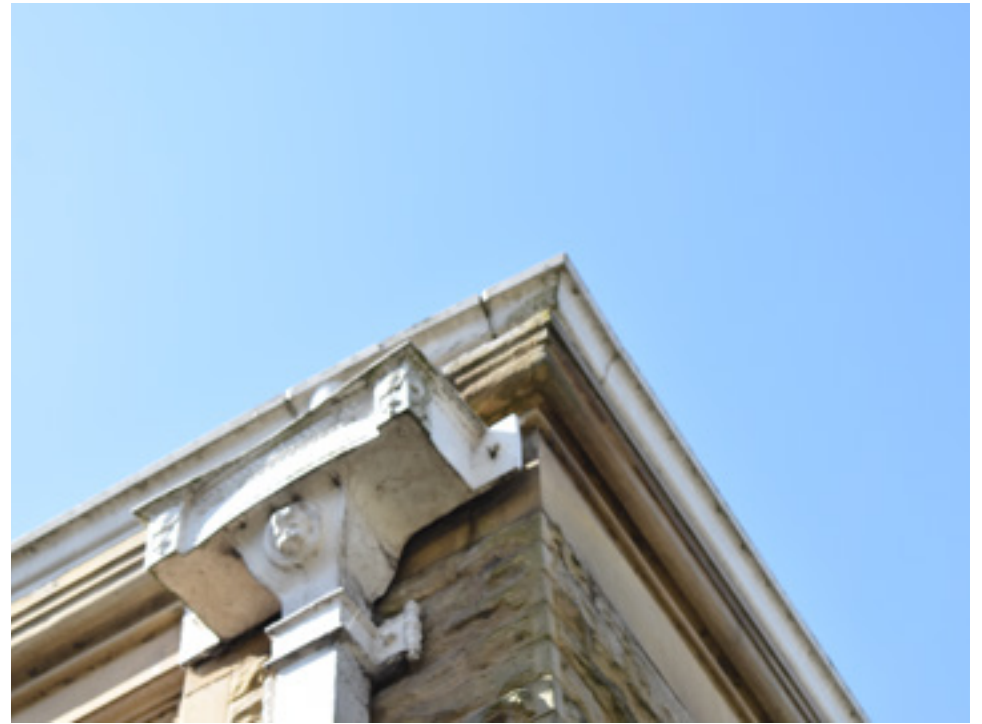
- The existing slate roof and lead flashings are defective and allowing water ingress into the building. The slates may be original and been re-used in re-roofing the building, having been re-nailed. The backs of the slates have degraded, and slates lifted had de-laminated. Non breathable underlay has been used in the re-roofing and where insulation has been retrofitted without ventilation being incorporated. The roof will need re-slatting, and at best only 25% on existing slate is likely to be re-usable. Re-slatting is proposed using Westmoorland slate to match the existing as closely as possible.

- The existing copings, stone balustrades and chimneys have no dampproof course (dpc) and have defective or inadequate flashings. It is proposed to lift and re-bed copings on a dpc, and to add a dpc and extra lead cladding. Where upstand to insides of parapets is inadequate a lead abutment gutter is proposed to be added – this should have nominal visual impact. The stone balustrade around the porch may be improved by lifting and re-bedding on a dpc, and by adding lead to the blocking course and cornice. The additional lead will change appearance but mitigated by means of being a high-quality heritage material.

- The existing rooflights do not follow the original bays formed by the internal trusses. These rooflights are in poor condition with defective timber being viewed in multiple instances. These rooflights form an

- The leadwork, is poorly formed and cheeks appear to be laid over non breathable plastic membrane. The lead needs reforming to correct detailing, with ventilation adding. This includes new “hidden” gutter details that would not be visible on the elevation but would enhance the function of the roof.

- A number of rafters are ‘soft’ where water has been leaking from defective gutters. The rafter ends are to be replaced as a side-by-side repair, and these will not be visible once ceiling finishes are repaired. Purlin ends built into walls appear to have been affected by damp in the past and there are a number of existing repairs using steel plate. Remaining purlin ends are reported as being soft and it is anticipated that similar steel plate repairs will be needed. Visible steel plate will have a painted finish, as per existing.

- The fleches on Zone 2 also need restoring with new leadwork detailing to enhance the existing function, timber repairs to structural timber, re-slatting with like-for-like to match the architectural language of the rest of the roof. A key proposal in the fleche works is to strip back and re-decorate the timber with RAL 6028 green to match the original paintwork that was evidenced upon the stripping off of the decorative elements.

- Existing cast iron hoppers and downpipes require refurbishment, repainting and better fixing, however there are plastic downpipes and gutters to the north elevations and to the dormers which require replacement in painted cast iron. This is considered to be an enhancement.
- Add a proprietary metal capped vent to the chimney. The chimney is at the rear elevation and so not prominently located – considered to have minimal visual impact.

As outlined above the proposals are essential to remedy failings with the roof to ensure the long-term conservation of the building and to enable the wider success of the previously consented adaptive reuse scheme without causing harm to the significance of the listed building or its contribution to the Rochdale Town Centre Conservation Area. As such they meet the requirements of the NPPF, specifically paragraph 210 which requires that heritage assets are sustained and enhanced in a manner according to their significance. Indeed works such as the proposed rooflight design, redecoration of the fleche and replacement of plastic downpipes with painted cast iron in accordance with the building’s original designs would present an enhancement alongside the significant benefits to both the building and the local community that its new multifunctional arts and heritage centre use will bring. As such the proposal would also meet the statutory duties of the Town and Country Planning Act (paragraphs 16, 66 and 72) and the requirements of the Local Plan

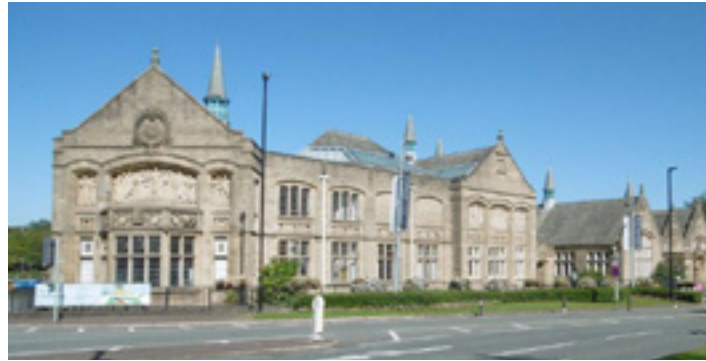
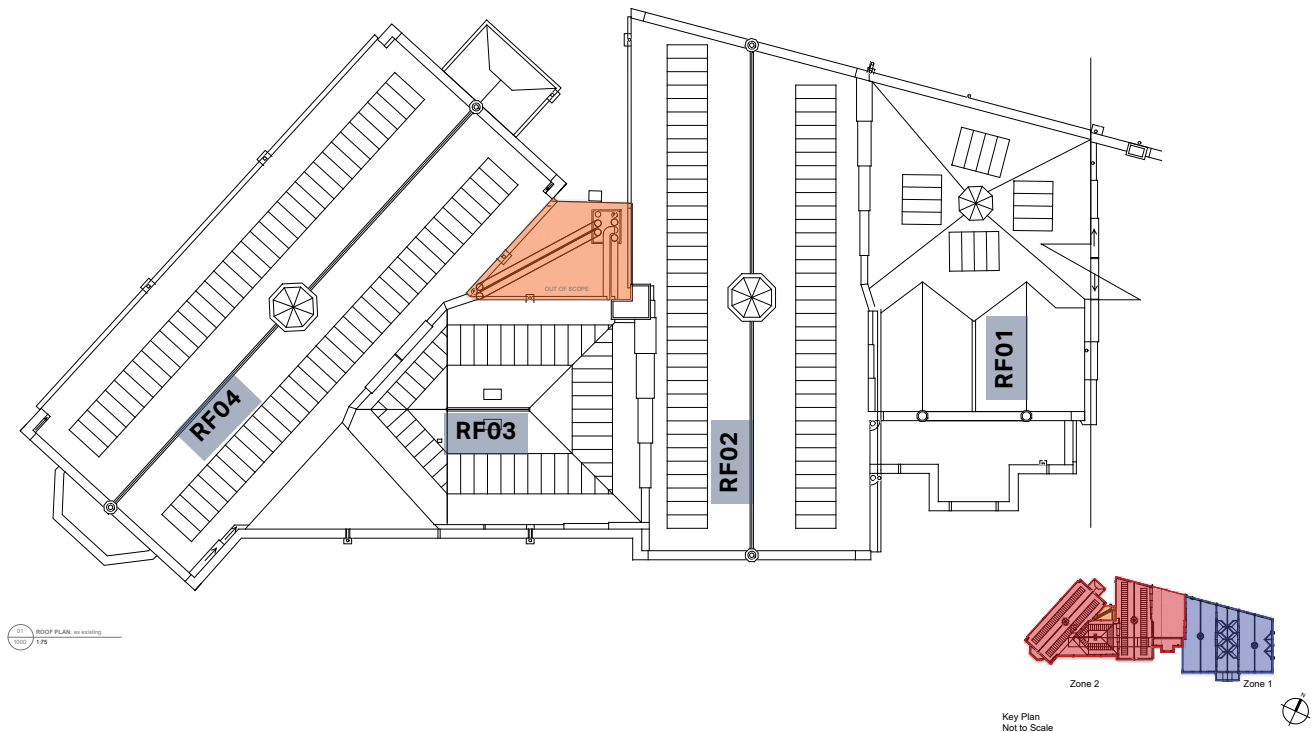
Roof Zone 2 comprises four bays with RF01, RF02 and RF04 running North-South and RF03 running East-West each comprising a slate covered pitched roof with stone gables with parapets to the south and north. Roofs RF01, RF02 and RF04 both have a fleche which incorporates passive stack ventilation, each with a lead lined base and slate covered capping. There is a lead lined abutment gutter at the junctions of the bays. RF03 has a section of flat roof to the North which is outside the scope of this application. All four bays have rooflights running along the roof slopes. These rooflights are not original and it is unclear the exact date when they were installed. The rooflights also do not follow the original bays defined by the roof trusses[Plates 2.1.1 and 2.1.2].

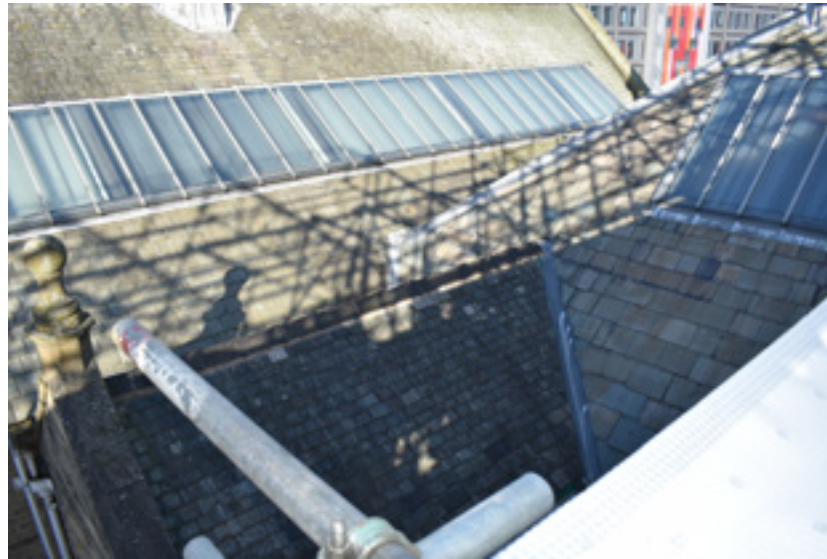
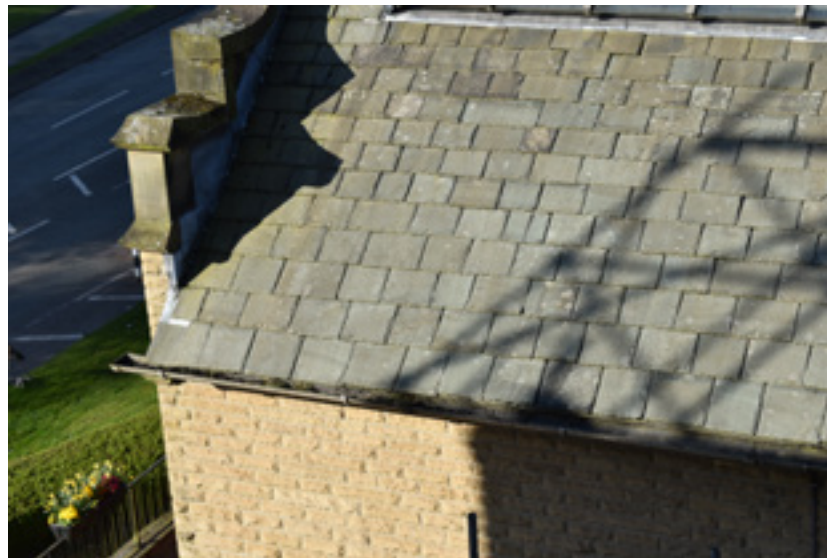
The roof requires stripping and sound slates set aside for re-use. As detailed above, optimistically only about 25% of slates are thought to be re-usable. Matching Westmorland green slate is on long order and a like for like replacement imported slate may be necessary, dependant on programme and lead in times. As the roof is being re-slatted an upgrade in the insulation will be required. The existing plaster ceiling will be retained, and so nominal insulation only will be added between the rafters from above. Ventilation to cold roof voids and between rafters will be provided at valleys, abutment and ridges using proprietary ventilation packs [Plates 2.1.1.1 and 2.1.1.2].

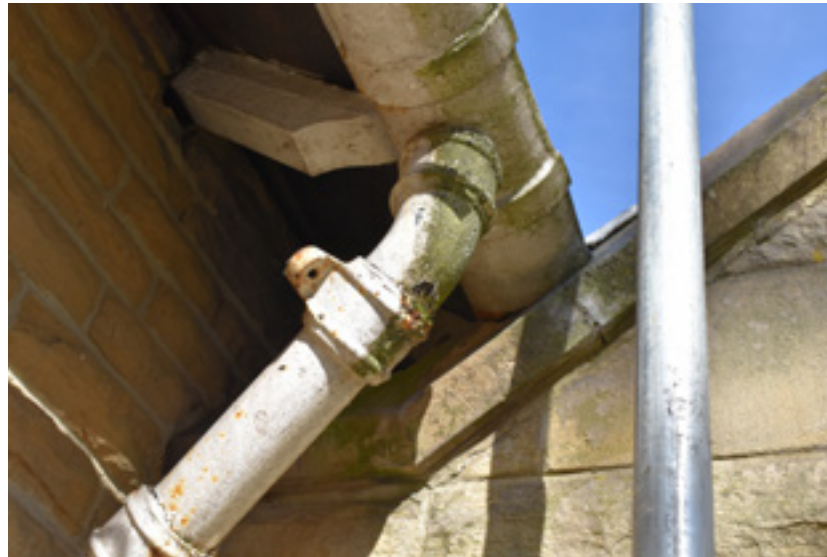
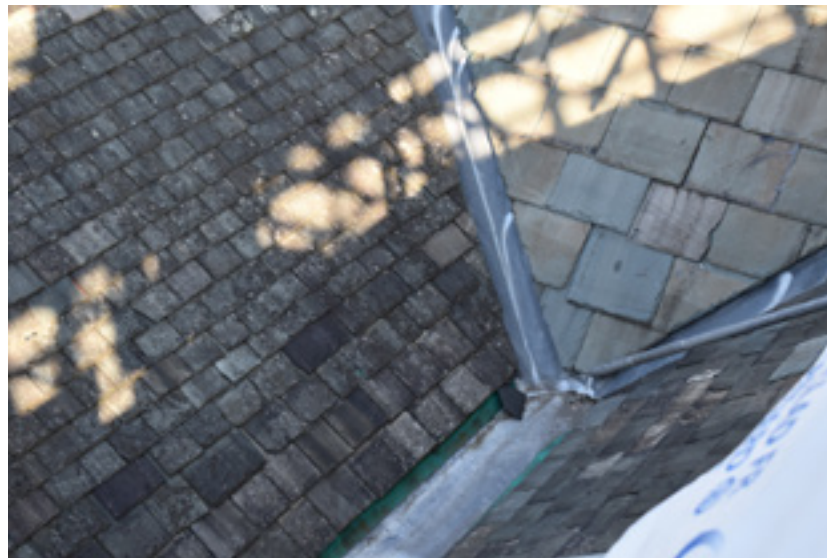
Inadequate laps were found at the junctions between soakers and cover flashings at the roof abutment with the back of the stone parapets. Some of the roof slopes have inadequate height between the slates and current top of flashing to meet recommended lap requirements. Chimney flashings and back gutter are in poor condition, with slipped lead and patch repairs in flash-band. The chimney appears to have been capped off using concrete, and it is proposed that it is unblocked and vented using a proprietary metal vented capping. The abutment gutters are blocked and leaking and drips are undersized [Plates 2.1.2.1 and 2.1.2.2].

The proposals include renewing all leadwork to latest Lead Sheet Training Academy details and recommendations. A 'secret' lead lined abutment gutter is proposed to mitigate where recommended upstands and laps are not achievable.

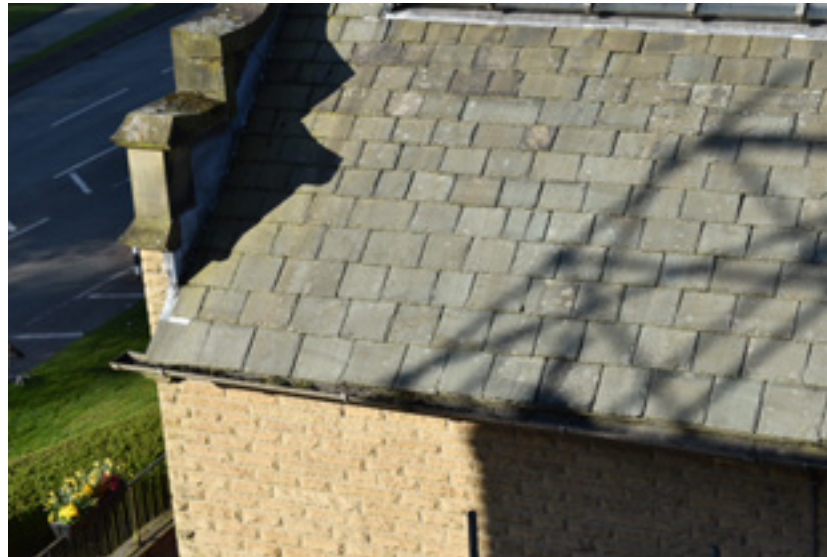
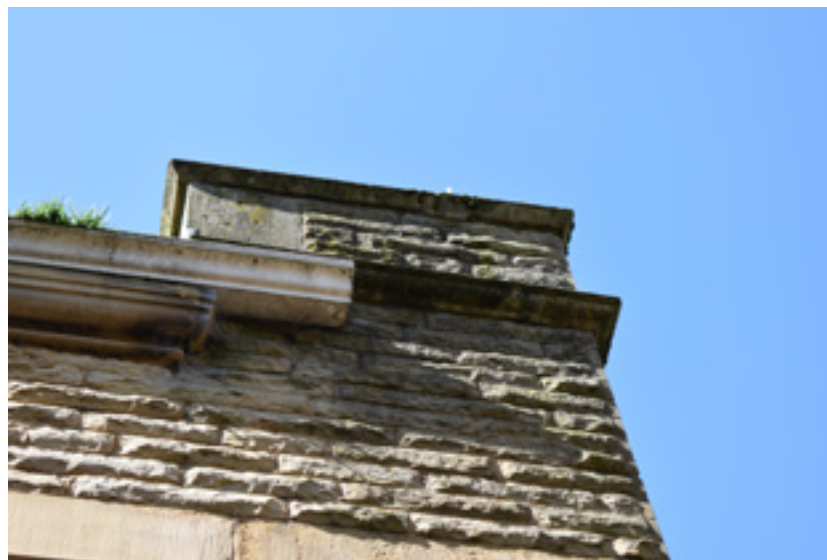
The parapets have no dpc and lack any overhang or drip - dark staining relating to damp at the top of the walls can be clearly seen. Parapet copings and stone finials have moved in places and there is cracking to mortar joints between coping units and between copings and masonry wall beneath. Fixings are visible to the top surface of the copings (eroded and forming a water trap), and extra fixings have been added to some of the copings [Plates 2.1.3.1 and 2.1.3.2].

Due to the movement noted it is proposed that all parapet copings and finials are carefully lifted and re-bedded on a lead dpc, integrated with the flashings and soakers, to make the back of the upstand fully weather proof. The porch will be reset on lead dpc, with lead taken down the front of the blocking course and over the top of the cornice.

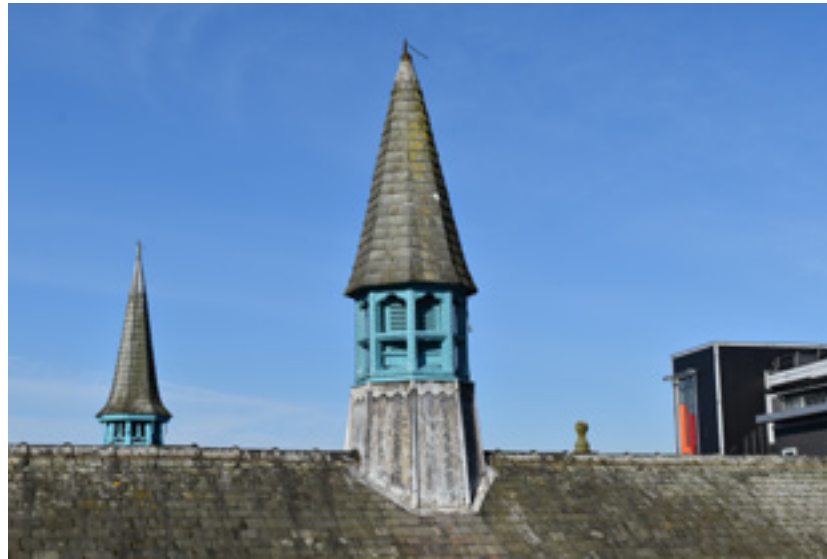
2.1.5

Water ingress was reported beneath both fleches and it appears the secret gutter around the top of the leaded base of each fleche is blocked or cracked whilst outlet pipes are undersized. Some of the slate has slipped. The lightning protection system on both needs testing as well.

The proposal includes to re-slate defecting slates on the fleches following an inspection of the sarking boards, membranes and other structural timber. The leadwork is proposed to be renewed with appropriate details as per LSTA recommendations. The original green paint colour to the fleche at Zone 1 was uncovered during those works and there it is proposed to redecorate the timber to match the original with RAL 6028. It is also proposed for a specialist to assess the current lightning protection and to propose renewal works **[Plate 2.1.5]**.

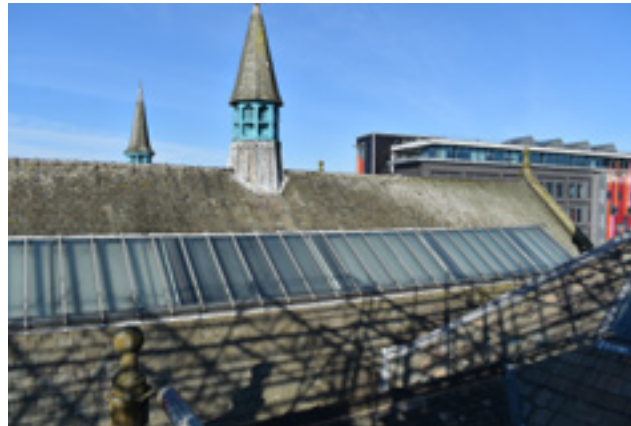
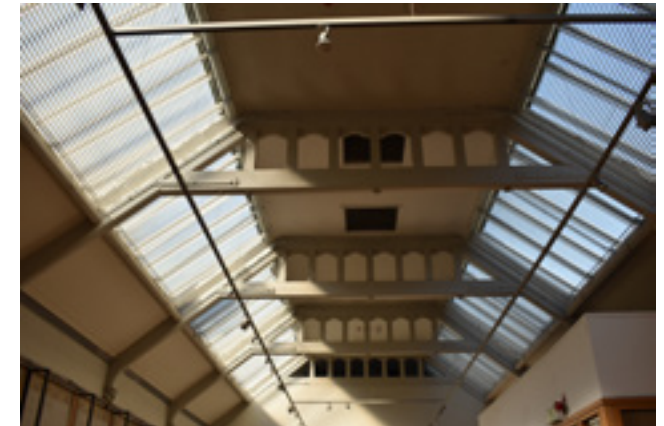
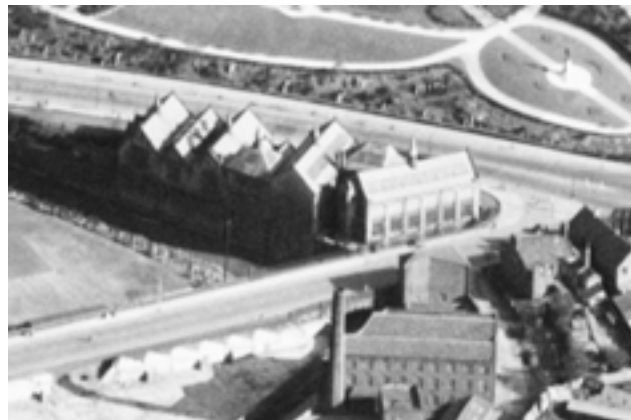
All four bays of the roof at Zone 1 have modern rooflights. The existing windows are modern, with fixed glass double glazing and lead flashings over the original rooflight bays. They also have blinds fixed on timber rails on the internal face of the roof. The rooflight at RF03 form a continuous channel on all four slopes of the roof.

There is evidence of the original rooflights to follow the bays formed by trusses on the roof and the proposal includes to reinstall the rooflights to match the historic layout and design [Plates 2.1.6.1 - 2.1.6.3].
