Project:
 37 Rochdale Road
 Project Address:
 37 Rochdale Road
 Middleton
 Manchester
 M24 2PT

Drawing Name: Existing (As Found)
Drawing Number: A102
Drawing Date: 07/04/25
Author: B.Rashid. CG.Morrison

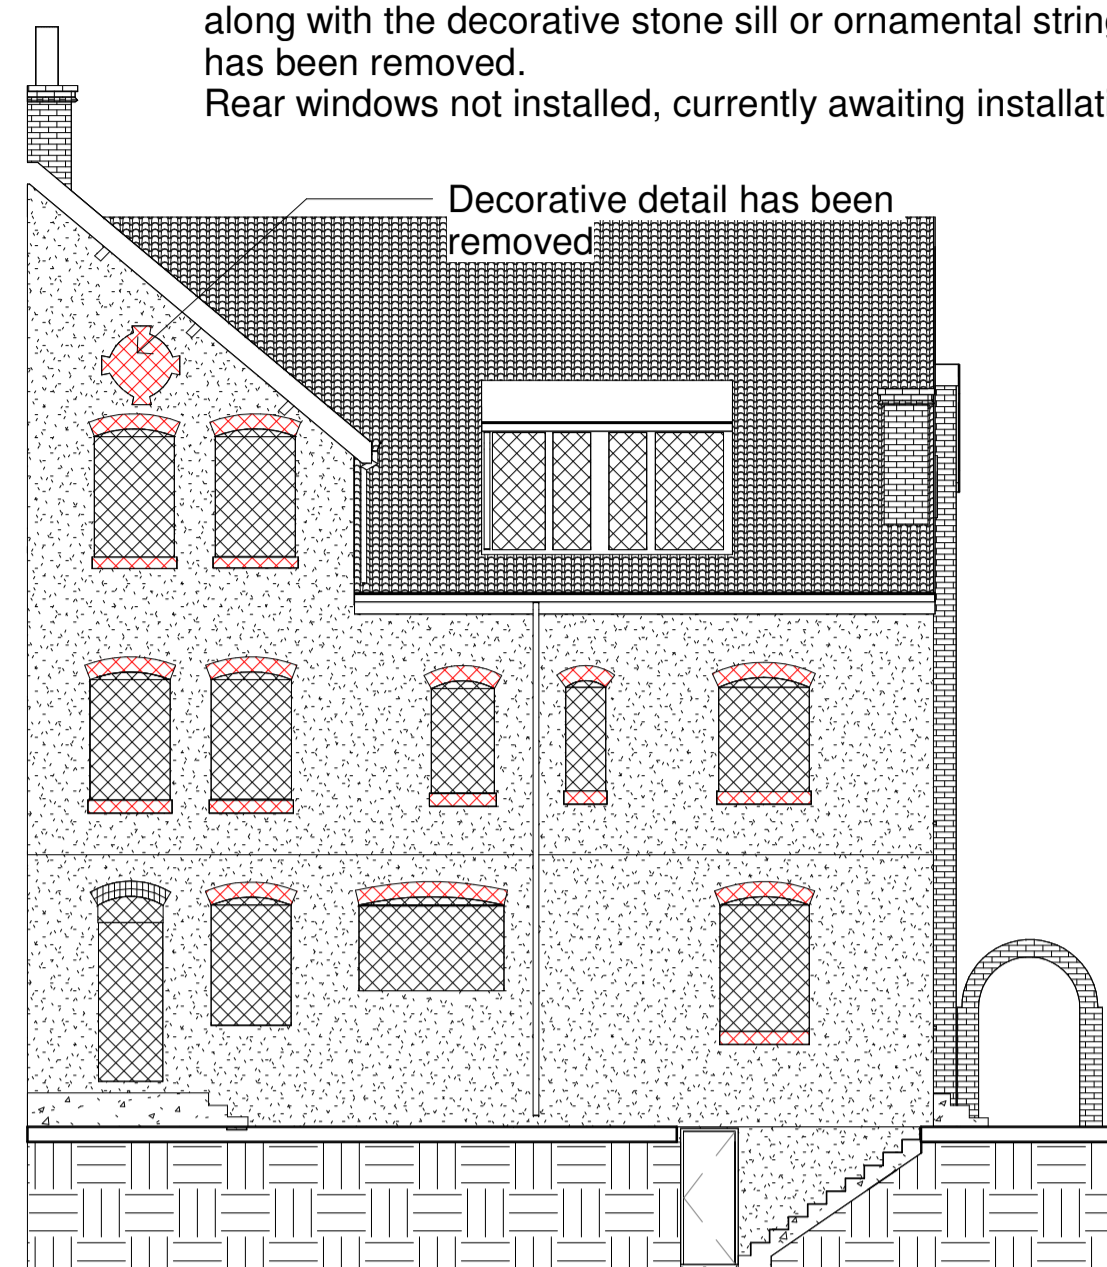
Existing (As Found) Rear
 1 : 100

Rear wall: Constructed from breezeblock, cavity wall construction with a rendered finish.
 Rear wall window: The arched soldier course detail above the window, along with the decorative stone sill or ornamental string course below, has been removed.
 Rear windows not installed, currently awaiting installation.

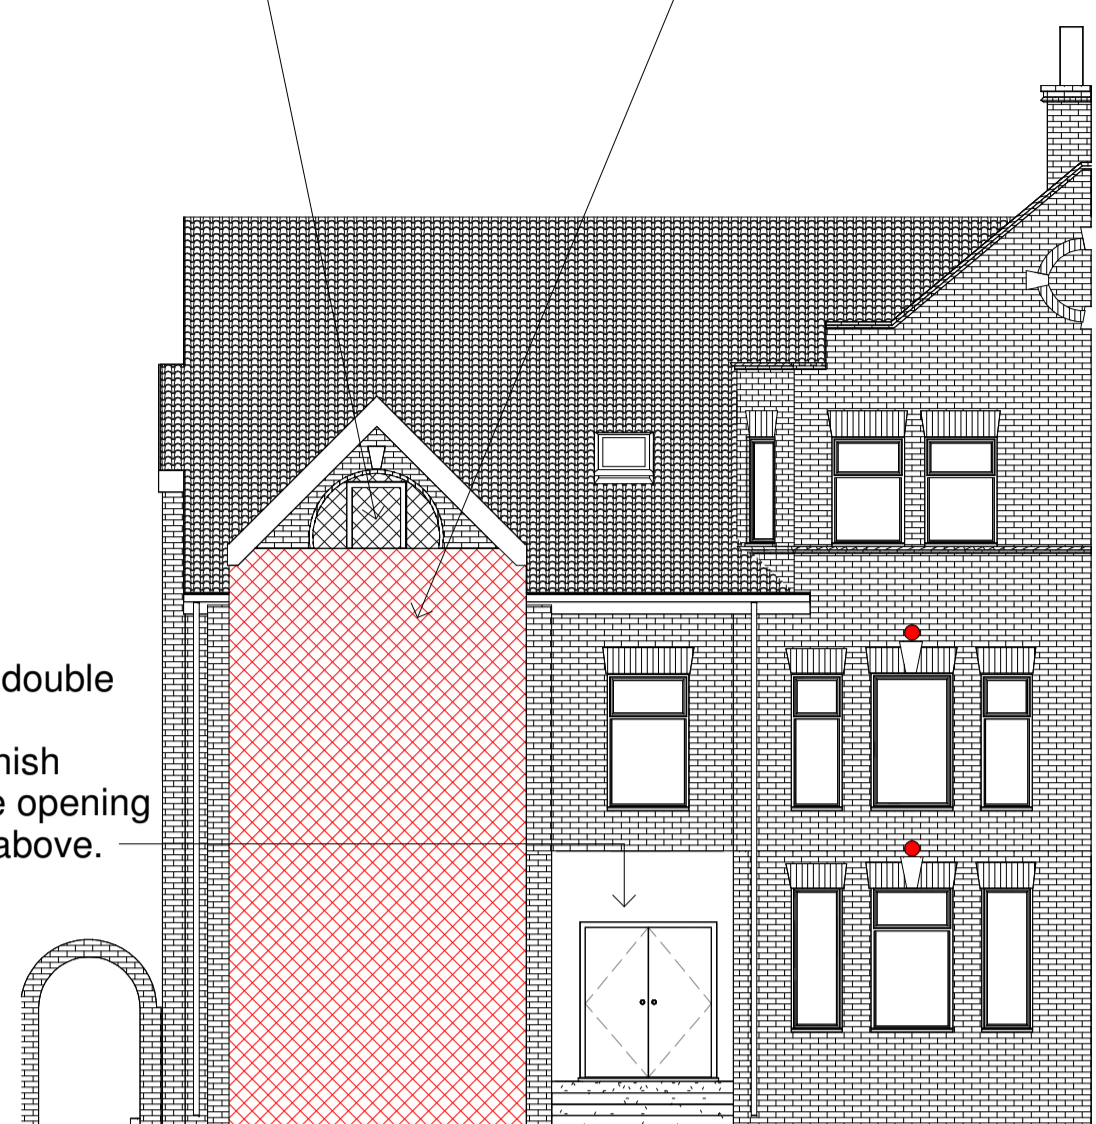
Existing (As Found) Front
 1 : 100

The structural integrity of the bay window beam requires assessment by a Structural Engineer, including an inspection for rot and potential structural deficiencies.

Decorative detail has been removed

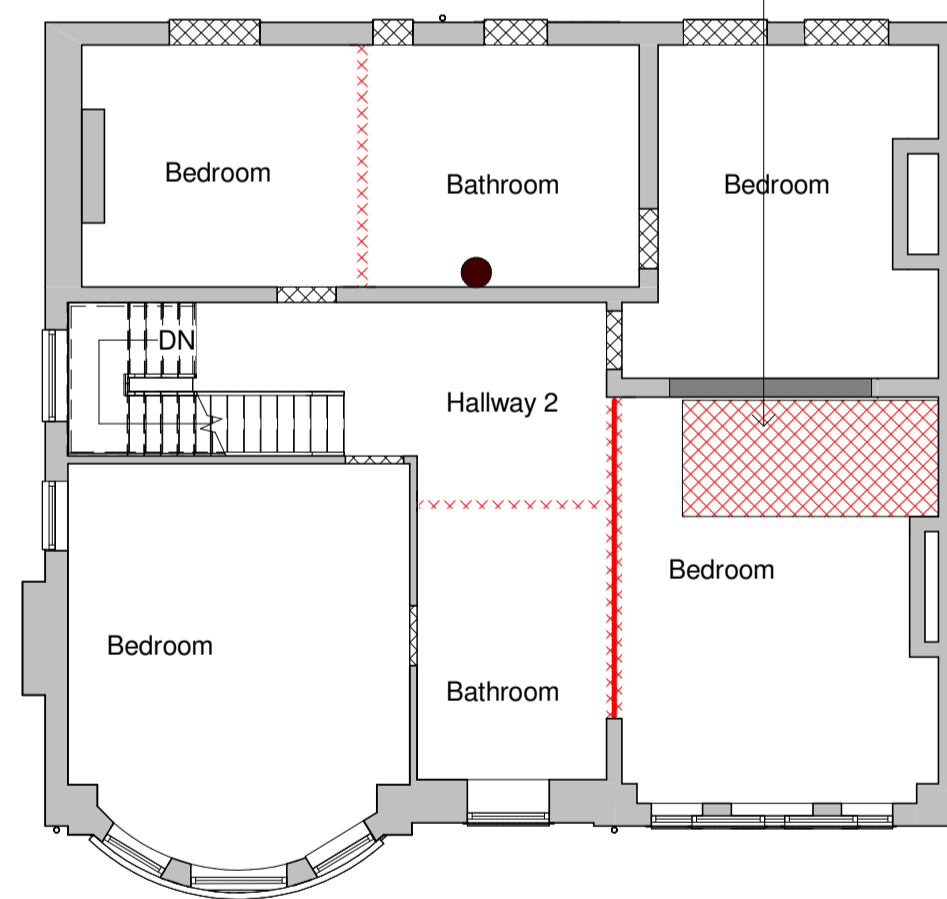
Existing (As Found) First Floor
 1 : 100

Opening formed in first-floor floor to accommodate the proposed staircase.

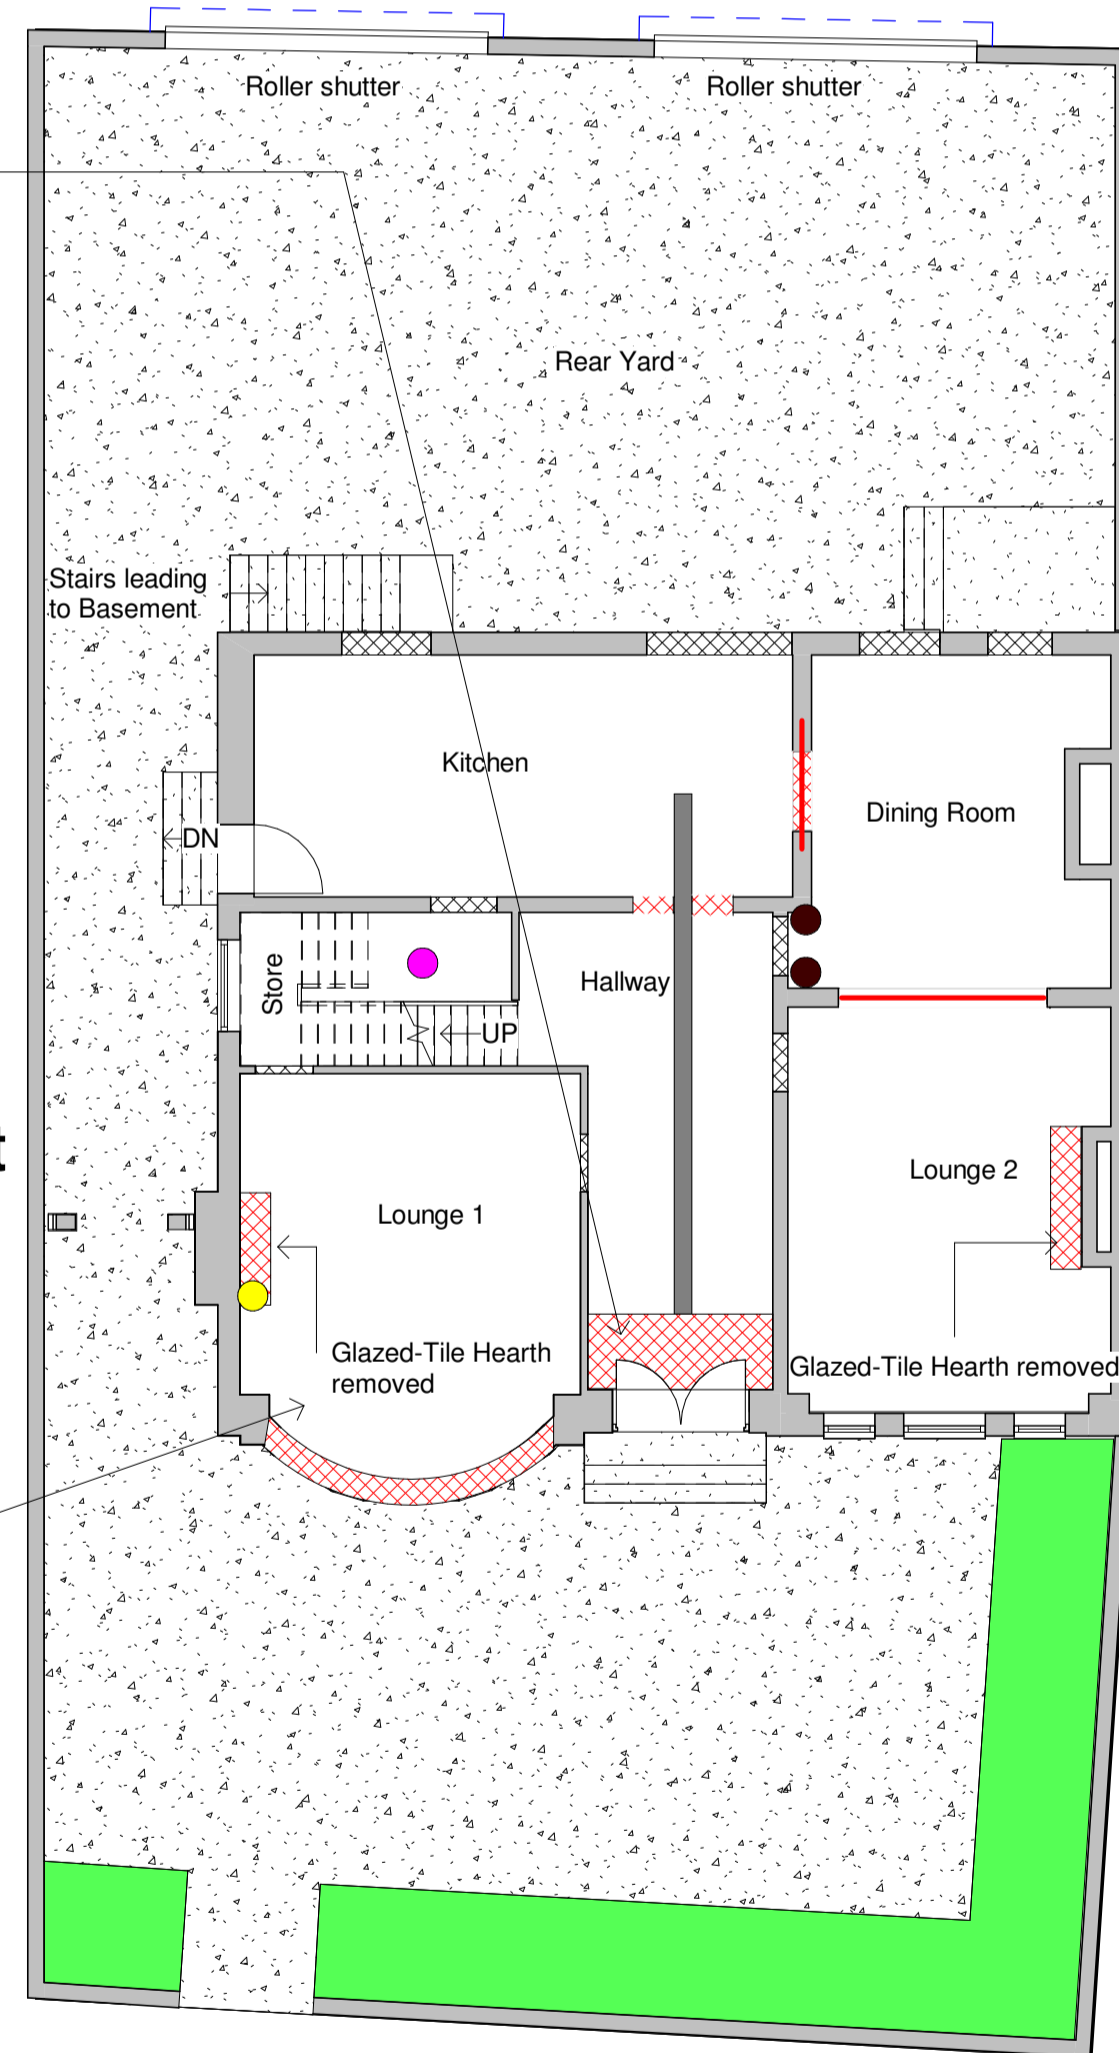
Existing (As Found) Ground Floor
 1 : 100

Small Format Mosaic Tiles have been almost entirely removed.
