# **ARBORICULTURAL REPORT & Impact Assessment to BS 5837:2012 at:**

***Hollingworth Heights,  
Peanock Lane,  
Littleborough  
OL15 0AD***

Reference: *AWA6929*

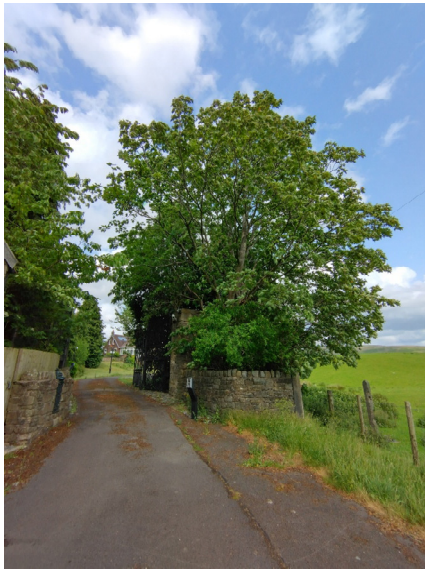
Photo 1: T1 from south

- 3.2.6 Most of the trees are semi-mature and early-mature with only occasional young or mature trees.
- 3.2.7 The site's most significant trees are T1 and T16. Both are early-mature Sycamore in good physiological and structural health and with moderate arboricultural and amenity value. T1 is within a walled area at the entrance to the site and may outgrow its current location. However, in the medium to long term it provides some interest in the landscape. T16 is located on the eastern boundary of the site and has good long-term prospects. Both these trees are retention category B.

| | Tree Species | | | Measurements | | | Crown (m) | | | | Tree Condition | | | | | | | Value | | Management | | |
|---|---|---|---|---|---|---|---|---|---|---|---|---|---|---|---|---|---|---|---|---|---|---|
| T1 | Sycamore | Acer pseudoplatanus | Early-mature | 12 | 1 | 480 | No | 3 | 6 | 6 | 6 | 6 | Debris at base. No visual defects | Single stemmed. Vertical | Minor deadwood. Tear outs | In walled area overhanging entrance to site. Plastic sheets and metal work around base. Access prevented detailed inspection. Stem slightly kinked at base to northeast before correcting to vertical. Torn stub in crown. | Good | Good | >40 yrs | Moderate | B | Pruning works required to facilitate the development: Prune back and crown raise the northern crown to give adequate clearance over the new driveway. |

- 4.2.7 T1, G2, T4 and T29 overhang the entrance and the proposed driveway. Whilst there is an existing driveway here it is likely that the crowns of these trees will require lifting and cutting back slightly to allow better access for machinery and adequate clearance for the laying of new surfacing.

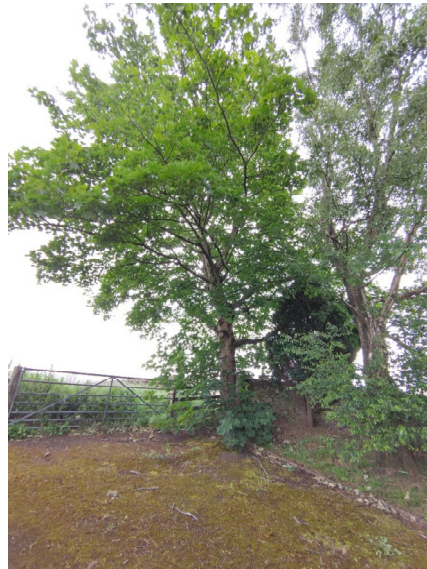
Photo 2: T16 from west

| | Tree Species | | | Measurements | | | | Crown (m) | | | | | Tree Condition | | | | | | | Value | | Management |
|---|---|---|---|---|---|---|---|---|---|---|---|---|---|---|---|---|---|---|---|---|---|---|
| T16 | Sycamore | Acer pseudoplatanus | Early-mature | 16 | 1 | 490 | No | 2 | 5.5 | 5.5 | 5.5 | 6 | No visual defects | Single stemmed. Old pruning wounds. Minor cavities. Epicormic growths | Minor deadwood | Roots pushing up tarmac to west. Epicormic growth at base. Access prevented detailed inspection of southeastern aspect of crown. | Good | Good | >40 yrs | Moderate | B | No works required to facilitate the development |

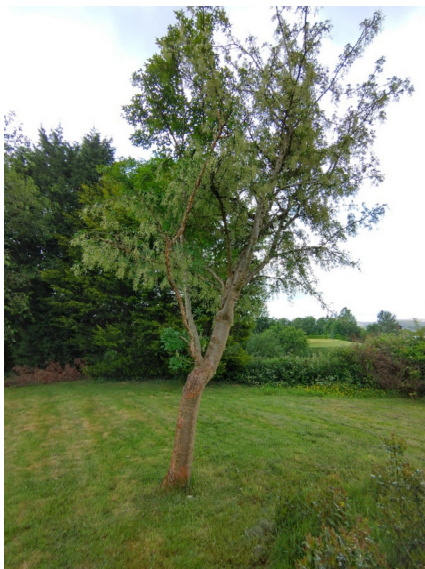
Photo 3: T17 from south

- 3.2.11 Laburnum T17 has a cavity on the southwestern stem aspect where a stem has previously torn out. The remaining crown is unbalanced, and the tree is structurally weakened. It is unsuitable for retention and is category U.

4.2.10 1 tree, T17, is a category U tree with defects that will significantly reduce its life-expectancy making it unsuitable for retention in the context of the proposed development.

| | Tree Species | | | Measurements | | | | Crown (m) | | | | | Tree Condition | | | | | | | Value | | Management |
|---|---|---|---|---|---|---|---|---|---|---|---|---|---|---|---|---|---|---|---|---|---|---|
| T17 | Laburnum | Laburnum sp. | Early-mature | 5 | 1 | 280 | No | 1.5 | 4 | 2 | 2 | 3 | No visual defects | Twin stemmed at 2m. Old pruning wounds. Major decay. Major cavity. Slight lean | Minor deadwood | Cavity from torn out stem at 1m on southwestern aspect. Stem leans to north. | Fair | Poor | <10 yrs | Low | U | Unsuitable for retention in context of proposed development |

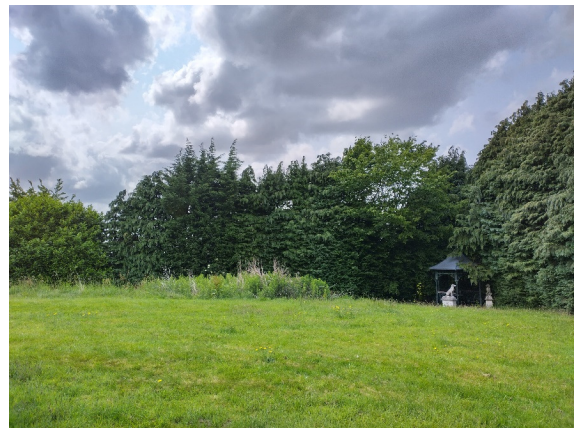
Photo 4: Northwestern edge of site

- 3.2.8 G2, G21, G22, G24, G25 and G28 and tall Cypress hedges and tree groups along the western, northwestern and southeastern edges of the site. They provide excellent screening from the site but otherwise are of low value.

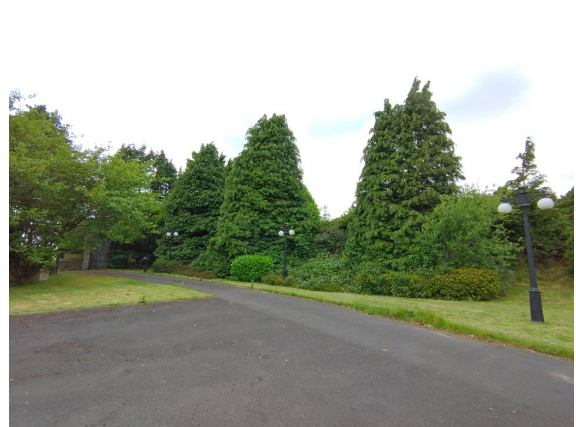
Photo 6: T4, T34, T35 and T36 from east

- 3.2.10 Lawson Cypress T34, T35, T36, T39 and T40 are large ornamental specimens within the landscaped gardens. Whilst they are a feature of the garden they are a low value species and are therefore retention category C.

| | Tree Species | | | Measurements | | | Crown (m) | | | | Tree Condition | | | | | | | Value | | Management | | |
|---|---|---|---|---|---|---|---|---|---|---|---|---|---|---|---|---|---|---|---|---|---|---|
| T4 | Cherry | Prunus sp. | Early-mature | 10 | 6 | 150 avg | Yes | 1 | 5 | 4 | 4 | 5 | No visual defects | Multiple stemmed at base. Stubs. Old pruning wounds. Tight union. Partially included bark | Minor deadwood. Old pruning wounds. Stubs | Dead stem in central crown from 0.5-2m. Tight unions at base. | Good | Fair | >40 yrs | Moderate | C | Pruning works required to facilitate the development: Prune back and crown raise the northern crown to give adequate clearance over the new driveway. |
