## **Site Tree Appraisal**

### ***Land Adjacent to the Sub-Station, Alkrington Hall Road North, Middleton M24 1SZ***

**“BS 5837 2012: Trees in Relation to Design, Demolition and Construction – Recommendations”**

Ref: RTS/29102025

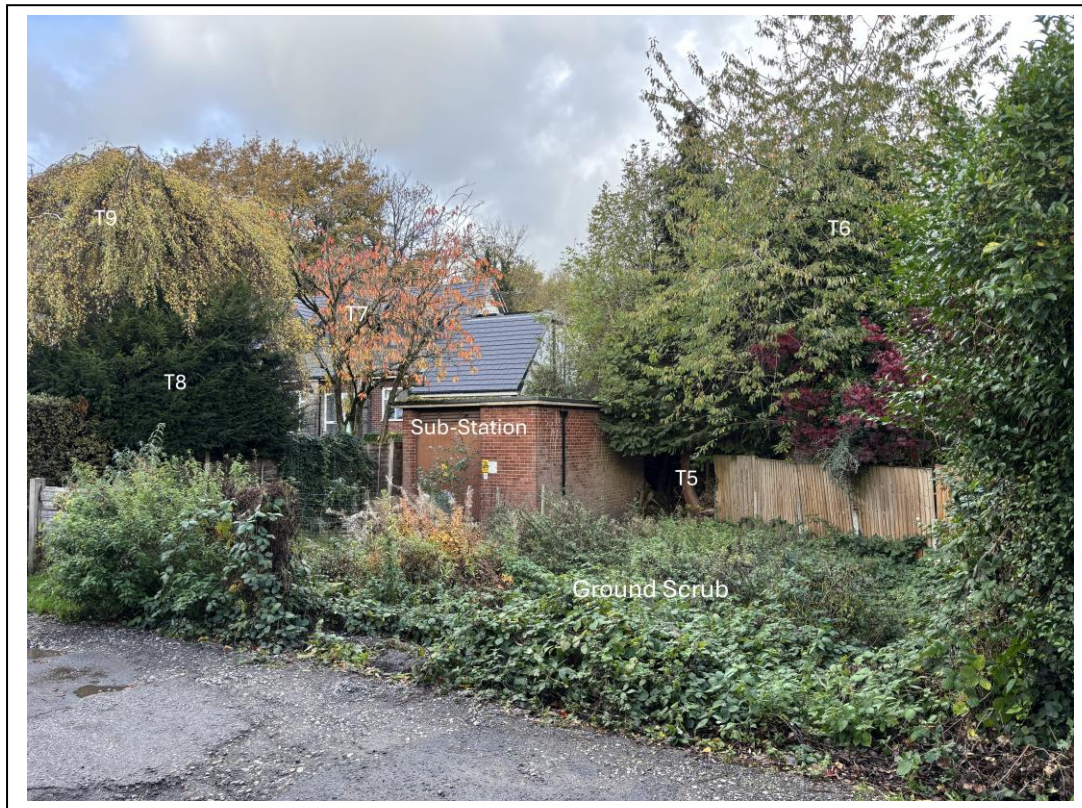
**Photo 01:**

- 3.3** Given that the closest trees to the site are located along the north boundary (photo 01), there would be no requirement to remove any of the trees to facilitate the development. Other adjacent trees, towards the west (T7, T8 & T9), are to the far west side of the Sub-Station land and well beyond being influenced by the proposed building.
