**Project:** 26\_5837\_03\_100  
**Site:** Stable Hills Chadwick Hall Road, Rochdale OL11 4DJ  
**Client:** Avees Azam

| Report Type: | Arboricultural Impact Assessment |

## Arboricultural impact assessment

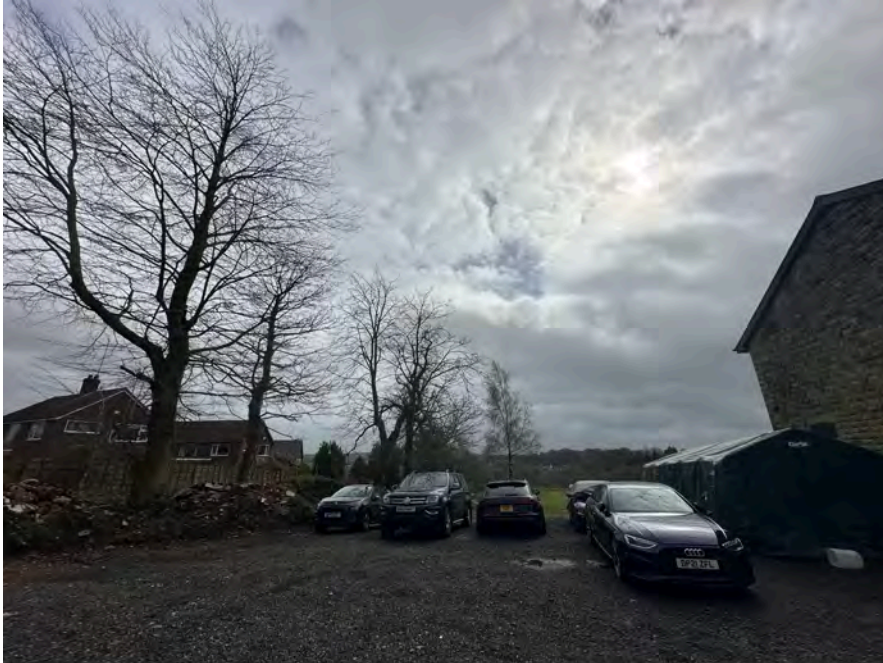
*Photographic plate showing large mature beech T1 (left), sycamore T5, common lime T6, and common lime T7 (centre) (ROAVR, 2026).*

The tree cover at Stable Hill is of generally good quality. A large, high-quality, mature beech tree (T1) lies on the northern extent of a linear group of trees (oriented north-south) adjacent to the area of the proposed garage. Several medium-quality trees on the site include fair vitality sycamore (T2, T3) and common lime trees (T6, T7). T5 and T9 are both sycamores with poor vitality.

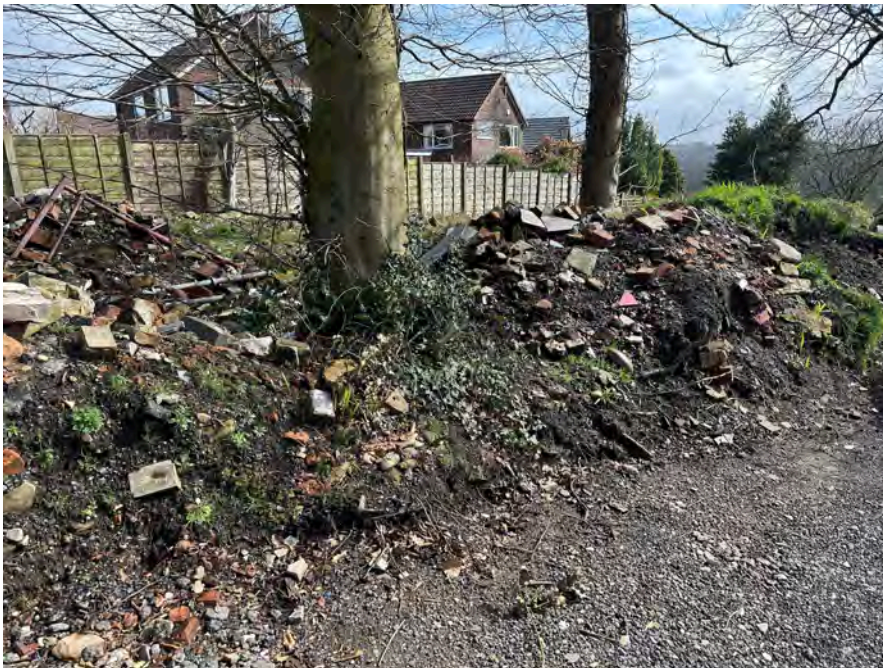
*Photographic plate showing the build-up of construction waste and suspected change in ground levels surrounding trees T1 and T5 (ROAVR, 2026).*

- Area of compacted stone surfacing within root protection areas (RPAs)
- Stockpiled spoil and construction debris stored around the base of retained trees
- Localised changes in ground levels and evidence of disturbance within RPAs

4.3.3 It is noted that the stockpiling of spoil around tree stems was not undertaken by the current client. The site has recently changed ownership and these materials have been inherited from the previous landowner.

- Soil level changes due to deposition of spoil around tree bases
- Stem burial at the root flare
- Soil compaction associated with hardstanding and vehicle movements
- Possible root damage arising from previous disturbance and material storage

4.5.2 These works are likely to have adversely affected soil structure, aeration and root function. The extent of damage cannot be fully determined without further investigation following removal..

- All spoil and debris around tree bases to be removed manually
- No mechanical excavation within RPAs
- Careful removal to avoid damage to buttress roots
- Expose root flare to original ground level where possible

| Tree Number | Species | Age Class | DBH | Height (crown height) | N | E | S | W | Condition | Life Expectancy | Physical Description | Comments | Managment Recommendations | RPA offset from stem. | Category Rating |
|---|---|---|---|---|---|---|---|---|---|---|---|---|---|---|---|
| T1 | <i>Fagus sylvatica</i> (Beech) | EM | 590 | 13(3) | 6 | 6 | 5 | 5 | Good | 40+ | Tree adjacent to driveway area. Part of linear group of trees adjacent to driveway area. | Part of linear group. TPO-protected tree. Evidence of recent change to ground levels. Construction waste built up against base of tree. | Remove construction waste surrounding tree. | 7.08 | A1 |

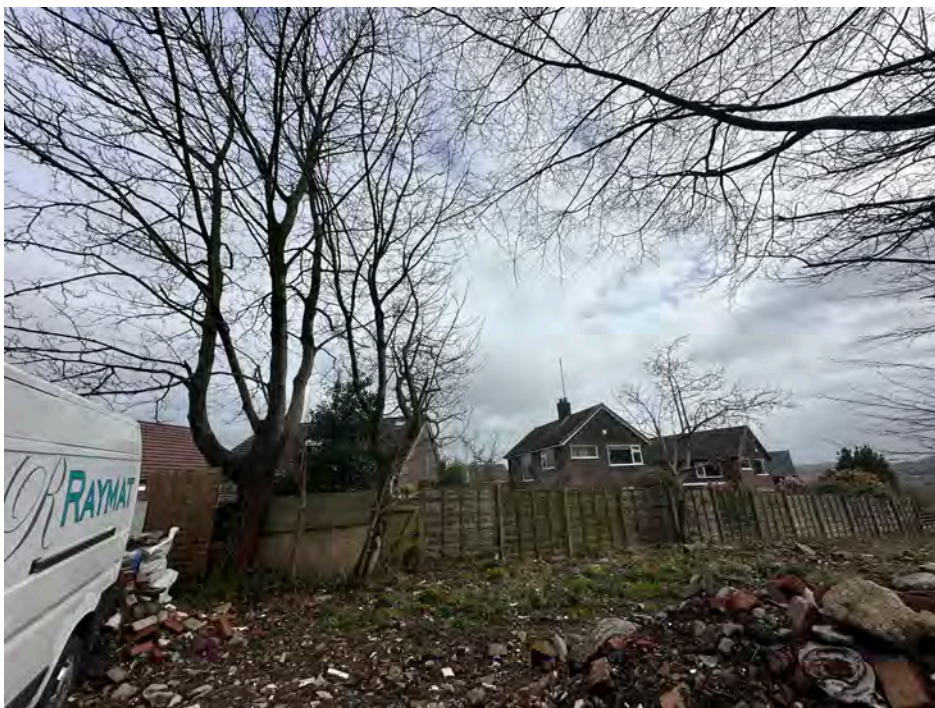
*Photographic plate showing trees T2 (left), T3 (left) and T4 (right) (ROAVR, 2026).*

| Tree Number | Species | Age Class | DBH | Height (crown height) | N | E | S | W | Condition | Life Expectancy | Physical Description | Comments | Managment Recommendations | RPA offset from stem. | Category Rating |
|---|---|---|---|---|---|---|---|---|---|---|---|---|---|---|---|
| T2 | <i>Acer pseudoplatanus</i> (Sycamore) | EM | 490 | 11(3) | 4 | 4 | 3 | 4 | Fair | 20+ | Tree on boundary with neighbouring property. | Multiple stems above 1.5m. Crown distorted due to group pressure. | None. | 5.88 | B1 |
| T3 | <i>Acer pseudoplatanus</i> (Sycamore) | EM | 290 | 9(3) | 2 | 4 | 2 | 3 | Fair | 20+ | Tree on boundary with neighbouring property. | Multiple stems above 1.5m. Crown distorted due to group pressure. | None. | 3.48 | C1 |
| T4 | <i>Sorbus aucuparia</i> (Rowan) | EM | 190 | 5(2) | 1 | 2 | 3 | 1 | Fair | 10+ | Tree on boundary with neighbouring property. | Poor shape & form. Major deadwood in crown. | None. | 2.28 | C1 |

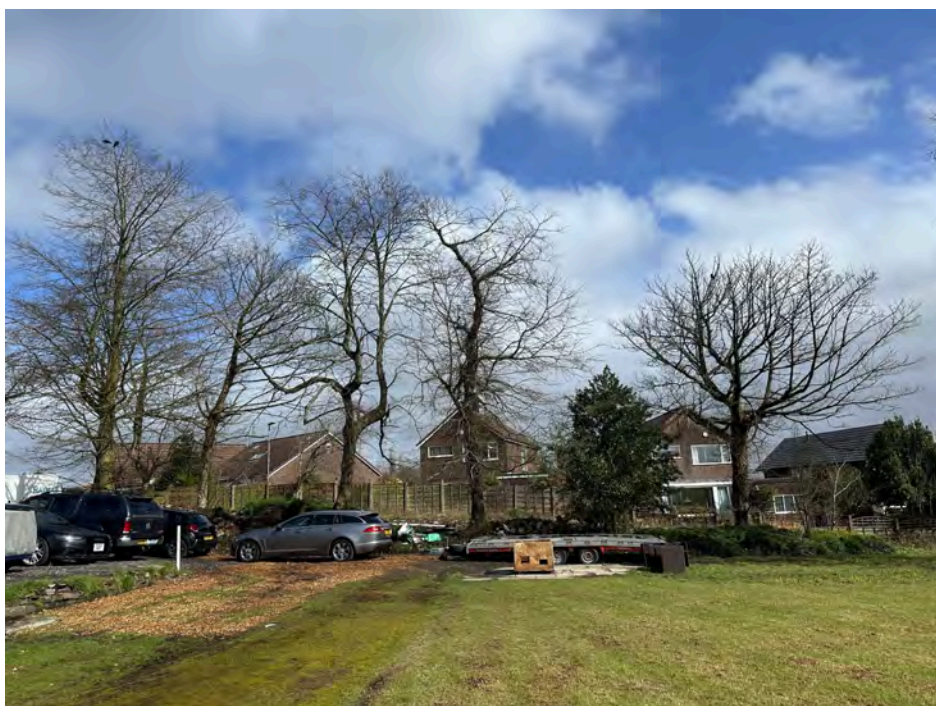
*Photographic plate showing, from left to right, beech T1, sycamore T5, common lime T6, common lime T7, holly T8, sycamore T9 and small hawthorn T10 (ROAVR, 2026).*

| Tree Number | Species | Age Class | DBH | Height (crown height) | N | E | S | W | Condition | Life Expectancy | Physical Description | Comments | Managment Recommendations | RPA offset from stem. | Category Rating |
|---|---|---|---|---|---|---|---|---|---|---|---|---|---|---|---|
| T5 | <i>Acer pseudoplatanus</i> (Sycamore) | EM | 410 | 10(3) | 1 | 5 | 4 | 5 | Poor | 10+ | Part of linear group of trees adjacent to driveway area. | Low vitality. Declining. Part of linear group. Crown distorted due to group pressure. | None. | 4.92 | C1 |
| T9 | <i>Acer pseudoplatanus</i> (Sycamore) | EM | 490 | 11(3) | 4 | 5 | 4 | 5 | Poor | 20+ | Part of linear group of trees adjacent to driveway area. | Low vitality. | None. | 5.88 | C1 |

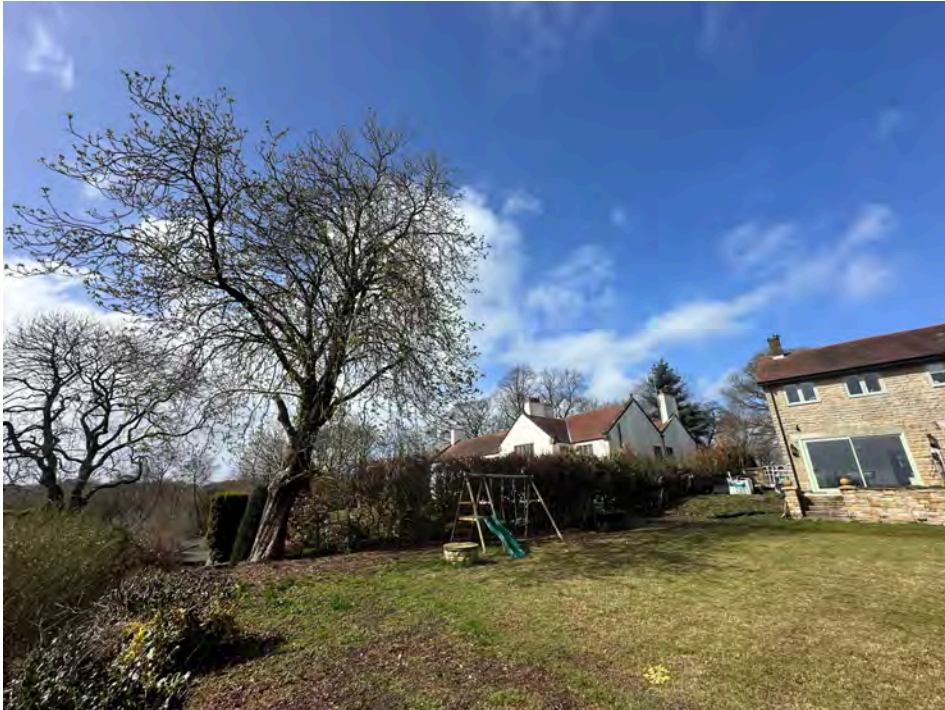
*Photographic plate showing large-diameter horse chestnut T12 (left) and beech boundary hedge H1 (centre) (ROAVR, 2026).*

| Tree Number | Species | Age Class | DBH | Height (crown height) | N | E | S | W | Condition | Life Expectancy | Physical Description | Comments | Managment Recommendations | RPA offset from stem. | Category Rating |
|---|---|---|---|---|---|---|---|---|---|---|---|---|---|---|---|
| T12 | <i>Aesculus hippocastanum</i> (Horse Chestnut) | M | 730 | 10(3) | 4 | 5 | 6 | 4 | Fair | 40+ | Large tree on boundary with neighbouring property. | TPO-protected tree. | None. | 8.76 | A1 |

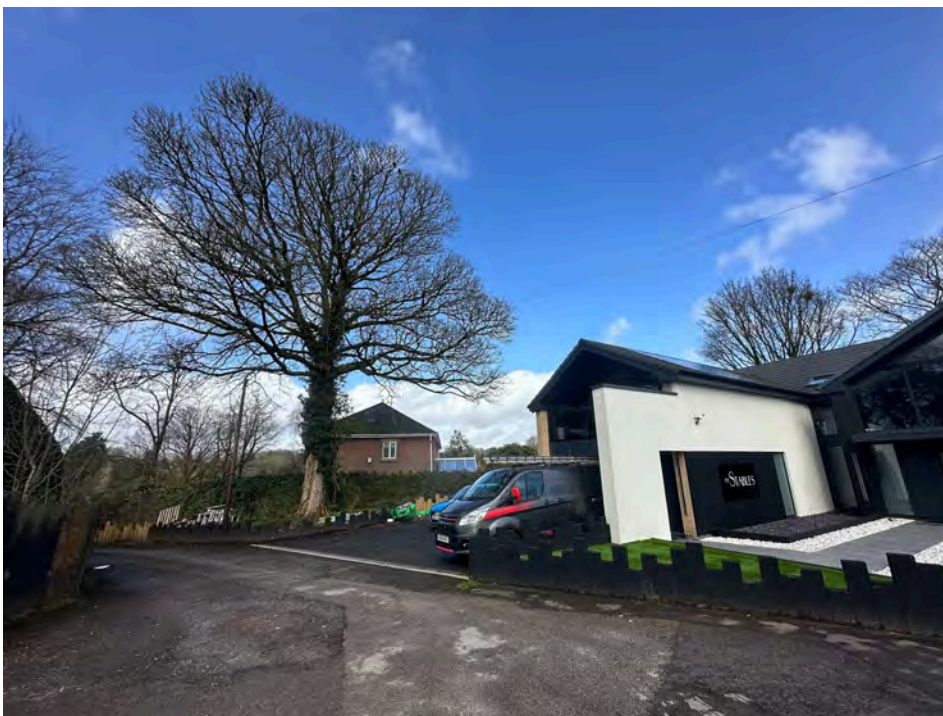
*Photographic plate showing large mature sycamore (T13) adjacent to the property entrance (ROAVR, 2026)*

| Tree Number | Species | Age Class | DBH | Height (crown height) | N | E | S | W | Condition | Life Expectancy | Physical Description | Comments | Managment Recommendations | RPA offset from stem. | Category Rating |
|---|---|---|---|---|---|---|---|---|---|---|---|---|---|---|---|
| T13 | <i>Acer pseudoplatanus</i> (Sycamore) | M | 910 | 13(4) | 7 | 6 | 8 | 7 | Good | 40+ | Large tree on neighbouring property adjacent to site entrance. | Good form and vitality. | None. | 10.92 | A1 |

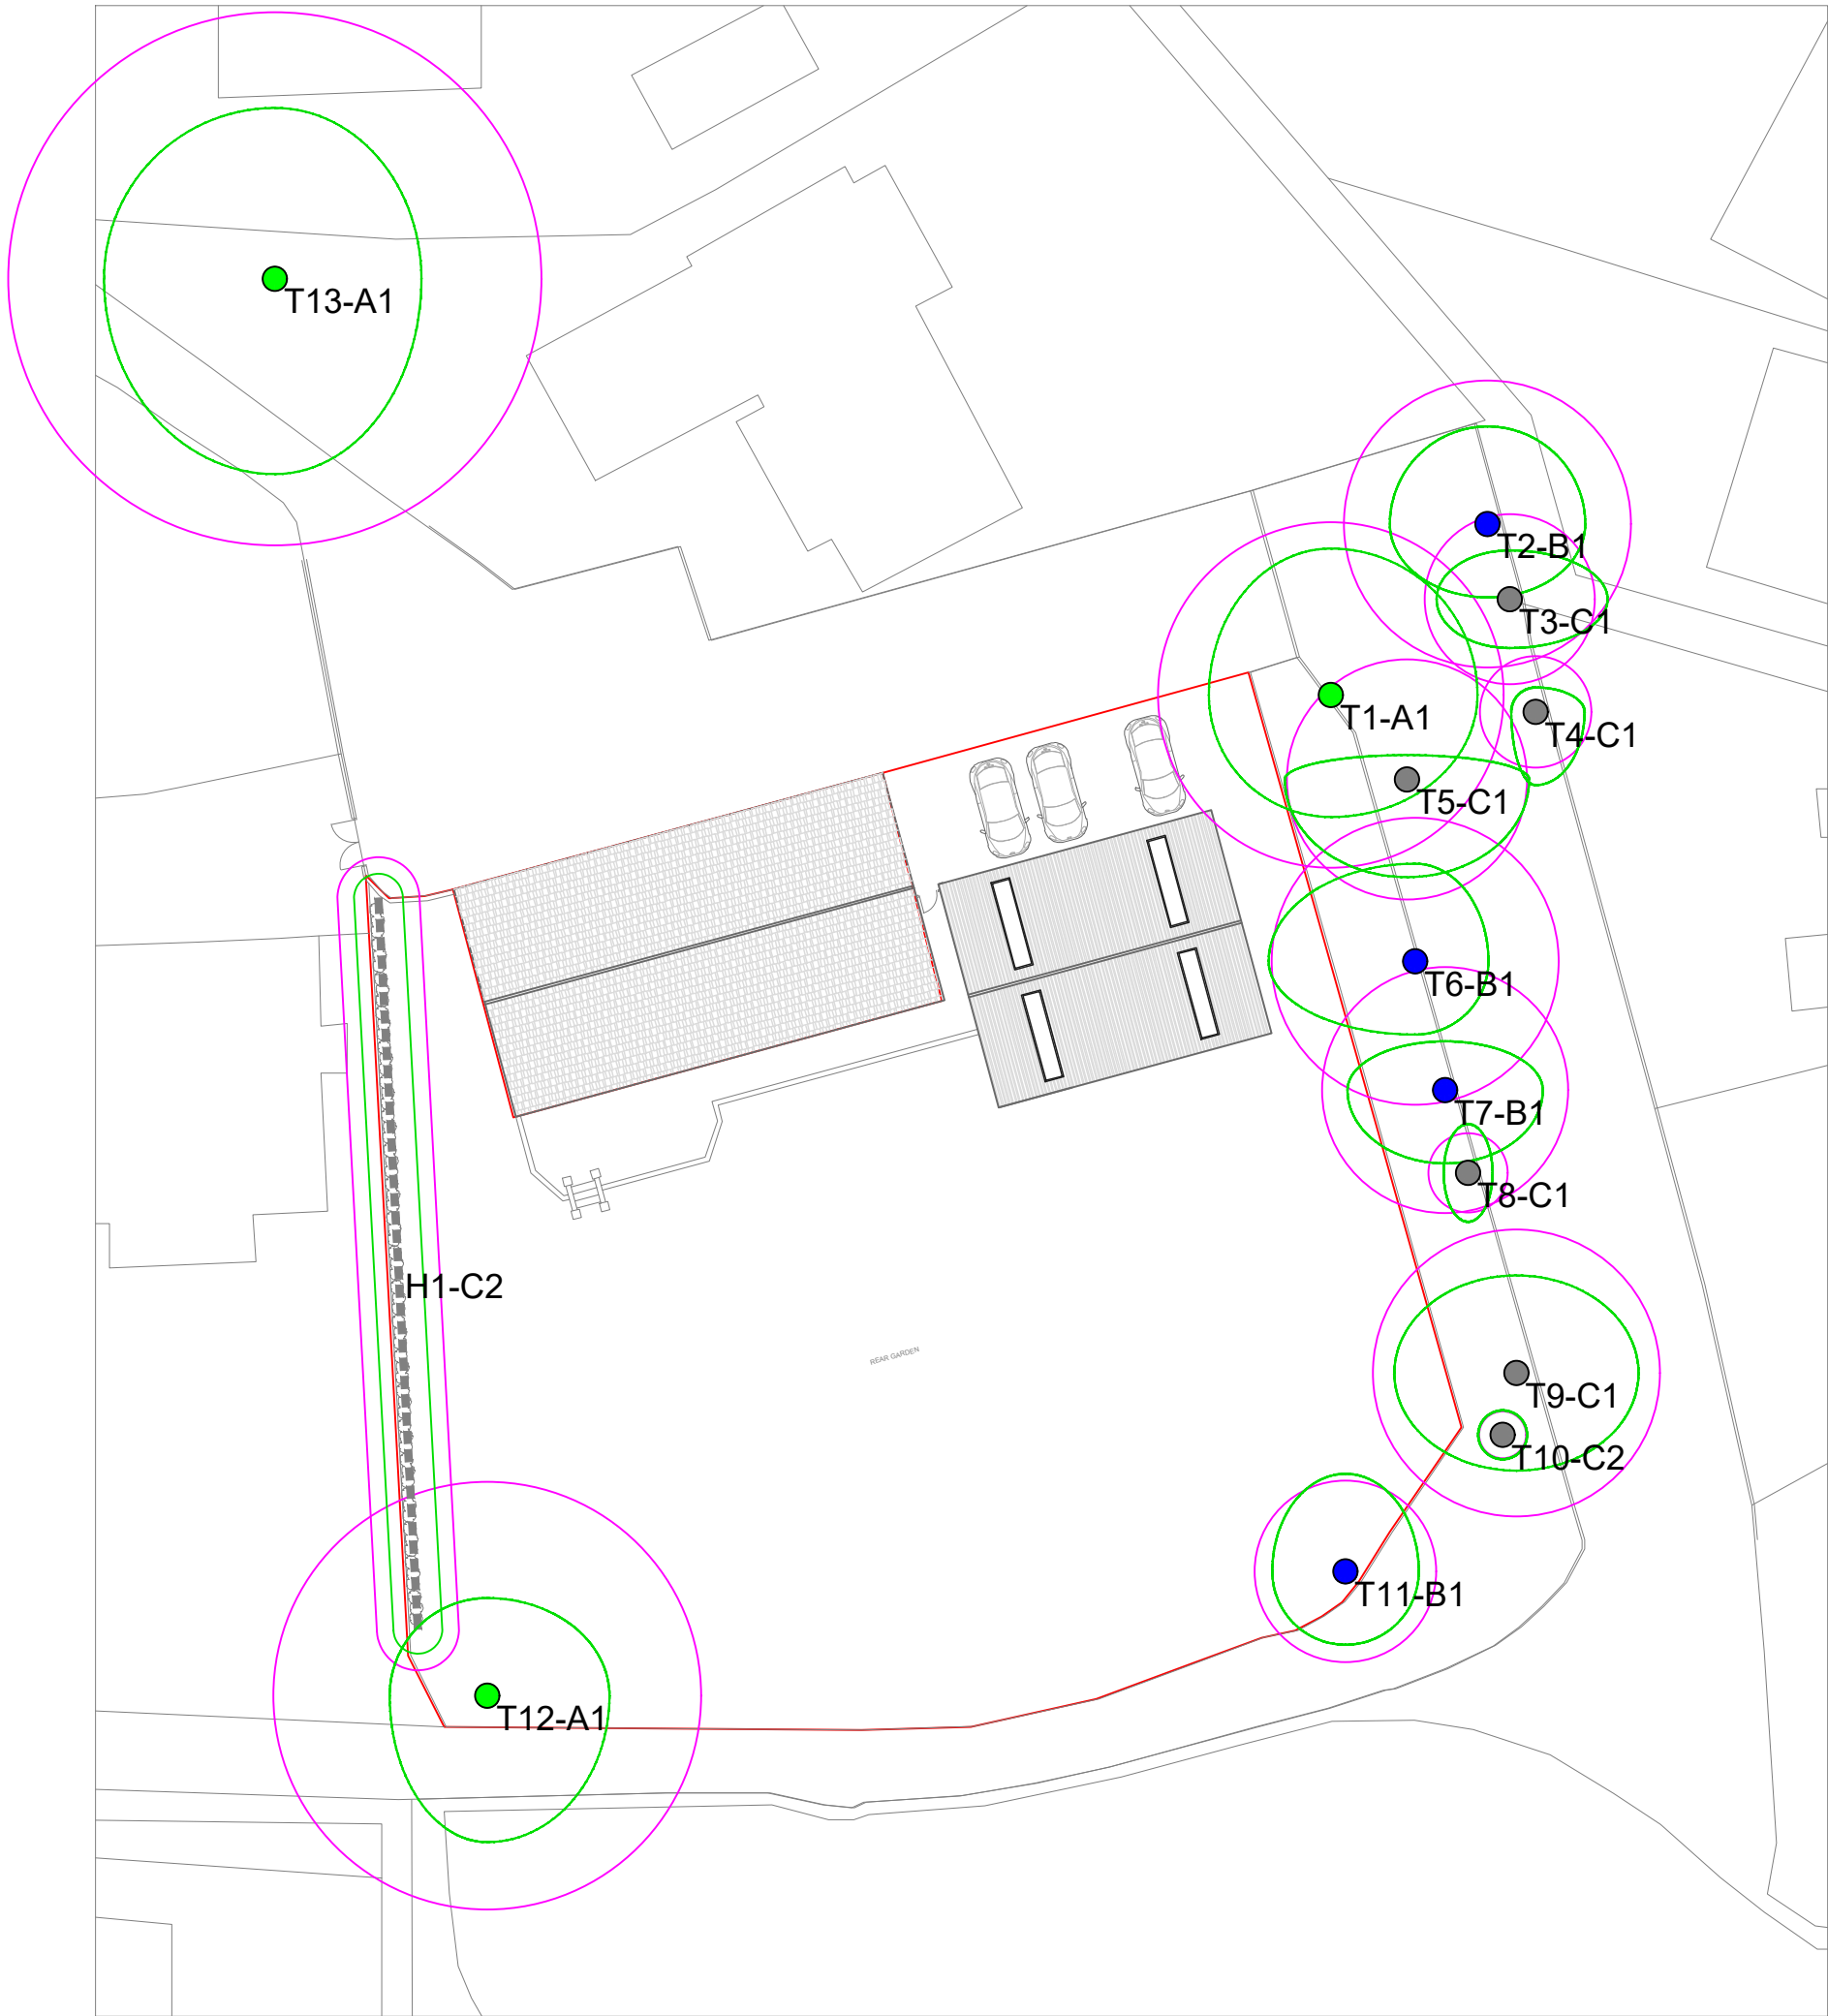
4.3.1 The site comprises an area of hardstanding currently used for parking, with adjacent trees positioned along the site boundary. The Tree Assessment Plan identifies multiple trees of varying quality, including several Category A and B specimens which are material constraints to development .

4.4.1 The Tree Assessment Plan shows that several trees are positioned in close proximity to the proposed works, including high and moderate quality specimens (Category A and B) with RPAs extending into the existing hardstanding and areas of disturbance .
