# **ARBORICULTURAL REPORT & Impact Assessment to BS 5837:2012 at:**

***Land South of  
Wallis Avenue,  
Rochdale  
OL16 4PS***

Report Date: *April 2026*

Reference: *AWA7343*

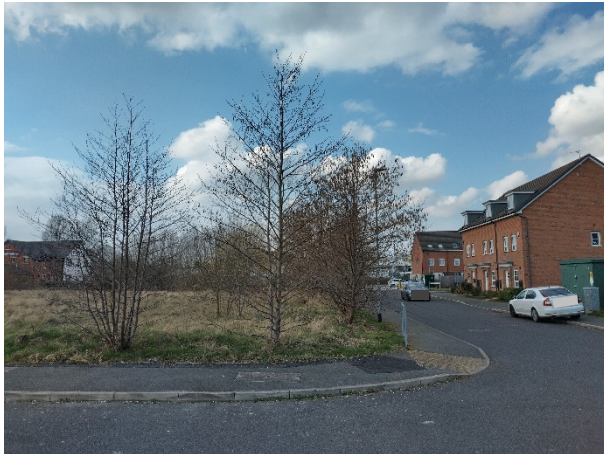
Photo 1: T1 -T3 from east

| | Tree Species | | | Measurements | | | Crown (m) | | | | | Tree Condition | | | | | | | Value | | Management | |
|---|---|---|---|---|---|---|---|---|---|---|---|---|---|---|---|---|---|---|---|---|---|---|
| T1 | Common Alder | <i>Alnus glutinosa</i> | Semi-mature | 3 | 10+ | 60 avg. | No | 0 | 1.5 | 1.5 | 2 | 2 | No visual defects | Multiple stemmed at base, Old pruning wounds | Normal | Pavement 0.5m west. | Good | Fair | 20 to 40 yrs | Low | C | No works required |
| T2 | Common Alder | <i>Alnus glutinosa</i> | Semi-mature | 4 | 2 | 110, 60 | No | 0 | 2.5 | 2 | 1.5 | 2 | No visual defects | Twin stemmed at base, Stubs, Old pruning wounds | Normal | Some branches rubbing smaller stems. Pavement 0.5m west and 1m north. | Good | Fair | 20 to 40 yrs | Low | C | No works required |
| T3 | Common Alder | <i>Alnus glutinosa</i> | Semi-mature | 5 | 4 | 170, 100, 90, 70 | No | 0.5 | 2.5 | 3.5 | 3.5 | 3.5 | No visual defects | Multiple stemmed at 0.5m, Old pruning wounds | Normal | Pavement 1m north. In contact with lamppost to east. | Good | Fair | 20 to 40 yrs | Low | C | No works required |

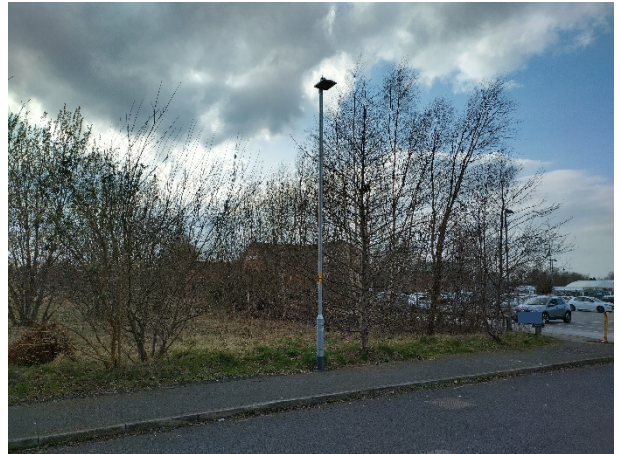
Photo 2: T11, T12 and G15 from north

| | Tree Species | | | Measurements | | | Crown (m) | | | | | Tree Condition | | | | | | | Value | | Management | |
|---|---|---|---|---|---|---|---|---|---|---|---|---|---|---|---|---|---|---|---|---|---|---|
| T11 | Common Alder | <i>Alnus glutinosa</i> | Semi-mature | 5 | 1 | 160 | No | 0.5 | 2 | 2.5 | 2 | 2.5 | No visual defects | Single stemmed, Vertical, Old pruning wounds, Stubs | Normal | Pavement 0.5m north. Close to contact with streetlamp to east. | Good | Good | 20 to 40 yrs | Low | C | No works required |
| T12 | Common Alder | <i>Alnus glutinosa</i> | Semi-mature | 4 | 5 | 100, 60, 60, 50, 30 | No | 0.5 | 2 | 2.5 | 2 | 1.5 | No visual defects | Multiple stemmed at base, Tight union, Partially included bark, Old pruning wounds, Stubs | Normal | Pavement 0.5m north. | Good | Fair | 20 to 40 yrs | Low | C | No works required |

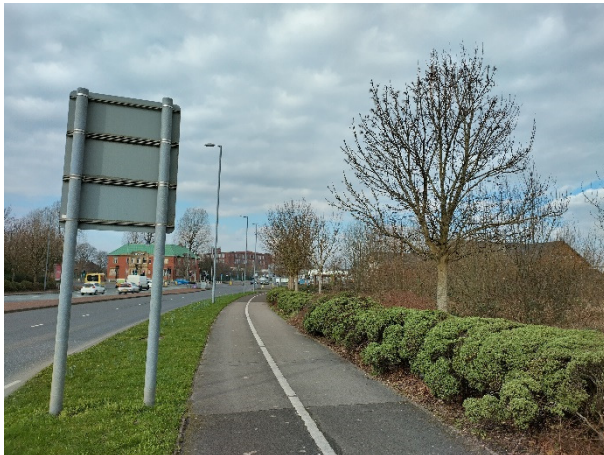
Photo 3: T17-T20 from southeast

| | Tree Species | | | Measurements | | | Crown (m) | | | | Tree Condition | | | | | | | Value | | Management | | |
|---|---|---|---|---|---|---|---|---|---|---|---|---|---|---|---|---|---|---|---|---|---|---|
| T17 | Norway Maple | Acer platanoides | Semi-mature | 8 | 1 | 220 | No | 2.5 | 3 | 3.5 | 2.5 | 3.5 | No visual defects | Single stemmed, Vertical, Multiple stemmed at 2m, Partially included bark | Minor deadwood | Pavement 2m south part of a line of Maples along the roadside. | Good | Fair | 20 to 40 yrs | Moderate | C | No works required |
| T18 | Norway Maple | Acer platanoides | Semi-mature | 8 | 1 | 220 | No | 2.5 | 2.5 | 2.5 | 3 | 3.5 | No visual defects | Single stemmed, Vertical, Multiple stemmed at 2m, Partially included bark | Minor deadwood | Pavement 2m south part of a line of Maples along the roadside. | Good | Fair | 20 to 40 yrs | Moderate | C | No works required |
| T19 | Norway Maple | Acer platanoides | Semi-mature | 6 | 1 | 160 | No | 2.5 | 1.5 | 2 | 1.5 | 2 | No visual defects | Single stemmed, Vertical, Multiple stemmed at 2m, Partially included bark | Minor deadwood | Pavement 2m south part of a line of Maple along the roadside. Central leader dead with section of bark damage extending down to branch junction. | Fair | Fair | 20 to 40 yrs | Moderate | C | No works required |
| T20 | Norway Maple | Acer platanoides | Semi-mature | 8 | 1 | 210 | No | 2.5 | 2 | 3.5 | 3 | 3 | No visual defects | Single stemmed, Vertical, Multiple stemmed at 2m, Partially included bark | Minor deadwood | Pavement 2m south part of a line of Maples along the roadside. | Good | Fair | 20 to 40 yrs | Moderate | C | No works required |

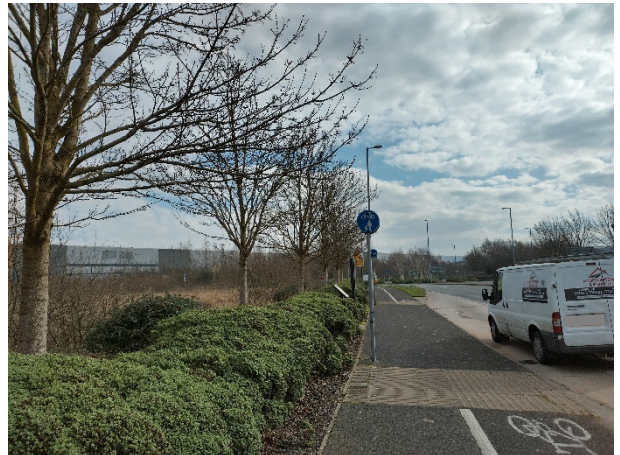
Photo 4: T26-T29 from southwest

| | Tree Species | | | Measurements | | | Crown (m) | | | | Tree Condition | | | | | | | Value | | Management | | |
|---|---|---|---|---|---|---|---|---|---|---|---|---|---|---|---|---|---|---|---|---|---|---|
| T26 | Norway Maple | Acer platanoides | Semi-mature | 8 | 1 | 210 | No | 2.5 | 2.5 | 3.5 | 3 | 3 | No visual defects | Single stemmed, Vertical, Multiple stemmed at 2m, Partially included bark | Minor deadwood | Pavement 2m south part of a line of Maples along the roadside. Close to contact with lamppost to southeast. | Good | Fair | 20 to 40 yrs | Moderate | C | No works required |
| T27 | Norway Maple | Acer platanoides | Semi-mature | 8 | 1 | 200 | No | 2.5 | 2.5 | 3.5 | 3 | 3 | No visual defects | Single stemmed, Vertical, Multiple stemmed at 2m, Partially included bark | Minor deadwood | Pavement 2m south part of a line of Maple along the roadside. Close to contact with sign to southeast. | Good | Fair | 20 to 40 yrs | Moderate | C | No works required |
| T28 | Norway Maple | Acer platanoides | Semi-mature | 8 | 1 | 200 | No | 2.5 | 2.5 | 2 | 3 | 2.5 | No visual defects | Single stemmed, Vertical, Multiple stemmed at 2m, Partially included bark | Minor deadwood | Pavement 2m south part of a line of Maples along the roadside. | Good | Fair | 20 to 40 yrs | Moderate | C | Removal required to facilitate the development |
| T29 | Norway Maple | Acer platanoides | Semi-mature | 8 | 1 | 200 | No | 2.5 | 2.5 | 3 | 3 | 2.5 | No visual defects | Single stemmed, Vertical, Multiple stemmed at 2m, Partially included bark | Minor deadwood | Pavement 2m south part of a line of Maples along the roadside. | Good | Fair | 20 to 40 yrs | Moderate | C | No works required |

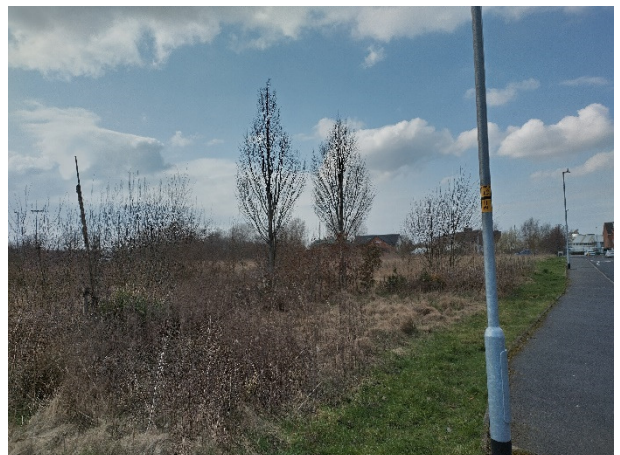
Photo 6: T41 and T42 from northeast

| | Tree Species | | | Measurements | | | Crown (m) | | | | Tree Condition | | | | | | | Value | | Management | | |
|---|---|---|---|---|---|---|---|---|---|---|---|---|---|---|---|---|---|---|---|---|---|---|
| T41 | Hornbeam | Carpinus betulus | Semi-mature | 5 | 1 | 110 | No | 1 | 1.5 | 1.5 | 1.5 | 1.5 | No visual defects | Single stemmed, Vertical, Tight union | Normal | Still staked in place. Tight upright form. | Good | Good | 20 to 40 yrs | Low | C | Removal required to facilitate the development |
| T42 | Hornbeam | Carpinus betulus | Semi-mature | 5 | 1 | 120 | No | 1 | 1.5 | 1.5 | 1.5 | 1.5 | No visual defects | Single stemmed, Vertical, Tight union | Normal | Still staked in place. Tight upright form. | Good | Good | 20 to 40 yrs | Low | C | Removal required to facilitate the development |
