Russell Grey  
Etive Ecology Ltd.  
Wirral

7<sup>th</sup> April 2026

**Hillcrest Garage, Hillcrest Road, Rochdale**  
**Bat Emergence Survey Report**

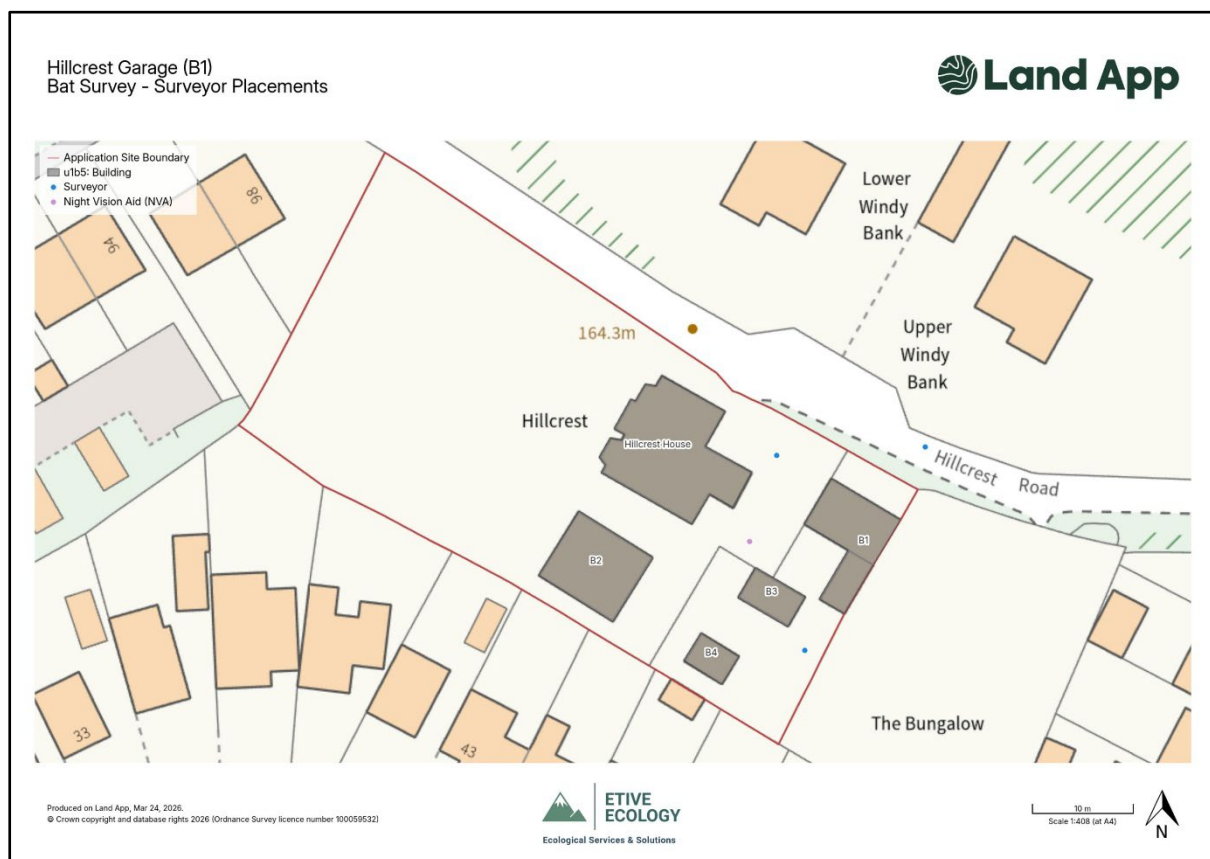
The survey was led by bat-licensed Russell Grey (2015-14472-CLS-CLS), an experienced ecologist with over 20 years spent as an ecological consultant. Survey assistance was provided by Laura Clement-Evans and Rebecca Whalley, all of whom have at least 2 years of bat survey experience. See the surveyor placements in Figure 1 below.
