# **Site Tree Appraisal**

## ***Plumpton Cottage, Bury & Bolton Old Road, OL10 4AT***

**"BS 5837 2012: Trees in Relation to Design, Demolition and Construction – Recommendations"**

Date: 11<sup>th</sup> August 2026  
Ref: RTS/27032026 002  
Revision: 002

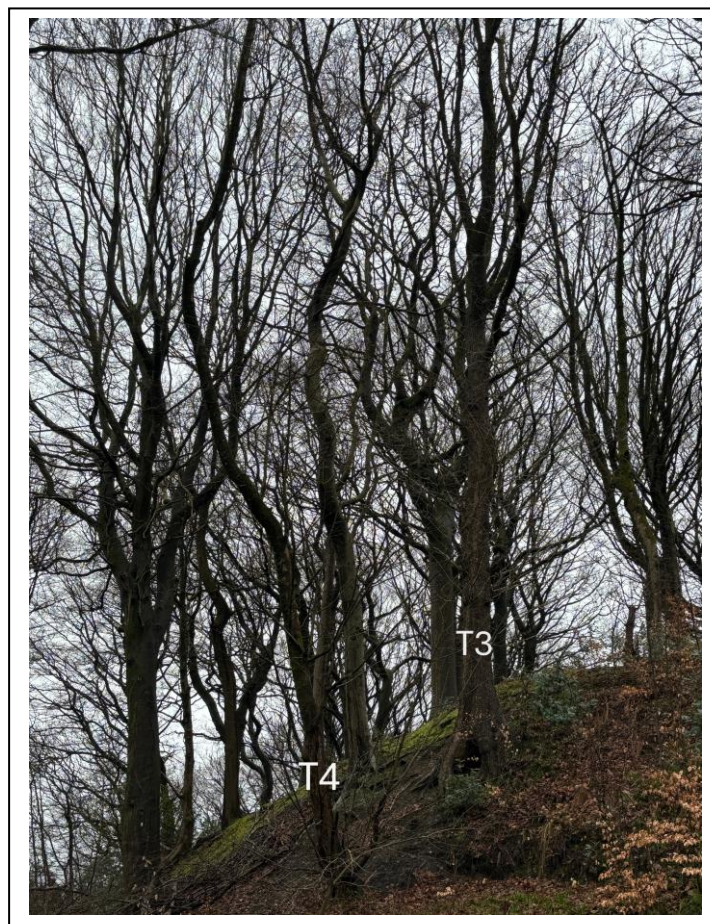
**Photo 04:**

**3.4** Given that T5 is a sizable dominant tree at the woodland edge, its removal will expose trees; T4 and T6 to altered wind forces. T4 (photo 04) is a tall slender tree of weak structural form that is currently in a sheltered location due to the presence of T5. Beech tree T6, also currently sheltered by T5, has suffered previous large co-dominant limb failure (photos 01 & 05). Removal of T5 will expose its remaining co-dominant upper limb to altered wind forces. In order to maintain wildlife habitat, given that the trees are in a designated SBI, topping of T4 and T6 is recommended to reduce their canopy sail area following removal of T5.

| Tree No | Species | Height (M) *<br>Crown Height above GL | DBH (mm) * | Crown Spread (M) * | Height to Lowest Branch (M)<br>Direction of Lowest Branch | Age Range | Condition | RPA Radius (M) | RPA Square metres | BS 5837 Category Rating | Observations and Comments |
|---|---|---|---|---|---|---|---|---|---|---|---|
| T4 | <b>Sycamore</b><br><i>Acer pseudoplatanus</i> | <u>20.0</u><br>15.0 | 320 | N – 3.0<br>S – 2.0<br>E – 1.0<br>W – 3.0 | <u>14.0</u><br>N | Early<br>Mature | Poor | 3.8 | 45 | U | Very tall poor structural form; The tree is located in a sheltered location. |

| Tree | Tree Work | Priority |
|---|---|---|
| T4 | Reduce the tree's height by topping to a height of approximately 10 metres. Following this work monitor the tree's condition for health and safety on an annual basis. | Prior to any other site works |
