**ARBORICULTURAL IMPACT ASSESSMENT  
to BS 5837:2012**

**Land at Ashdene / Burwell Close  
Rochdale  
Lancashire  
OL12 6DJ**

**Client:**  
PNS Landscapes

**JCA Ref:**  
23621a/DP

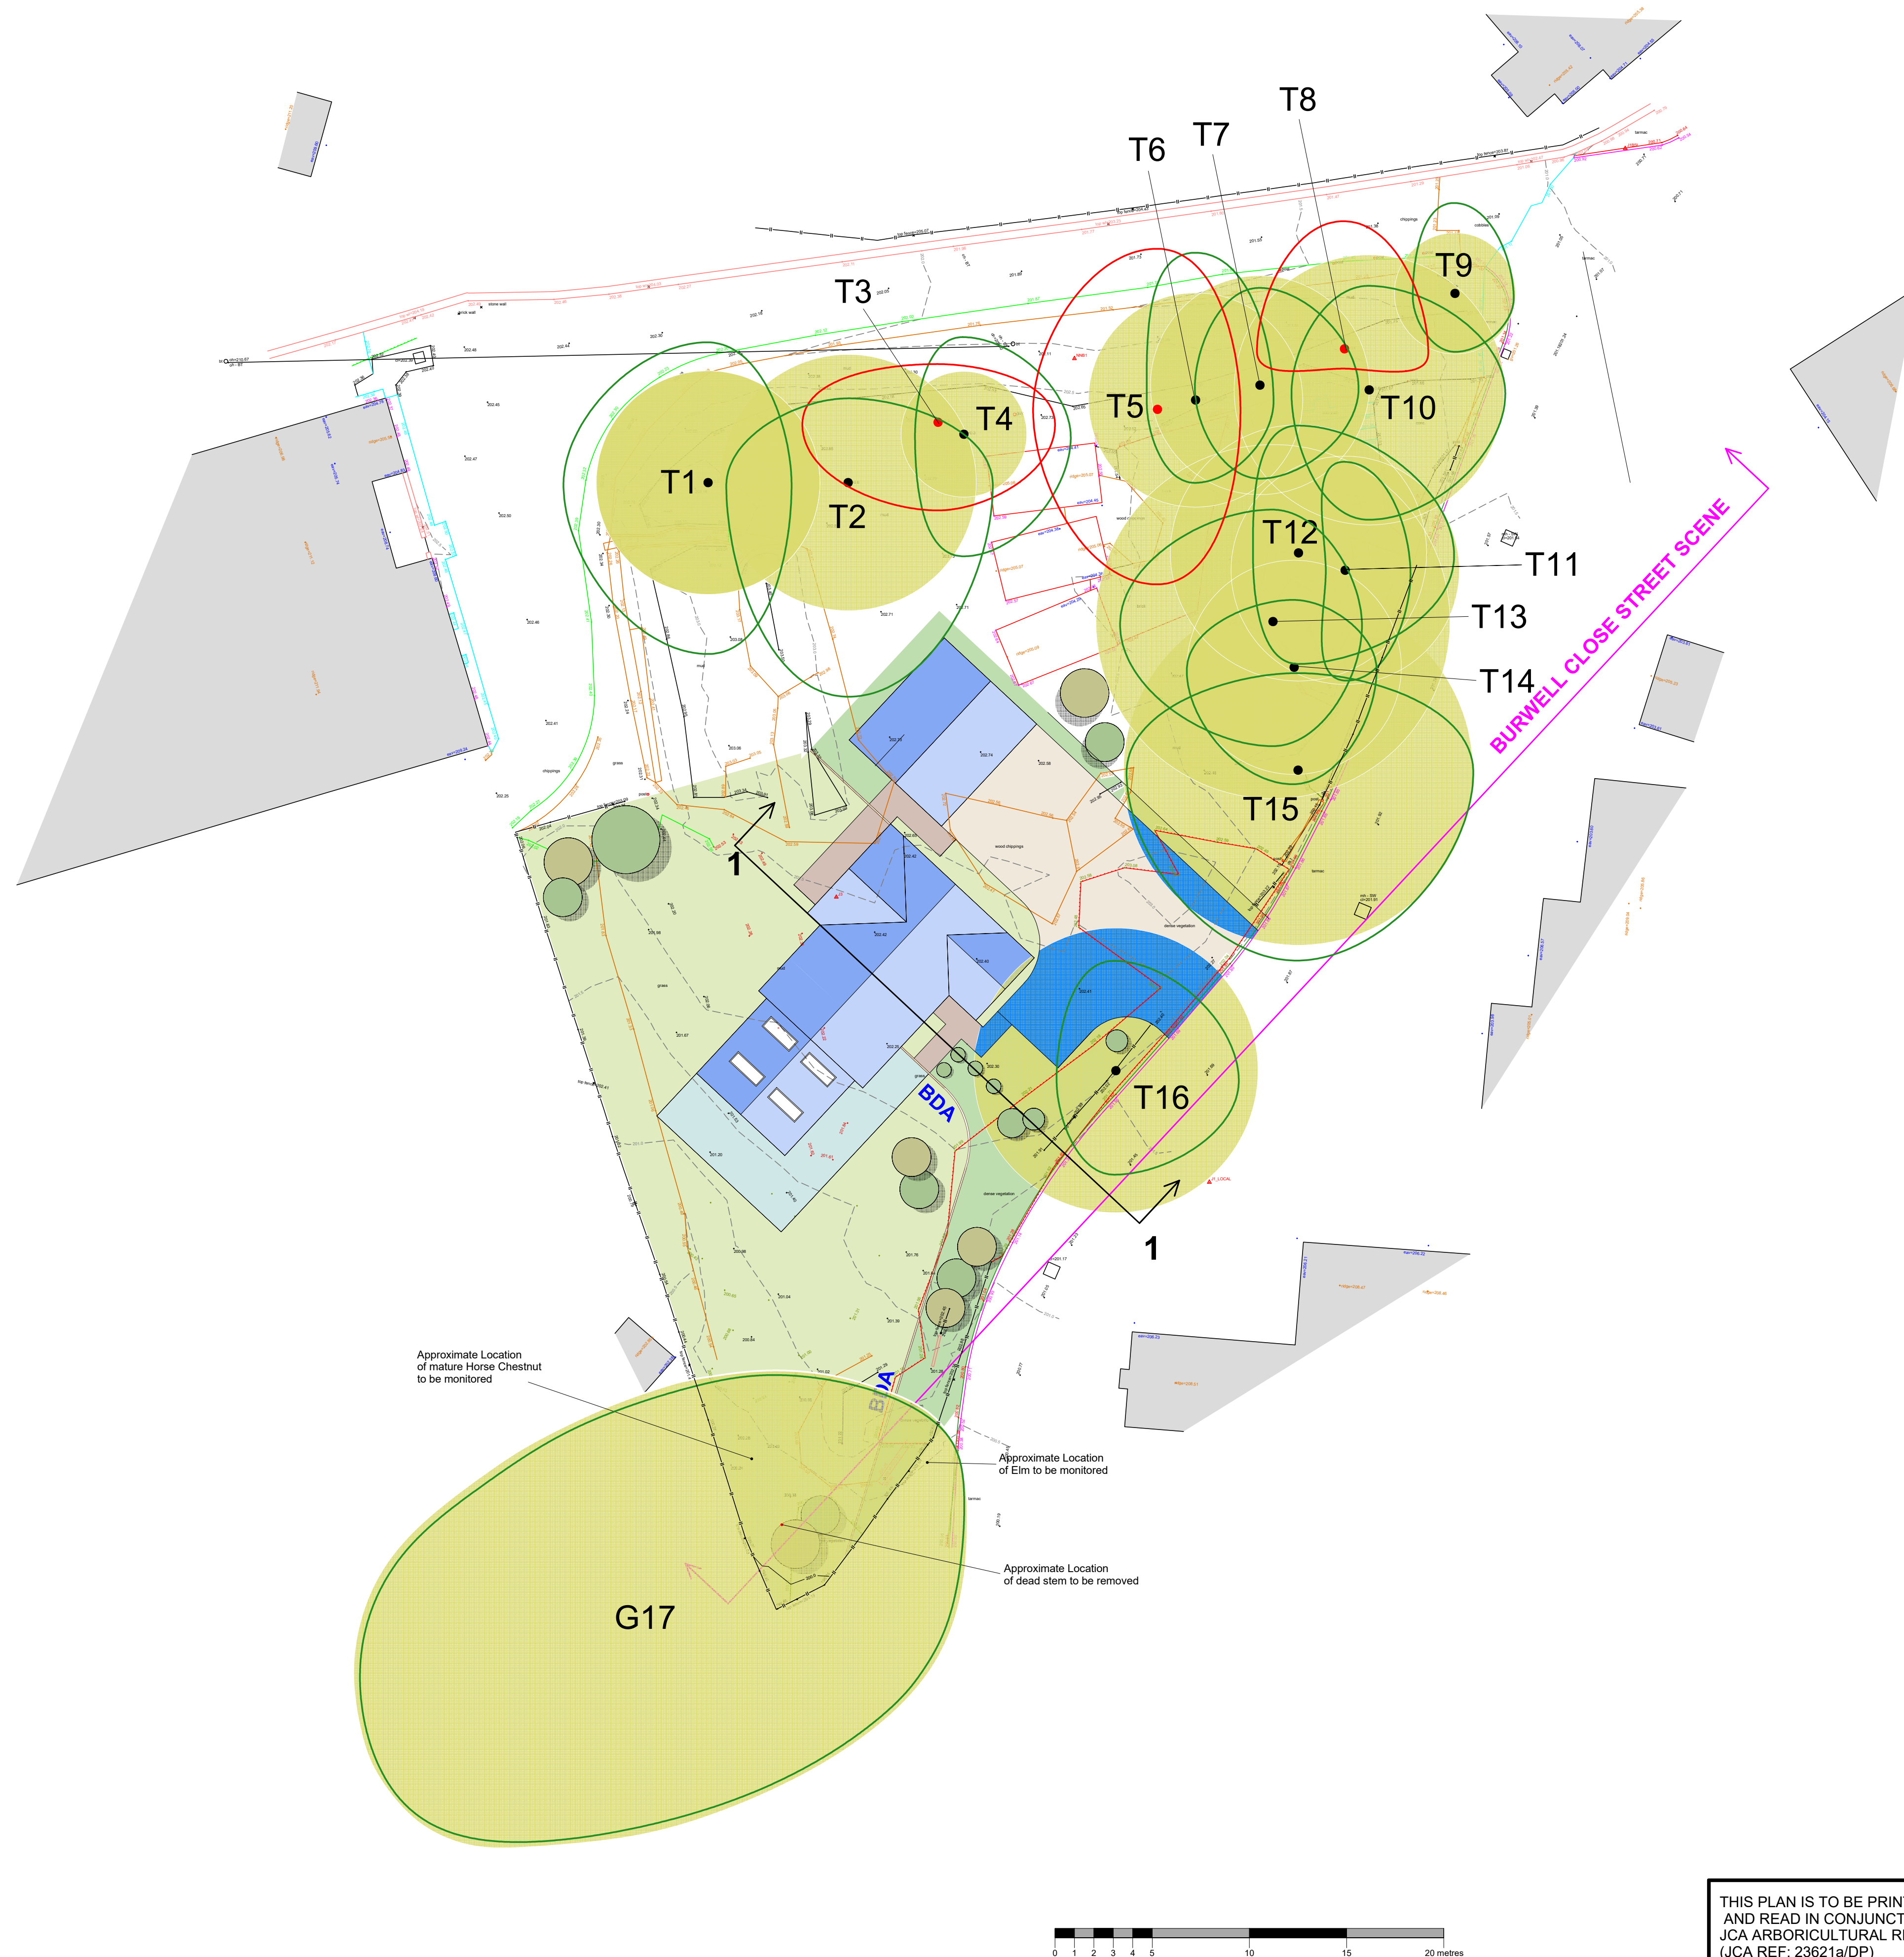
## Appendix 6: Arboricultural Implications Plan

- 3.5.2.1 The proposed development entails the construction of hard surfacing within the RPAs of **T15** and **T16** of the retained trees. This takes the form of a driveway/parking area and a footpath. Existing historic hard surfacing is present within the site. However, due to its age, the effects of weathering and extensive ground vegetation, its precise condition and extent are uncertain.

- 3.5.2.3 However, if the proposed hard surfacing extends beyond the existing hard surfacing and enters open ground within the RPAs of **T15** and **T16**, or if the existing hard surface cannot be retained, a 'no-dig' method of construction will be utilised to prevent foreseeable damage to tree roots.

- 3.6.2 Part of the proposed development will encroach into the RPAs of **T15** and **T16**, resulting in possible root loss. It would therefore be prudent to apply appropriate mycorrhizae fungi to the soils around these trees after the construction phase is complete. Certain mycorrhiza fungi form a symbiotic relationship with tree roots. A tree root associated with such mycorrhiza will take up nutrients more effectively and this will therefore help the tree to produce new roots more effectively, so benefitting their recovery.

- 3.5.2.4 The chosen system must be fit for purpose and of suitable construction to dissipate compaction damage to tree roots, allow gaseous diffusion to/from the soil and the percolation of water to the soil surface. This may require the use of specialist materials and sensitive edging systems to prevent damage to tree roots. It is recommended that this surfacing be constructed as a final phase of construction.

- 3.5.2.5 Design principles must be confirmed by an appropriately qualified engineer and should be included in an Arboricultural Method Statement.
- 3.5.2.6 If it is necessary to remove the existing hard surfacing, it is vital that only the existing surfacing is removed and that the underlying soil is not disturbed, to prevent potential damage to tree roots. The existing surfacing must therefore be removed in a cautious manner, ideally using hand tools when working within the RPAs.
