# Preliminary Roost Assessment

95 Marland Fold, Rochdale, Lancashire OL11 4RF

The proposal is described as: The demolition of existing dwelling and for construction of new dwelling and associated works.

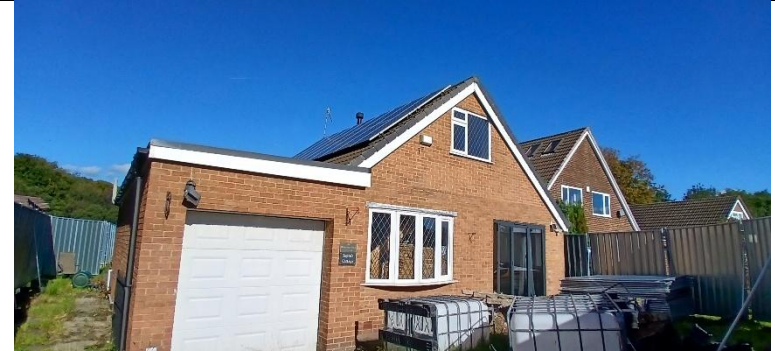
B1 is a two-storey, brick built residential dwelling with a pitched roof with gables on the northern and southern elevation. There is a flat roof adjoined garage to the western elevation, and a single-storey wood-panelled summer house adjoined to B1 via the northern elevation.

B1 – Southern elevation

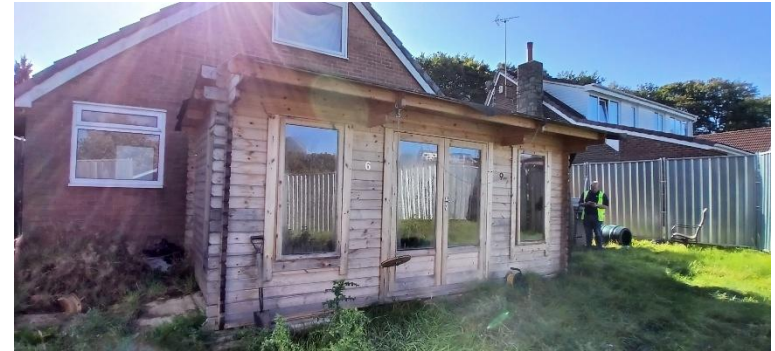
Adjoining wooden panel structure to rear of B1

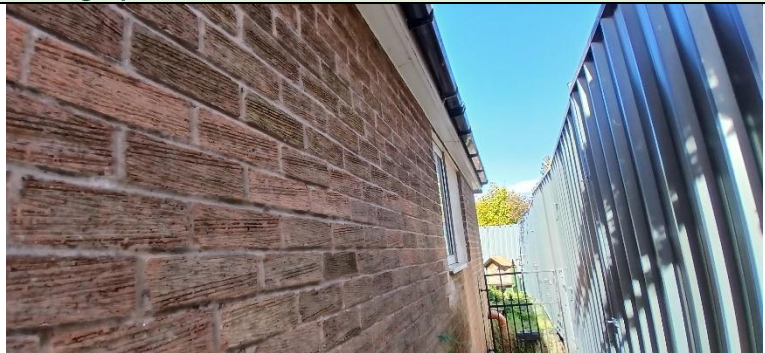
| Feature | Materials | Condition/description/suitability | Photograph(s) |
|---|---|---|---|
| Walls | Brick built | The walls of B1 are in good condition with no areas of damage or crevices which roosting bats could exploit. | <p>Example of the walls on B1</p> |

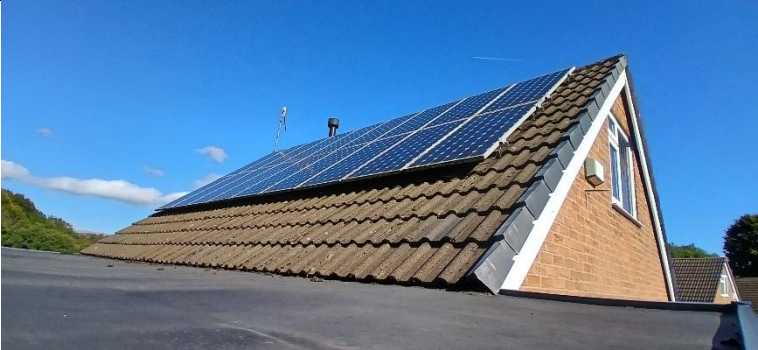
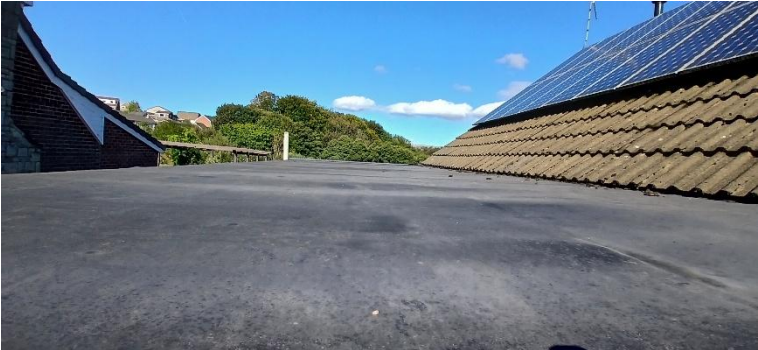
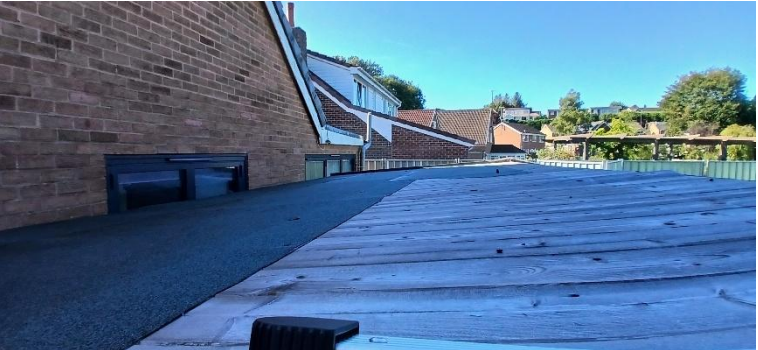
| Roof | Cement tiles,<br>bitumen felt | <p>The cement tiles are pan tiles which, by nature of design, interlock tightly. No obvious areas of damage or missing tiles were identified. However, there are solar panels on the western roof aspect. Features suitable for roosting bats may be present below the solar panels and may have been missed as a result of their obstruction.</p> <p>The flat roof section to the west is covered with bitumen felt which is in good condition with no areas of sagging or tearing.</p> <p>To the rear of the property, there is a single storey wood structure which is also covered in bitumen felt. No evidence of bats utilising this area was identified. The flat roof aspects of B1 are considered negligible for roosting bats.</p> | <p>Showing interlocking pan tiles and solar panels on western roof aspect.</p> <p>Bitumen felt roof to the west.</p> <p>Roof of wood structure to rear of B1.</p> |

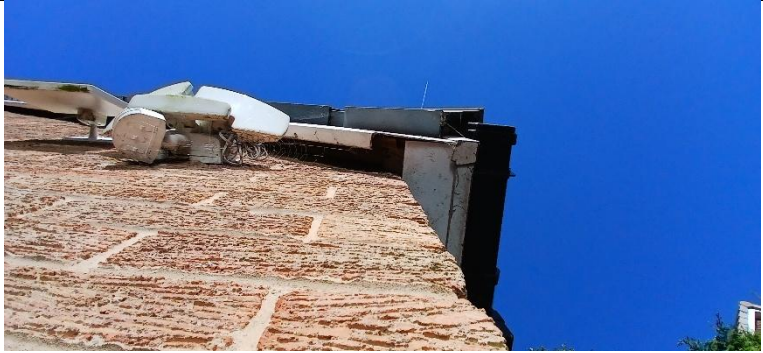
| Barge boards/fascia boards | PVC | The fascia and barge boards of B1 are comprised of PVC and are tightly sealed to the structure for the most part. There is a section to the southeast of B1 where there is a gap behind the soffit. This feature is sub-optimal due to the thermal properties of PVC which would hinder bats ability to thermoregulate and daily torpor if roosting within this feature. The presence of individual crevice dwelling bats utilising this feature on a transient basis cannot be discounted. | |

Gap behind soffit boards

| Site Location and Context | | | | | |
|---|---|---|---|---|---|
| 1. Prior to demolition of the building, a suitably qualified ecologist should conduct an inspection of all identified features using a torch or endoscope to ensure that bats are not present within the structure. If any evidence of roosting bats are noted, bat emergence surveys are required. | | | | | |

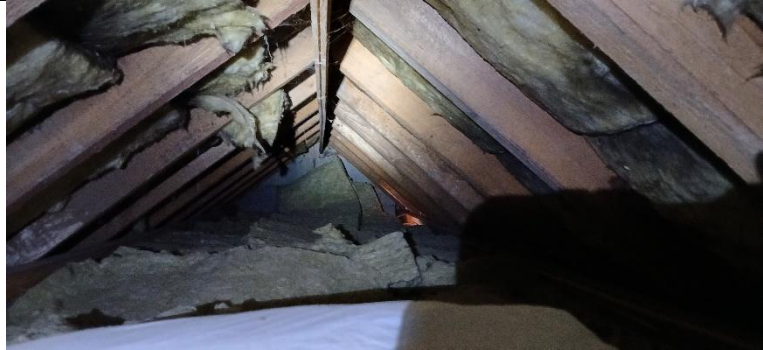
| Internal voids | Timber beams and mineral wool insulation | Internal space measures 6m L x 1m W x 0.5m H with internal conditions recorded 13.6°C and 70.6% relative humidity. The loft space is shallow rendering it not possible to fully enter the void. The space is also considered too shallow to facilitate warm up flights by void dwelling species. The roof and floor are lined with mineral wool insulation. No evidence of roosting bats such as live animals, droppings, staining or foraging remains, was identified within the internal space. | |

B1 loft void

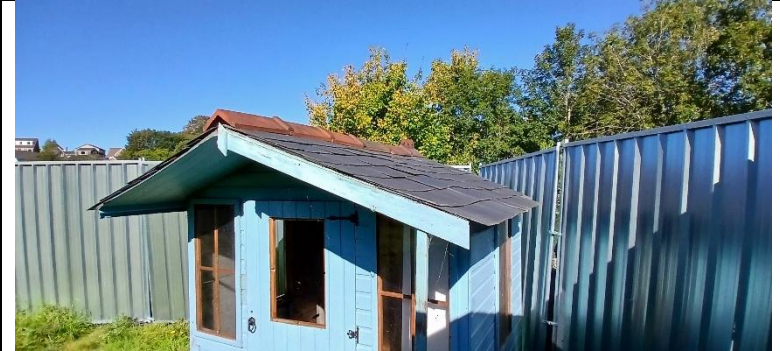
B2 is a timber shed situated to the northeastern vegetated garden. The timber shed, is open via windows on the southern and western elevation. The interior is not suitable for void dwelling species due to permitting daylight and weather exposure. The pitched roof has slate tiles and clay ridge tiles. There are several gaps beneath the roof and ridge tiles that are suitable for crevice dwelling species to exploit. The eaves are wooden and overhanging with no crevices or areas for roosting bats to exploit.

B2 southern elevation

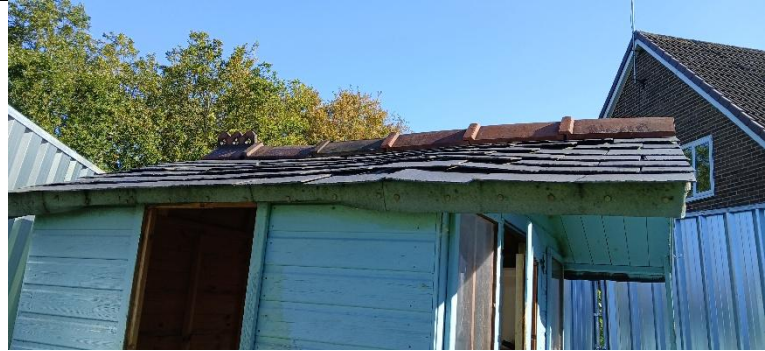
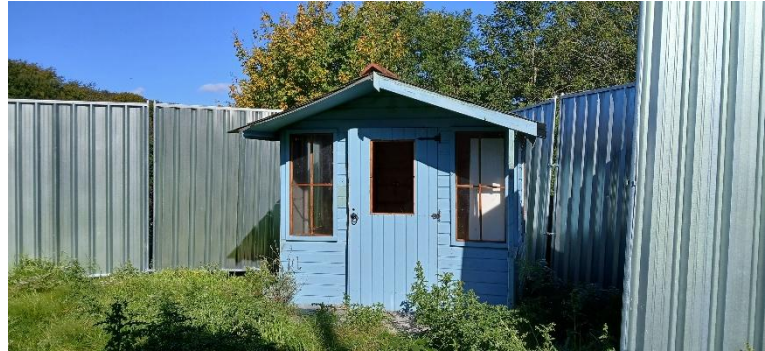
| Feature | Materials | Condition/description/suitability | Photograph(s) |
|---|---|---|---|
| Roof | Slate roof tiles, clay ridge tiles | There are gaps beneath the slate tiles on the western elevation and a gap at the apex ridge tile. These features are suitable for crevice dwelling species. These features are considered sub-optimal due to the height at which the features are. Bats are less likely to utilise features within 2m of the ground. | <p>Lifted tiles on B2</p> |

| <i>Recommendations</i> | <p><b>No works to the property that may block or remove potential roosting features should be carried out until the required surveys have been completed. Undertaking such work beforehand could unlawfully affect bats if present and may compromise the validity of the surveys and hinder the planning application process.</b></p> <p><b>Roosting habitat [Buildings]</b><br/>As only a small number of features have been identified, and all features can be assessed and inspected using a torch and/or endoscope, prior to the demolition of B1 and B2 an endoscope survey should be conducted. This will ensure no bats or evidence of bats are identified within any of the identified features. Should there be no evidence of bats within these features, no further surveys are required. Demolition should take place the day of the inspection to ensure no bats can move into the structure in the interim between the inspection and demolition.</p> <p>If evidence of bats are identified during the survey, no works can commence. Three bat emergence/re-entry survey will be required on B1 and B2 during the active bat season (May – September) to characterize the roost present. These survey visits should be completed during the optimal survey period mid-May to August inclusive.</p> | | |

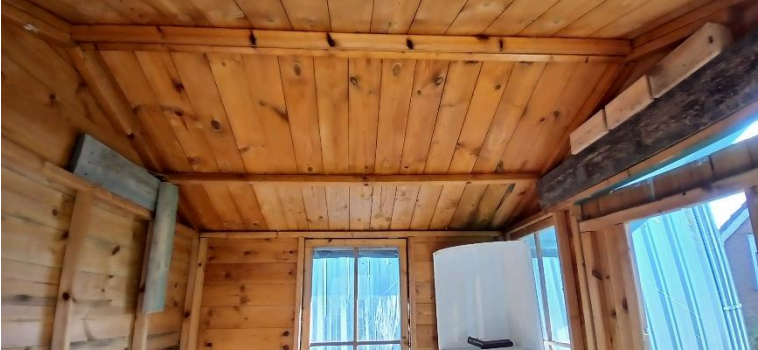
| Internal voids | Timber beams and wooden chipboard roof | The interior of B2 has a high degree of permitting daylight which reduces the suitability of the internal for void dwelling species. No suitable crevices for crevice dwelling species were identified within the interior. | <p>Gap at apex tile</p> <p>Interior of B2</p> |
