## GeoEnvironmental Site Investigation Report

Waterfold Lane

Heywood

**Report Ref: A4301/21/SI**

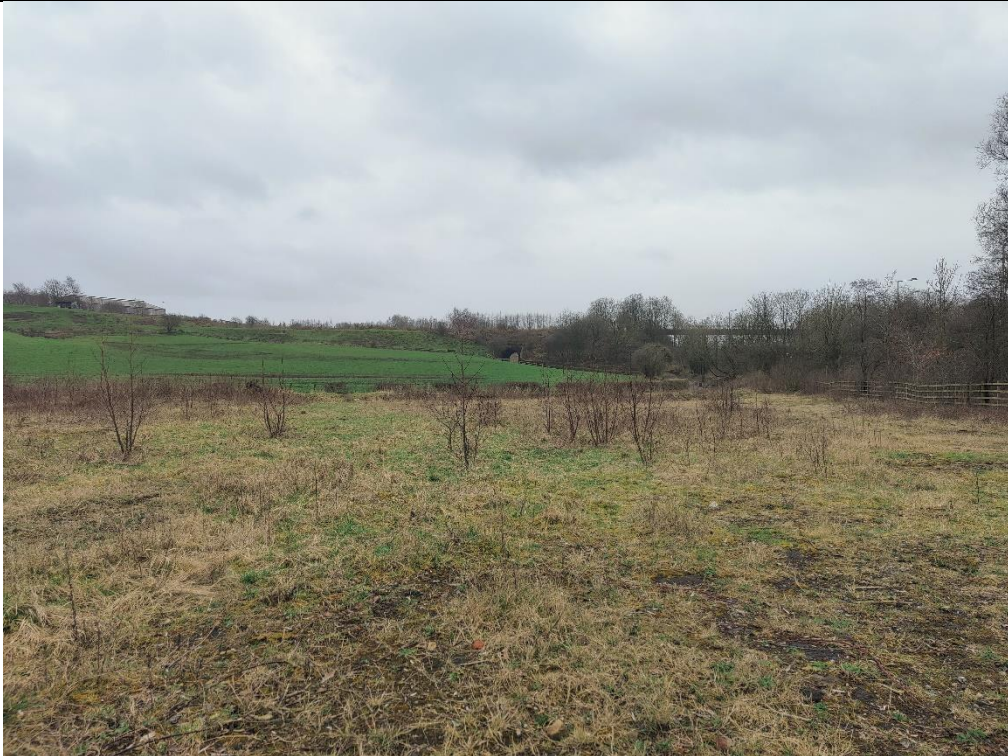
Photograph taken across the site, facing south

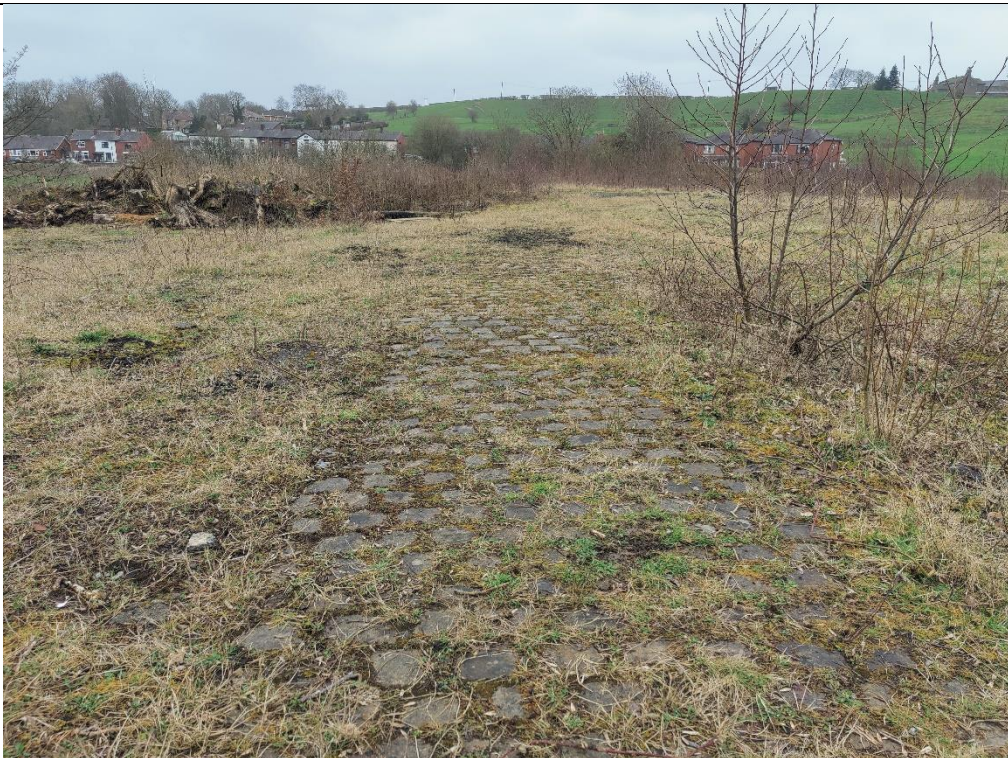
Photograph taken of relic cobbled path, facing east

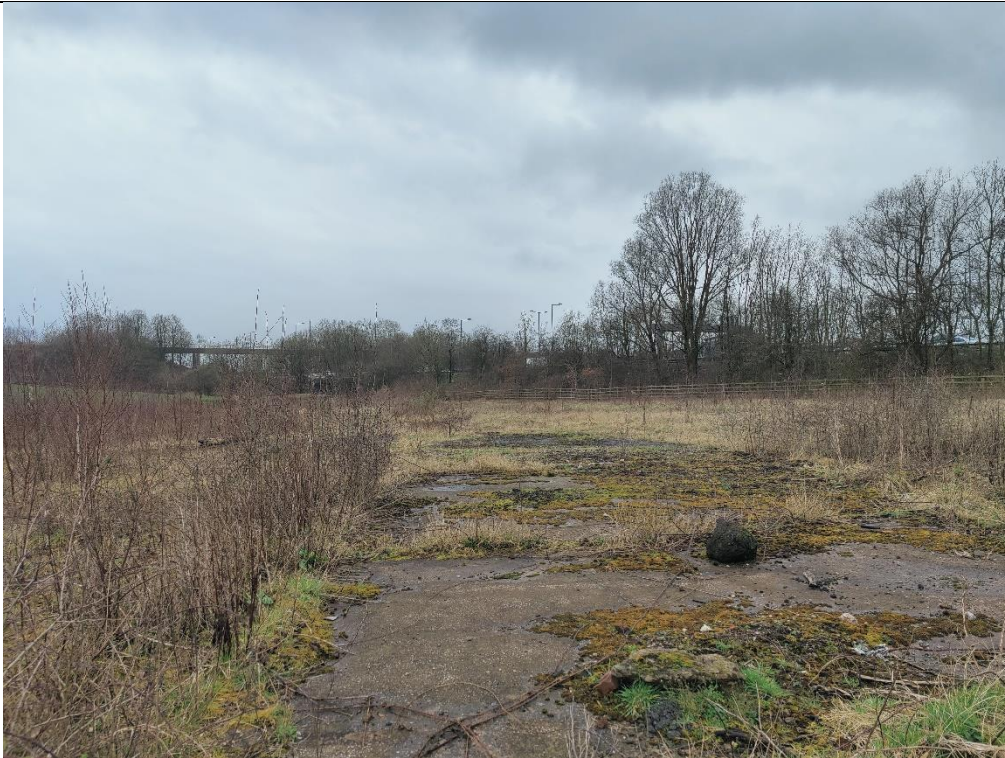
Photograph taken of relic road, facing south

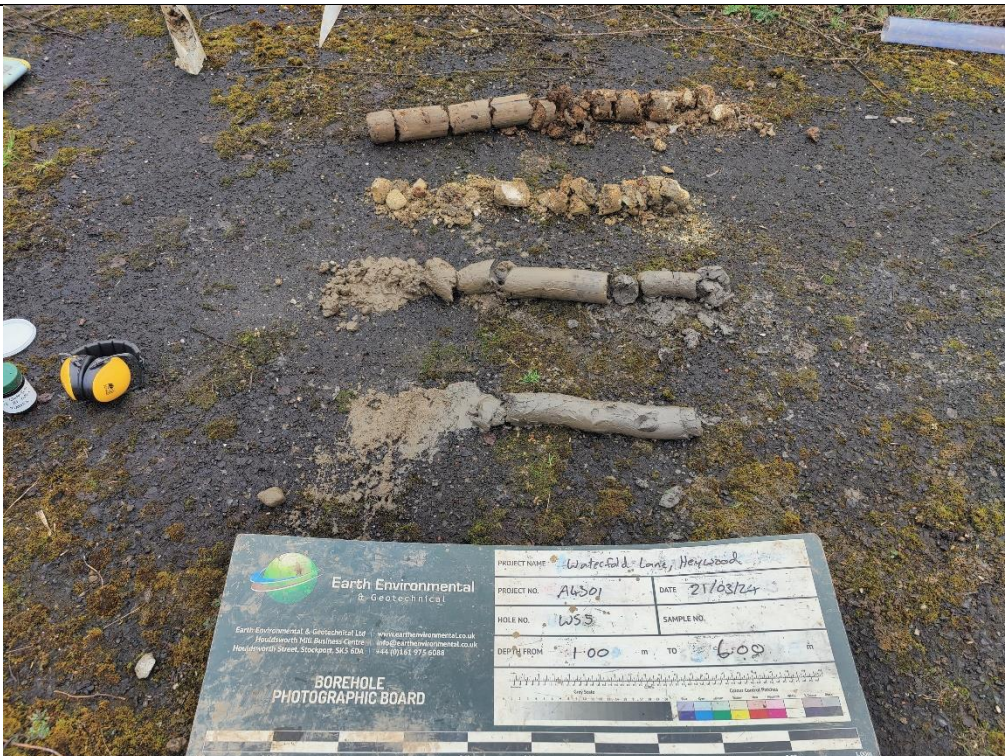
Photograph of representative soils (WS5)

Clinker was observed throughout the made ground across the site, with ash also identified within WS5.

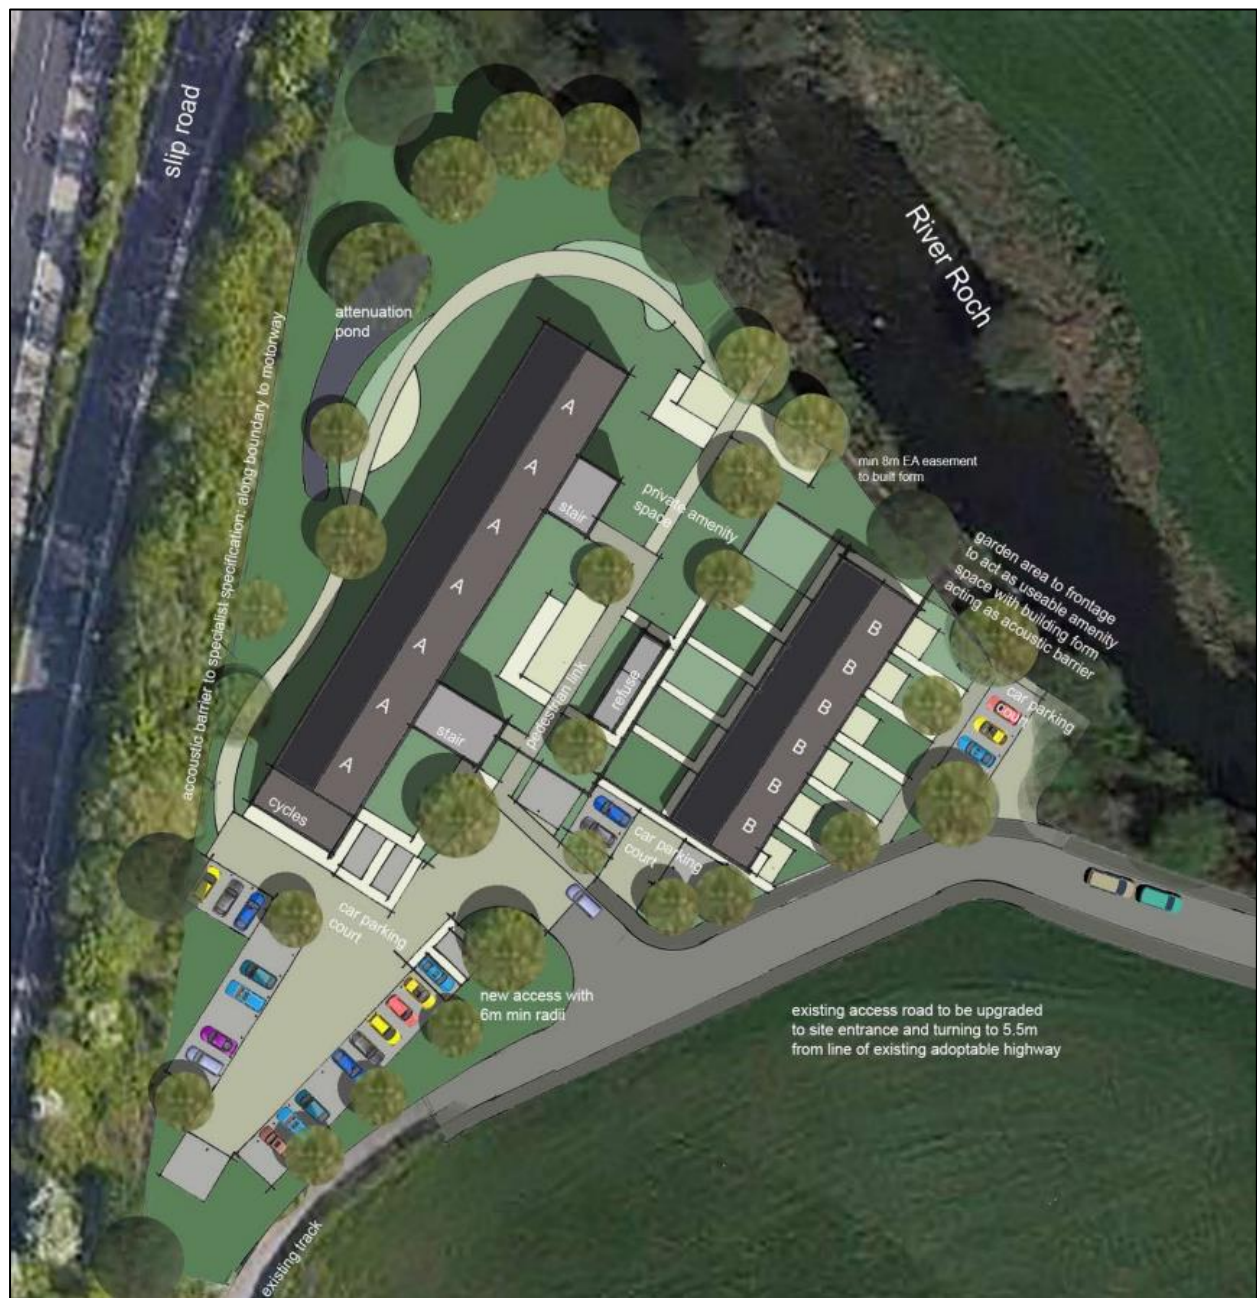
**Figure 3: Proposed Development Plan**

It is understood that the client wishes to develop a new row of townhouses and a residential apartment block, comprising six three-bedroom townhouses and twenty one, one-bedroom flats.

The proposed development layout details are shown in Figure 3 below.

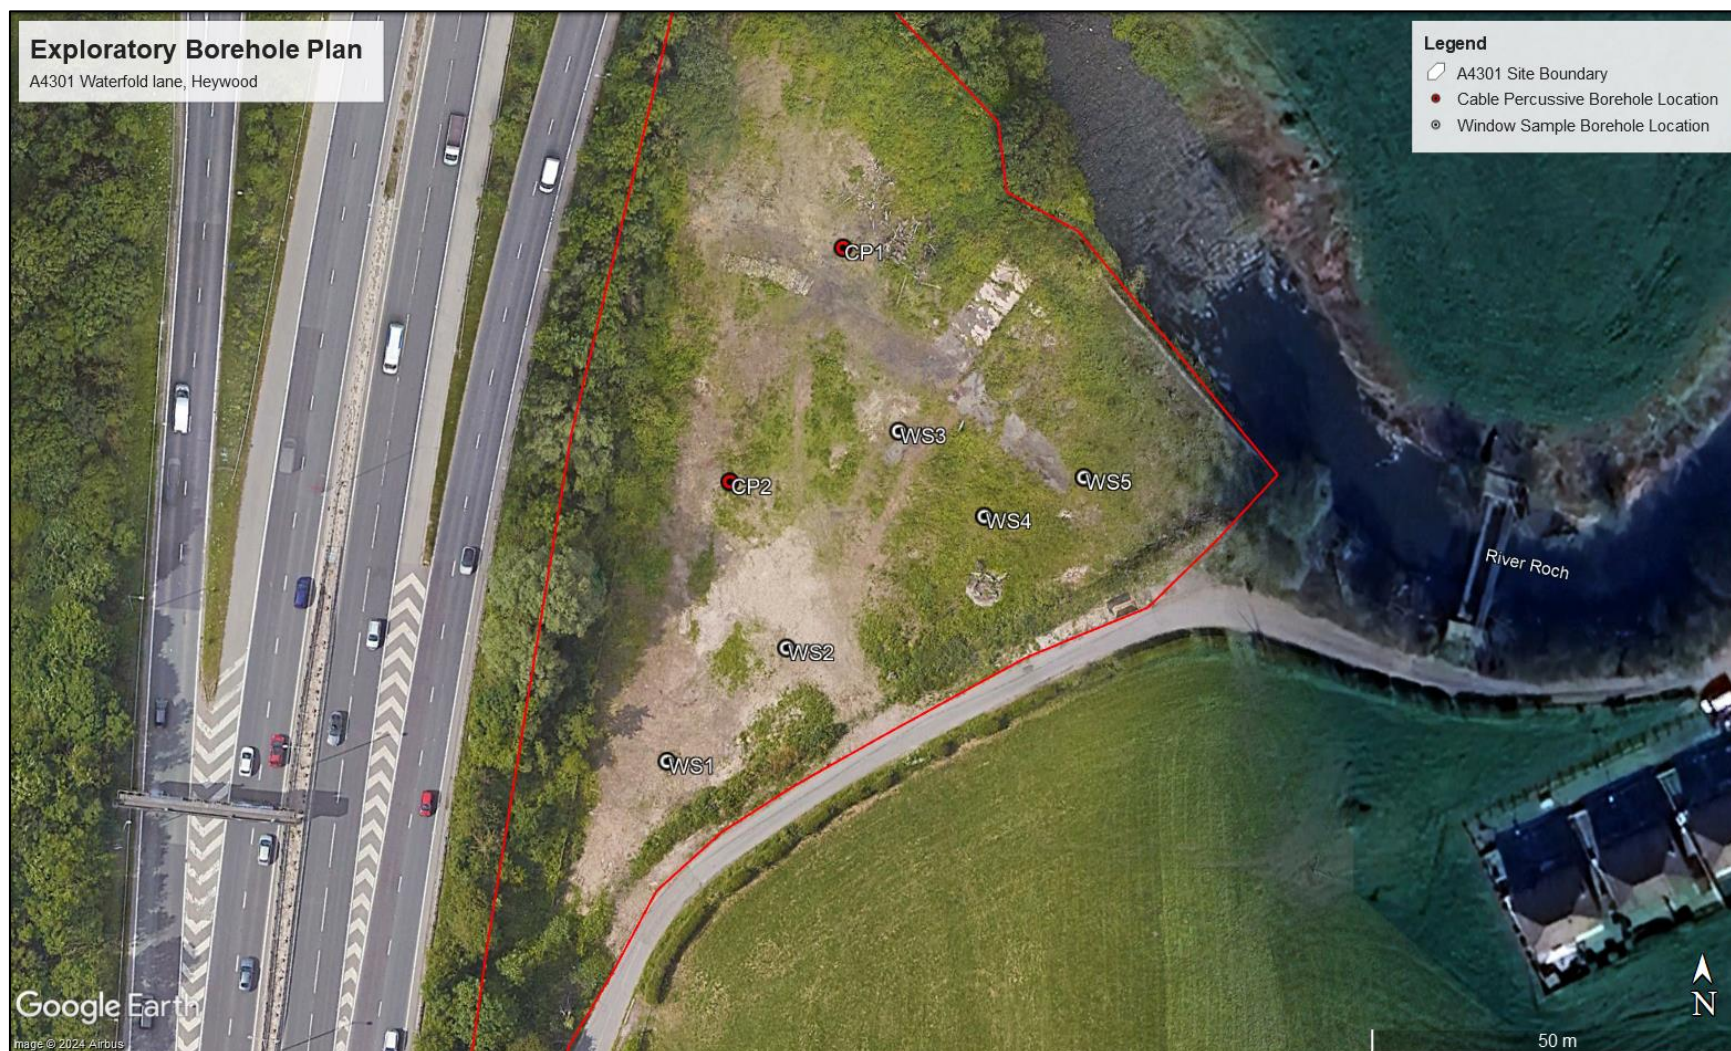
Figure 4: Exploratory Hole Location Plan

An Exploratory Hole Location Plan is presented as Figure 4, overleaf.
